**swissport**    
fueling services  
2350 S. 190<sup>th</sup> Street  
Seattle, WA 98198

The following areas of concern of Title 49 CFR Part 195 were noted as a result of WUTC inspection in June 3-4, 2014 of Swissport Fueling Inc.- SeaTac Fuel Facilities LLC.

1. 49 CFR 195.432 Inspection of in-service breakout tanks.

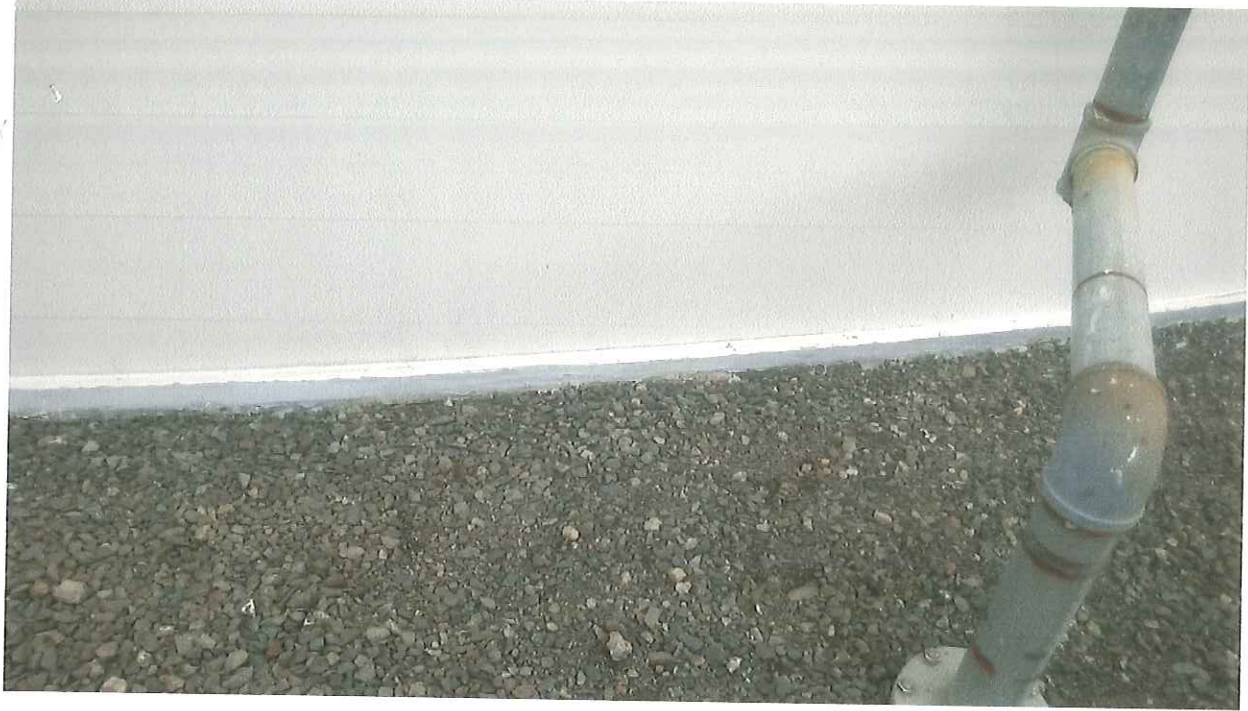
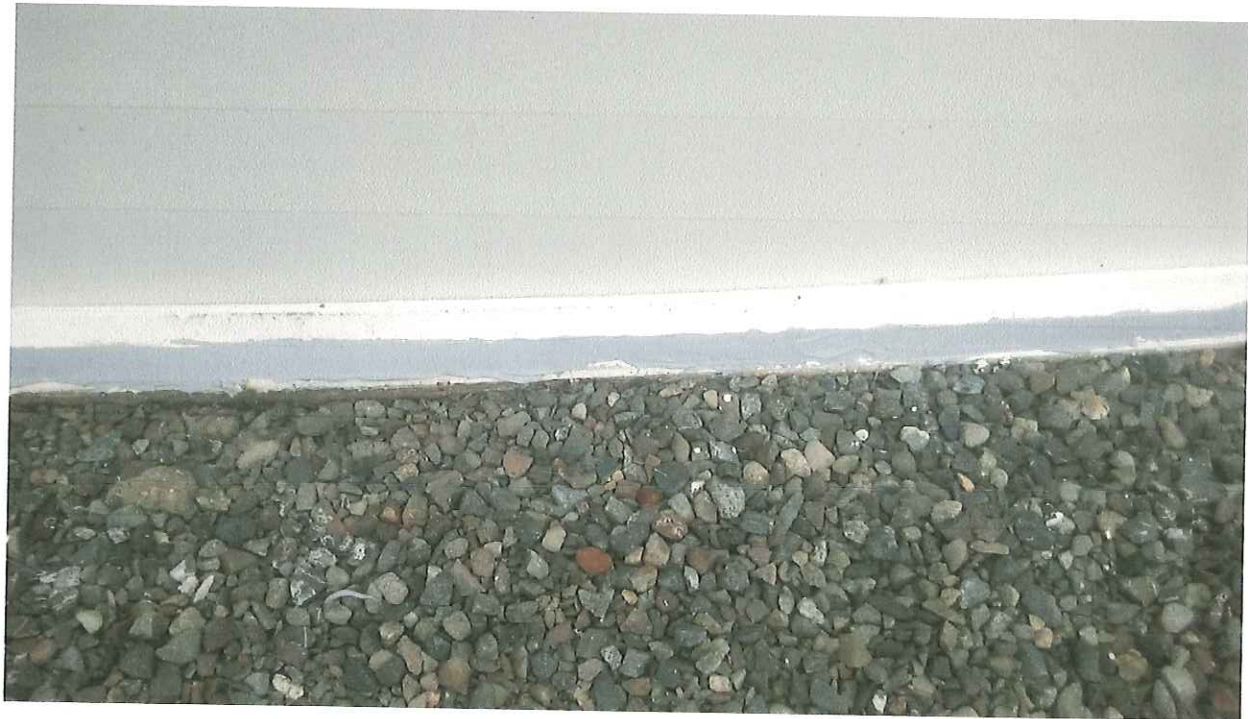
**Finding:** In the last two 5 years in-service API inspections, API 653 inspectors noted that there should be a moisture barrier caulking applied between the foundation and the tank shell.

**Corrective Action:** We followed their recommendation and we applied moisture caulking between the foundation and tank shell of Breakout Tank 115.
