# PLYMOUTH PLANT INCIDENT INVESTIGATION

# Overview

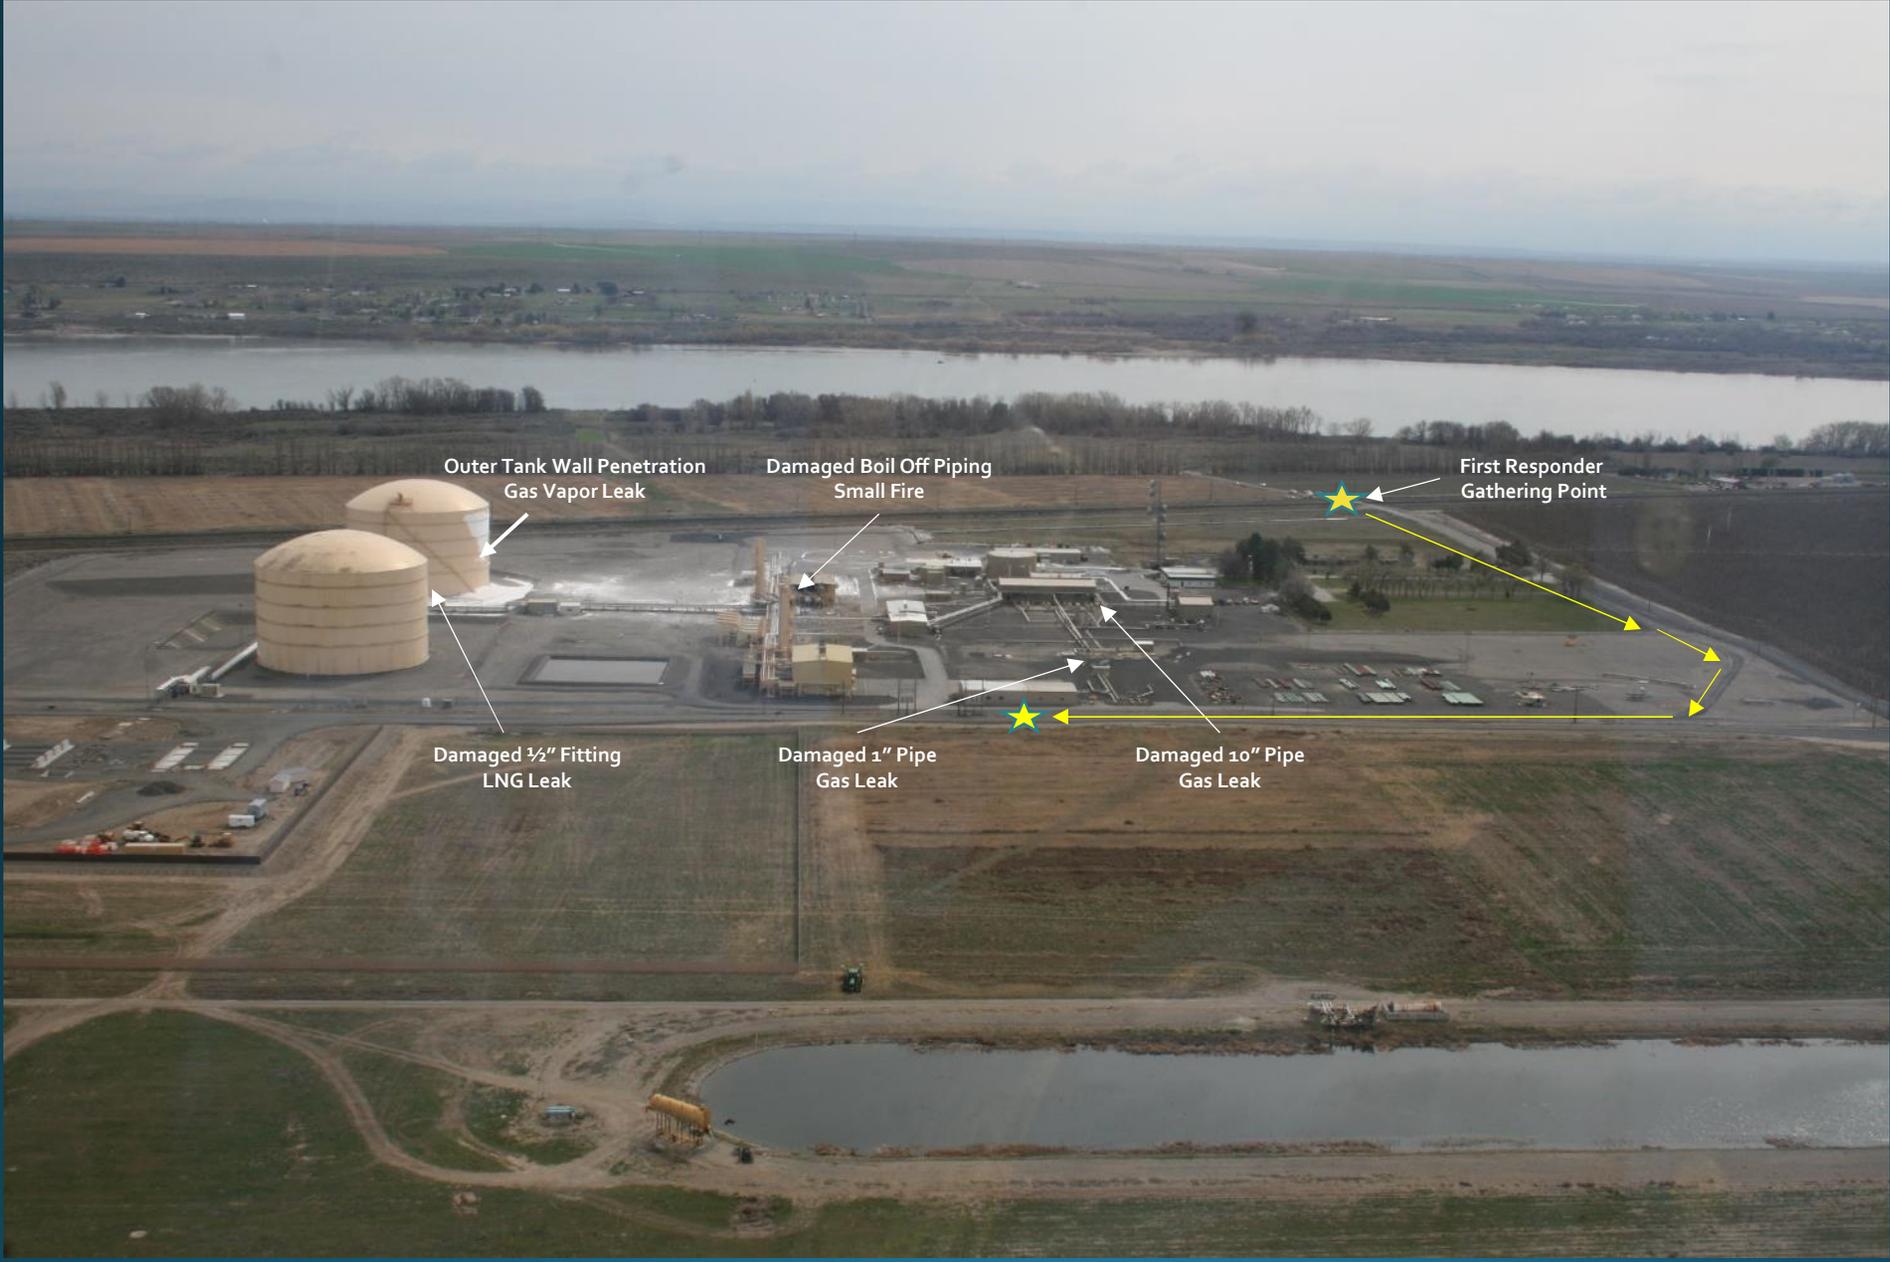
Outer Tank Wall Penetration  
Gas Vapor Leak

Damaged Boil Off Piping  
Small Fire

Damaged 1/2" Fitting  
LNG Leak

Damaged 1" Pipe  
Gas Leak

Damaged 10" Pipe  
Gas Leak

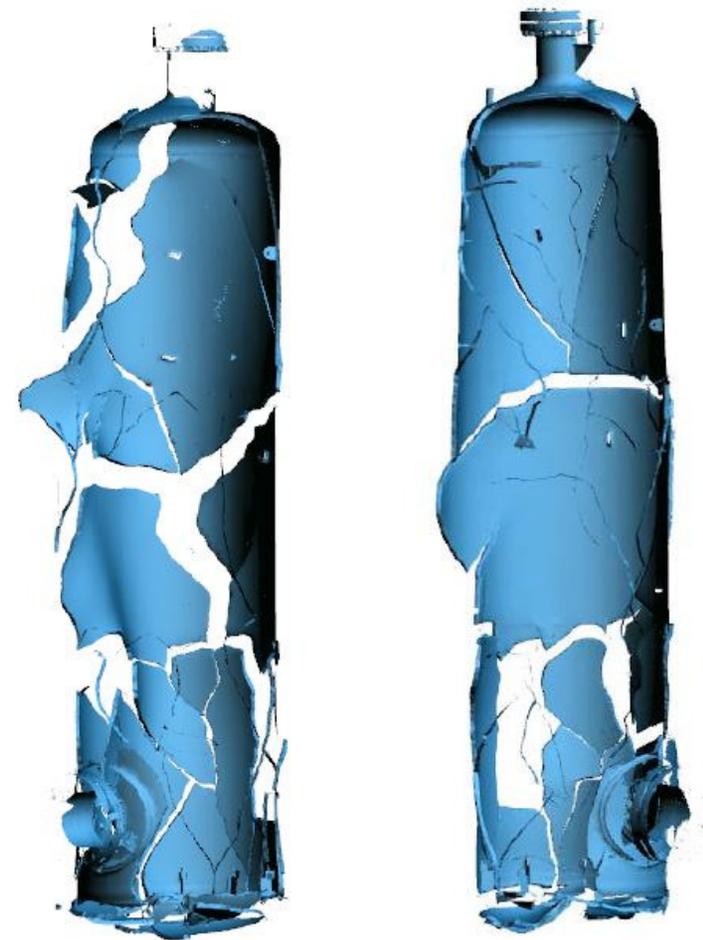
- Adsorber D-20A weighing ~50,000 lbs
- Debris generated from the failed adsorber caused significant collateral damage
- Mechanical failure of the adsorber was the initial focus of the investigation
- Stress Engineering Services (SES) was contracted and mobilized to the site to evaluate vessel fragments
- SES performed high resolution scans of all available vessel fragments
- Scanned fragments were weighed and re-assembled in a 3-D model to ensure all pieces were accounted for

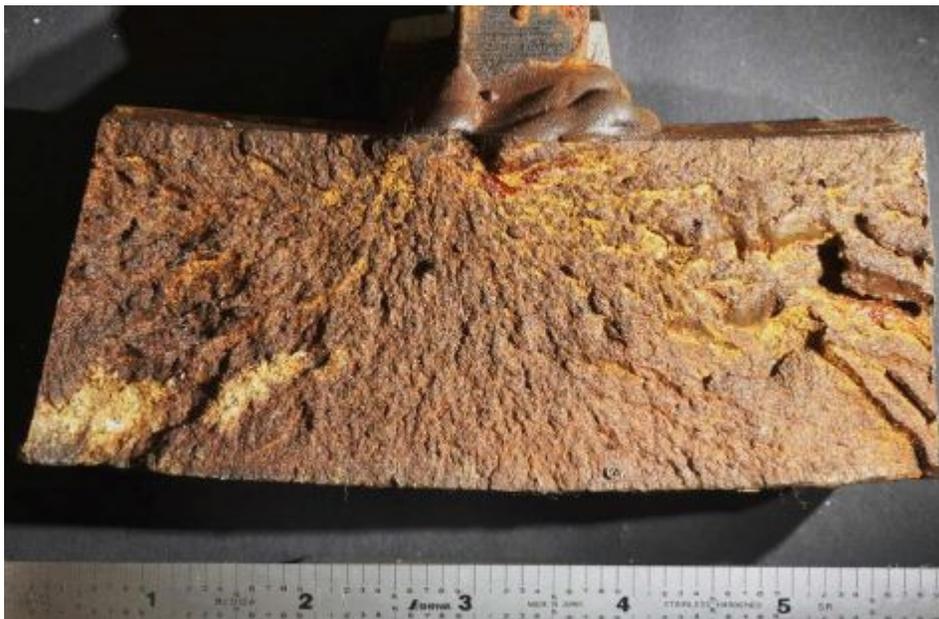
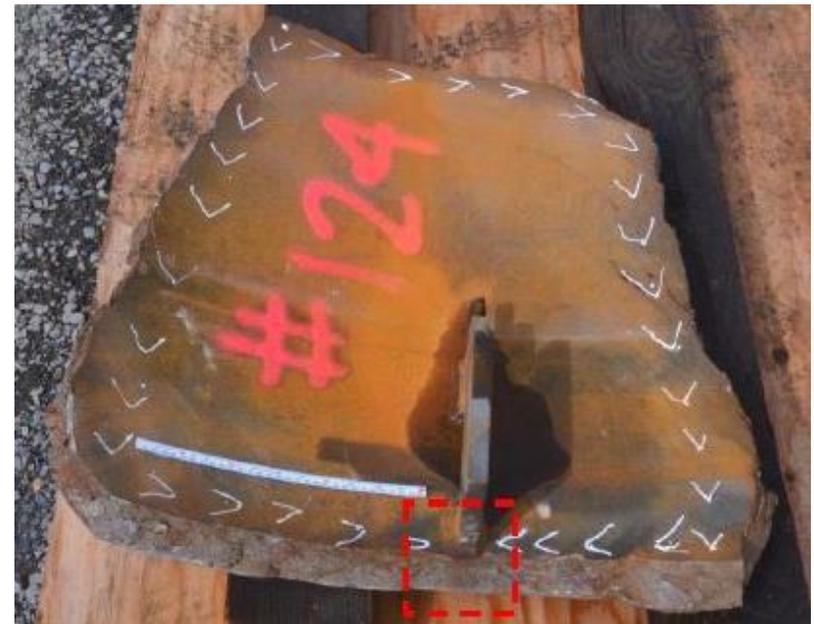
- Chevron markings point towards fracture ‘initiation sites’
- Fragments containing points of interest were shipped to SES facilities in Houston for detailed examination

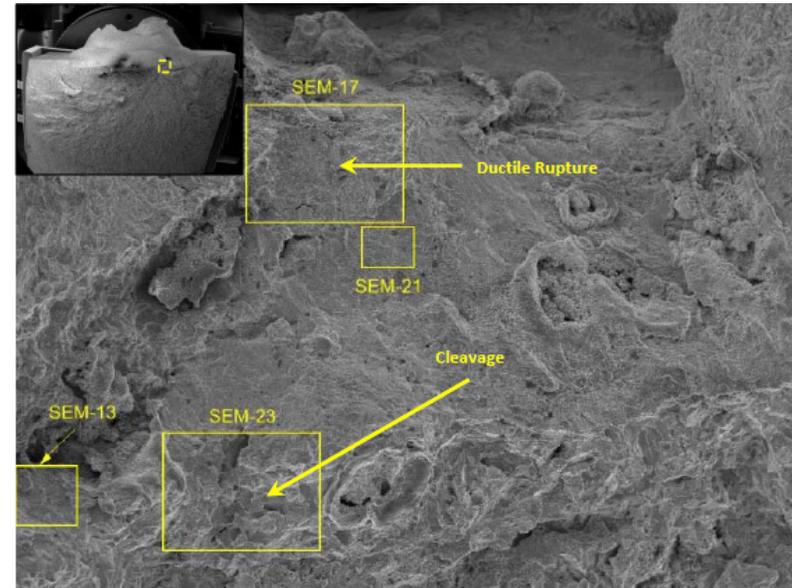
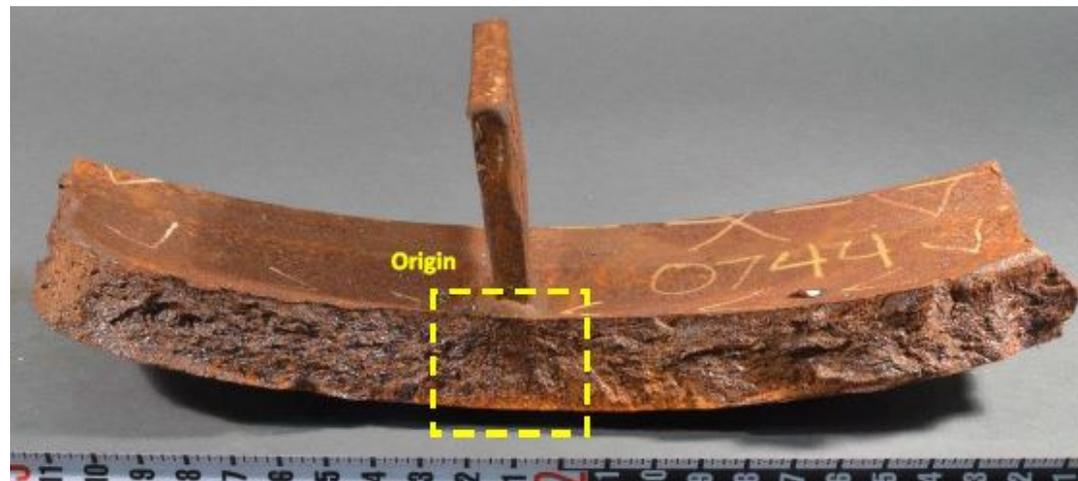
- SES also performed testing to confirm proper materials of construction
  - Found no cause for concern
  - Found no evidence of soot/combustion materials on vessel walls

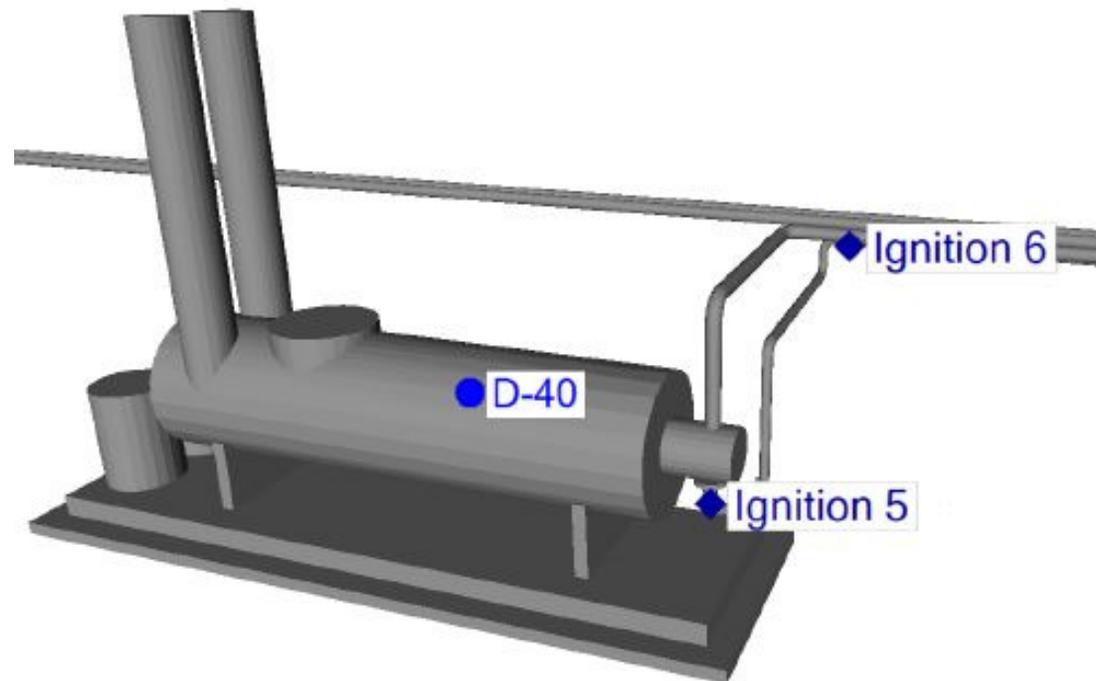
- Results identified the Salt Bath Heater inlet nozzle as the initial ignition location (identified as ignition location 5)

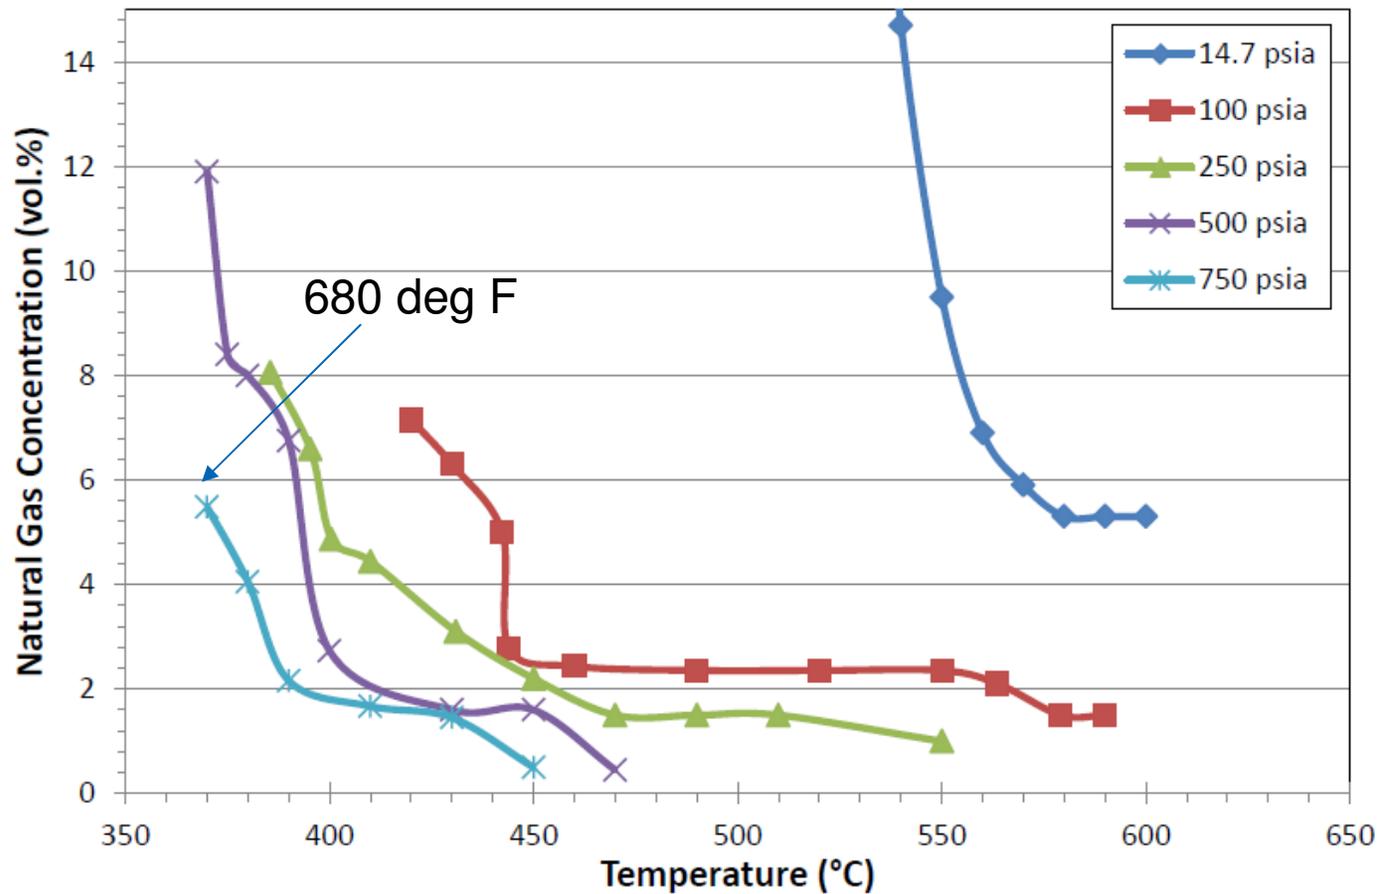
- Concluded that auto-ignition of Plymouth inlet gas at ~700 psig could fall as low as 680 deg F.
- The plant heater was running @ 550 deg F
- Calculated additional heat was provided during pressure up from 53 psig to 685 psig (adiabatic compression) 15 minutes prior to the incident

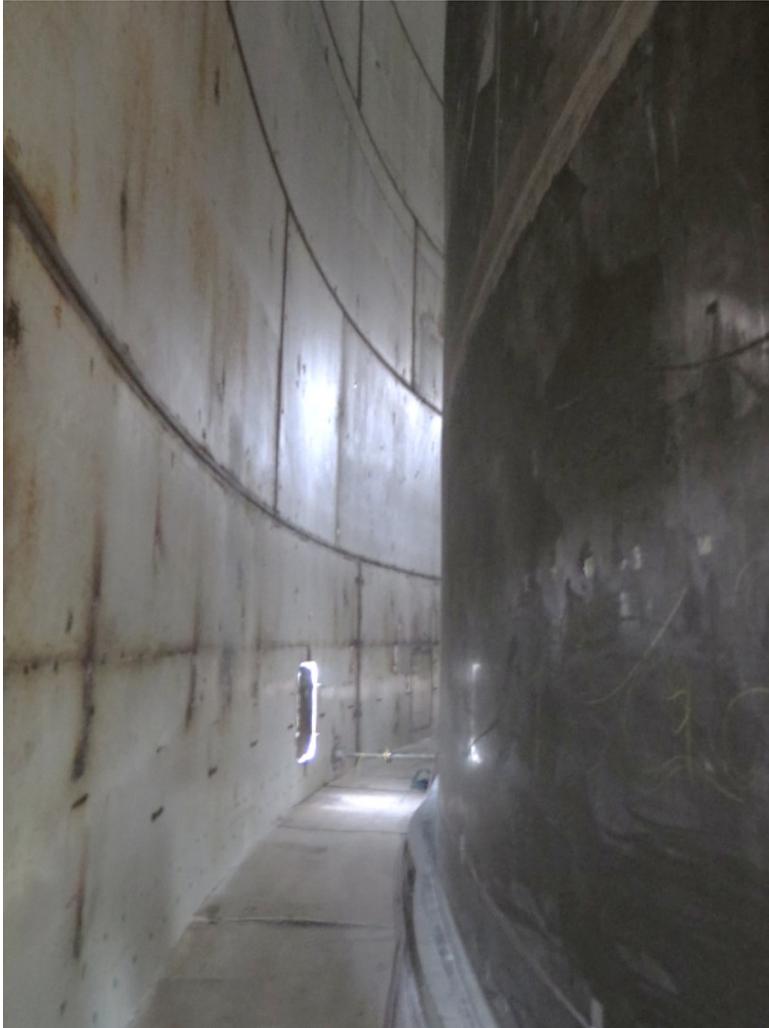
# LNG I Tank Internal Inspection

- Dent indication on east quadrant was characterized using electromagnetic residual stress sensors and laser scanning. Fitness for service was performed by Stress Engineering. The dent was repaired by blend grinding and was made safe for continued operation
- External foundation inspection
- Roof support bolts inspected by Chicago Bridge and Iron
