**POST INSPECTION MEMORANDUM****Inspector:** Al Jones, UTC**Reviewed:** Joe Subsits, UTC, 9/27/2012**Peer Reviewed:** RR**Follow-Up Enforcement:** **No Violation** ✓~~PCP\*~~ ~~PCO\*~~ ~~NOA~~ ~~WL~~ ~~LOC~~**Director Approval\*** Chris Hoidal*CH 12/17/12***Date:** September 28, 2012**Operator Inspected:** Olympic Pipe Line Company    **OPID:** 30781    **Region:** Western**Unit Address:**2201 Lind Ave. SW, Suite 270  
Renton, WA 98055

State of Washington  
UTC  
Pipeline Safety Program**Unit Inspected:** Olympic Pipe Line - NORTH**Unit ID:** 925**Unit Type:** Interstate Hazardous Liquid**Inspection Type:** I-07 – IMP Field Verification, O-07 – Integrity Management Follow-up**Record Location:** Renton, WA**Inspection Dates:** September 17 - 19, 2012**AFOD:** (I-07=1, O-07=0.5)**SMART Activity Number:** 14/587**Operator Contact:** Jim Bruen**Phone:** 630 536-2535    **Fax:** 630 420-5519    **Emergency:** 888-271-8880**Unit Description:**

# UTC IMP verification Form

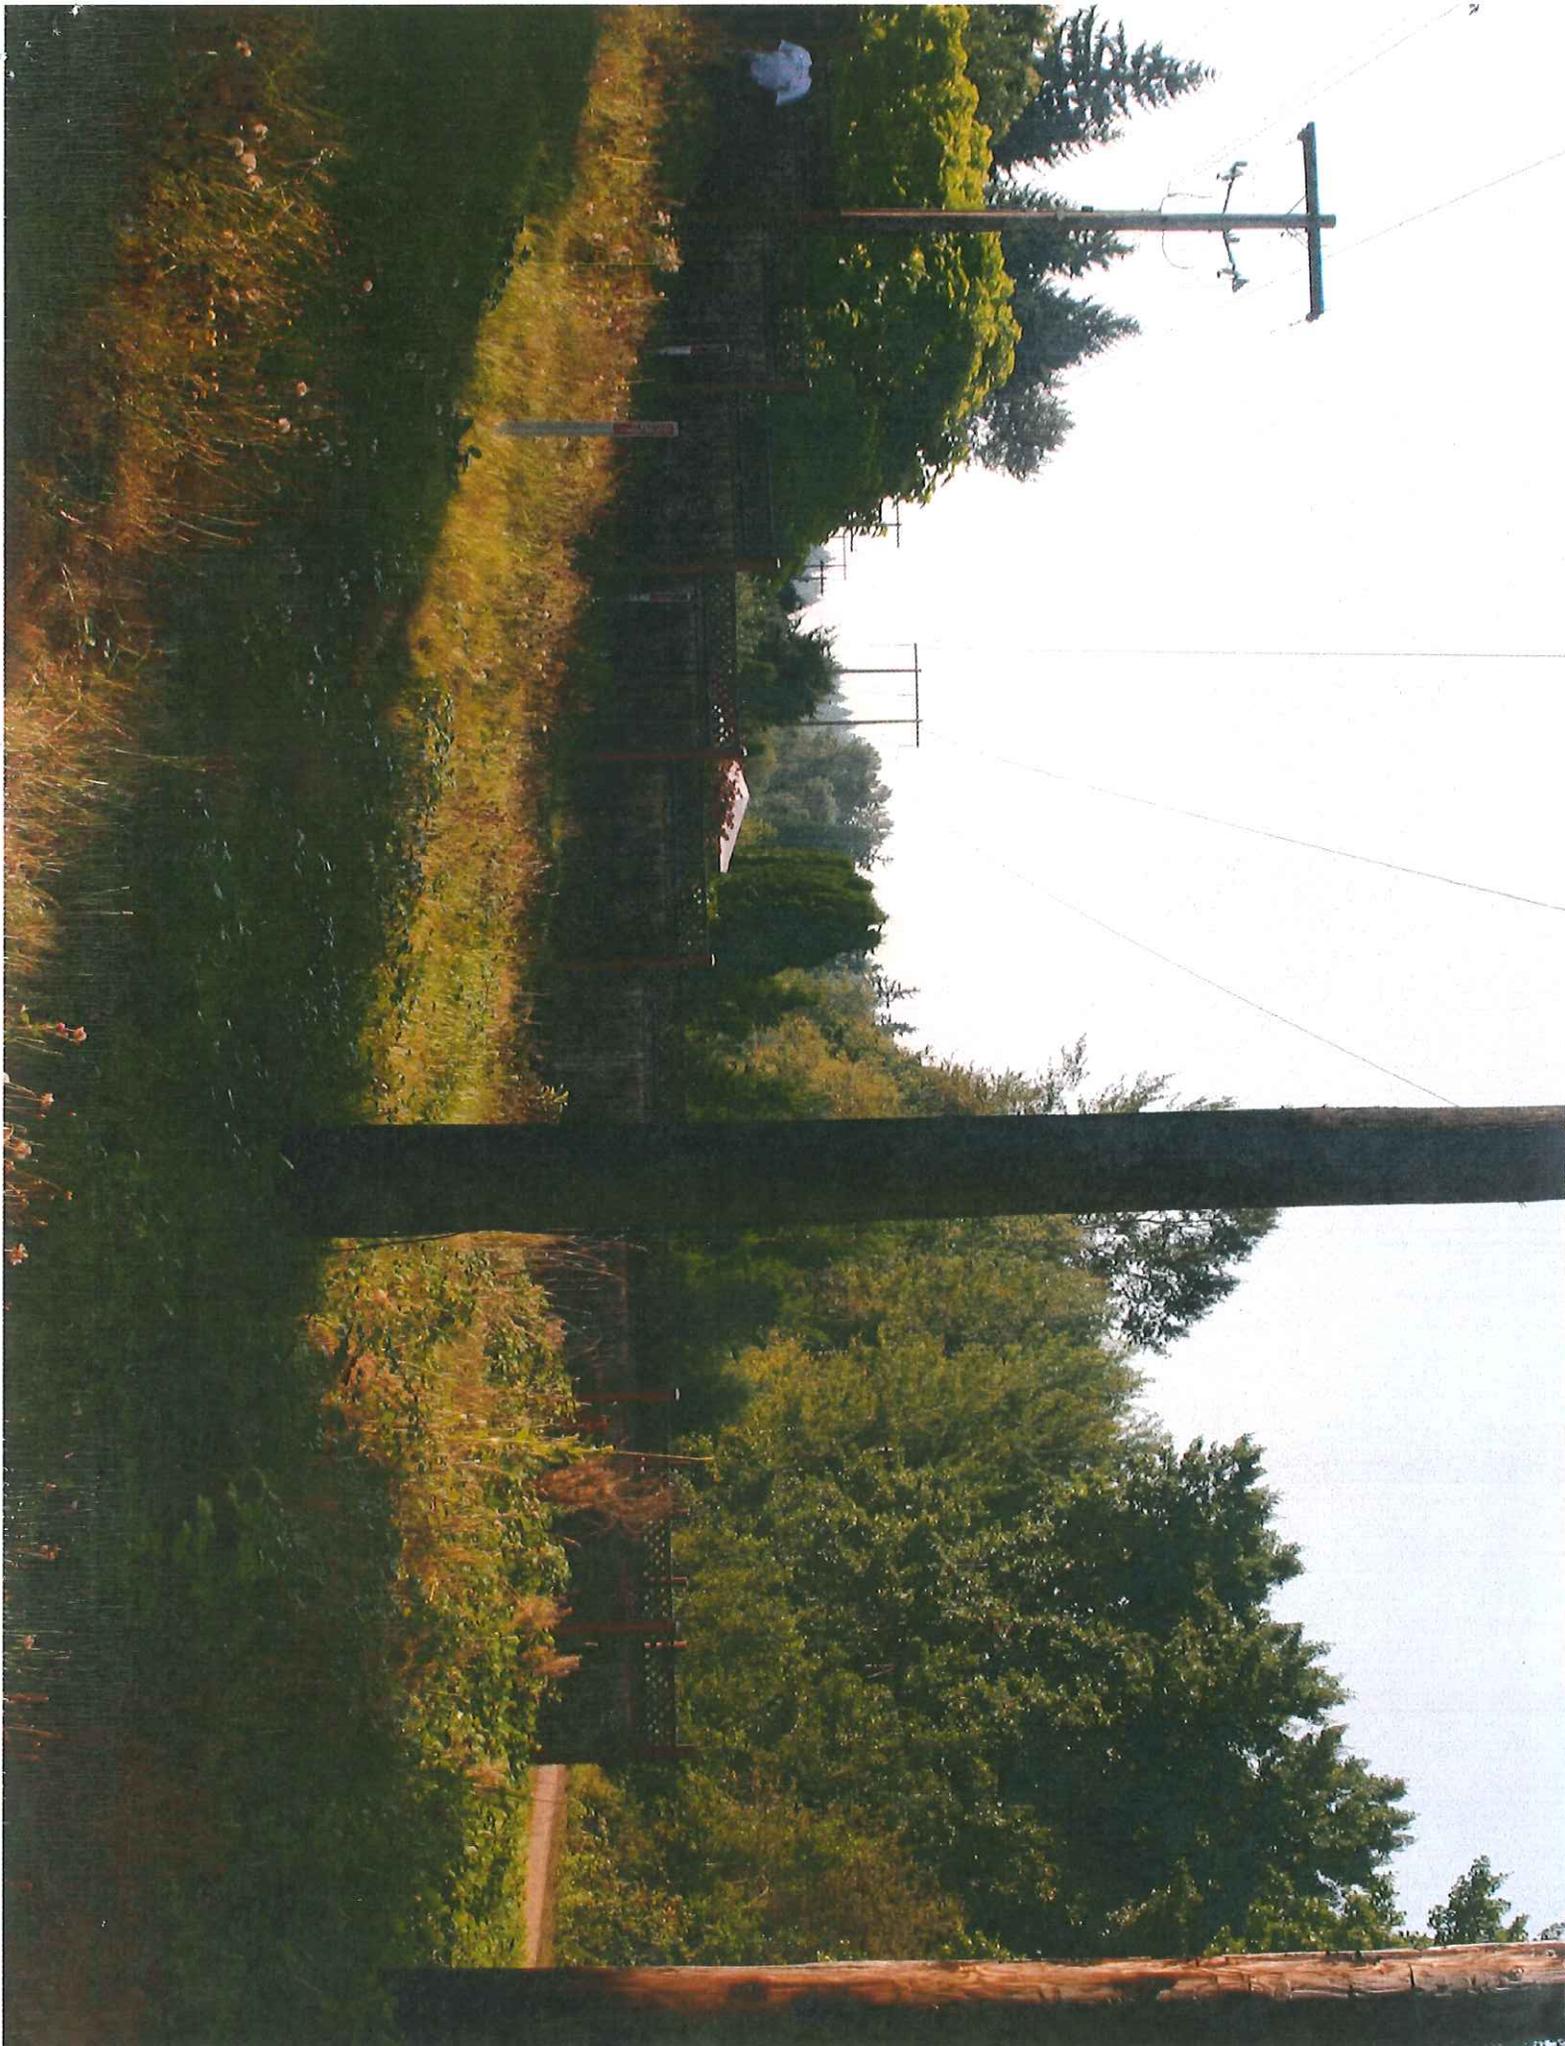
8.	PD.RW.ROWCONDITION.O	Sat+	Sat	Con	Unsat	NA	NC
195.412(a)			✓				
<b>Are the ROW conditions acceptable for the type of patrolling used?</b>							
<b>Notes</b>							
Yes, see attached photos of the cleared ROW conditions.
