**RE: Incident Investigation (NRC No. 1163165): 4420 180th Street East, Tacoma, WA
Nov. 2, 2016 - Olympic Pipe Line-South (Inv. No. 7192)**

UTC Incident Investigation Form

Operator:	Olympic Pipeline Company
District/Unit:	Olympic Pipeline South
Locations:	4420 180th St E
Incident Dates:	November 2, 2016

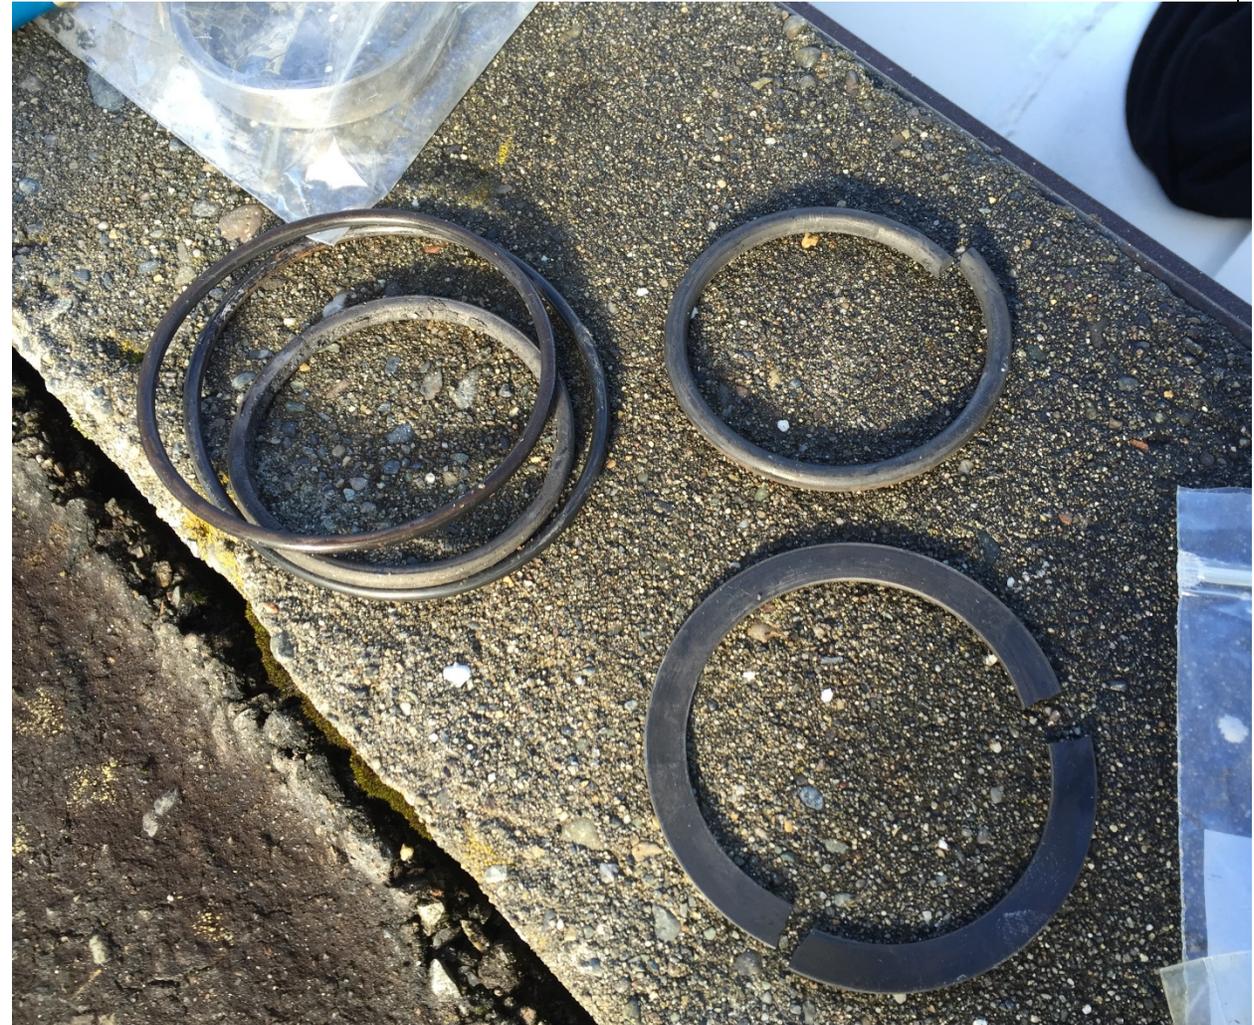
A Failed O-ring and Gasket caused the product to leak from a control valve.

A root cause investigation which included the manufacturer, was ordered shortly after the incident in 2016 and completed sometime in June of 2017. The results of the investigation were inconclusive as to the failure of the O-ring which is believed to have caused the failure of the gasket. They could find no indication of any type of systemic problem with the O-ring or gasket.

Failed O-Ring and Gasket

13:00- Repairs completed on the control valve.
