**RE: 2017 National Response Center Incident No. 1169311 – Cascade Natural Gas Company,
Wenatchee District – (Investigation No. 7434)**

UTC Incident Investigation Form

Notification ID:	3112 NRC #1169311	Investigation ID:	7434
-------------------------	----------------------	--------------------------	------

Operator:	Cascade Natural Gas - 2128
District/Unit:	Wenatchee
Locations:	1317 South Hills Ave, Wenatchee WA
Incident Dates:	January 19, 2017

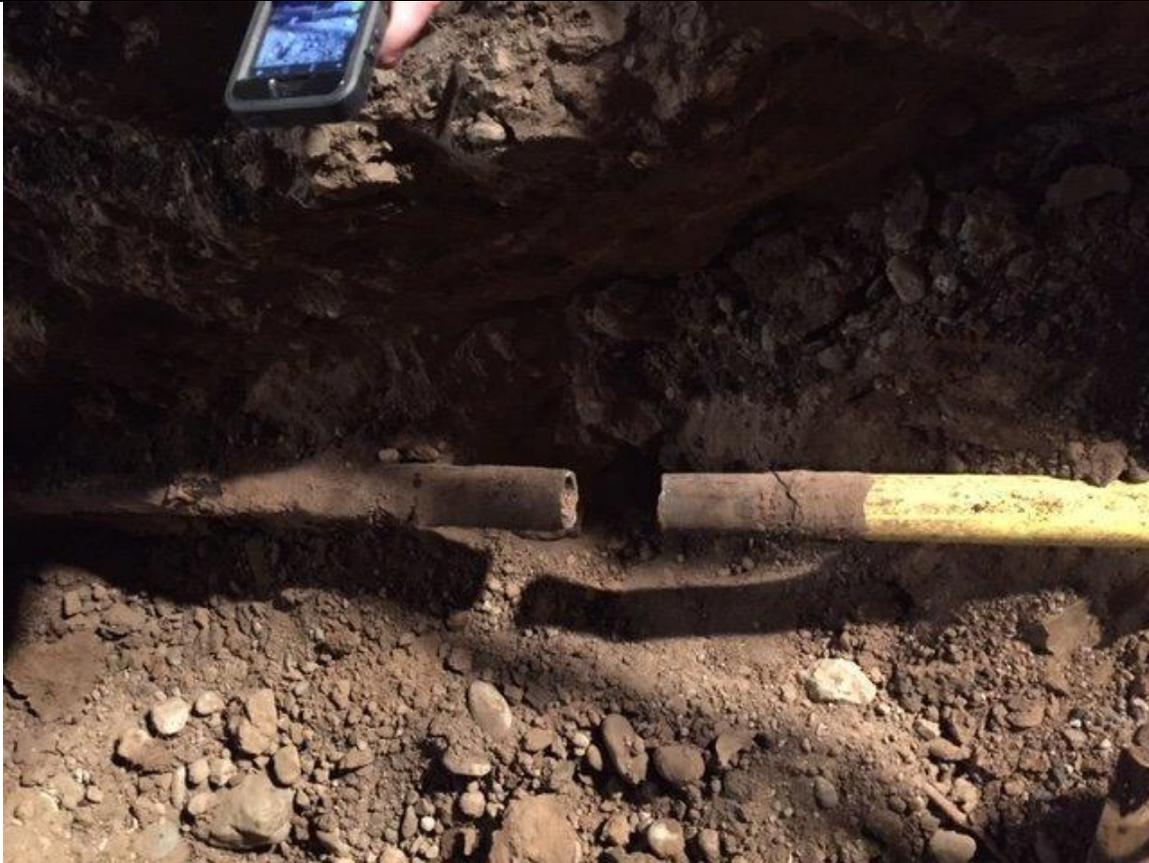
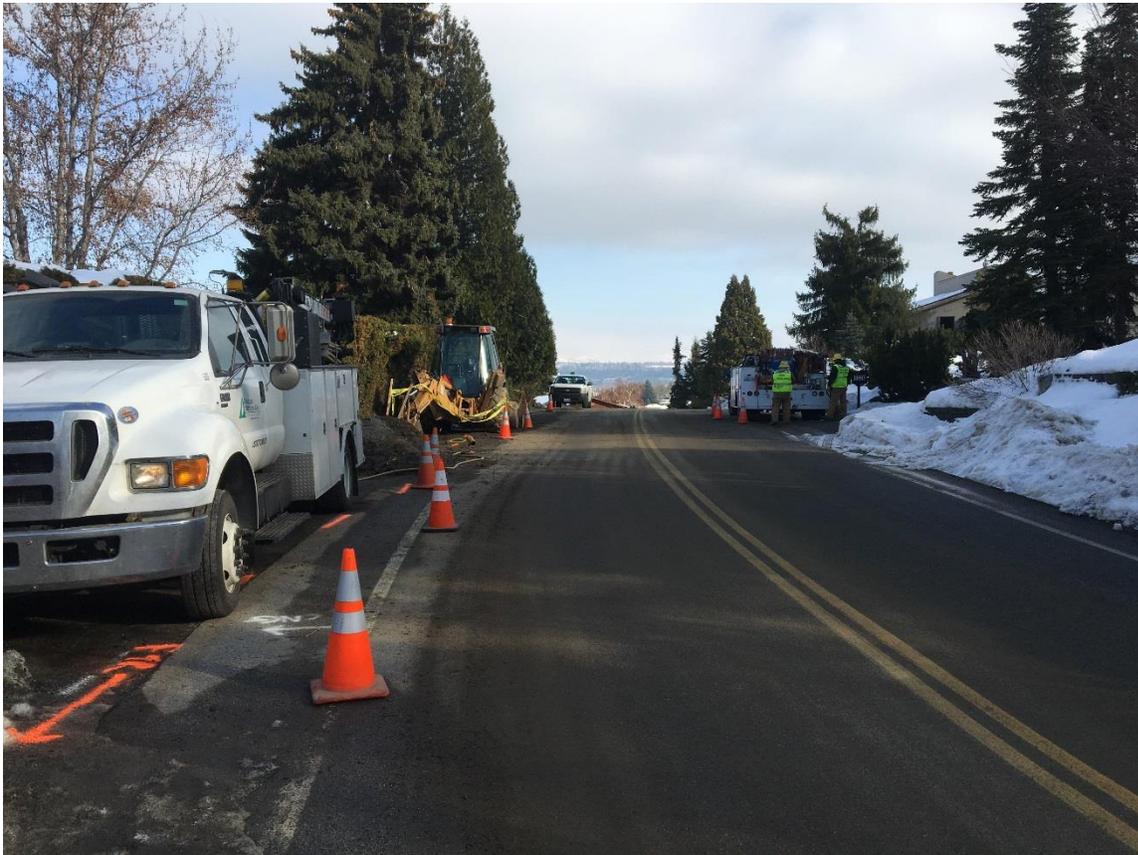
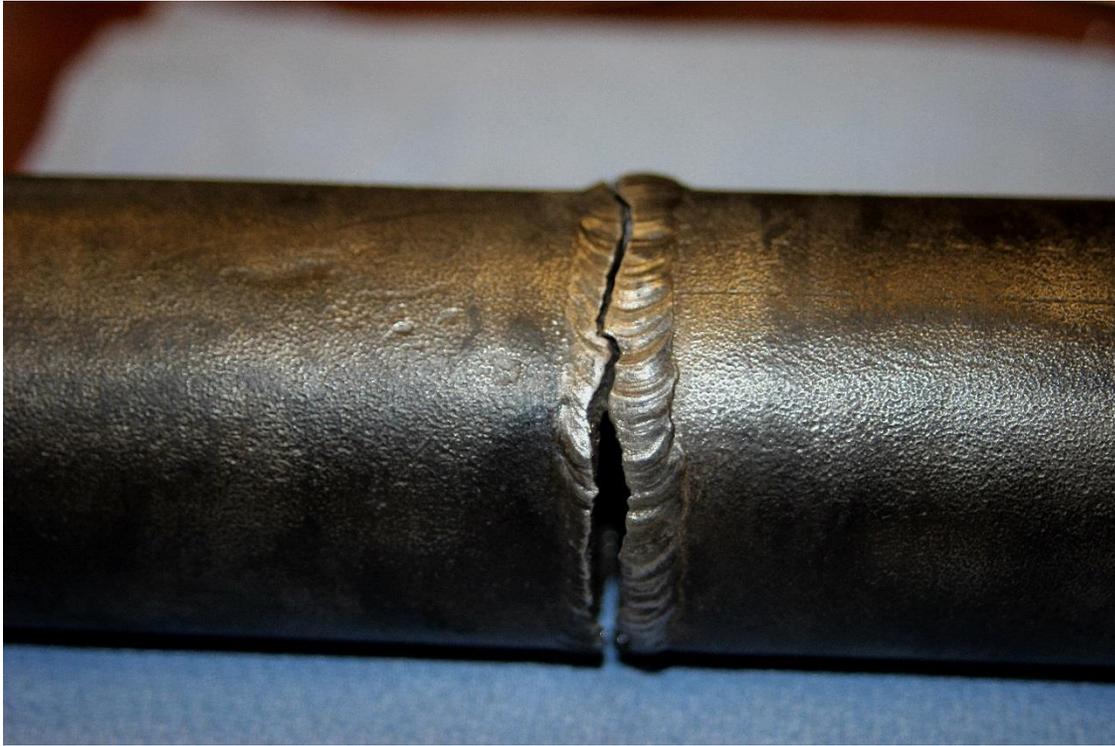
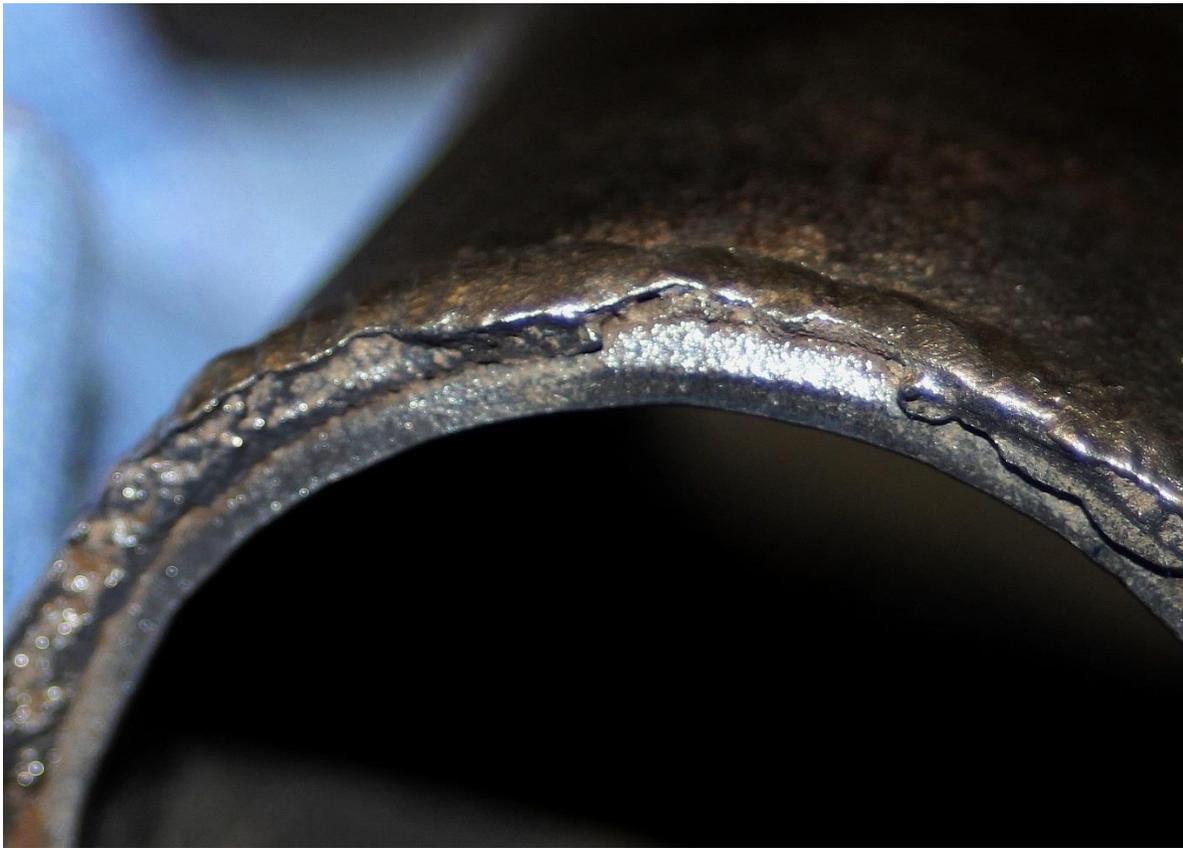
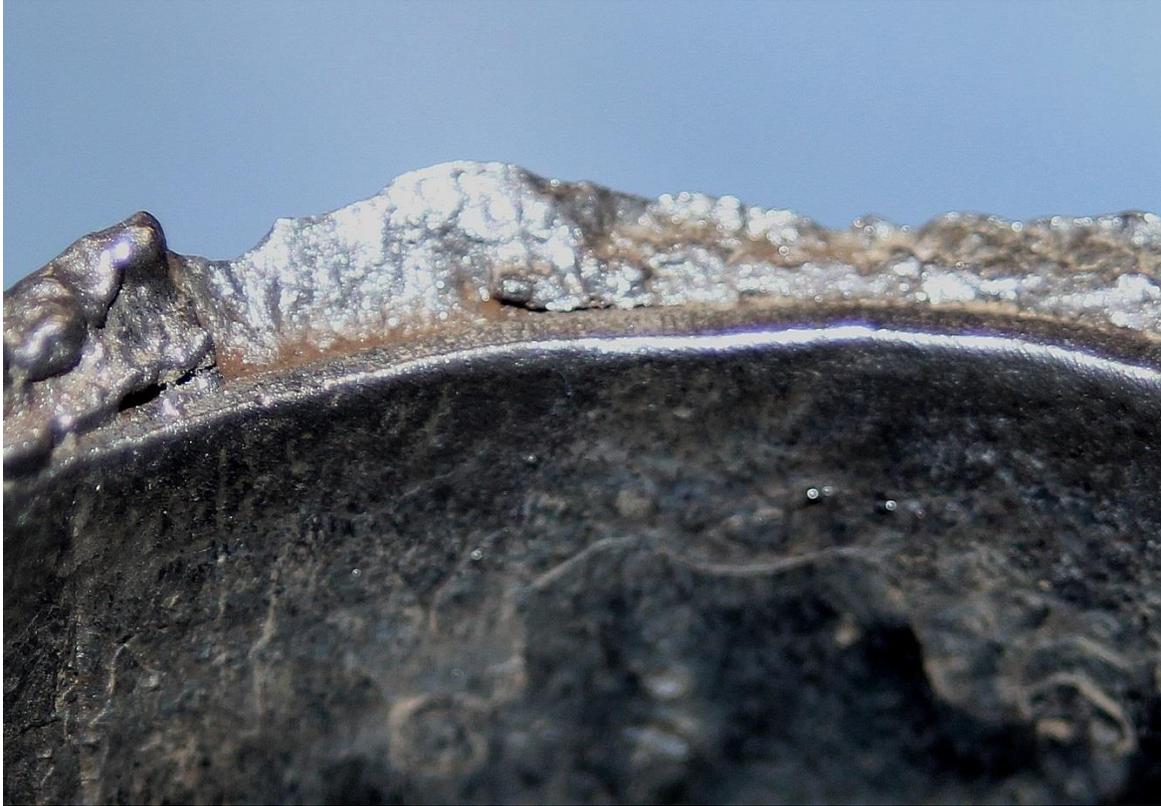
Description:
<p>Prior to failed specimen exam - A two-inch steel main separated underground due to unknown reasons, potentially weather/frost heave related. An approximately 4" gap was present when the main was exposed. A bypass was installed around the pipeline due to it being a one way feed. This increased the time the gas was released and resulted in over 3mmcf being released which met the definition of an incident requiring NRC reporting.</p> <p>After close examination and CNG engineering analysis - After a close examination of the failed specimen it was determined that the weld failed due to inadequate to no penetration of the pipe face at the butt weld. Some portions of the weld had only the weld cap and no pipe face penetration of the filler metal. Although pre code pipe installed in 1967, the specimen examined did not meet API 1104 or CFR Part 192, Appendix C requirements. This combined with extremely cold weather and a frost line that extended below the depth of the buried pipeline caused the minimally joined weld surfaces to fracture and pull apart.</p> <p>In addition – CNGC has plans to replace the entire development of similar vintage steel pipeline mains and services and the project is currently out for bid.</p>

Inadequate fusion of the weld filler metal to the pipeline.
Inadequate penetration of the root pass.

Extreme weather conditions with a frost line that extended below the depth of the pipeline put excessive stress on the weld where it cracked and separated.

CNG took appropriate action and removed and replaced the failed weld.
CNG will conduct weekly leak surveys until the lab analysis is completed.
If it is determined that it failed due to poor workmanship on the weld it is anticipated that CNG will replace the entire segment of pipeline that was installed in 1967. This includes 2,700 ft. of main.
Also discussed was removing and testing additional welds which was agreed would be the second option if the entire segment is not replaced. UTC staff and CNG will discuss once the lab analysis is completed.
It was noted to CNG that once CNG receives the lab analysis it should be submitted to the UTC within 5 days per WAC code.
