Re: NW Natural Response to Camas Transmission Line Inspection

The Washington Utilities and Transportation Commission (WUTC) Staff conducted a pipeline safety inspection of NW Natural's (P04) Camas Transmission Line on June 17-19, 2014. This letter is in response to the findings of Inspection Report, dated August 27, 2014.

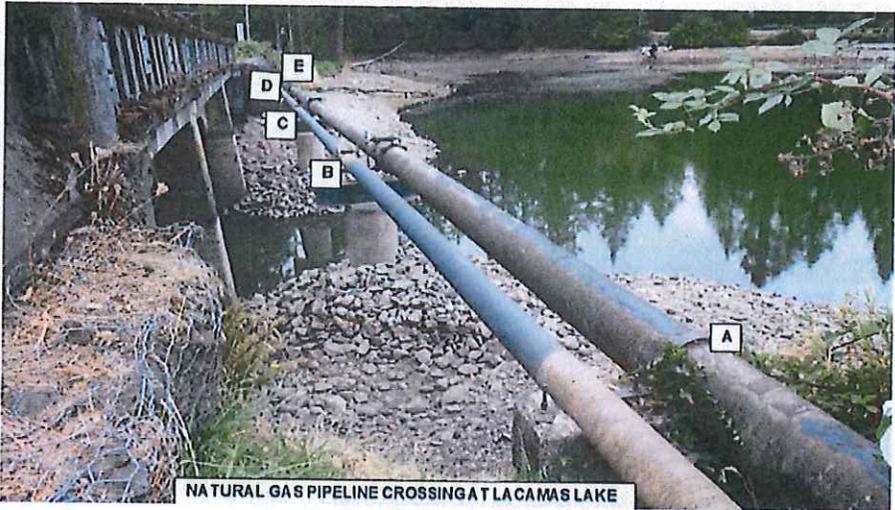
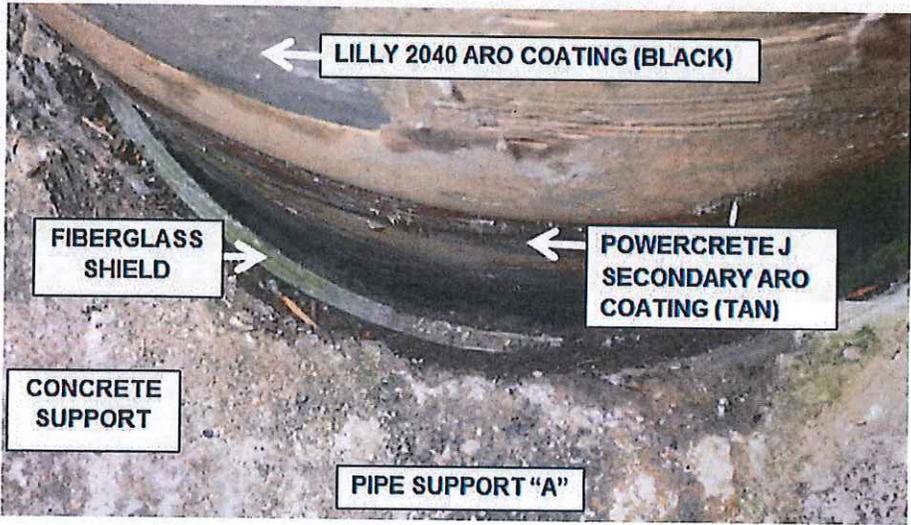
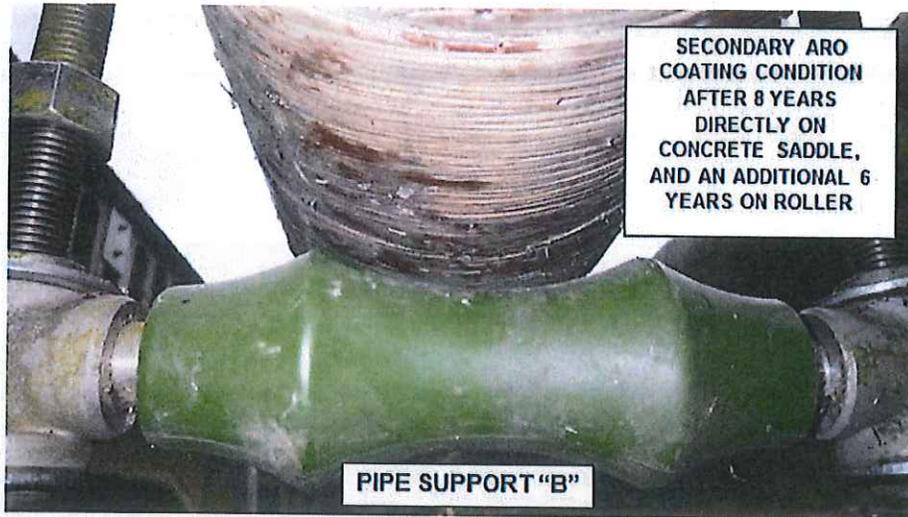
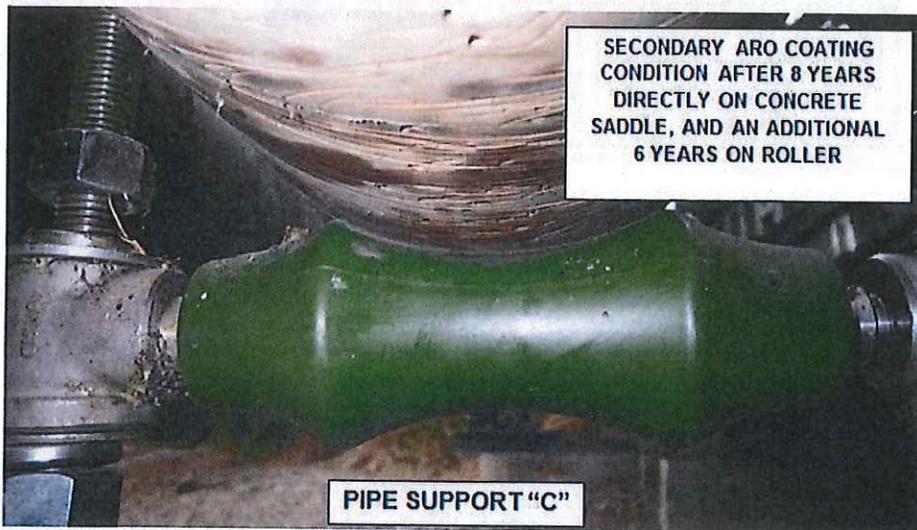
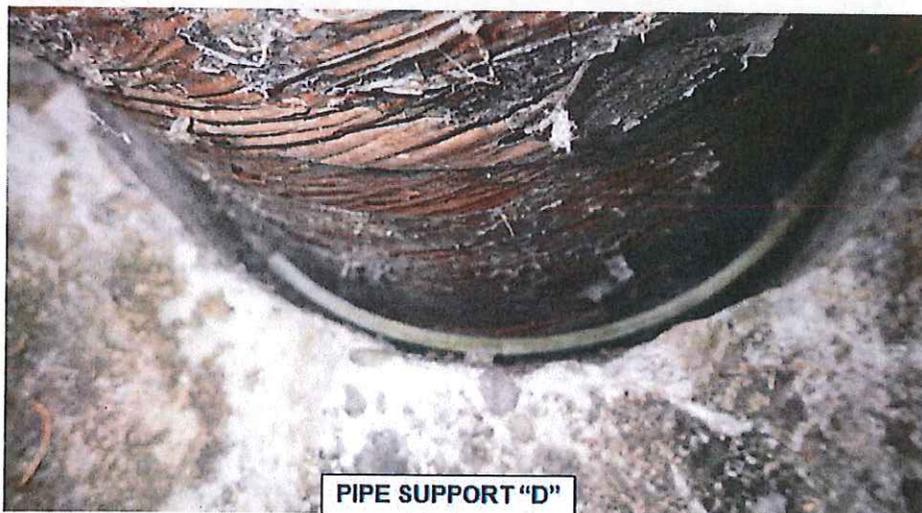
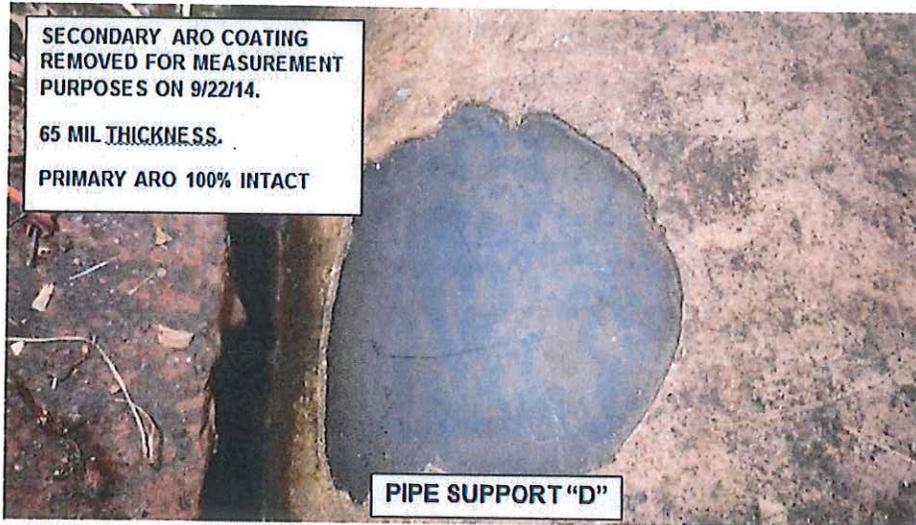
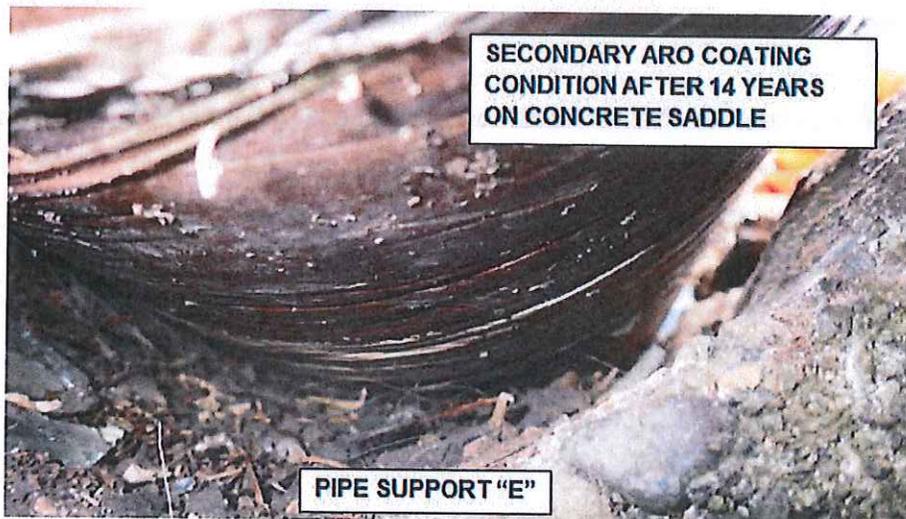
- On September 22, 2014 NW Natural took readings of the existing pipe coating at all five piers at the Lacamas Lake crossing. These readings were taken with a DeFelsko PosiTector (serial # 45-4805-13), ultrasonic thickness tester. This included examination of the coating under the roller pipe supports on the piers that were replaced in 2008. A measurement was taken in each quadrant at all pipe support locations. These readings are summarized in attachment 1 and photos below. In addition, the resulting observations of the coating at each support showed no signs of coating disbondment, abrasion, UV degradation or atmospheric corrosion. In our opinion, the findings

Visual observation at each pipe support revealed the following:

- A fiberglass reinforced plastic shield is still intact between the three layer coating and the concrete support at locations A and D
- The black primary ARO was not visible in any area containing the secondary ARO (i.e. the primary ARO was fully encapsulated in the secondary ARO layer).
- The green FBE corrosion protection later was not visibly exposed to the atmosphere at any location.
- The coating system is functioning as designed.

Additionally, NW Natural will continue its on-going discussions with the City of Camas regarding their pier replacement project. As the opportunity is presented, NW Natural will install new generation pipe support rollers at this site.
