Re: NW Natural Response to Inspection of Clark County (#6182)

The Washington Utilities and Transportation Commission (WUTC) Staff conducted a pipeline safety inspection of NW Natural's Clark County service area from March 30-April 10, 2015. This letter is in response to the findings of Inspection Report #6182, dated May 29, 2015.

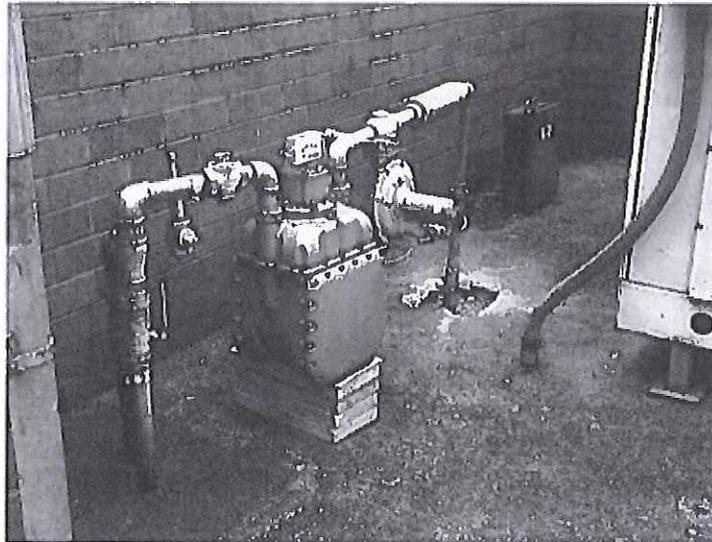
*During the field verification portion of the inspection, random annual pipe-to-soil (P/S) reads were taken at NWN test sites. One of those sites in Washougal, WA is the Jemtegaard Middle School meter set. During this read, it was also noted the Jemtegaard Middle School meter set was supported with wood 2x6 material. This material is combustible. This is a NOPV as combustible materials are prohibited. As finding this situation was a coincidence, it does bring up the question, Are there any other meters which are supported by combustible materials and, if so, NWN will need to find them and ensure they are remediated.*

The location identified above was remediated the week following the inspection by replacing the wood blocks with concrete blocks separated from the meter by fiberglass sheets. Please see photo below:
