**RE: Natural Gas Incident Investigation: 14360 SE Eastgate Way, Bellevue, Washington
– June 18, 2015 (Insp. No. 6469)**

UTC Incident Investigation Form

14360 SE Eastgate Way, Bellevue
Natural Gas Pipeline Rupture and Unintentional Ignition

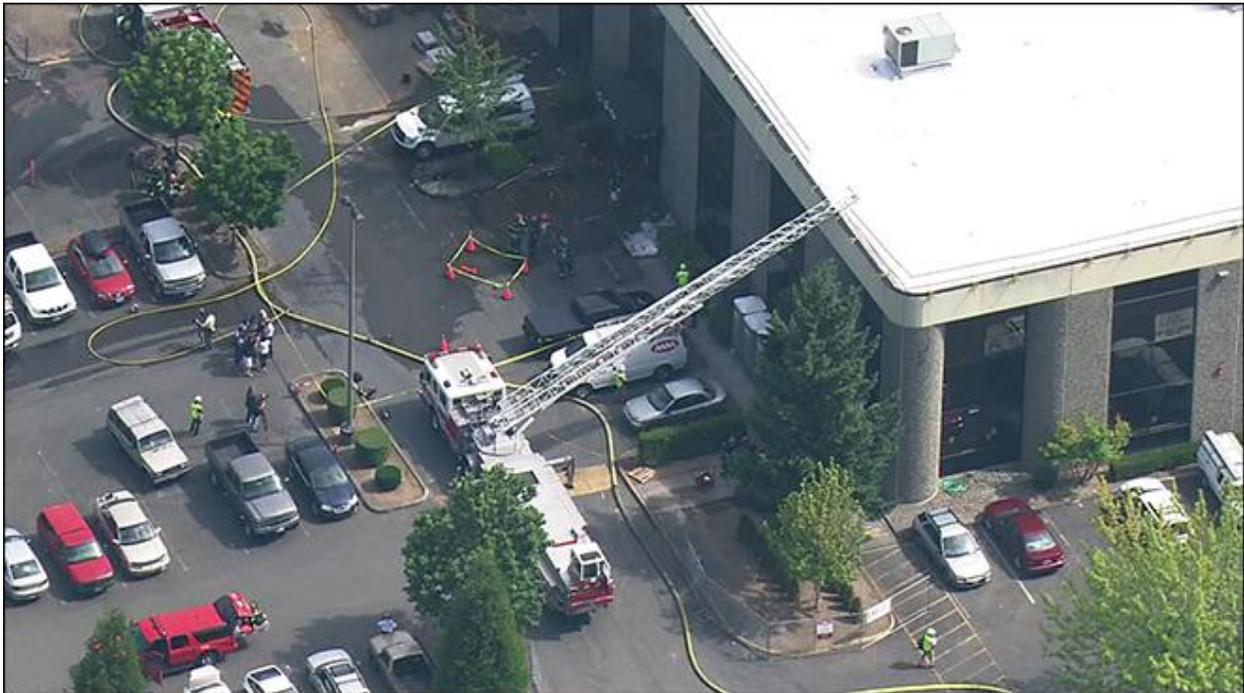
Photo 1: Aerial view of incident scene and BFD response

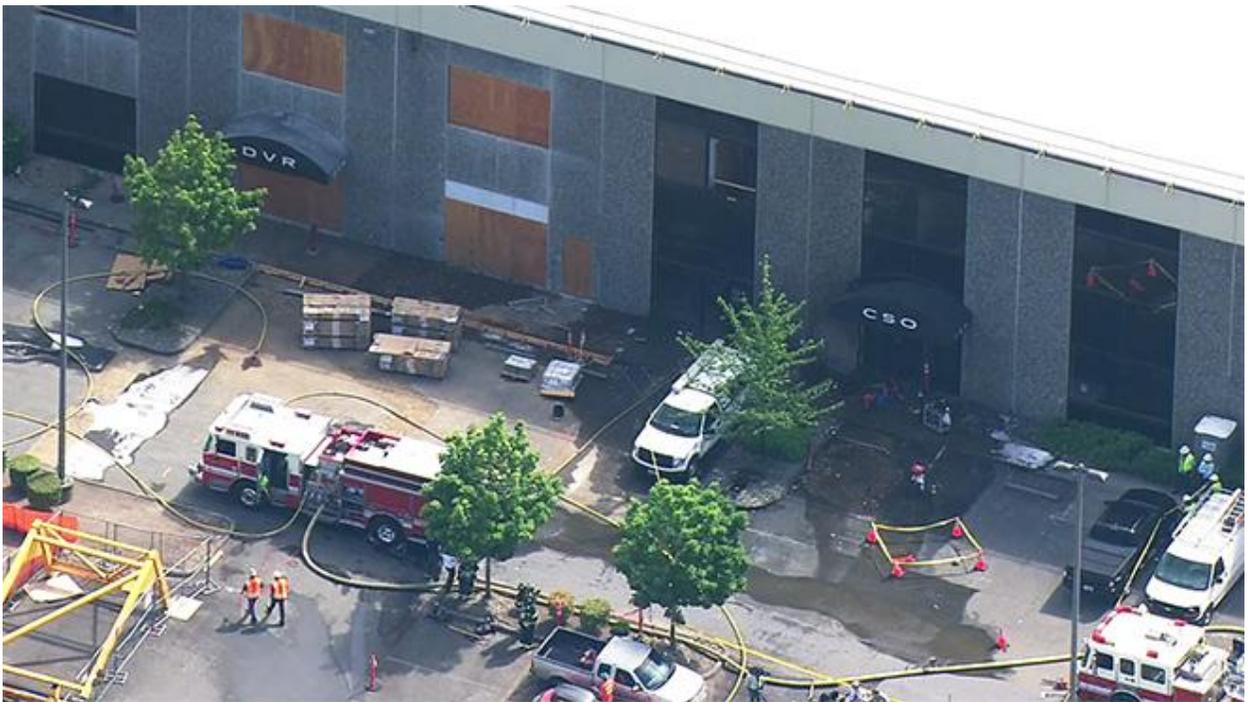
Photo 2: Aerial view of incident scene and BFD response

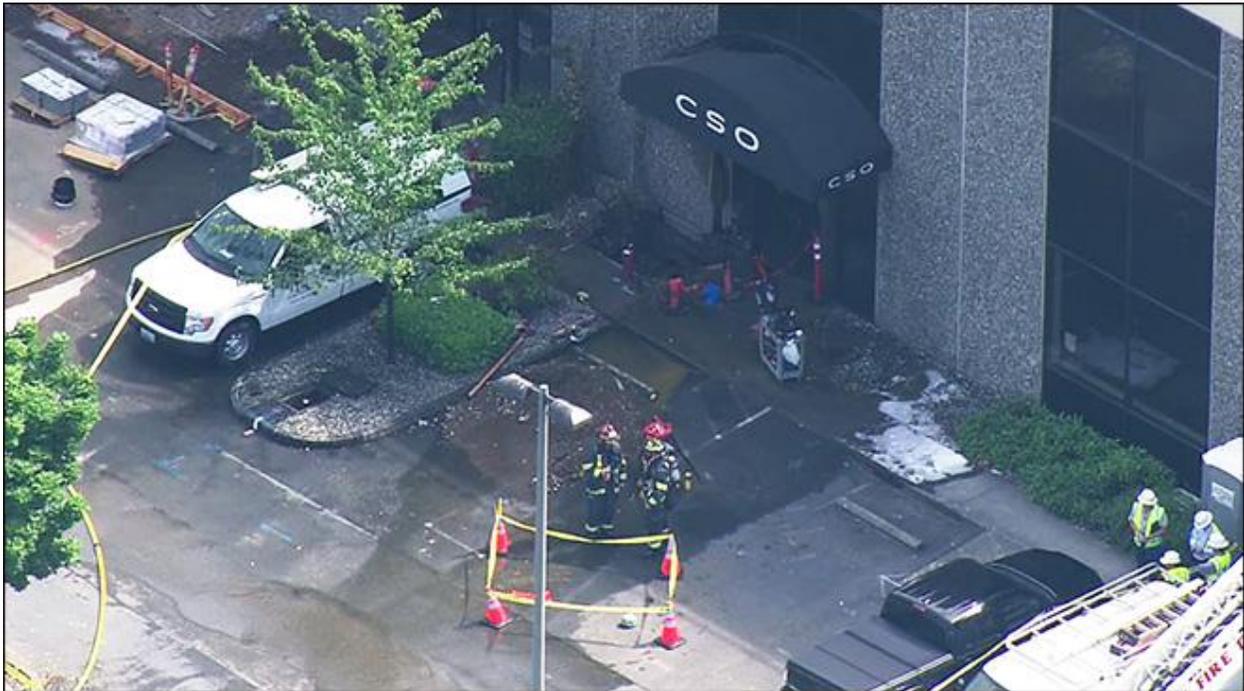
Photo 3: Aerial view of incident scene and BFD response

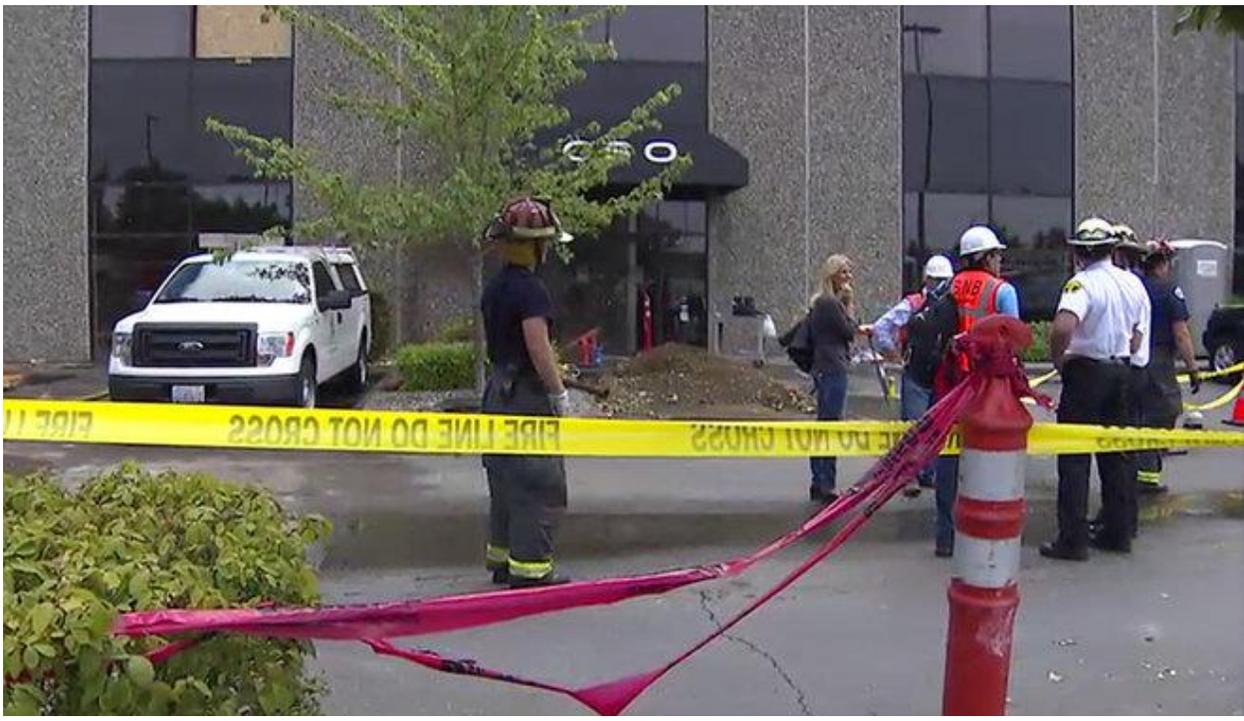
Photo 4: Looking east towards incident scene and BFD response

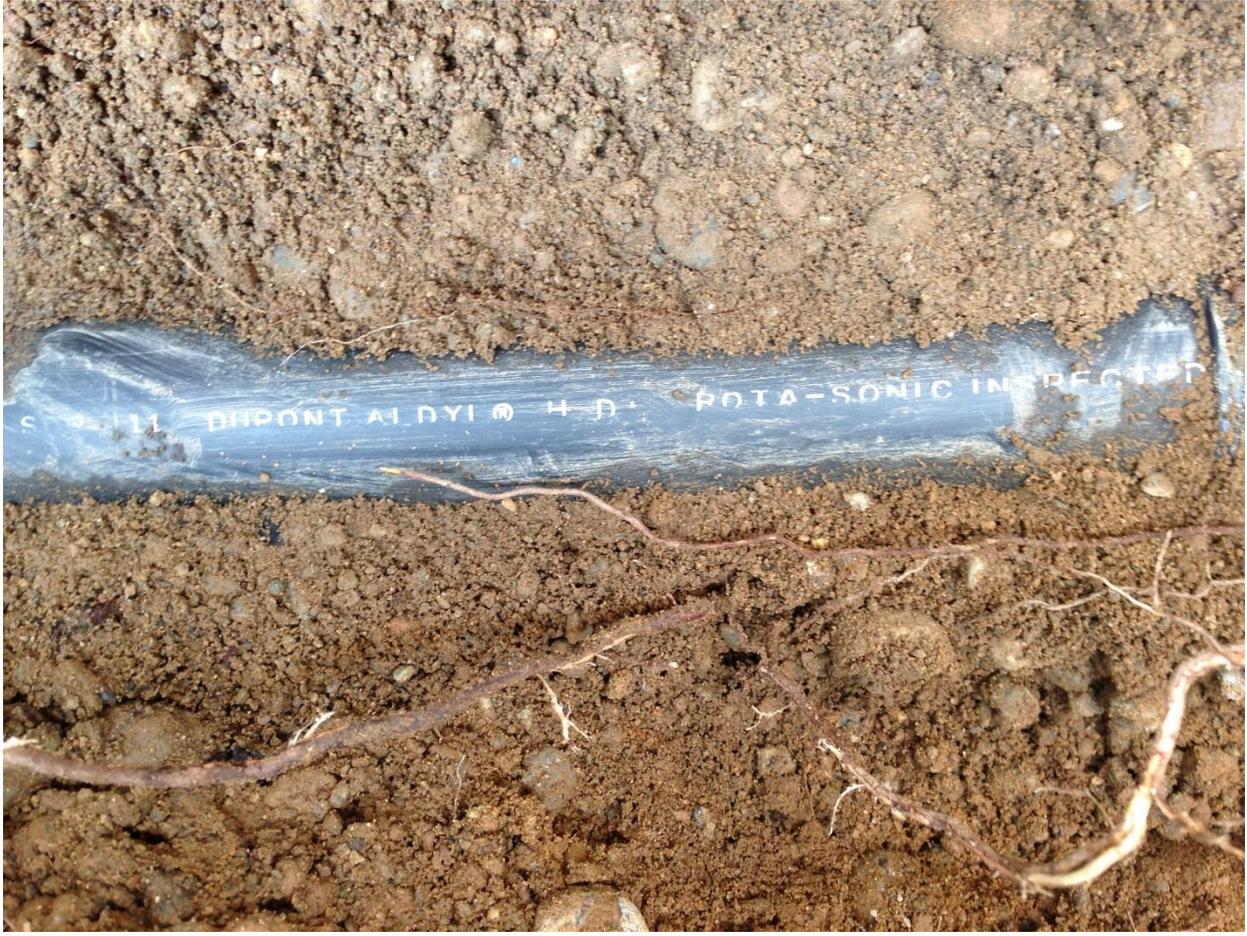
According to Puget Sound Energy (PSE) Operations & Maintenance, the procedure requiring 6-inch vertical separation from all non-power facilities was not in effect in [1981] when the gas service line was installed. Also, the Washington regulation requiring a minimum of six inches separation from other utilities did not apply to PSE at the time of construction, this rule was established in [2005].

According to PSE Operations & Maintenance, this procedure was not in effect in [1981] when the gas service line was installed. There does not appear to be a procedure violation with respect to the separation of the gas service line.

Photo 5: Existing Aldyl-dupont gas service line installed in [1981]

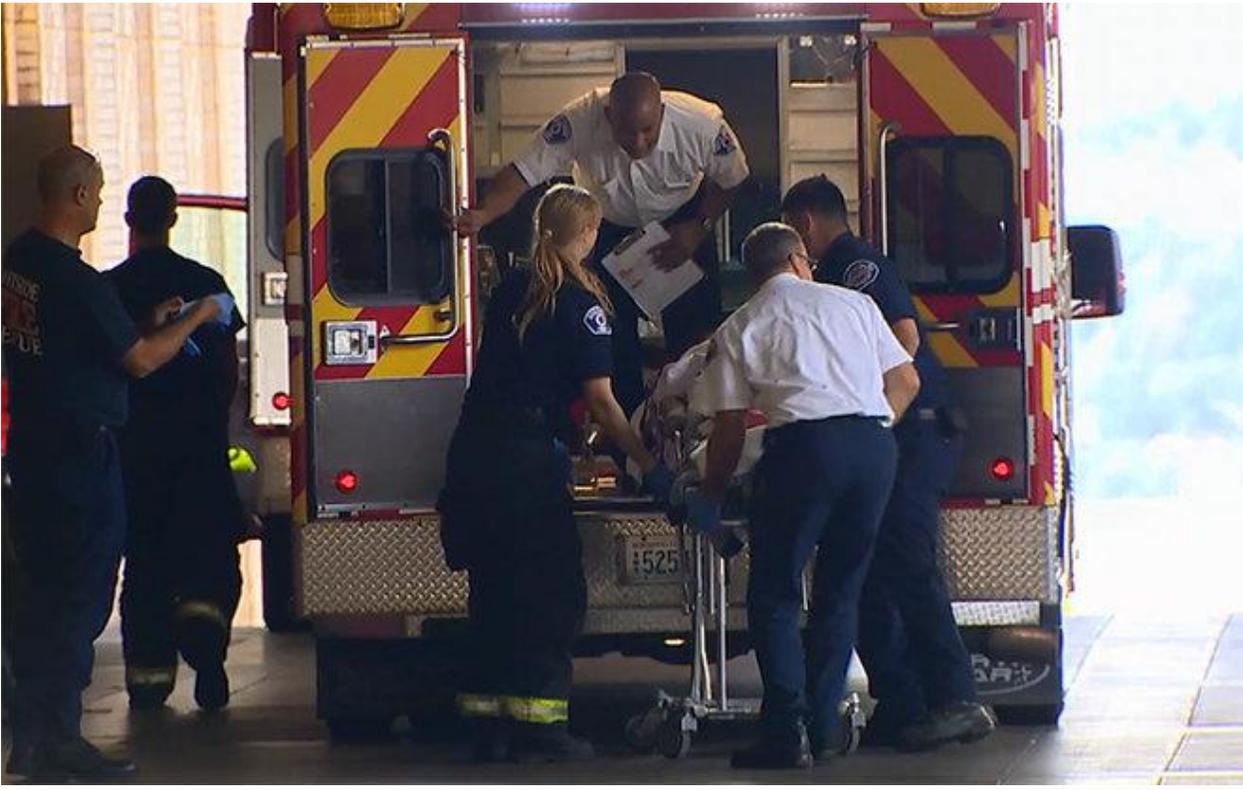
Photo 6: Injured workers transported to the hospital

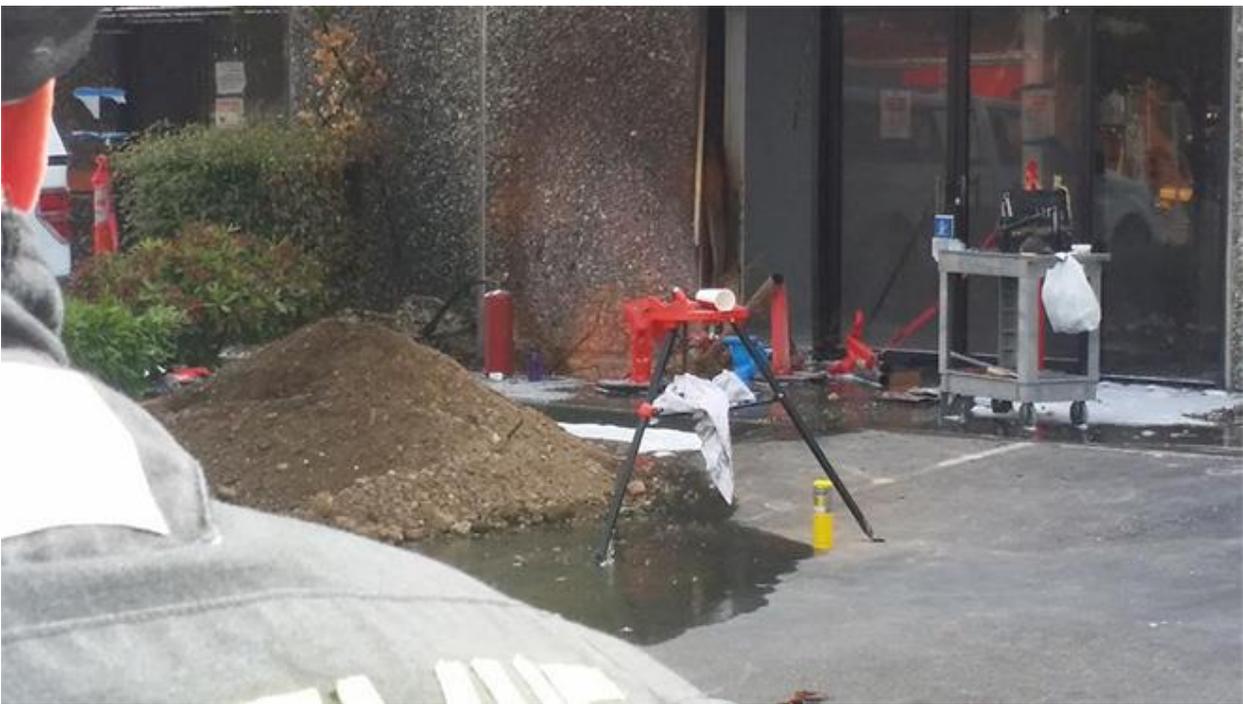
Photo 7: Looking NE at excavation and fire damage. Note scorch pattern on aggregate wall

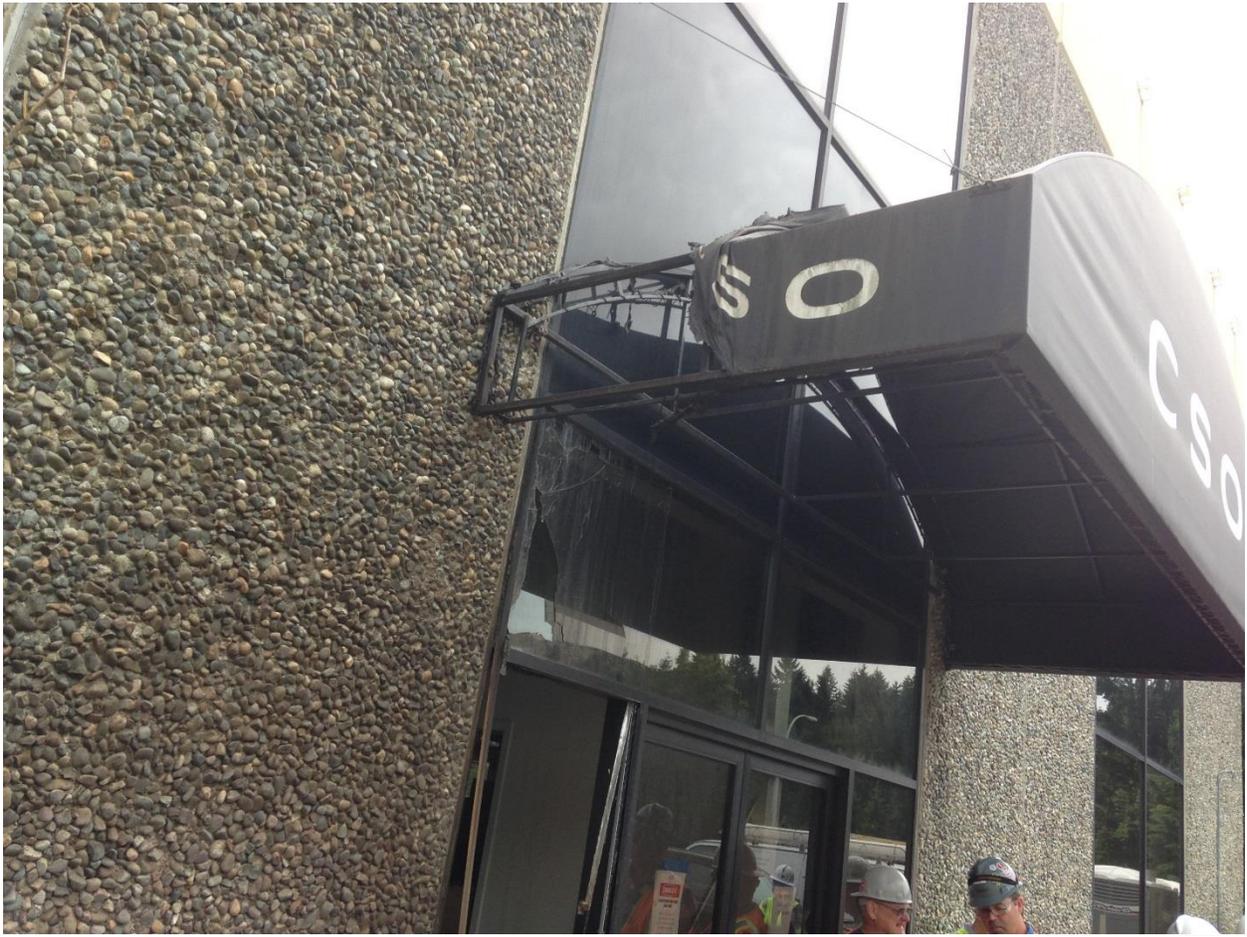
Photo 8: Looking SE at structural fire damage

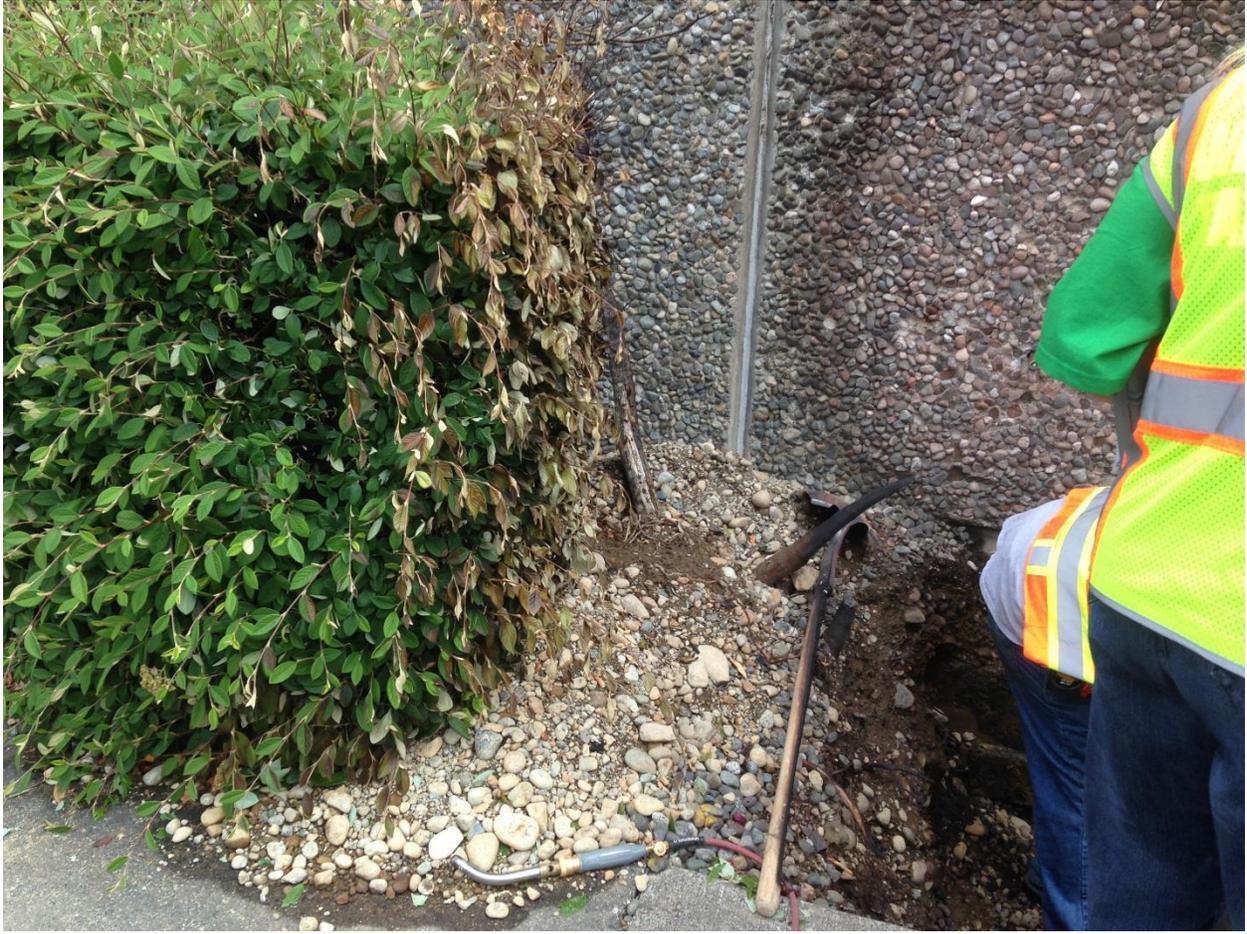
Photo 9: Looking NE at structural fire damage.

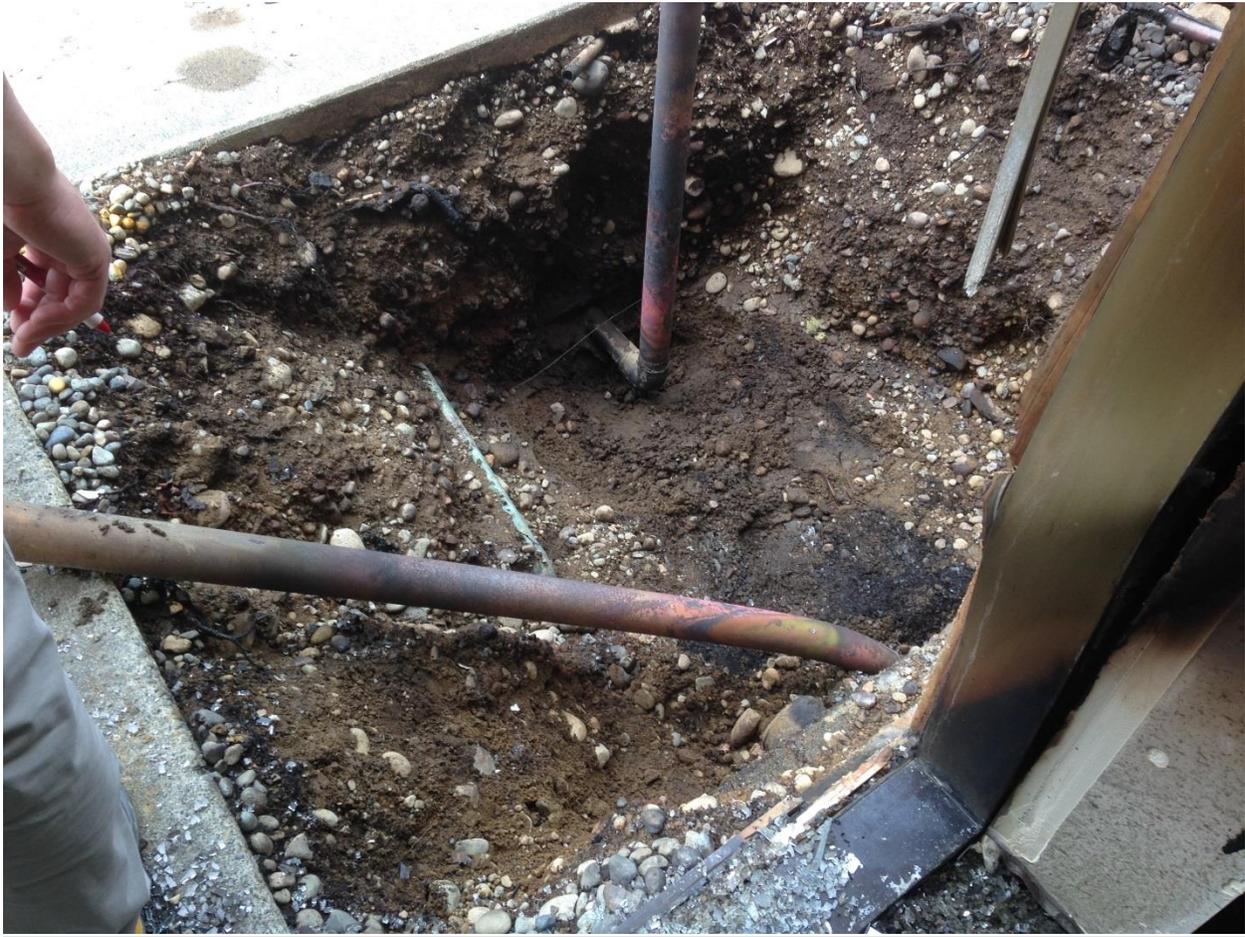
Photo 10: Looking into undisturbed excavation. Note: heat from fire warped copper water pipeline riser located next to building and seen here sagging across the excavation and out of the frame.

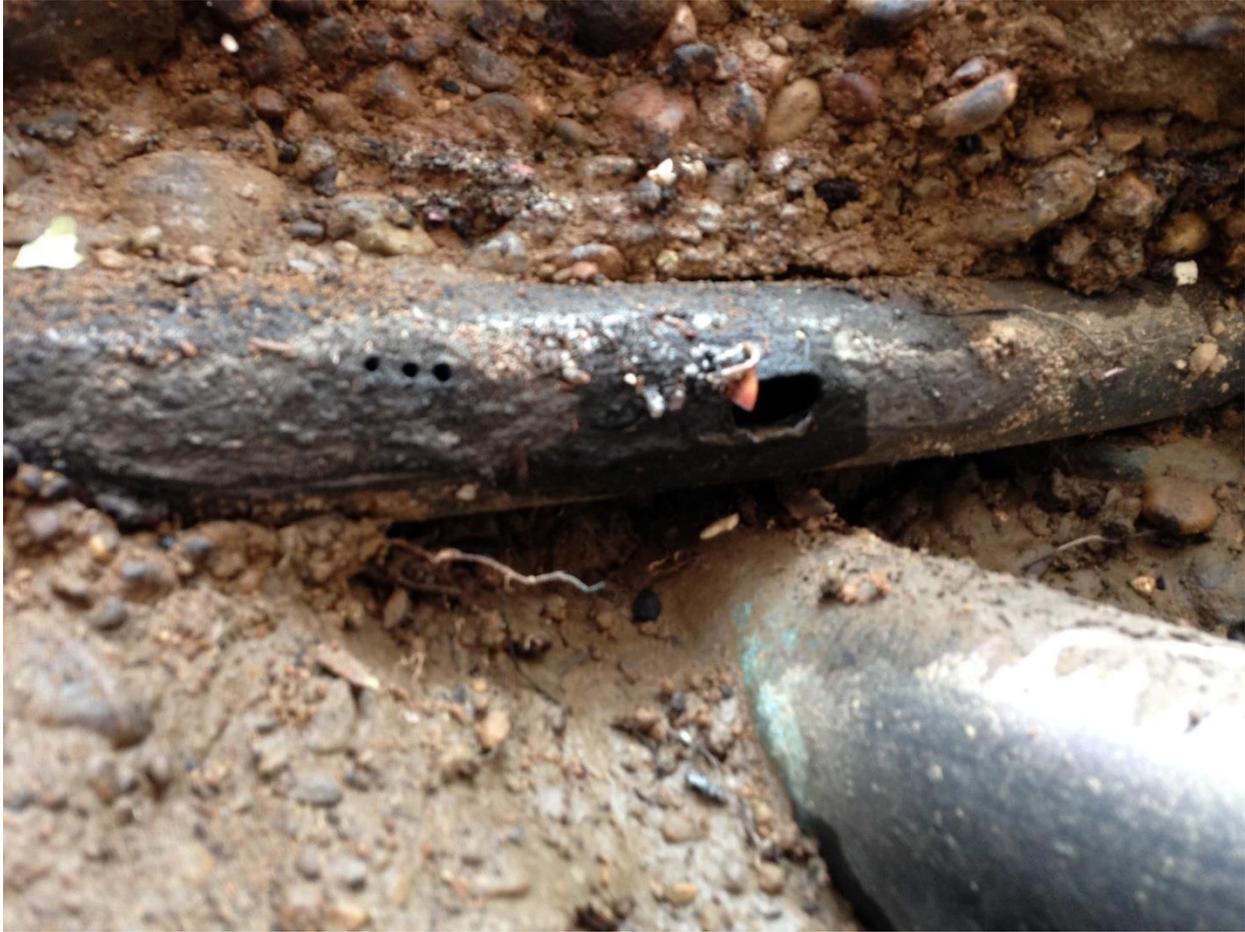
At approximately 9:26 am, the heat from the brazing torches melted a 1-1/4-inch PE gas service line, installed in [1981], located less than 2-inches from the water pipeline, installed in [1997], causing the wall of the gas pipeline to melt, allowing pressurized gas to escape. The escaping natural gas was then ignited by the torches being used to install the water pipeline and engulfed the excavation in fire. Both contracted workers were transported to a hospital with injuries. PSE first responders controlled the incident by squeezing down the PE service line, after BFD evacuated an unknown number of structures in close proximity to the incident. Later, Infrasource, a PSE service provider, made final permanent repairs to the gas pipeline.

It appears that the release and unintentional ignition of natural gas by an outside force represented by two MM contracted employees installing a flow valve in an excavation, was an unfortunate accident. There was less than 2-inches separation between the water pipeline and the gas service line, but the investigation did not reveal any supportive documentation that would indicate that PSE knew or should have known, there was not enough separation between the two utilities.

Photo 11: Looking at the gas service line found above the water pipeline and less than 2-inches from water line. The escaping pressurized gas was determined to have exposed the gas service line in the excavation after it was melted and ruptured.

19:10- InfraSource made the final repair, replacing 9-feet of 1-1/4-inch PE service.

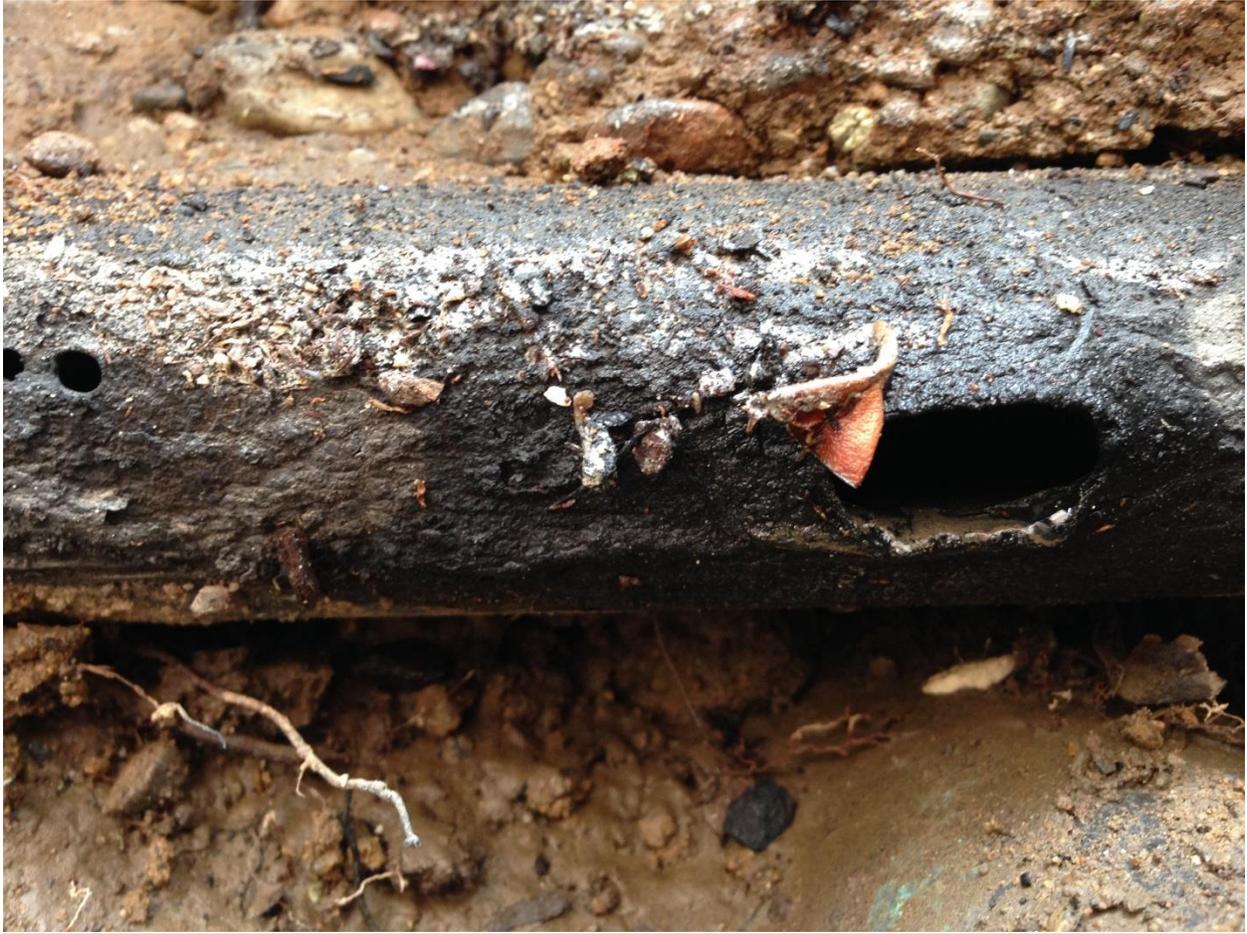
Photo 12: Looking at close-up view of gas service line rupture.

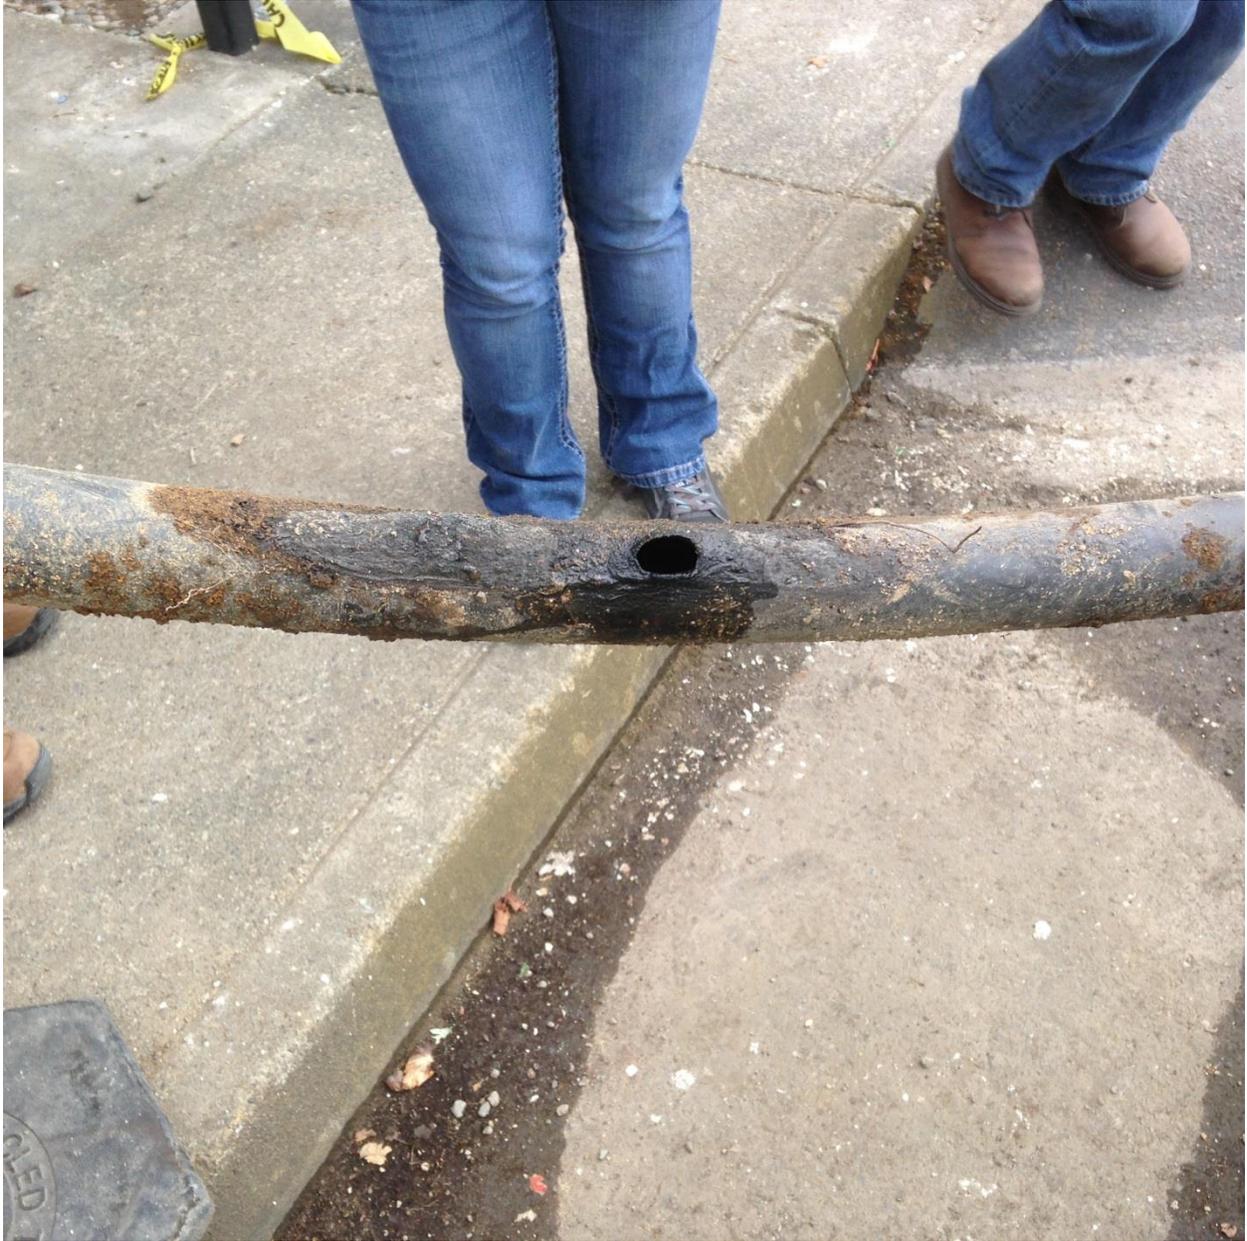
Photo 13: Looking at the gas service line after it was removed from the excavation by PSE.

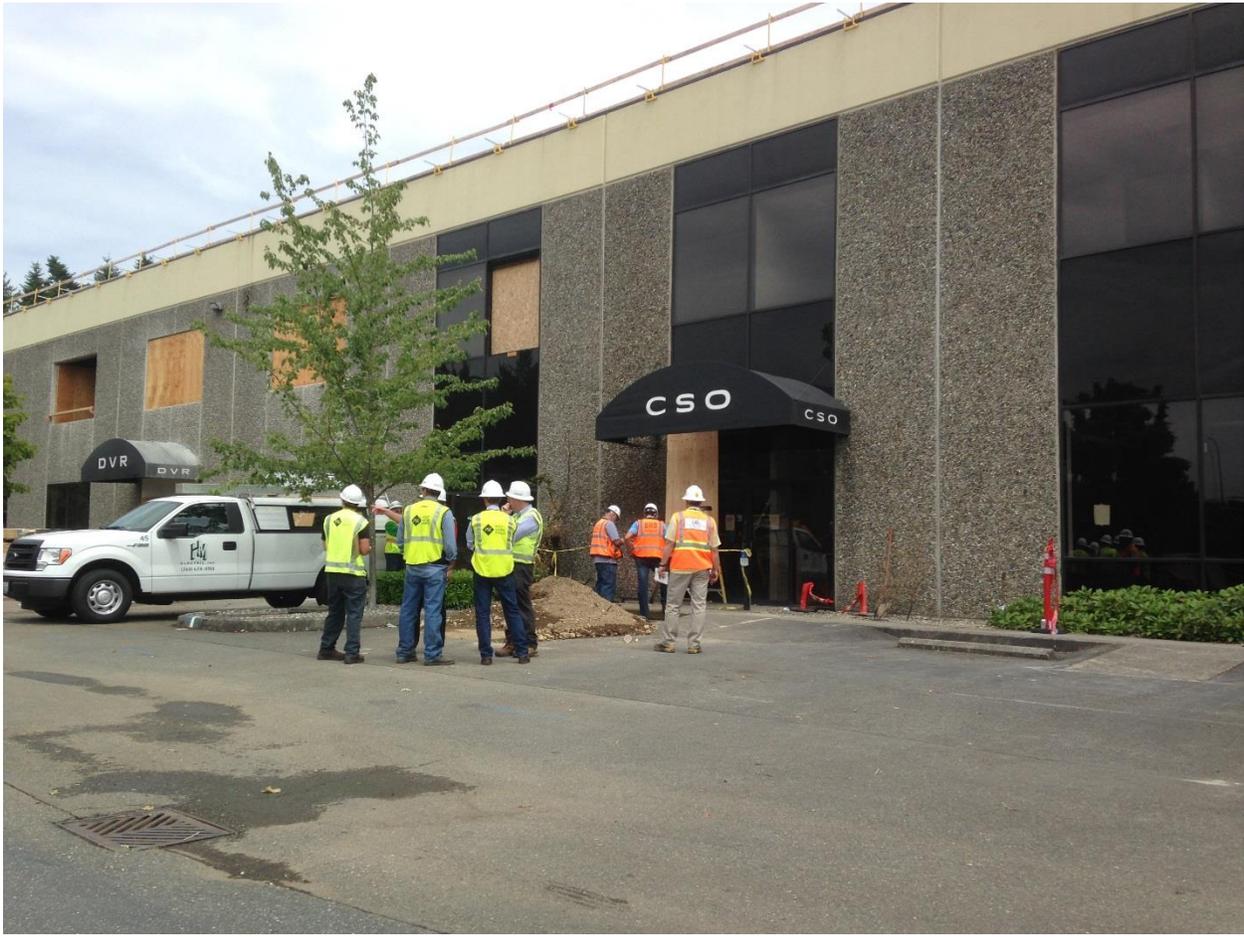
Photo 15: Looking NE at Opening Conference with PSE, L&I, and WUTC investigators
