UTC Incident Investigation Form

Notification ID:	3199	Investigation ID:	7508
NRC#	1186063

Operator:	McChord Pipeline Company, OPID 31049
District/Unit:	McChord Pipeline Company 3001 Marshall Ave, Tacoma, WA 98421
Locations:	100 th St at A St Tacoma, WA
Incident Dates:	August 2, 2017

Summary:

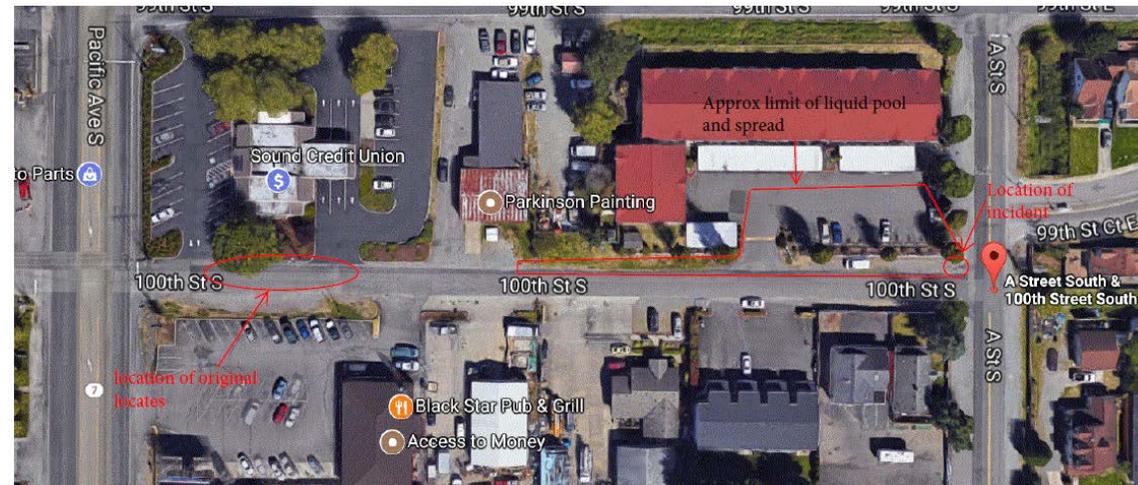
Photo 1--Google Satellite view of Parkland area near Tacoma where accident occurred (North is up).

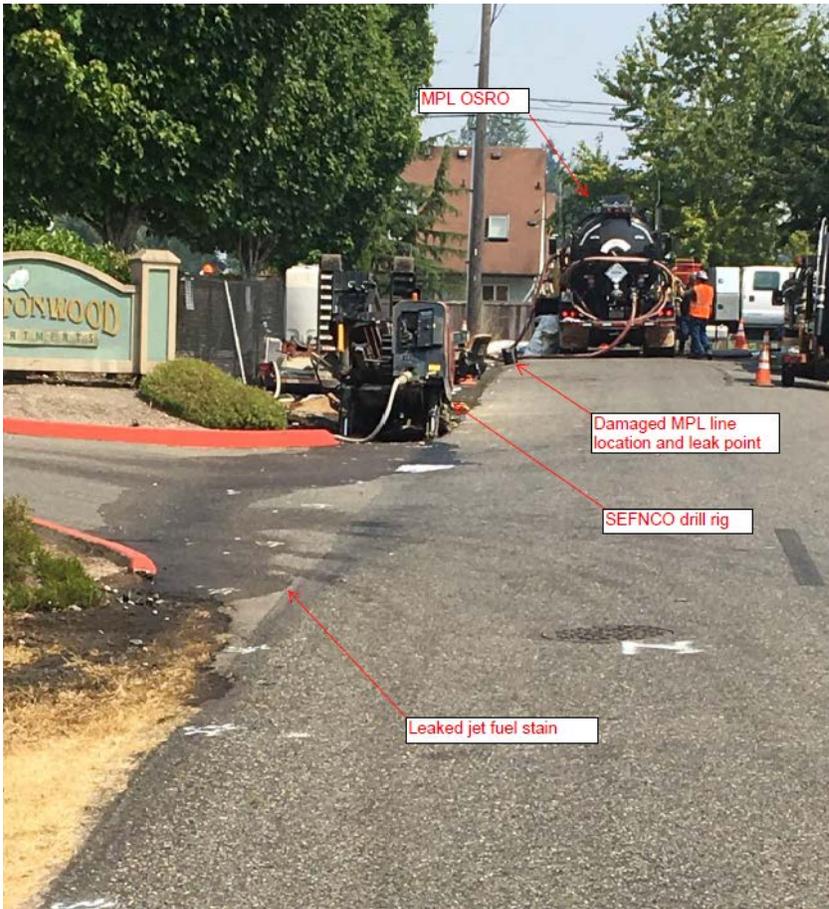
Photo 2--looking east on 100th St at leak location which is uphill.

The emergency response to the leak was prompt and effective. USOR emergency response personnel and OSROs were on scene within an hour. OSROs were stationed at appropriate locations downhill from the leak (ditches and catchbasins) for product recovery (**Photo 2-6**). An apartment complex adjacent to the leak was first priority for clean-up efforts **Photo 1 and 2**.

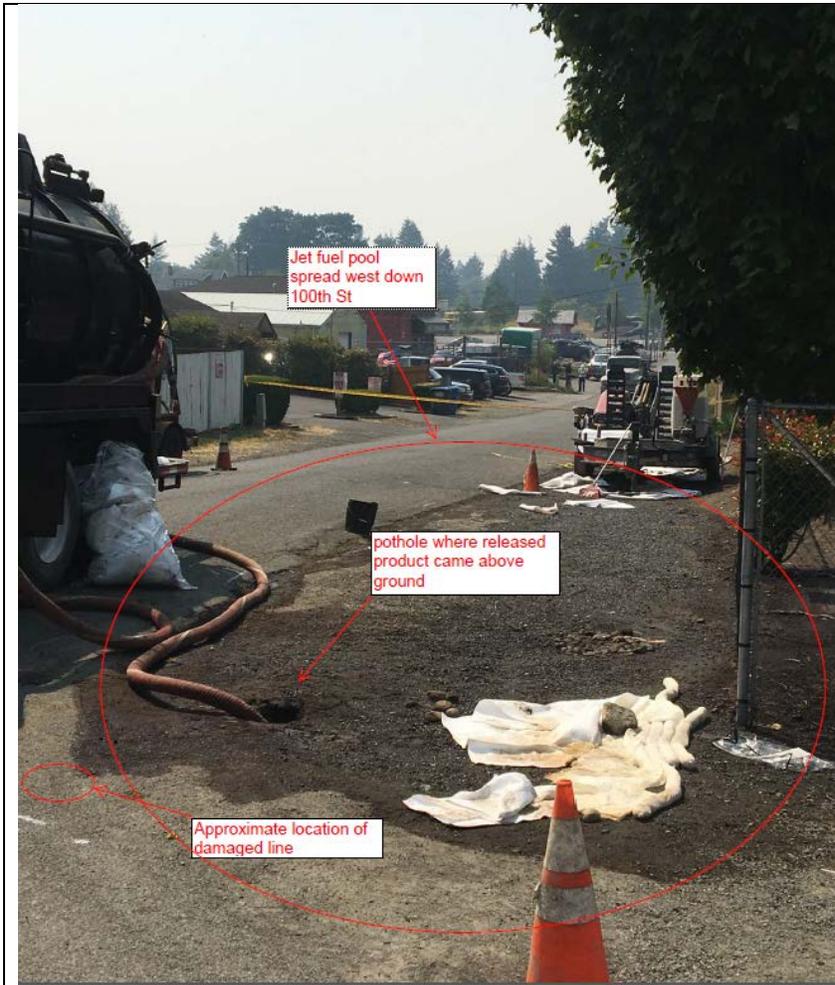
Photo 3—looking west on 100th St at A St. Note location of MPL damaged line in relation to pool spread (down hill).

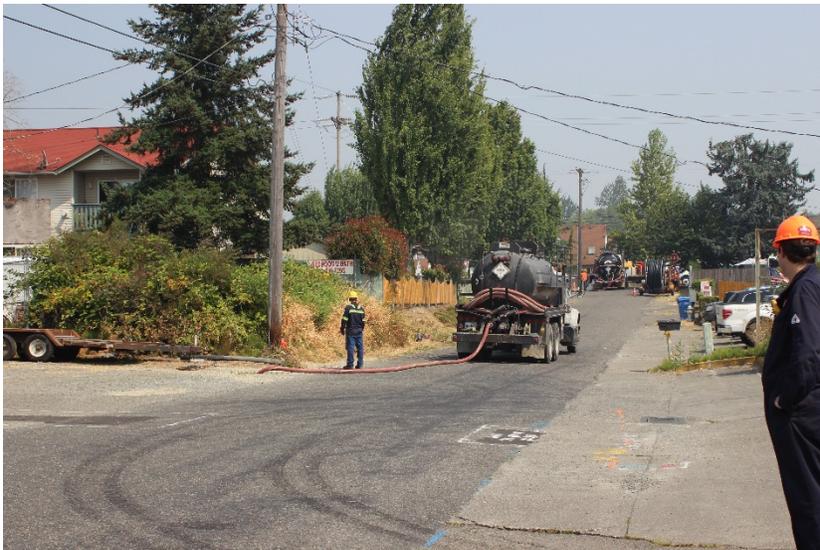
Photo 4—looking east on 100th St. Product recovery efforts using MPL's OSROs.

USOR emergency response personnel and OSROs were on scene within an hour. OSROs were stationed at appropriate locations downhill from the leak (ditches and catchbasins) for product recovery (**photo 3-6**). An apartment complex adjacent to the leak was first priority for clean-up efforts (**photo 1-2**).

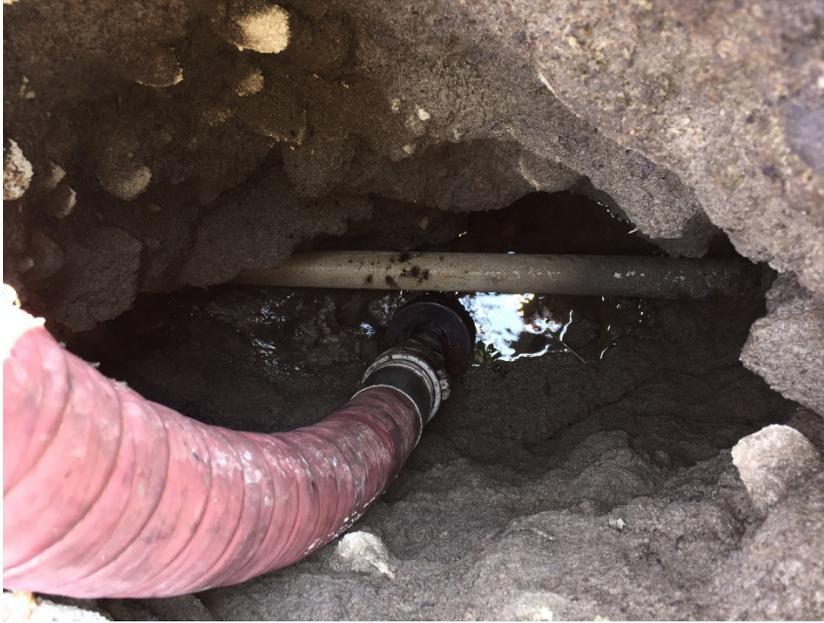
Photo 5—Looking north at on 100th St. Leaked product in bell hole approximately 300 feet west of leak site. Hose is removing leaked product.

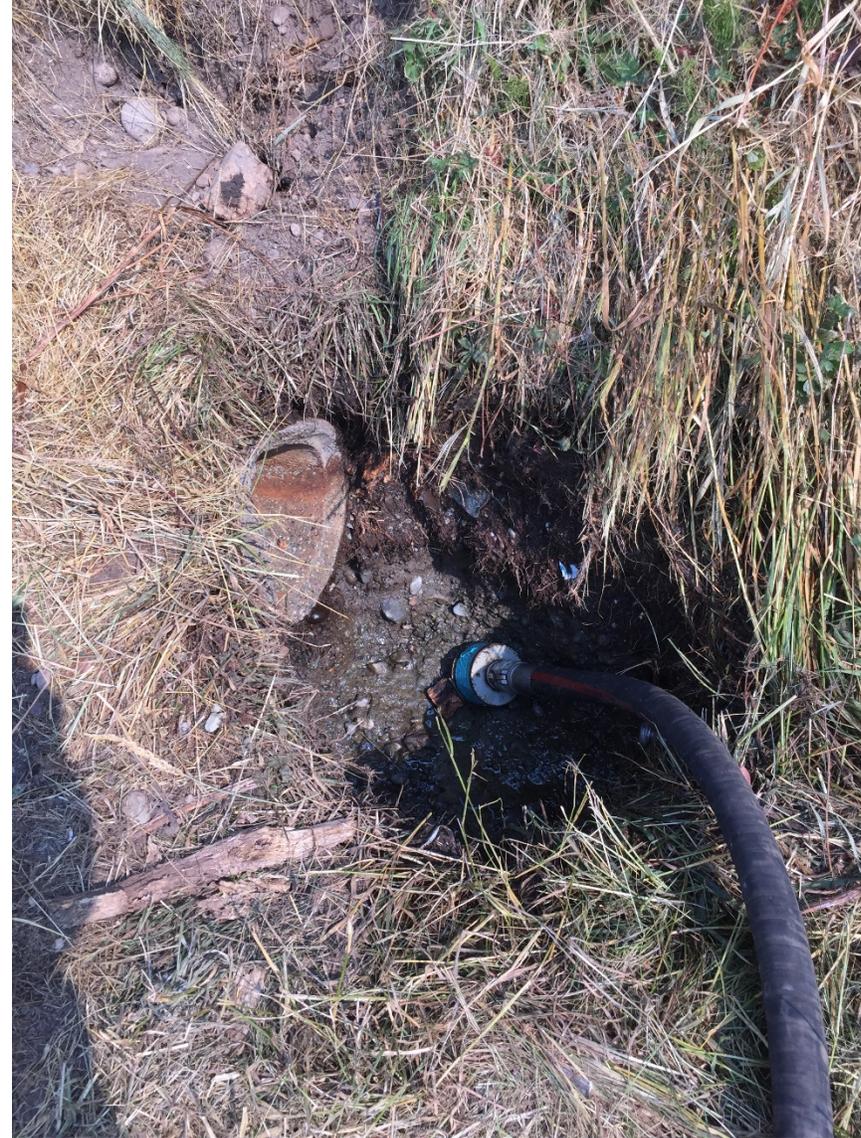
Photo 6—looking north on 100th St. Product recovery efforts in bell hole approximately 200 feet west of leak site.

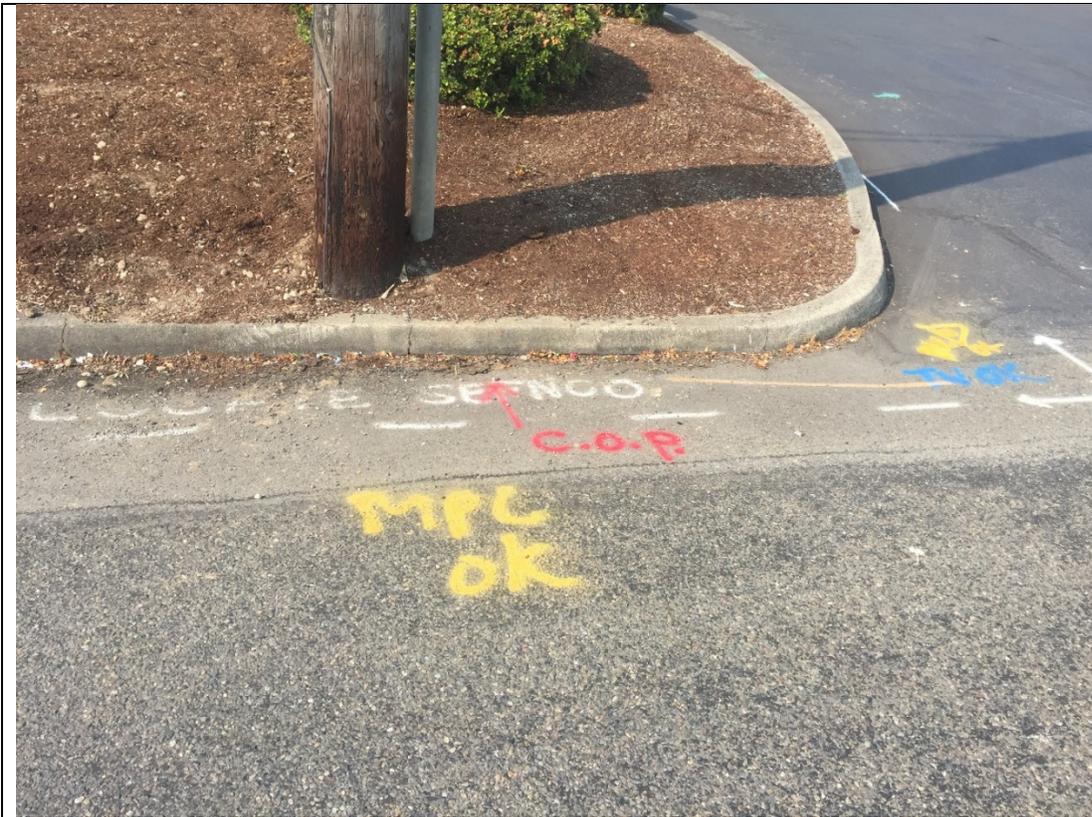
The white paint, as required by RCW 19.122, delineating where to locate, was clearly visible on the west end of 100th St. adjacent to 9911 Pacific Ave (Sound Credit Union). (**Photo 7, 8**).

Photo 7— Looking north 100th St adjacent to Sound Credit Union entrance. SEFNCO white locate boundary with utility locate marks.

The white paint, as required by RCW 19.122.030(1)(a), delineating where to locate, was only clearly visible on the west end of 100th St. adjacent to 9911 Pacific Ave. (**Photo 7 and 8**). McChord Pipeline, Tacoma Water, PSE (ELM), locates were clearly visible at this location and were marked within the required two business days of receipt of the notice. (Note, Parkland Water did not meet the two business day requirement--they stated they did not get the notice until August 29, 2017. However, they did meet SEFNCO on site on August 1, 2017 and located their facilities. They also told SEFNCO Tacoma Water was in their drill path).

SEFNCO made no attempt to correct the erroneous white painted boundary limits (**Photo 7 and 8**) nor did they call in a new locate. Unfortunately, as they did not call in a new locate, other utility operators in the area did not know the effective construction limits had changed. Instead, SEFNCO called two utilities directly, PSE and Tacoma Water, but failed to call McChord Pipeline. Had the white boundaries showing locate limits been accurate, or a new locate been called in, this incident likely would not have occurred.

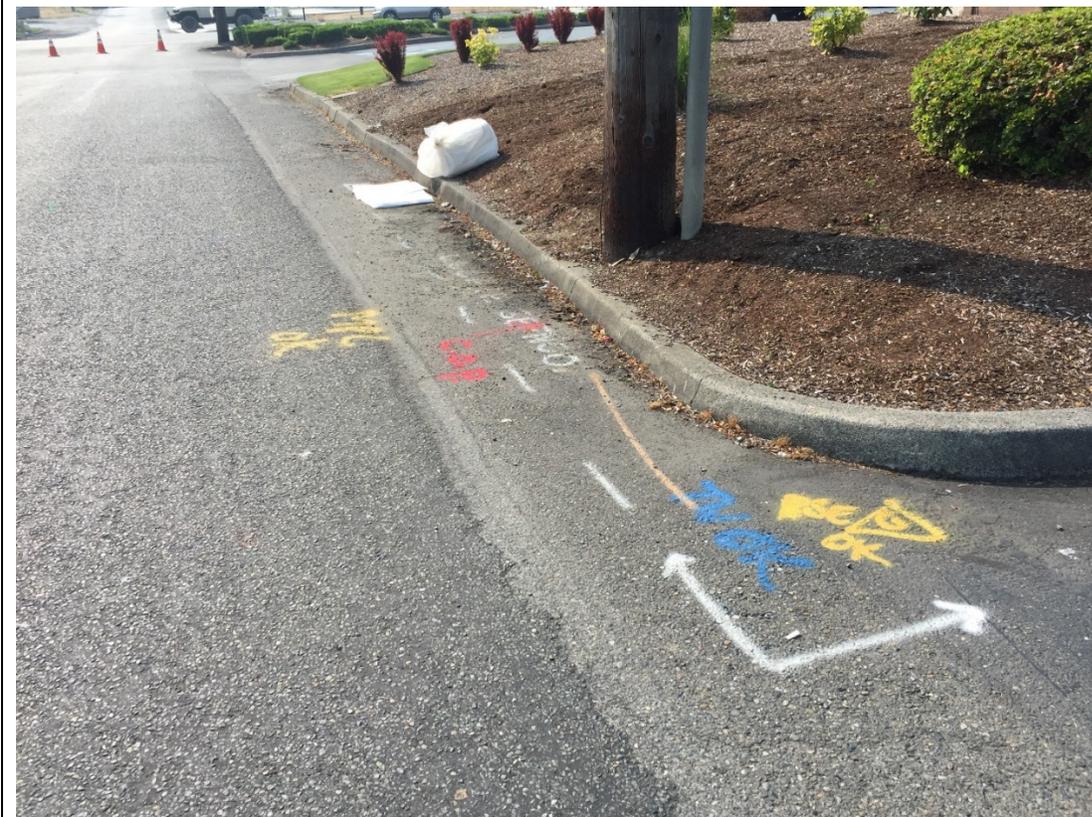
Photo 8—Looking west on 100th St. White SEFNCO locate boundaries with multiple locate marks noted including PSE (yellow), Tacoma Water (blue) and McChord Pipeline (yellow to left of red marks).

Locates from McChord Pipeline (MPL), Puget Sound Energy (PSE), and Tacoma Water were noted at this location (**Photo 7 and 8**). Other locates (**Photo 9**) were noted towards the east end of 100th St, however, these were completed the day prior to the accident when the foreman (FM) for SEFNCO called City of Tacoma Water and PSE directly as he believed these utilities were in the area of drilling activity. The FM did not call McChord Pipeline and did not call in a new locate.

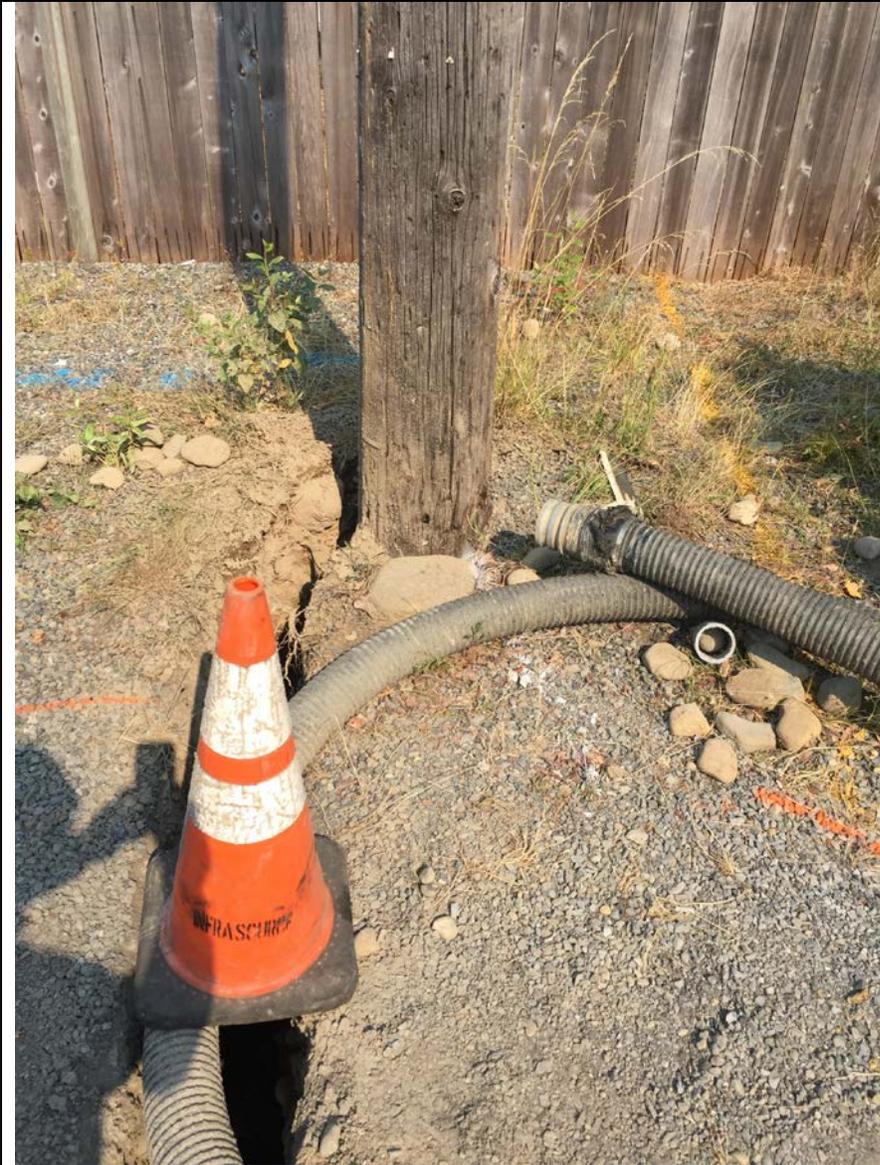
According to SEFNCO Construction Supervisor, Mike Violette, who called in the original locate, the job scope changed. Originally SEFNCO was going to come overhead from Pacific Ave then go underground at the credit union—this is why white paint was originally around the credit union. The project later changed to bring cable in from the east side of A Street approximately 600 feet to the east. According to Violette, he personally put white paint on the ground at the pole near A Street. These marks not very noticeable while on site (a pot hole was dug near this location and might have damaged marks; however, other locators did not apparently see them either as there were no locates in this area prior to August 1, 2017 (**Photo 9**)).

Photo 9--Looking east at A S. White paint at base of pole barely visible. Other locates were place on August 1, 2017

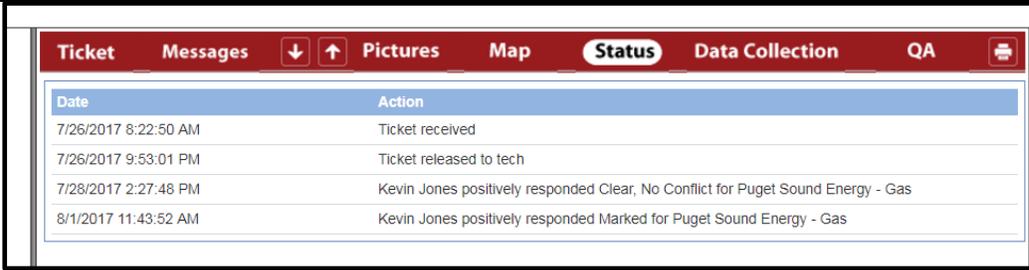
Figure 3—ELM (locator for PSE) log showing responding to/clearing locate ticket 17284954 on 7/28/17

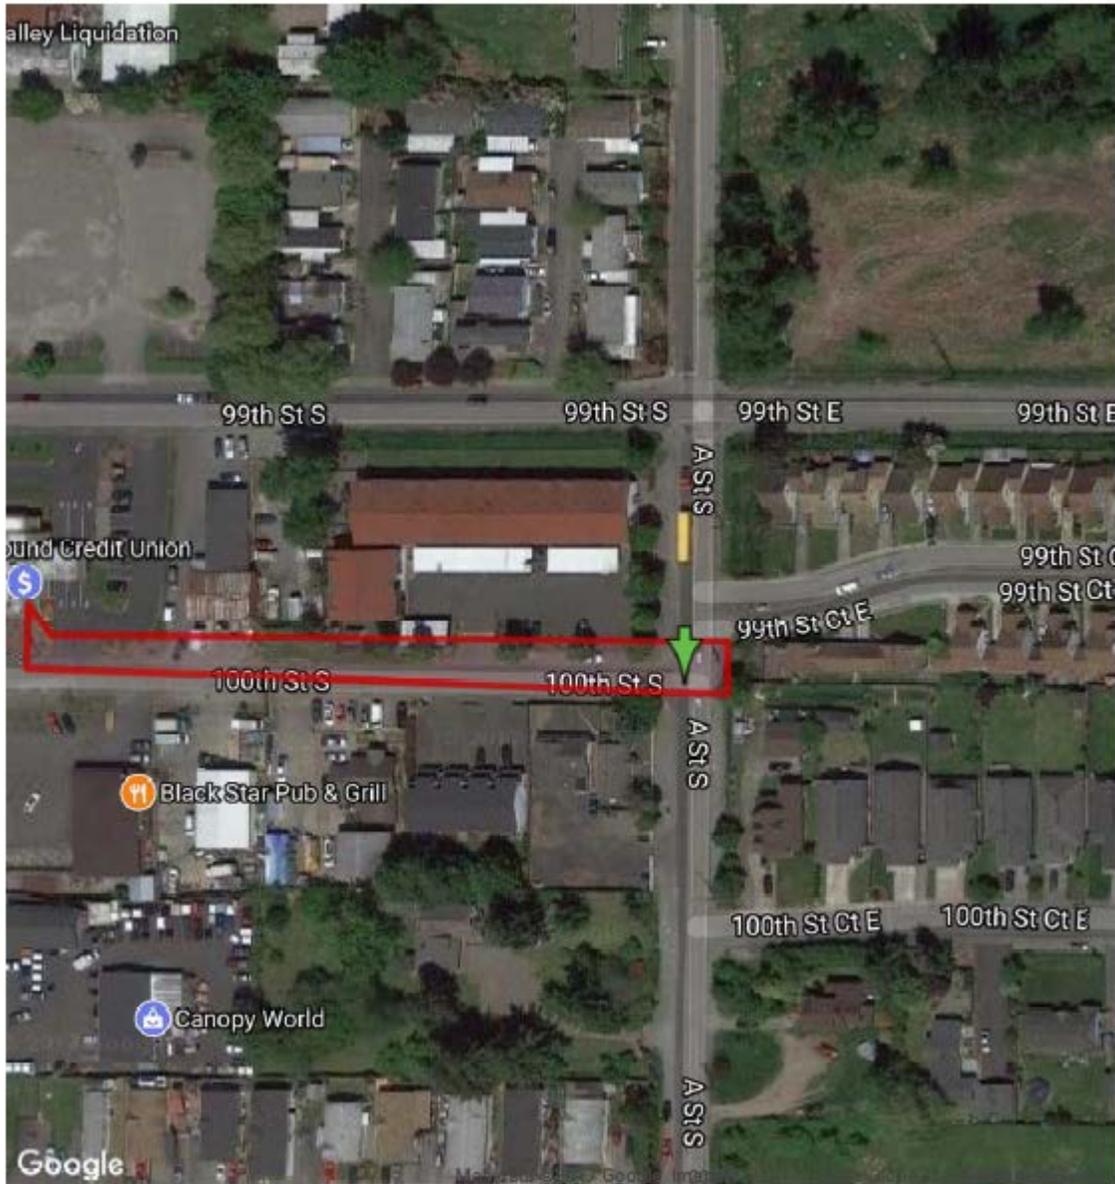
Figure 6-WA One Call locate ticket called in by SEFNCO July 26, 2017

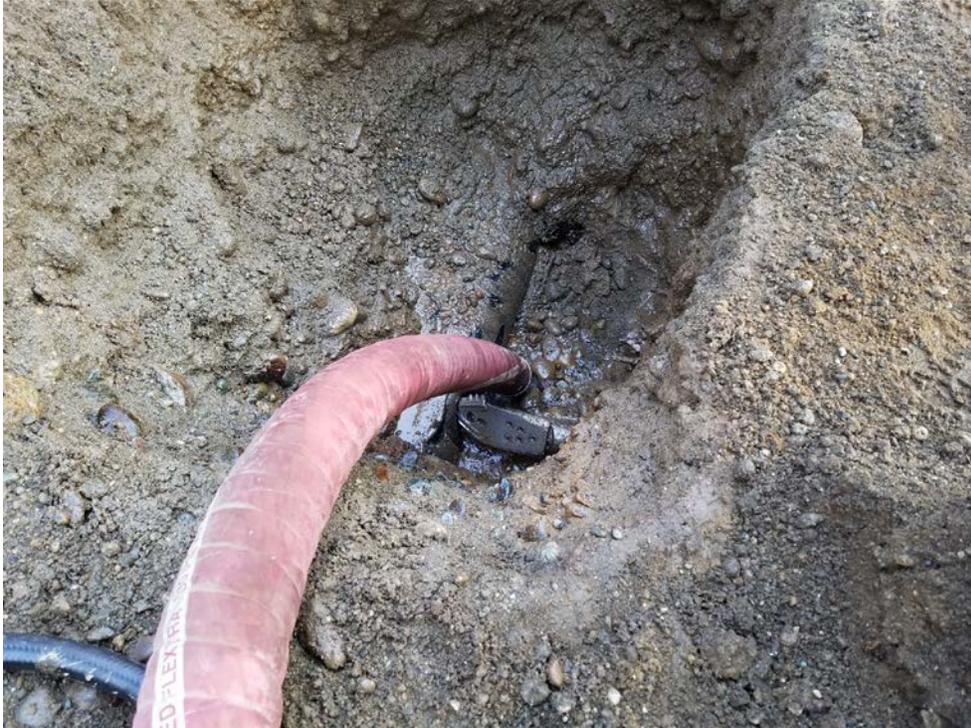
Photo 10—looking south at 100th St and A St. USOR photo showing drill head embedded in MPL pipeline. Hose is removing leaking product.

USOR excavates to damaged pipeline (**Photo 10**).

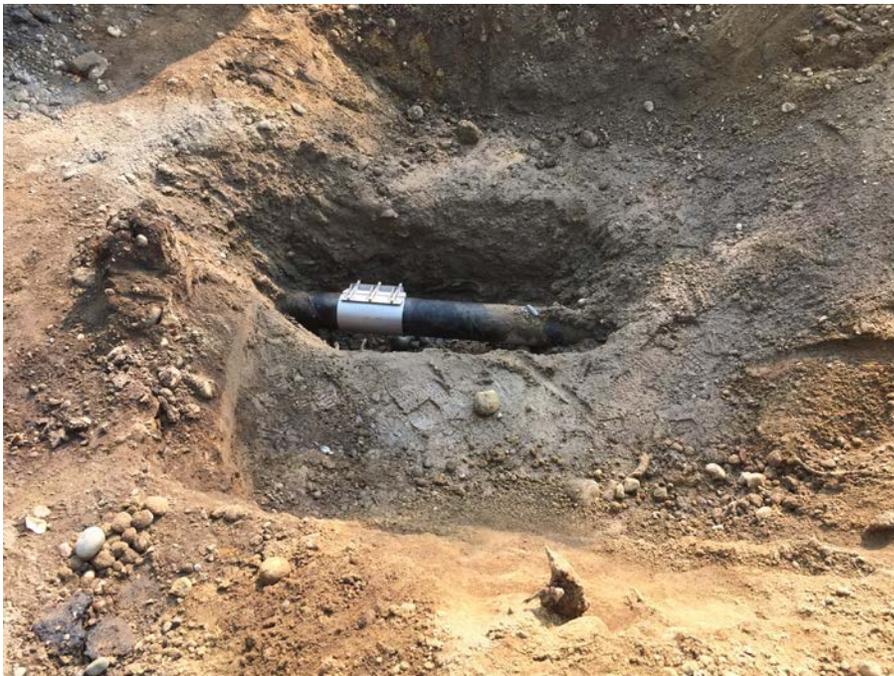
Photo 11--Looking east on 100th St at temporary leak clamp.

At 20:00, USOR has effectively stopped product release by installing a leak clamp over the hole **Photo 11**. Cleanup and product recovery continue.

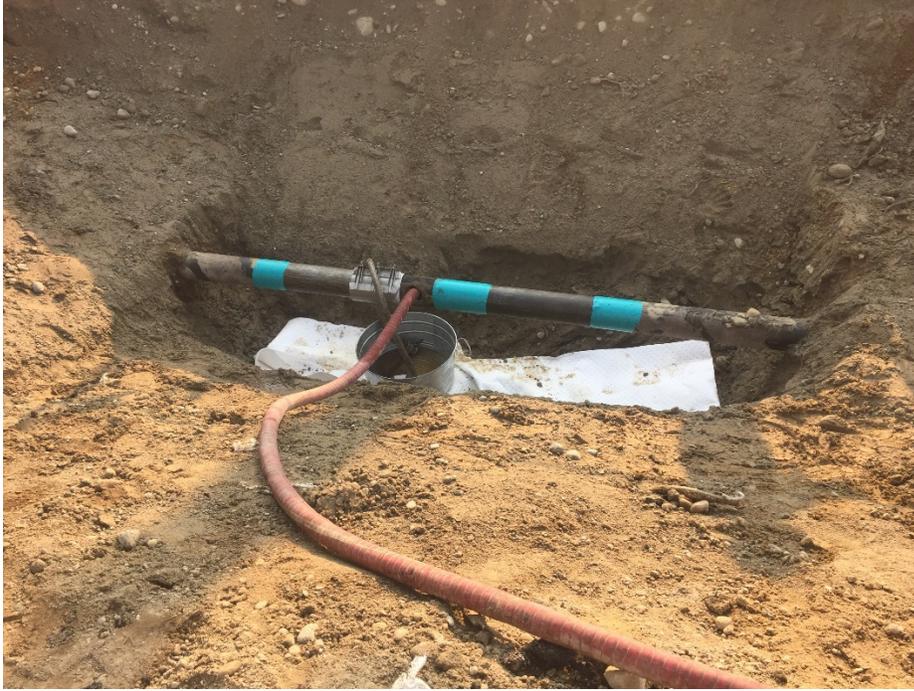
Photo 12—looking east on A St. Drill head removed and hose recovering product from line.

USOR repaired the damaged segment on August 4, 2017. They cut out the damaged portion and installed a new section of pre-tested pipe (**Photos 12-18**).

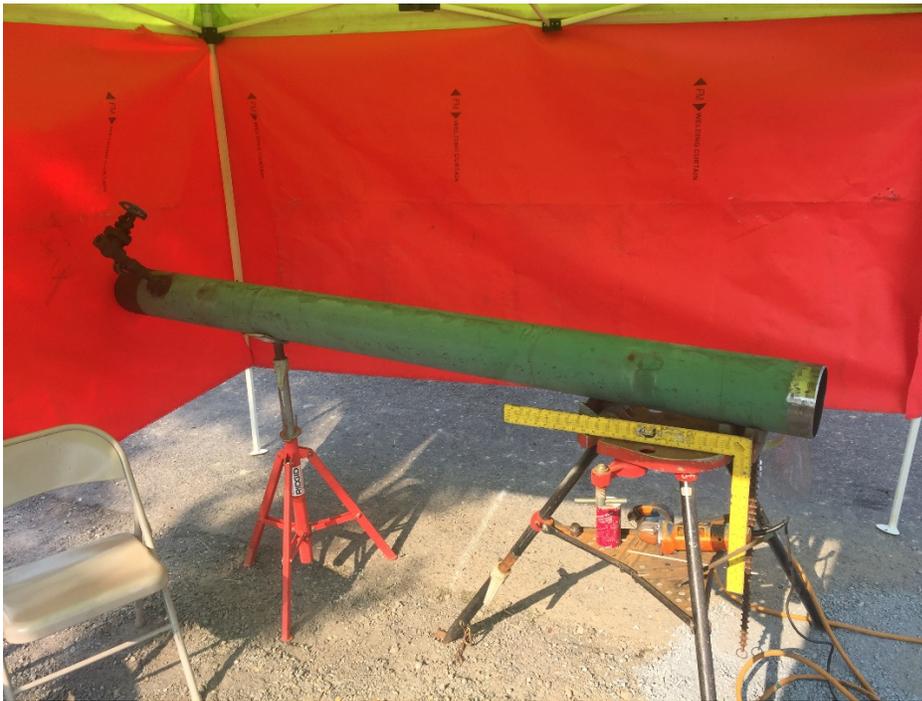
Photo 13—pretested (hydrostatic pressure test) pipe used for repair of damaged section.

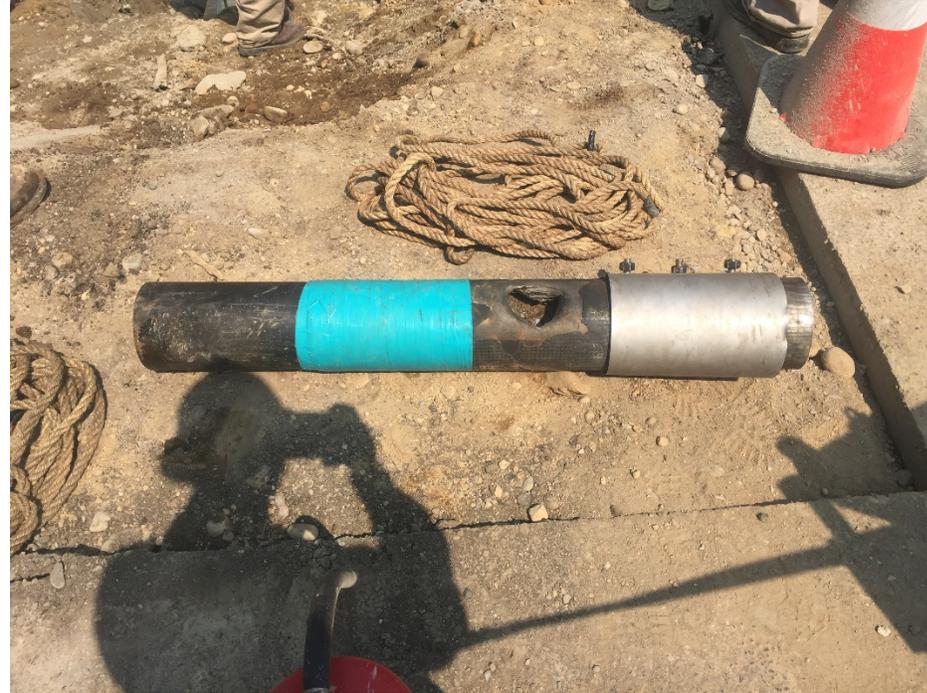
Photo 14—cut-out section of damaged pipe

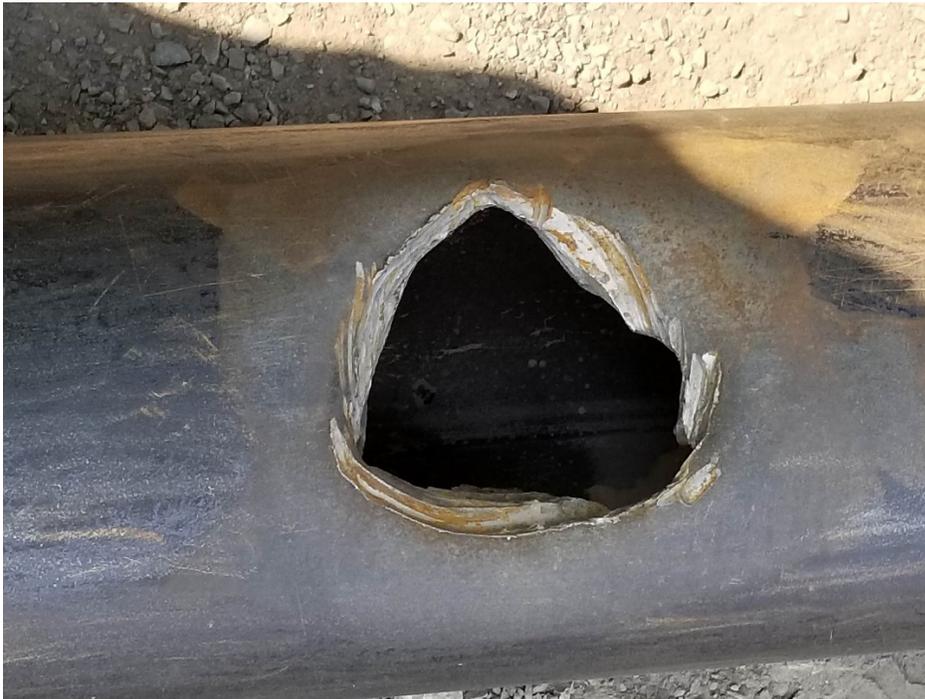
Photo 15—USOR photo of hole punctured in six-inch steel line by directional drill. Note drill head shaped hole.

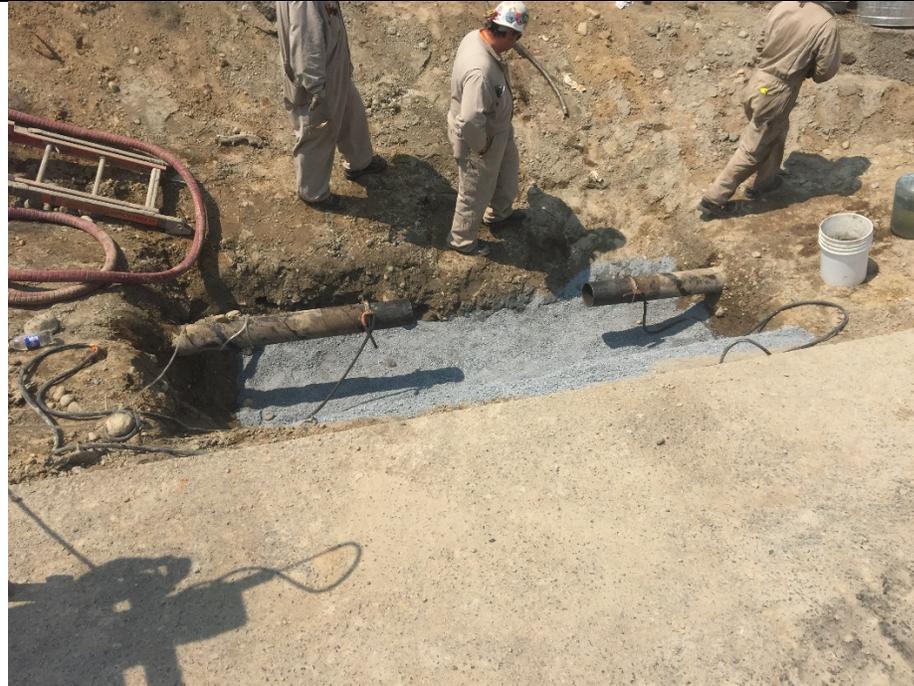
Photo 16—looking west on A St. at MPL line after damaged section removed.

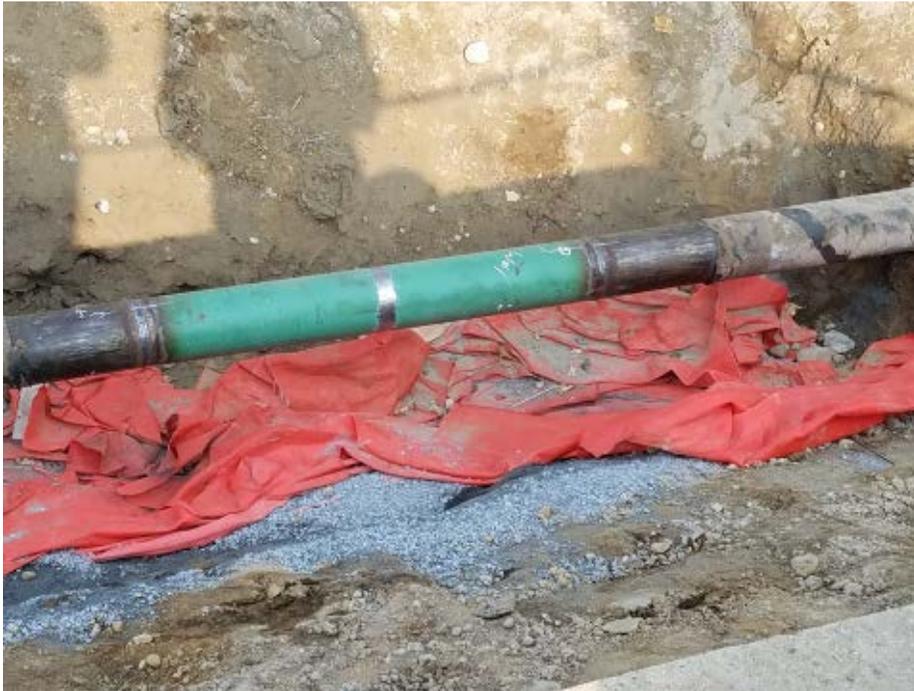
Photo 17—USOR photo of new pup welded in place and x-rayed

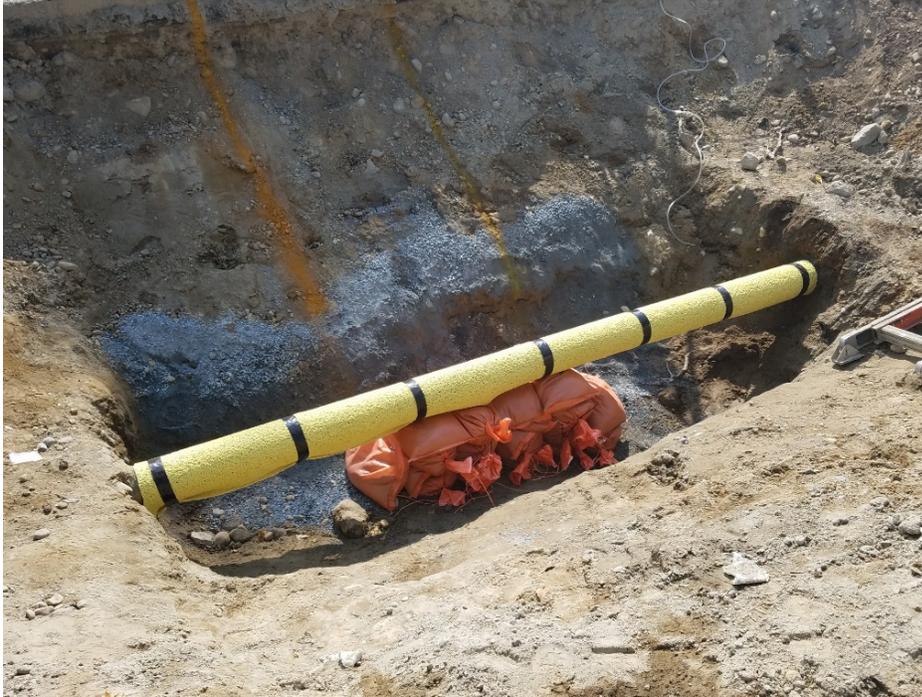
Photo 18—USOR photo of final repair ready for backfill. Yellow wrap is for rock protection
