# UTC Incident Investigation Form

<b>Notification ID:</b>	3521	<b>Investigation ID:</b>	7988
-------------------------	------	--------------------------	------

<b>Operator:</b>	Olympic Pipe Line
<b>District/Unit:</b>	South
<b>Location:</b>	Castle Rock, Washington (Latitude: 46.26538 Longitude: -122.8829)
<b>Incident Date:</b>	6/04/2019

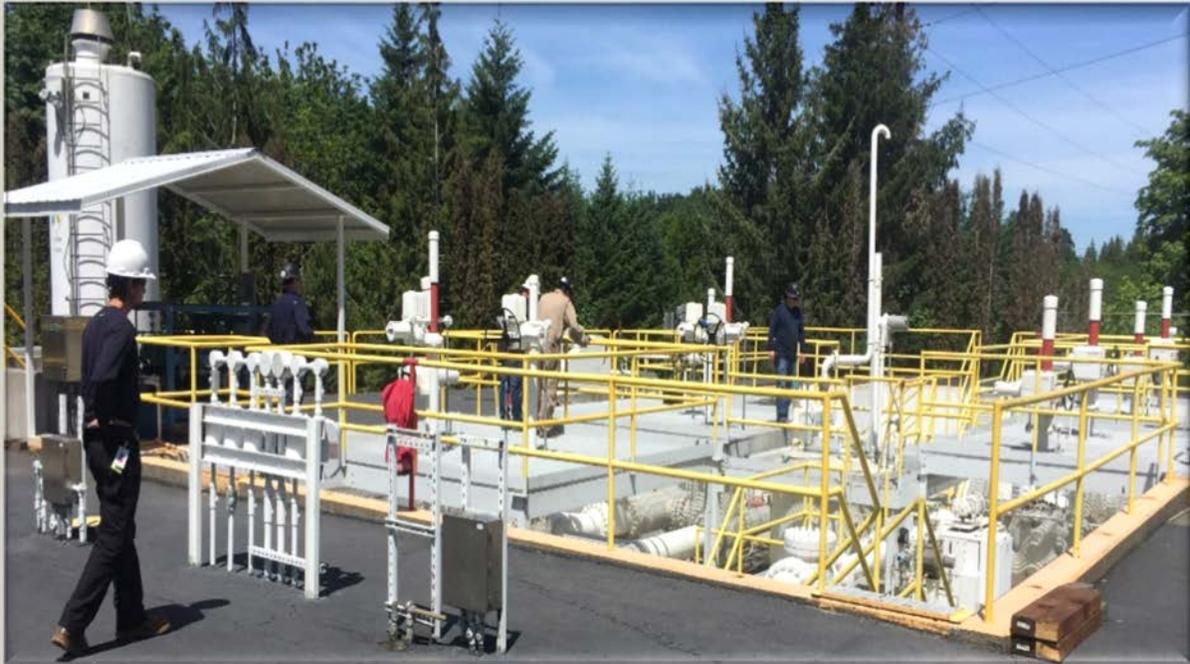
Image of containment area where the spill occurred.

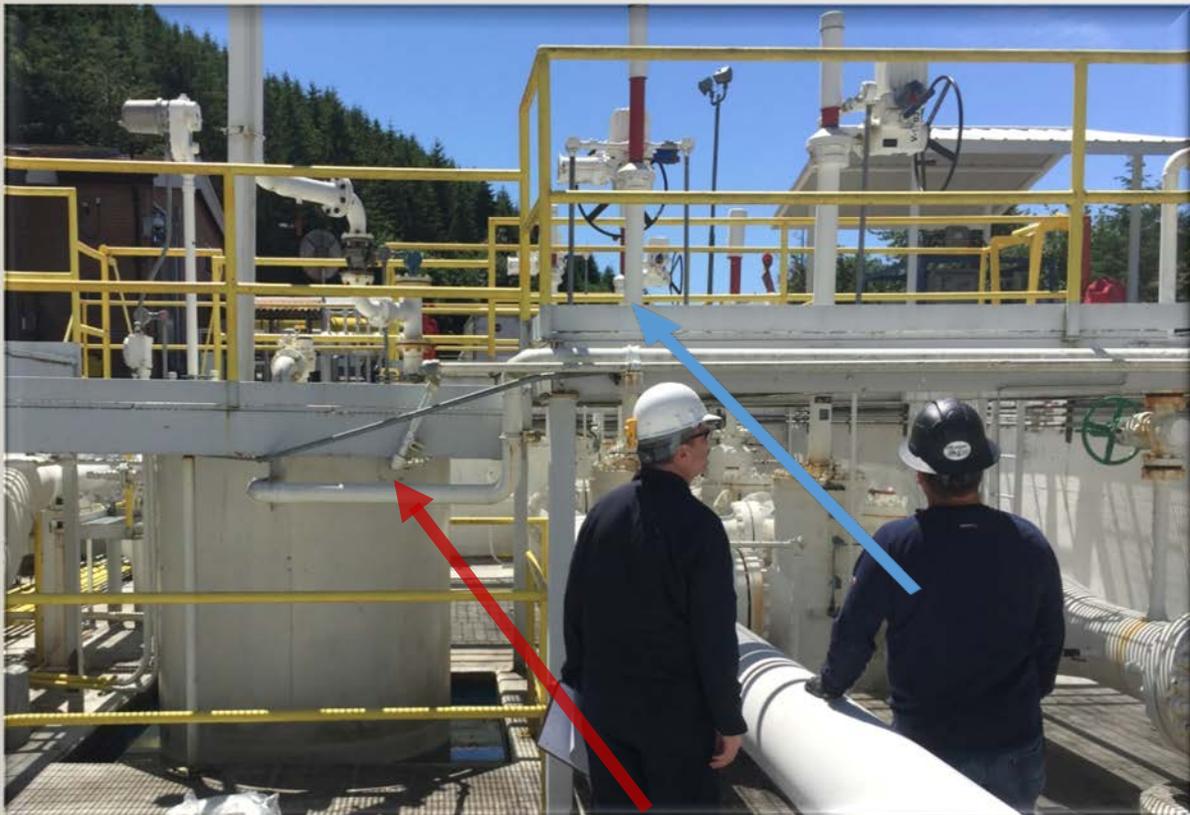
Proximity of sump tank and associated pump (red arrow) to valve V-1705. (blue arrow)

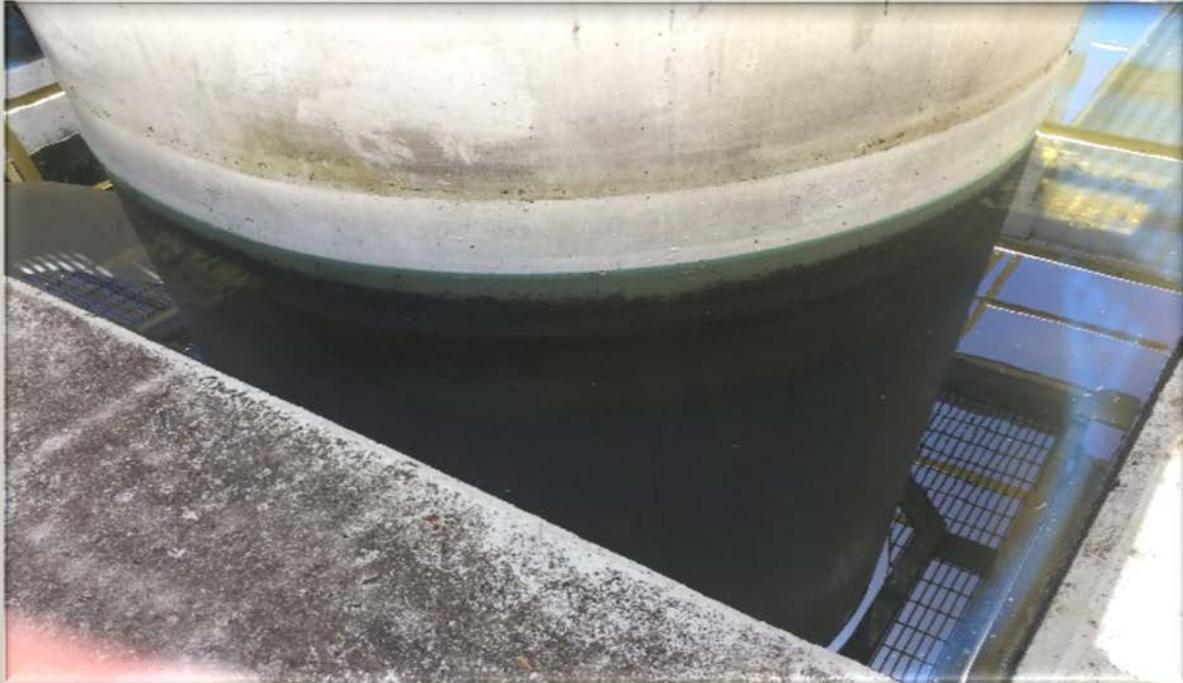
Sump tank containment with product floating on top. All product was captured within the containment.

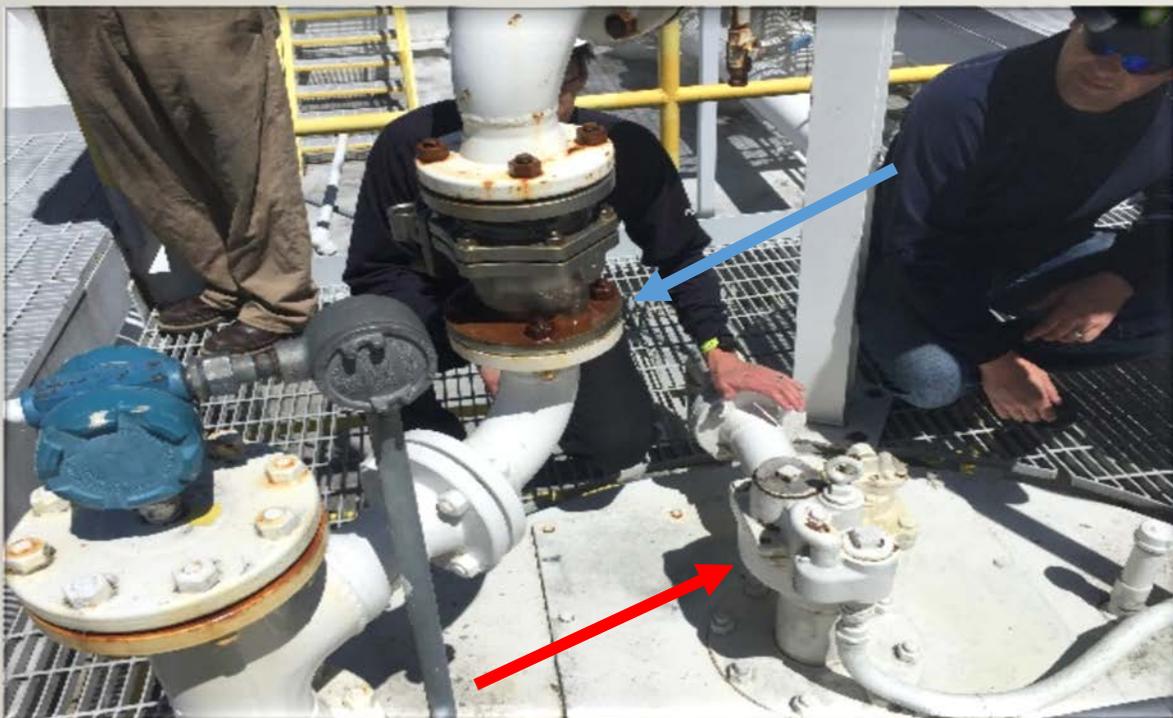
The **blue arrow** indicates a flange with residual leaked product remaining.  
The **red arrow** is the pump that was also operated during the investigation and it did not appear

to leak during testing after cycling the pump off and on.

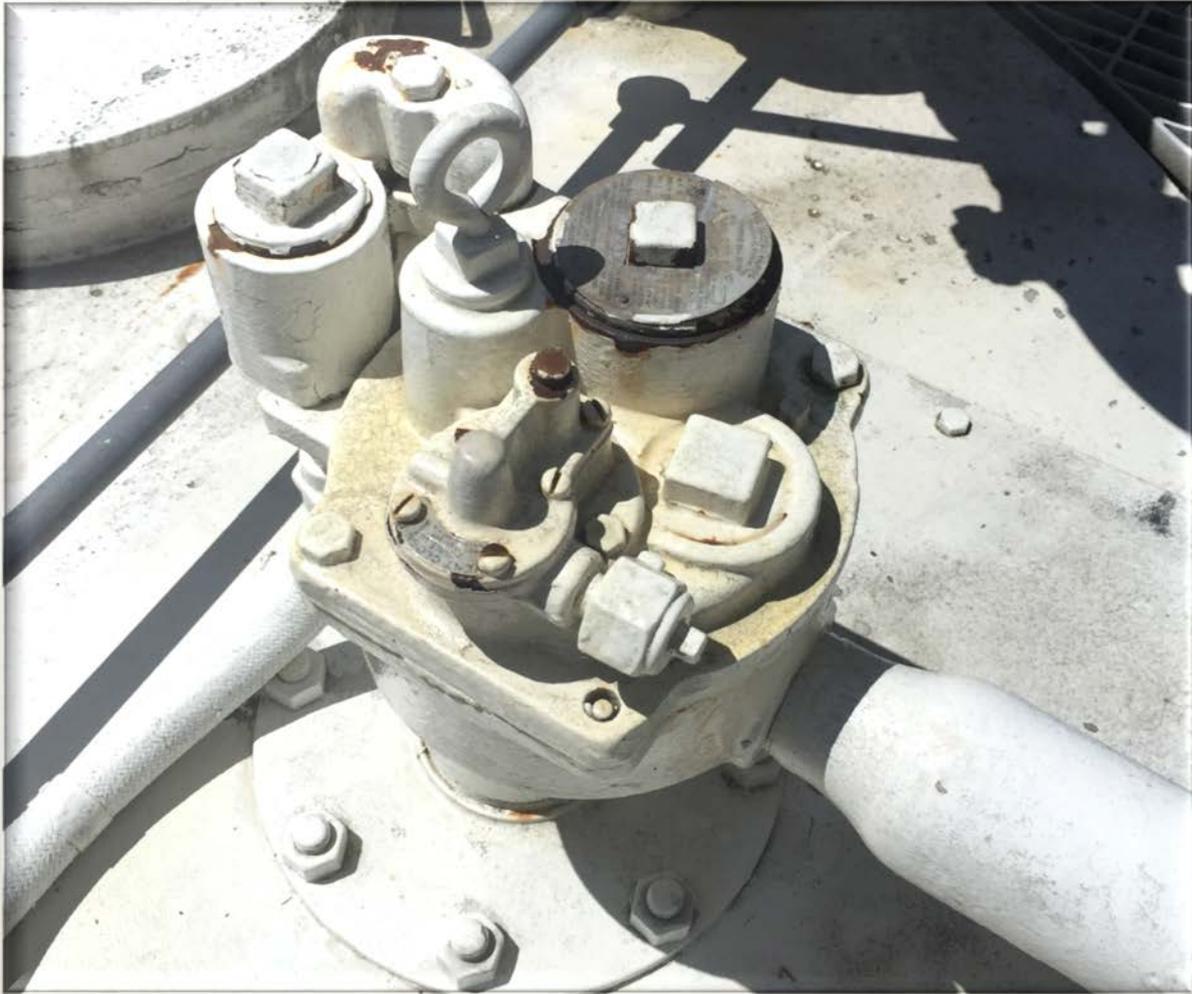
Close up image of Red Jacket sump pump at Castle Rock Station. No visible product leakage noted on pump housing. Date, serial number, and model number on capacitor cover is illegible in the photo.

**08-16-2019** OPL 7000-1 Supplemental - Accident Report received. The OPL report states: "The 4-5 gallon leak was due to a torn / worn O-ring and seal in the vent case of the Red Jacket sump pump. The O-ring and seal were replaced."

A data request has not been made to the operator to determine the model and service history of the pump. I cannot determine the date, serial number, and model number from field photos taken shortly after the incident. I reviewed the Red Jacket Petroleum Equipment service manual for the 4" "Extracta" Petroleum Pumps. It is unknown if that is the same model that failed during this incident. The document, RJ 5190.pdf Rev 3/93, does state that for pumps manufactured prior to 6/6/84 there are upgraded seal kit to be used. Additionally, The manufacturer states: "All Red Jacket submersible petroleum pumps manufactured prior to November 7, 1984 (Date code 21184) were supplied with a brass check valve. After this date, pumps were supplied with plastic check valves. Effective February 1993, pumps are supplied with a stainless steel check valve."

It is unknown if this is the pump, the 4" "Extracta" Petroleum Pump, that is in service without further investigation and with a service report from OPL detailing what components were replaced, the material type of the existing seals, and the historical service history. A cause or contributing factor, in absence of the information, is undetermined.

The seal failure appears to be an isolated case. I recommend that we continue to monitor for failures involving seals and O-rings of these types of pumps in the future and take further action if there is a pattern of reoccurrence.
