PHMSA/Inspector Training & Qualification

Inspection Findings!!

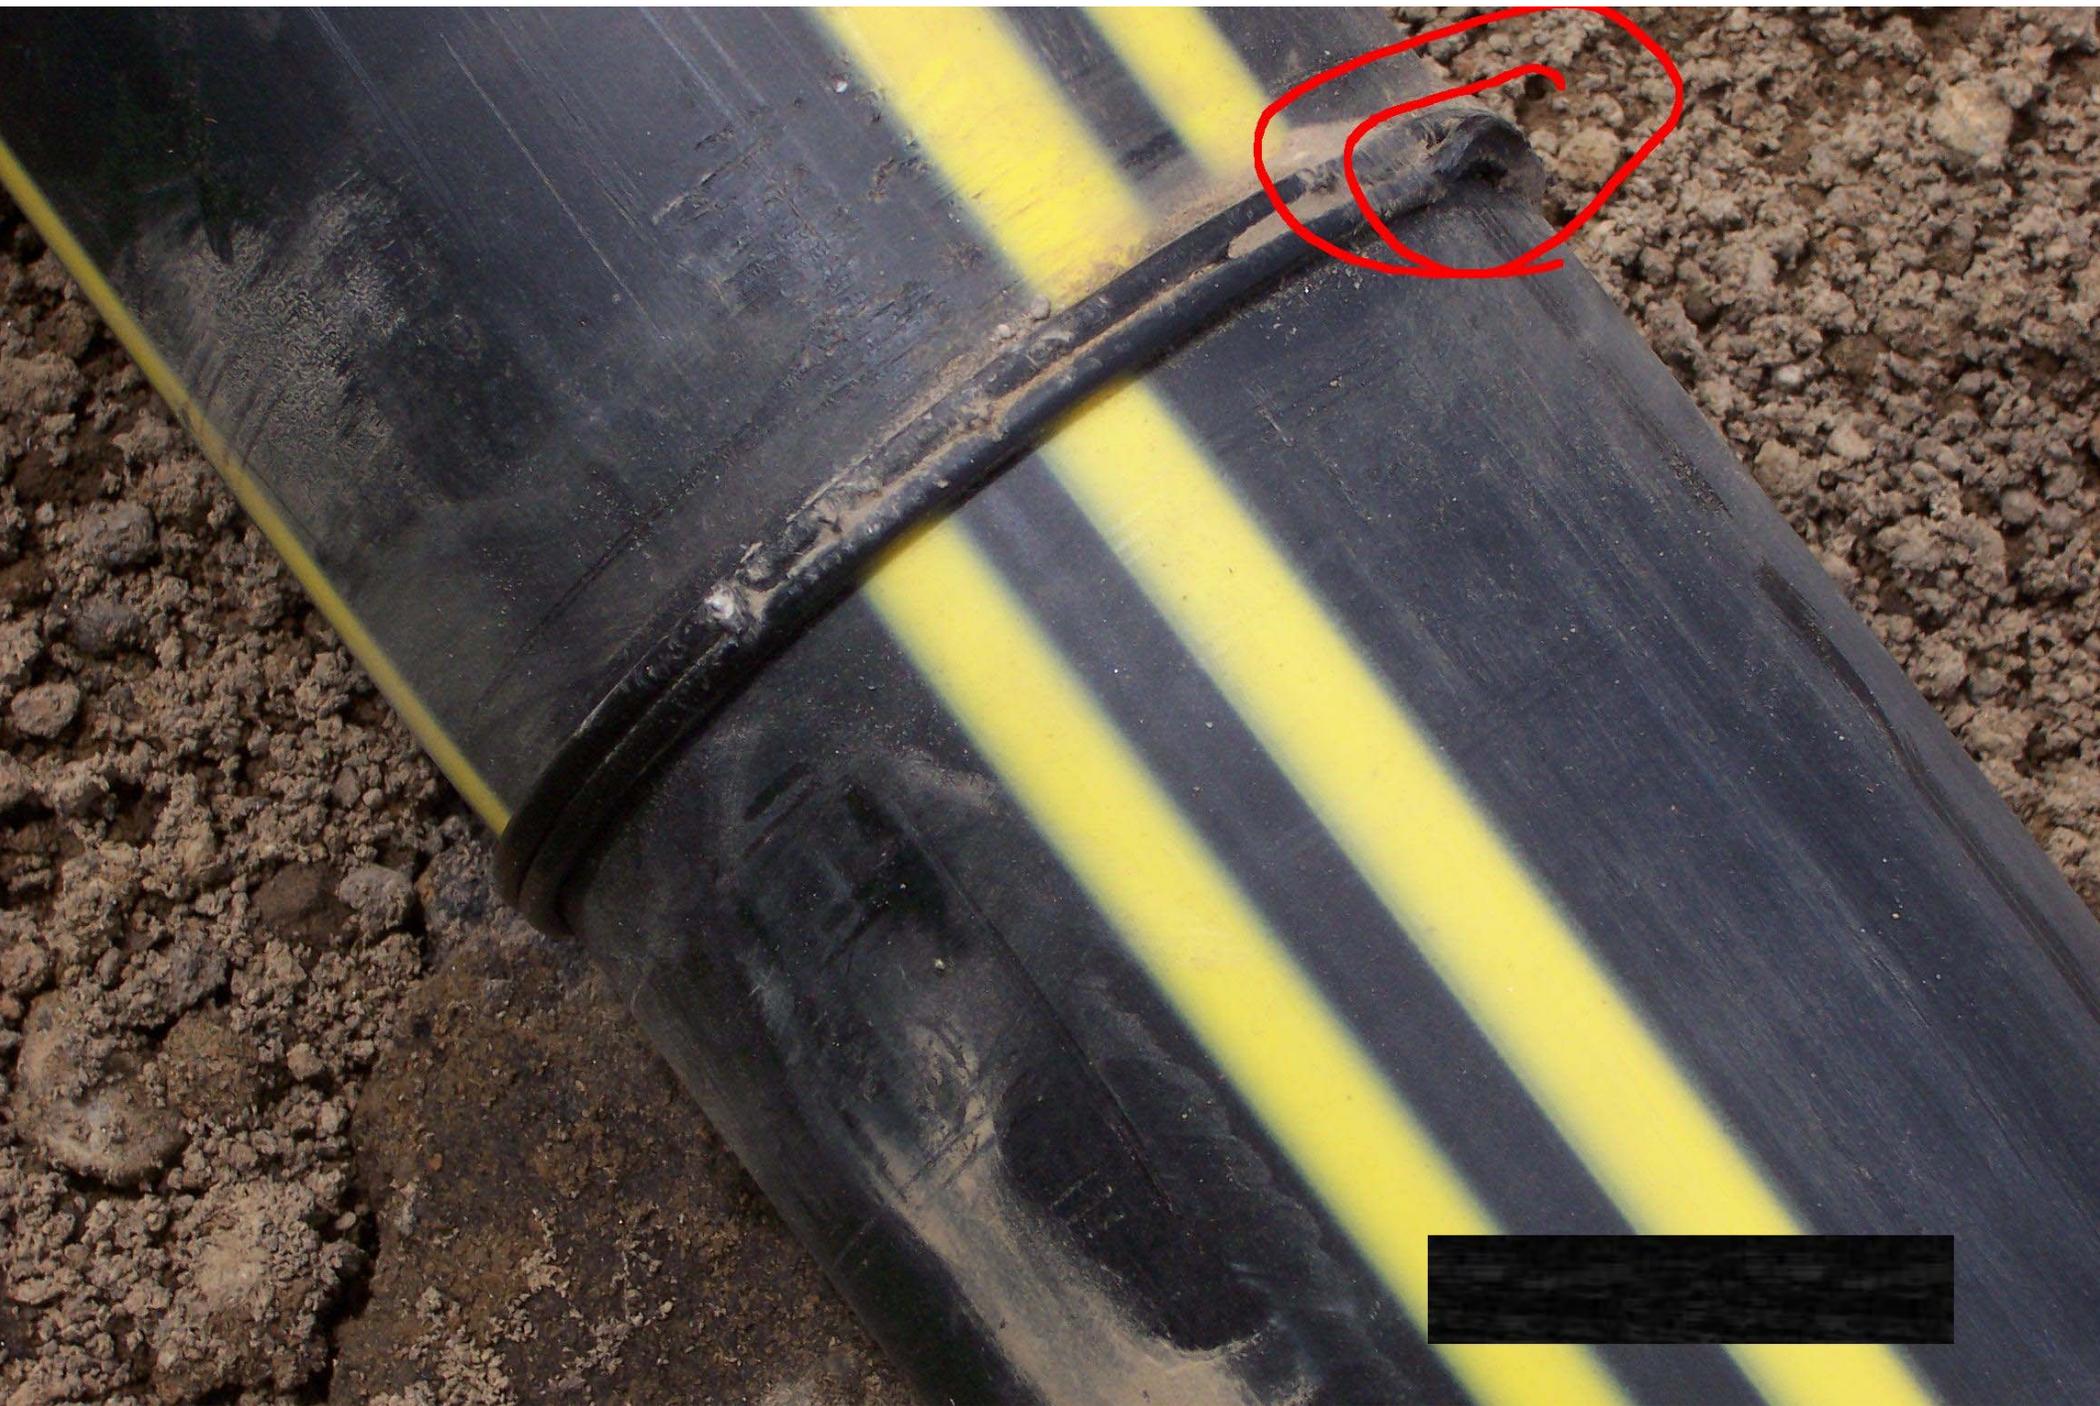
**Right in the
area to be
joined...**

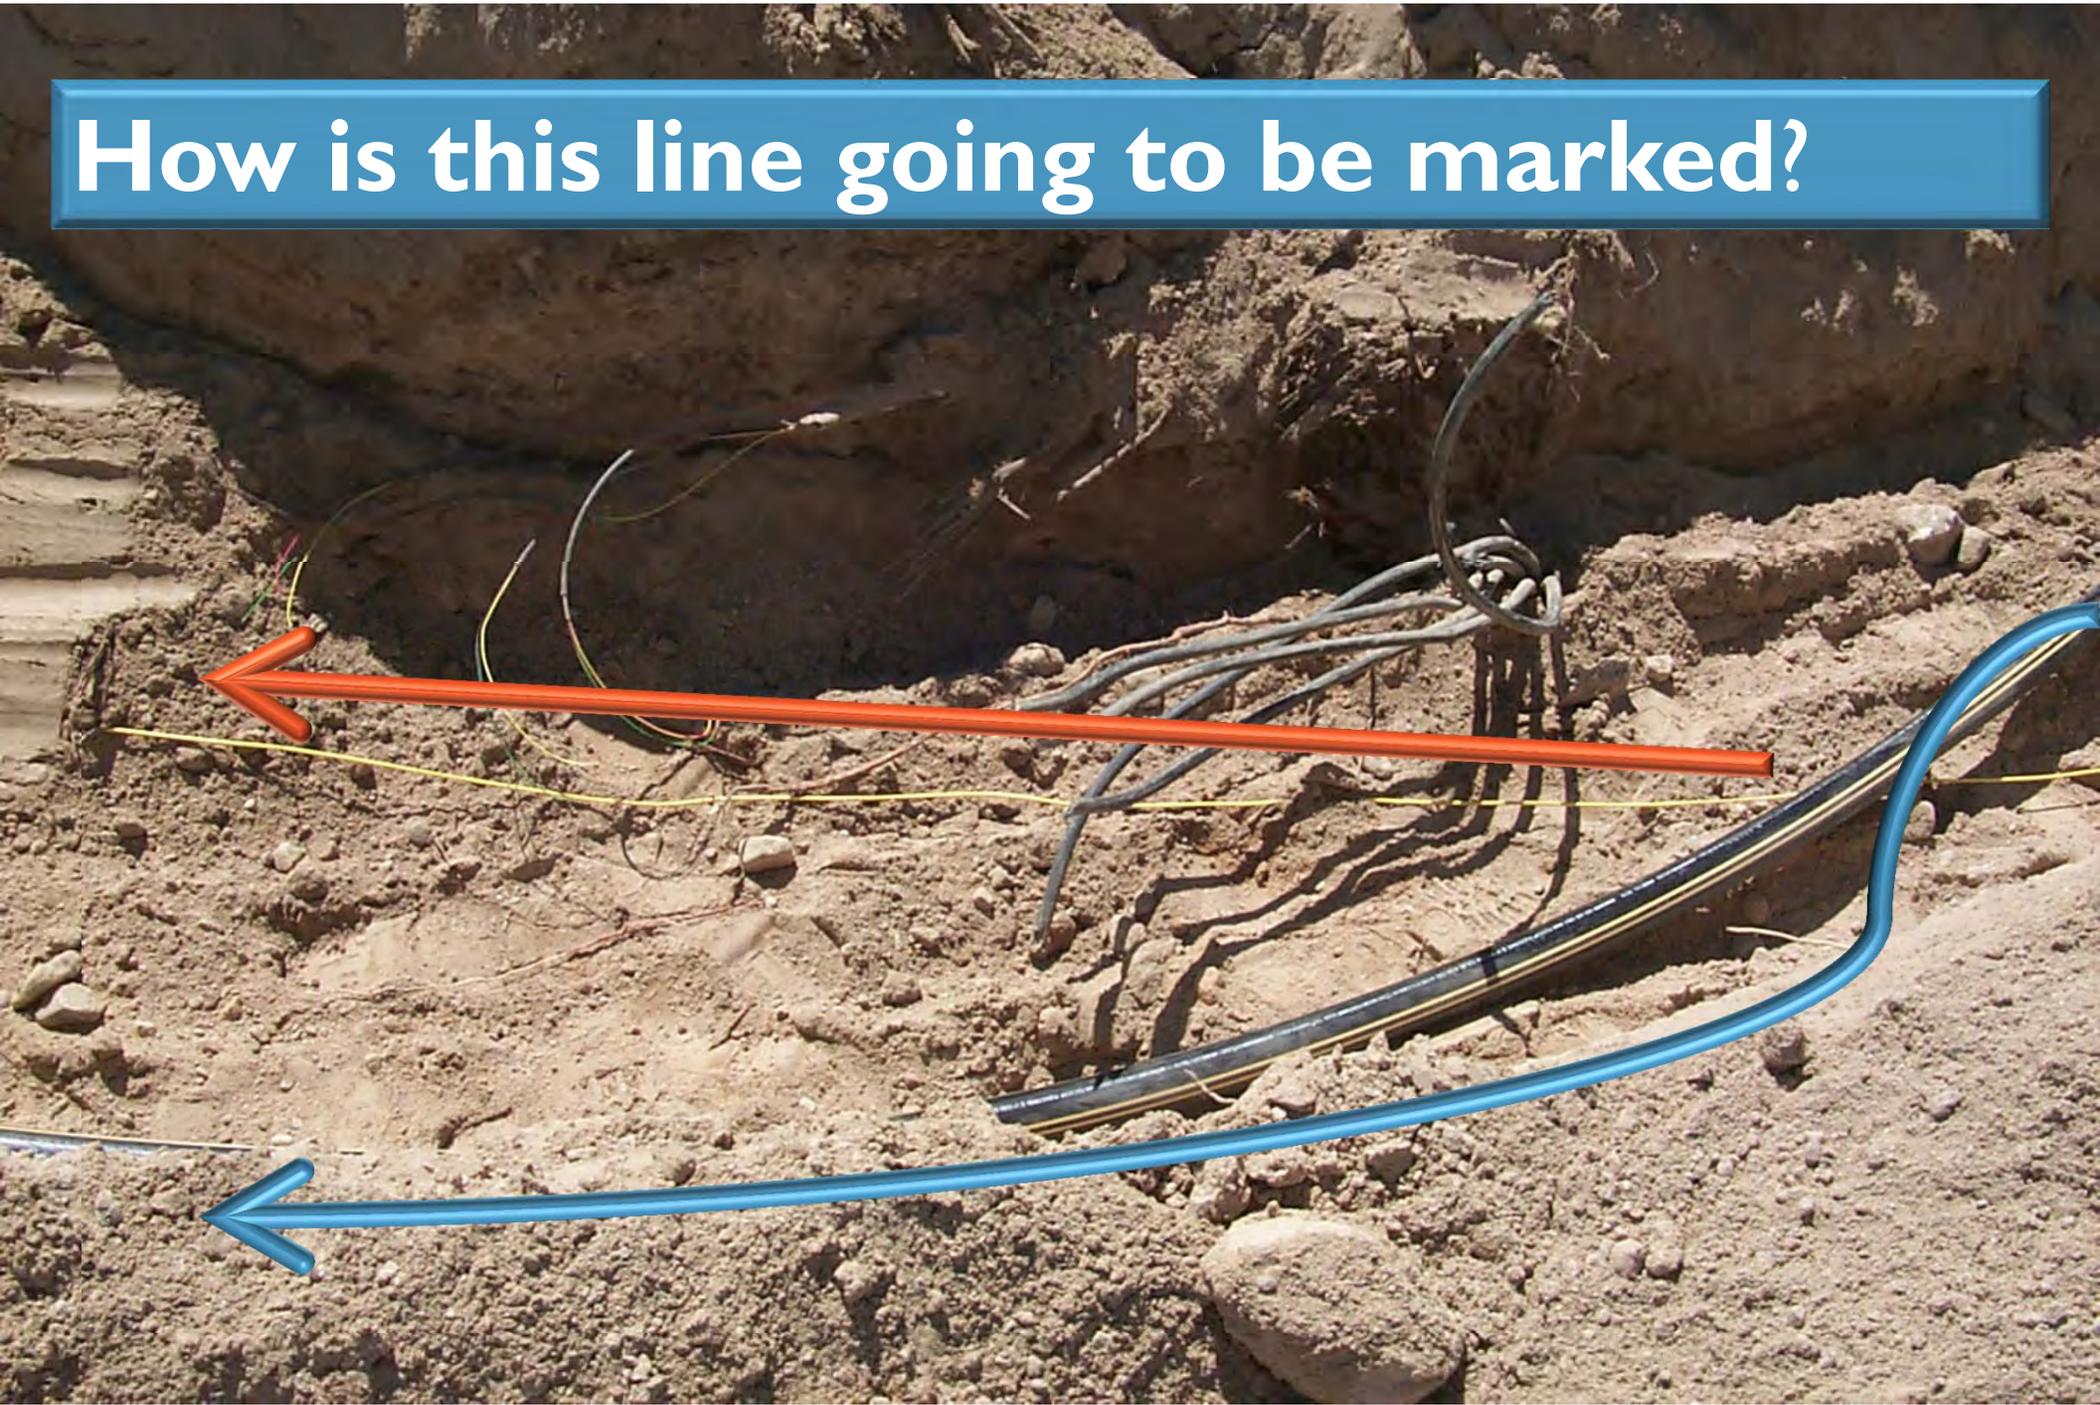
Is this a violation?

§192.321(e) Installation of Plastic Pipe

- ...tracer wire may not be wrapped around the pipe and contact must be minimized, but is not prohibited

How is this line going to be marked?

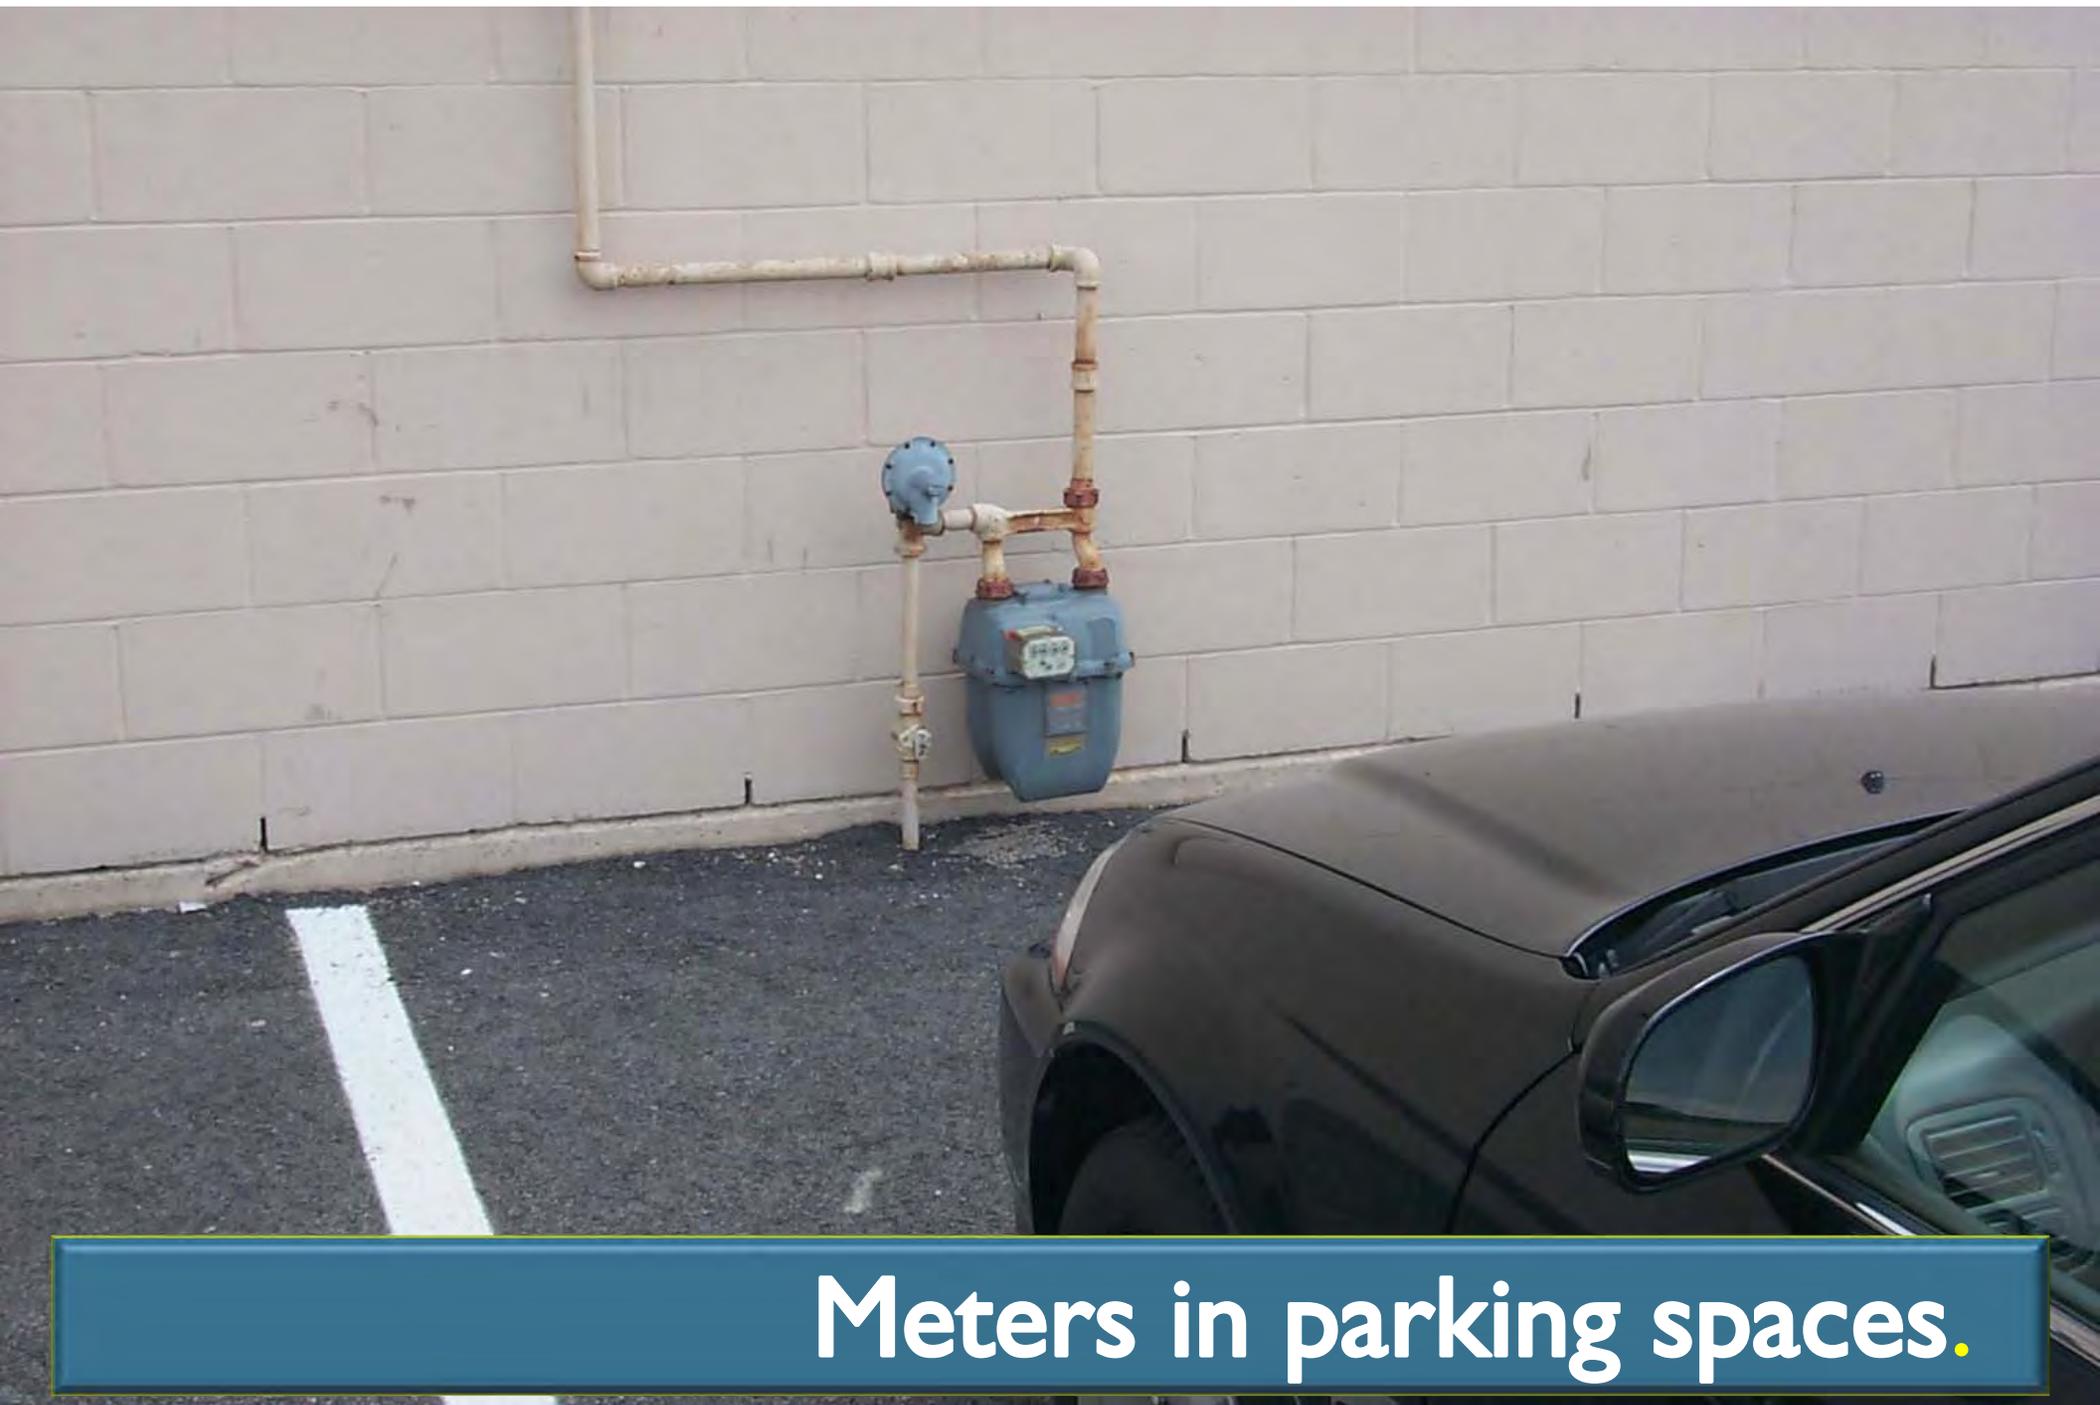
Meters in parking spaces.

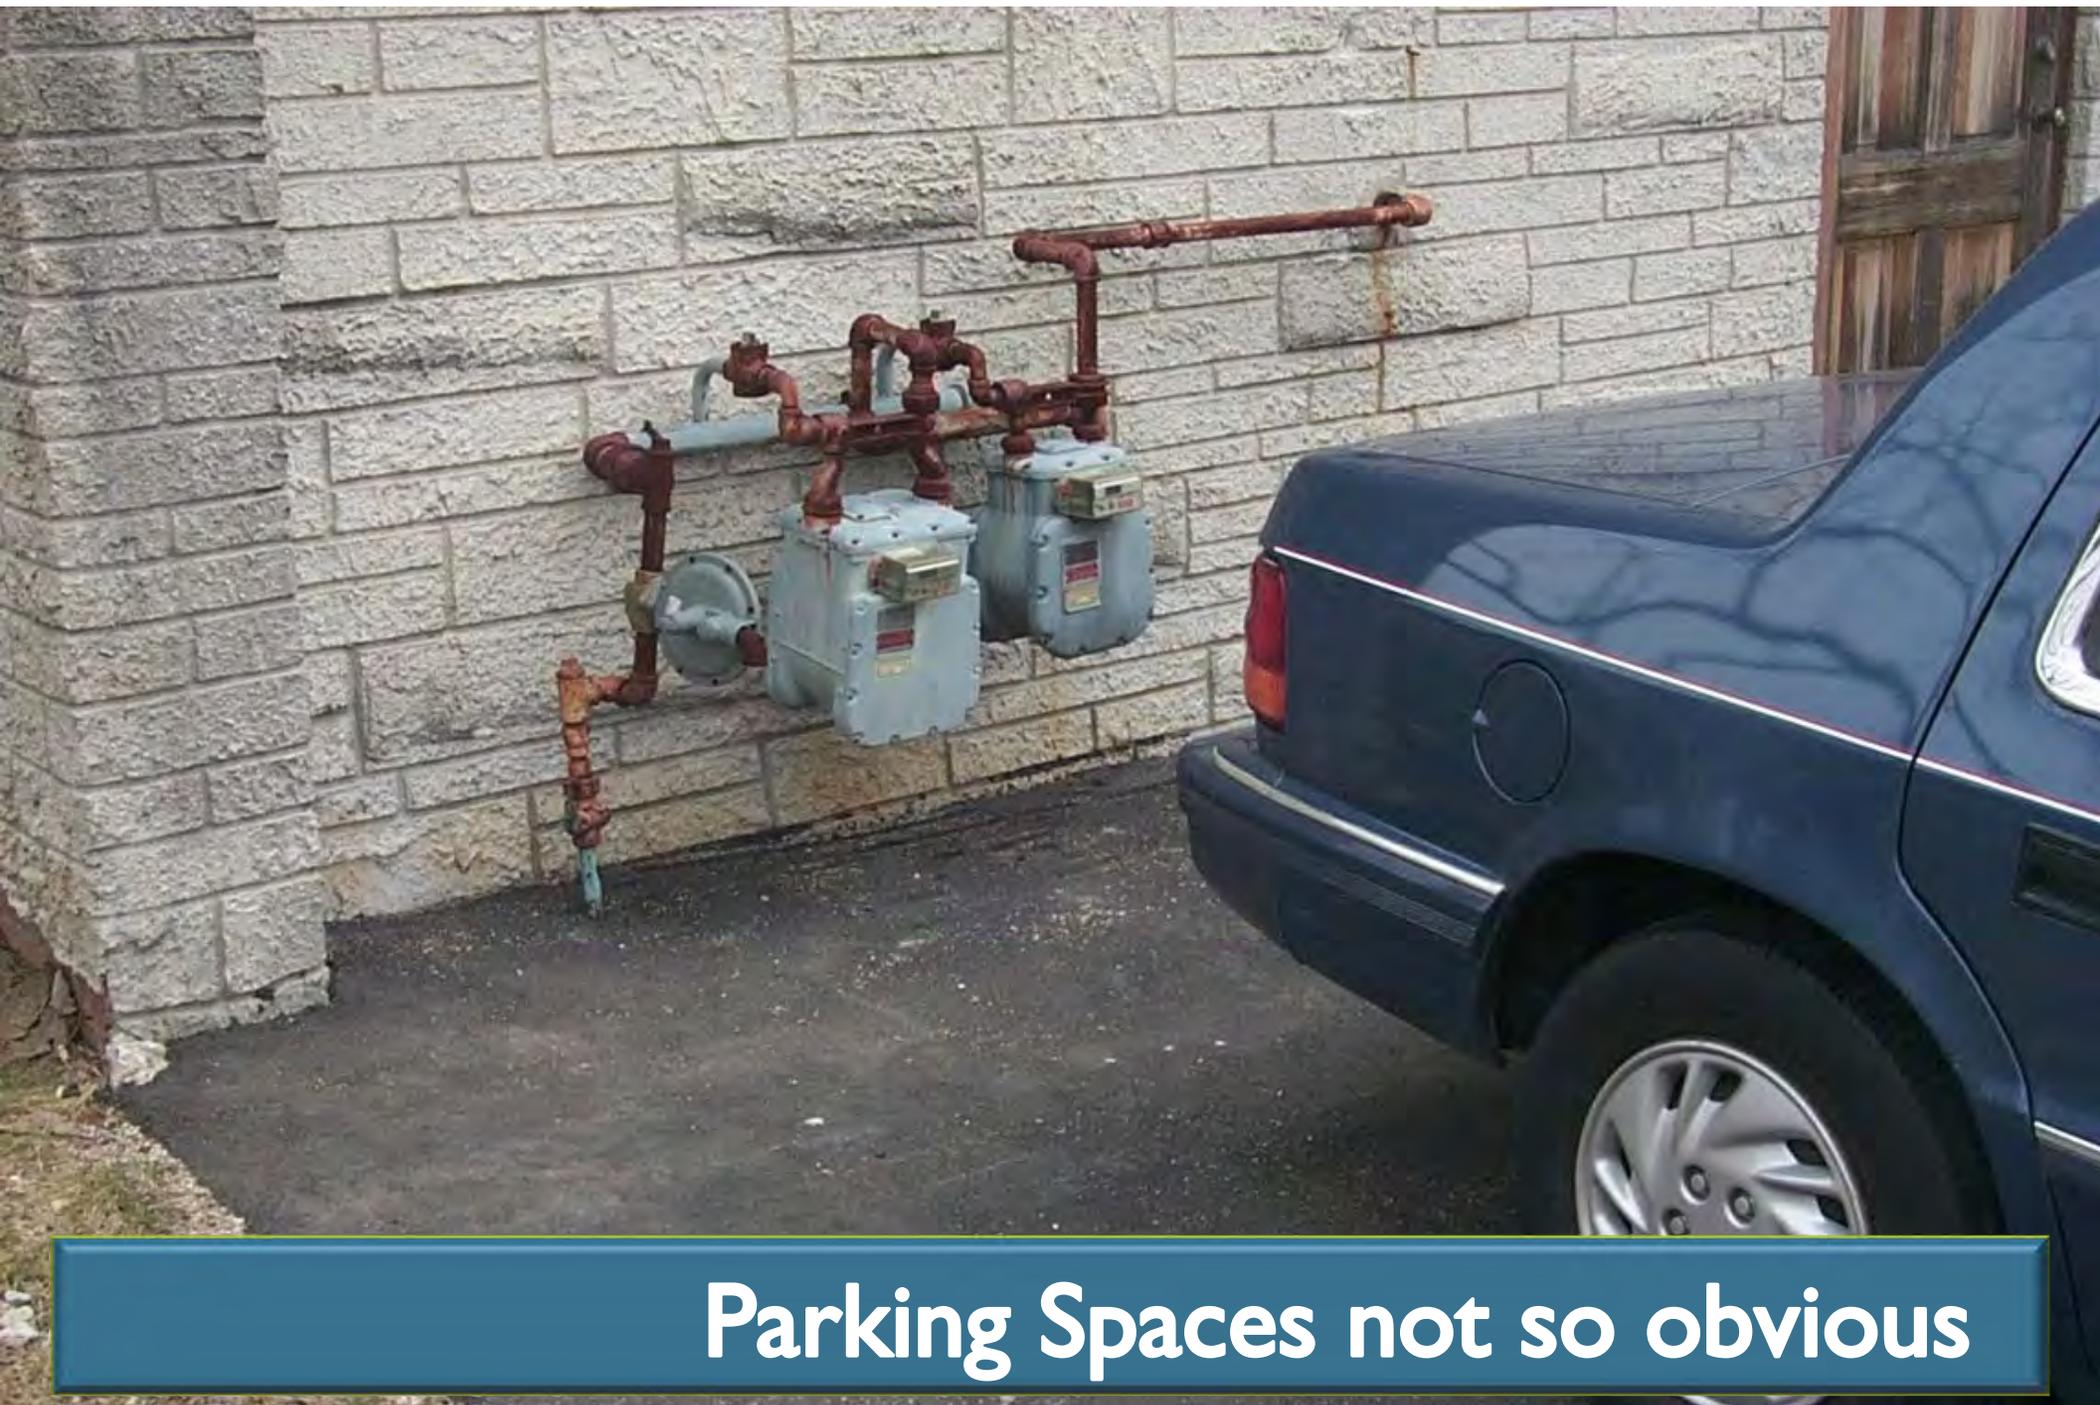
Parking Spaces not so obvious

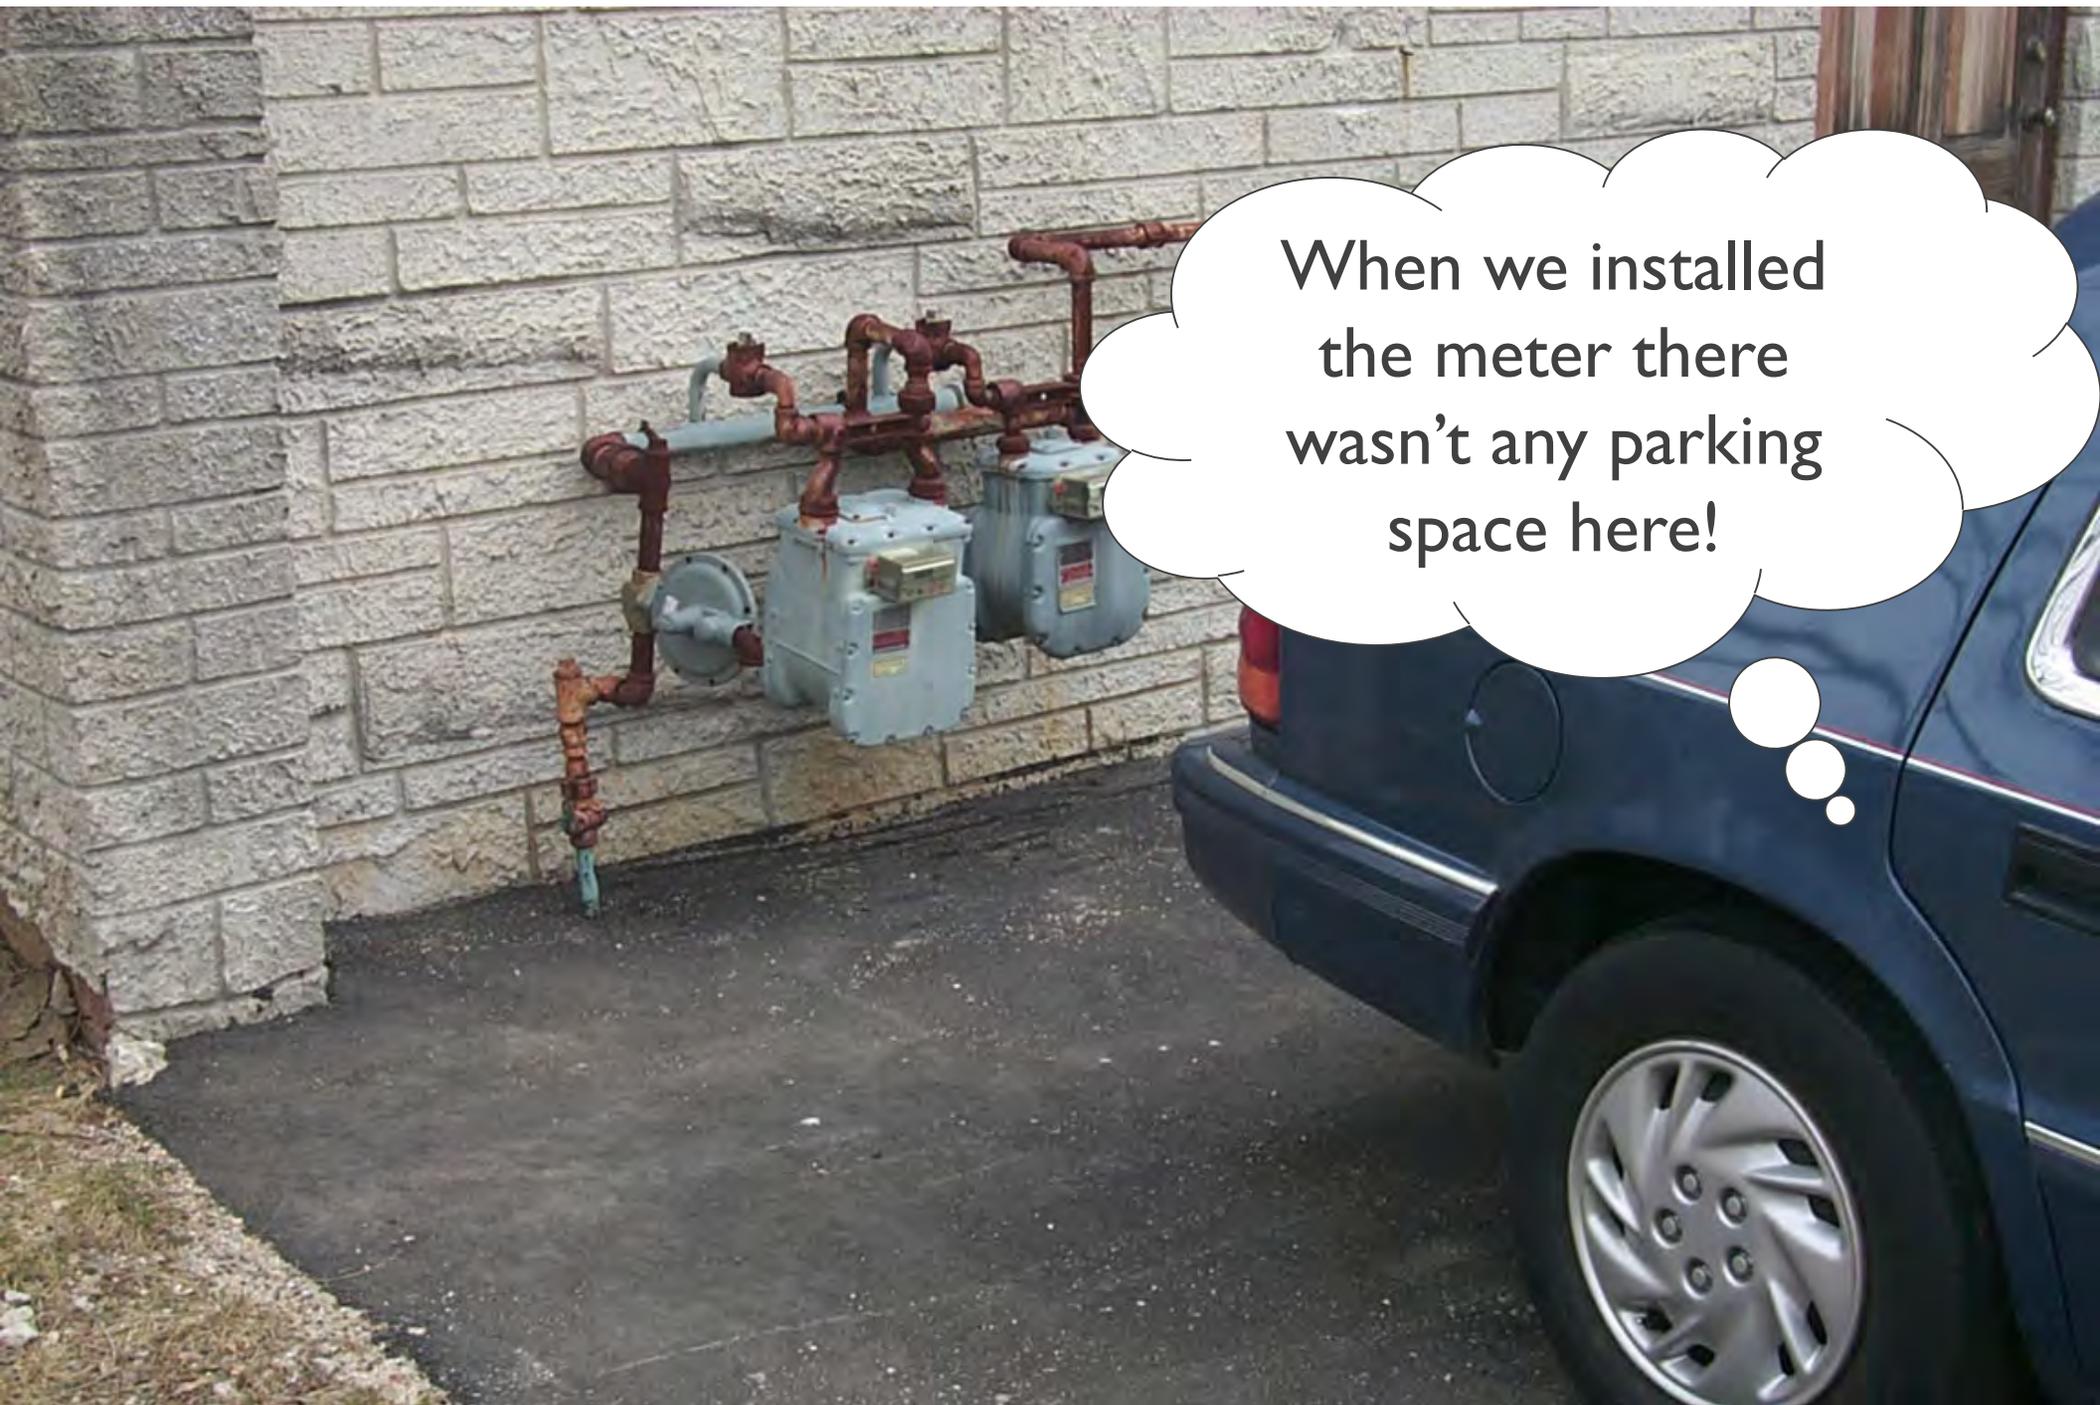
When we installed
the meter there
wasn't any parking
space here!

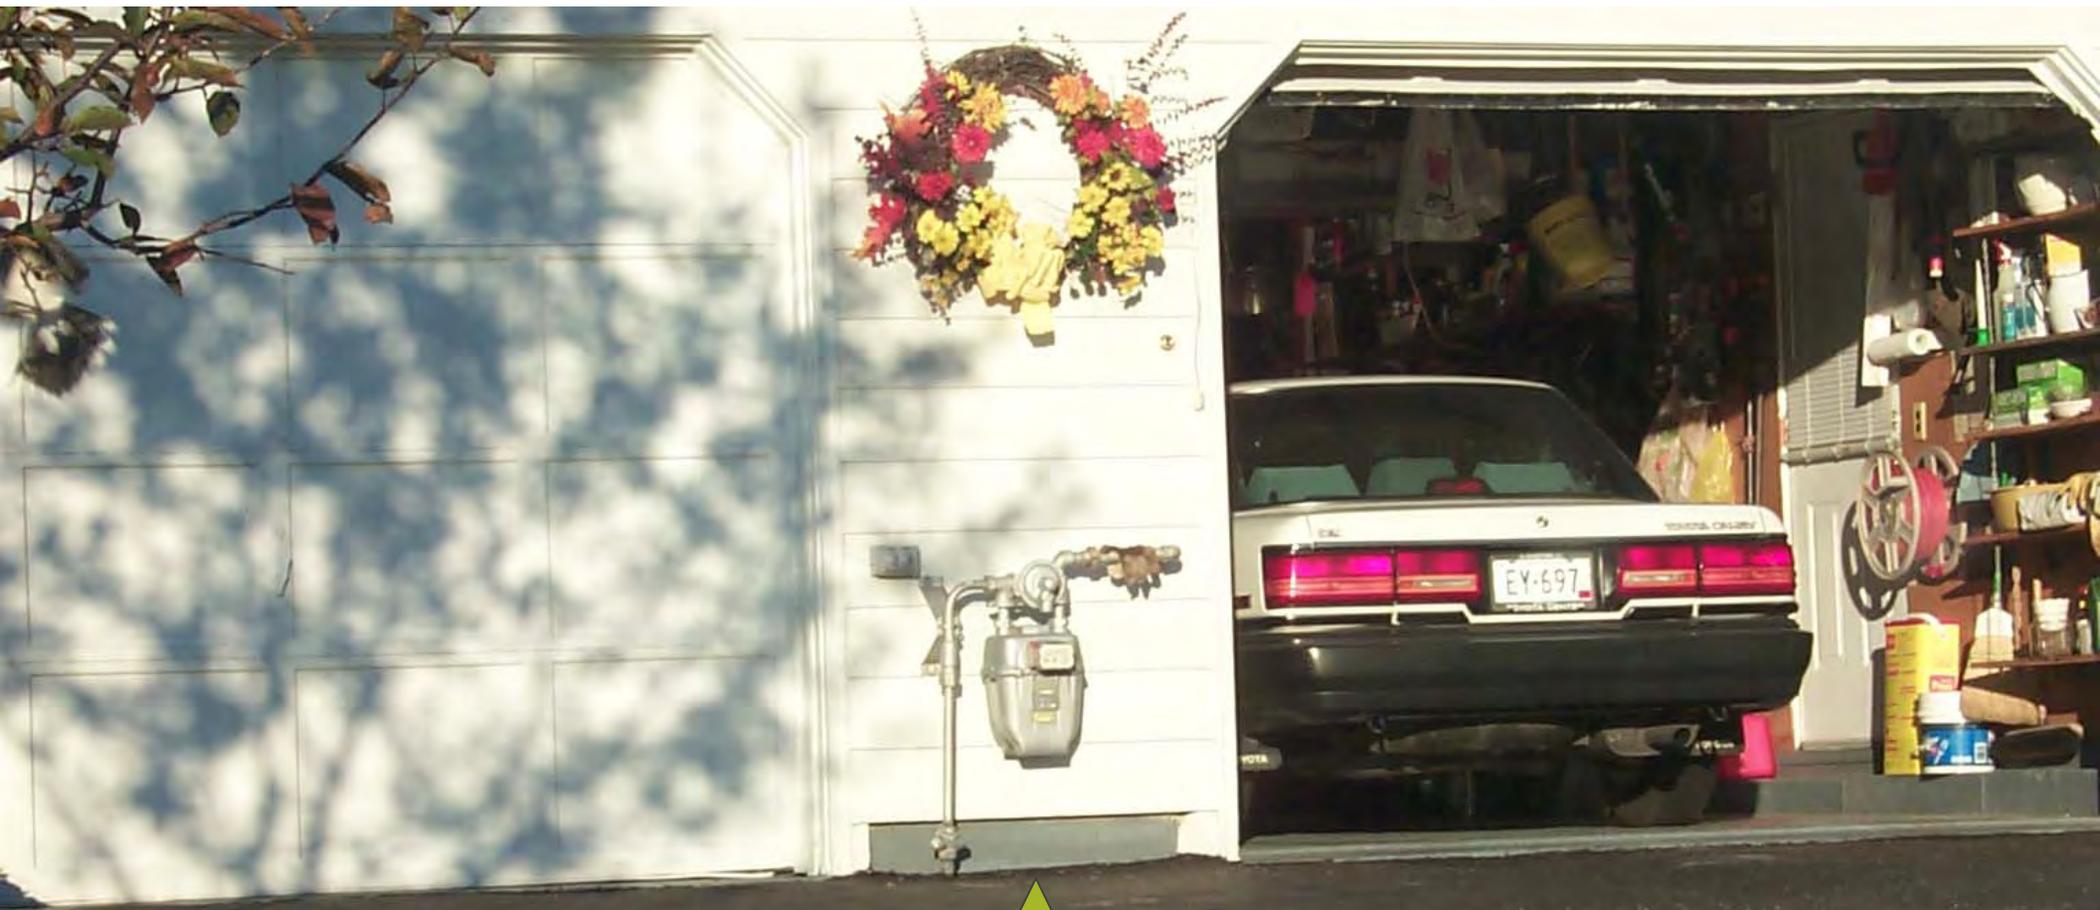
In front of garages

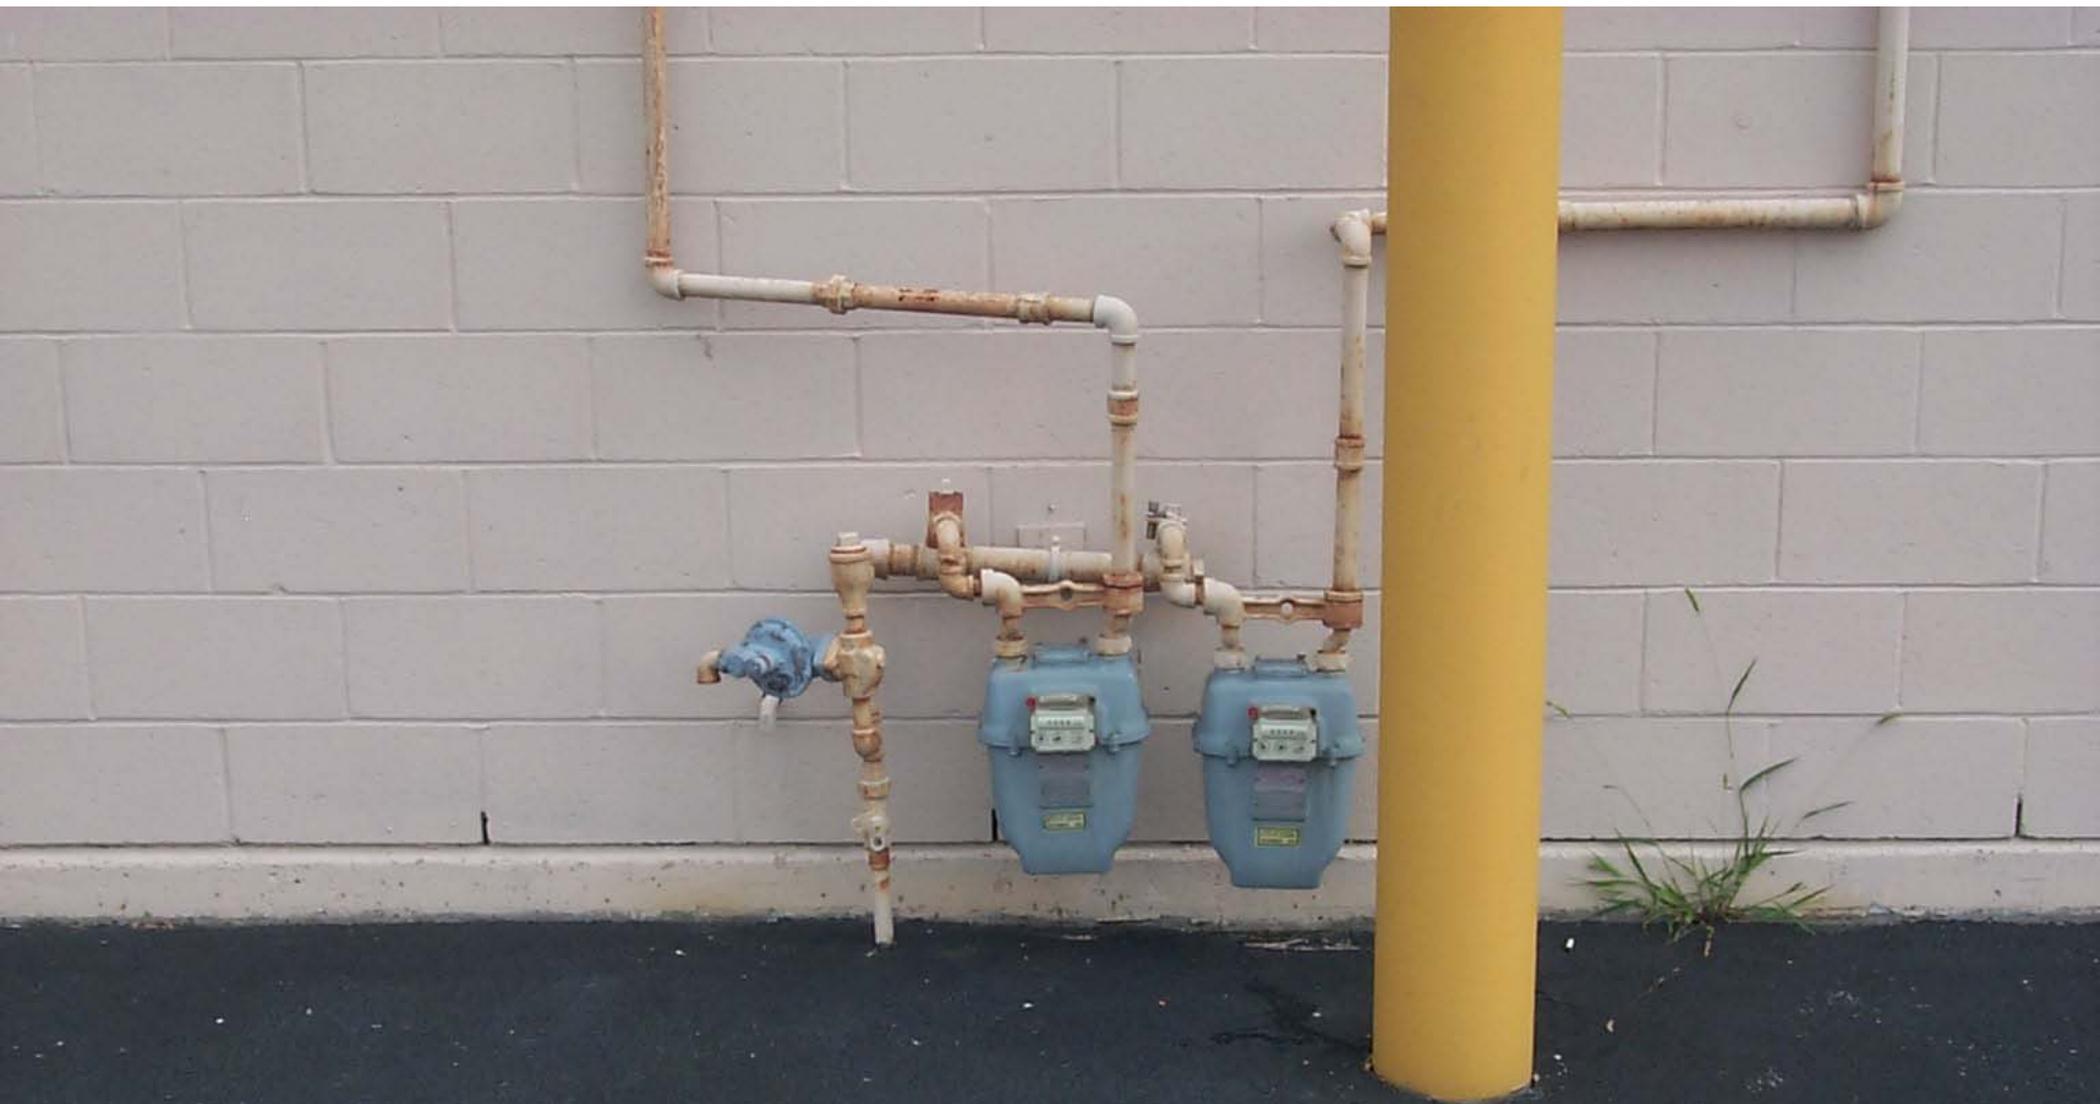
Is one pole enough?

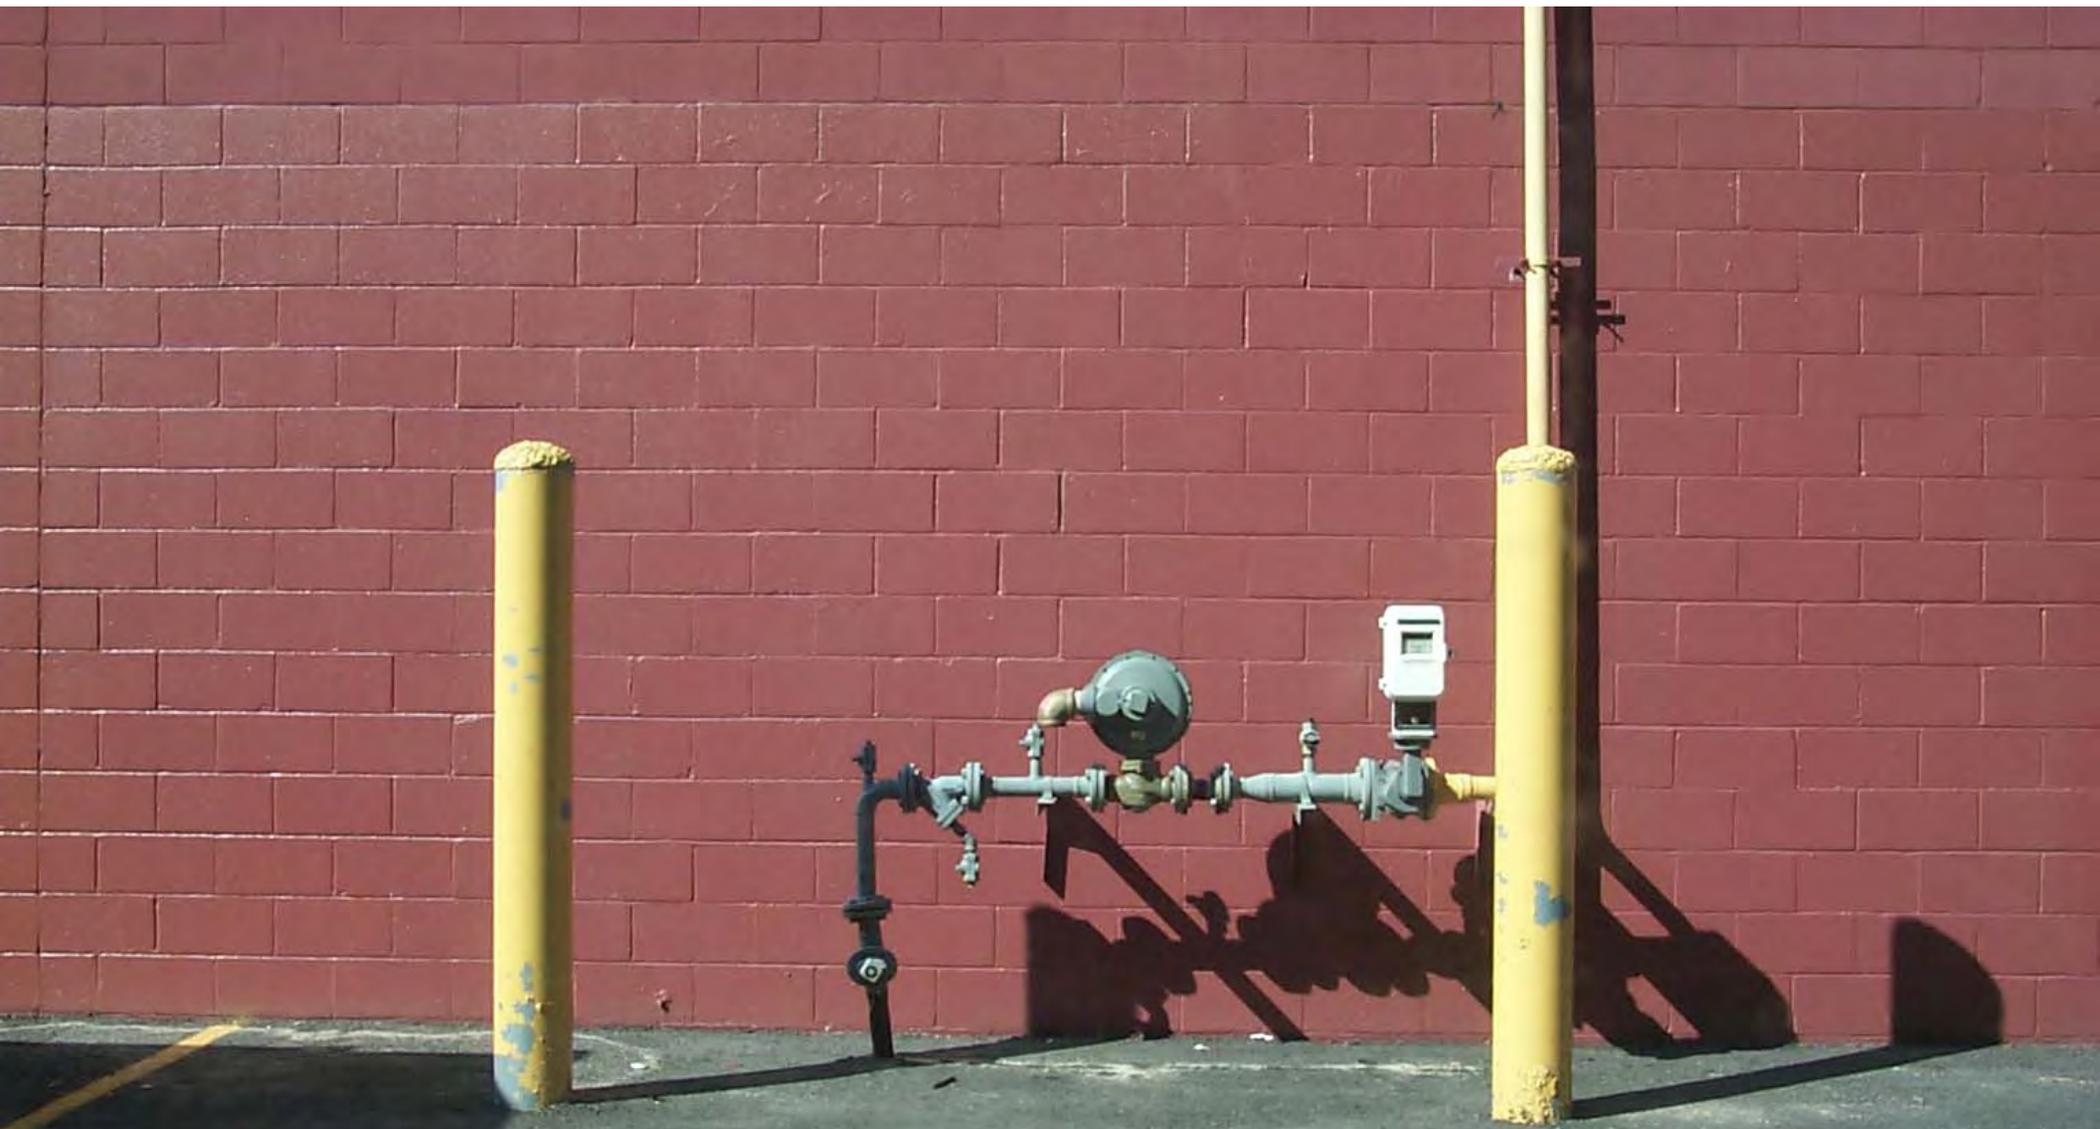
Can you drive a car through the opening?
