PHMSA/Inspector Training & Qualification

Inspection Findings!!

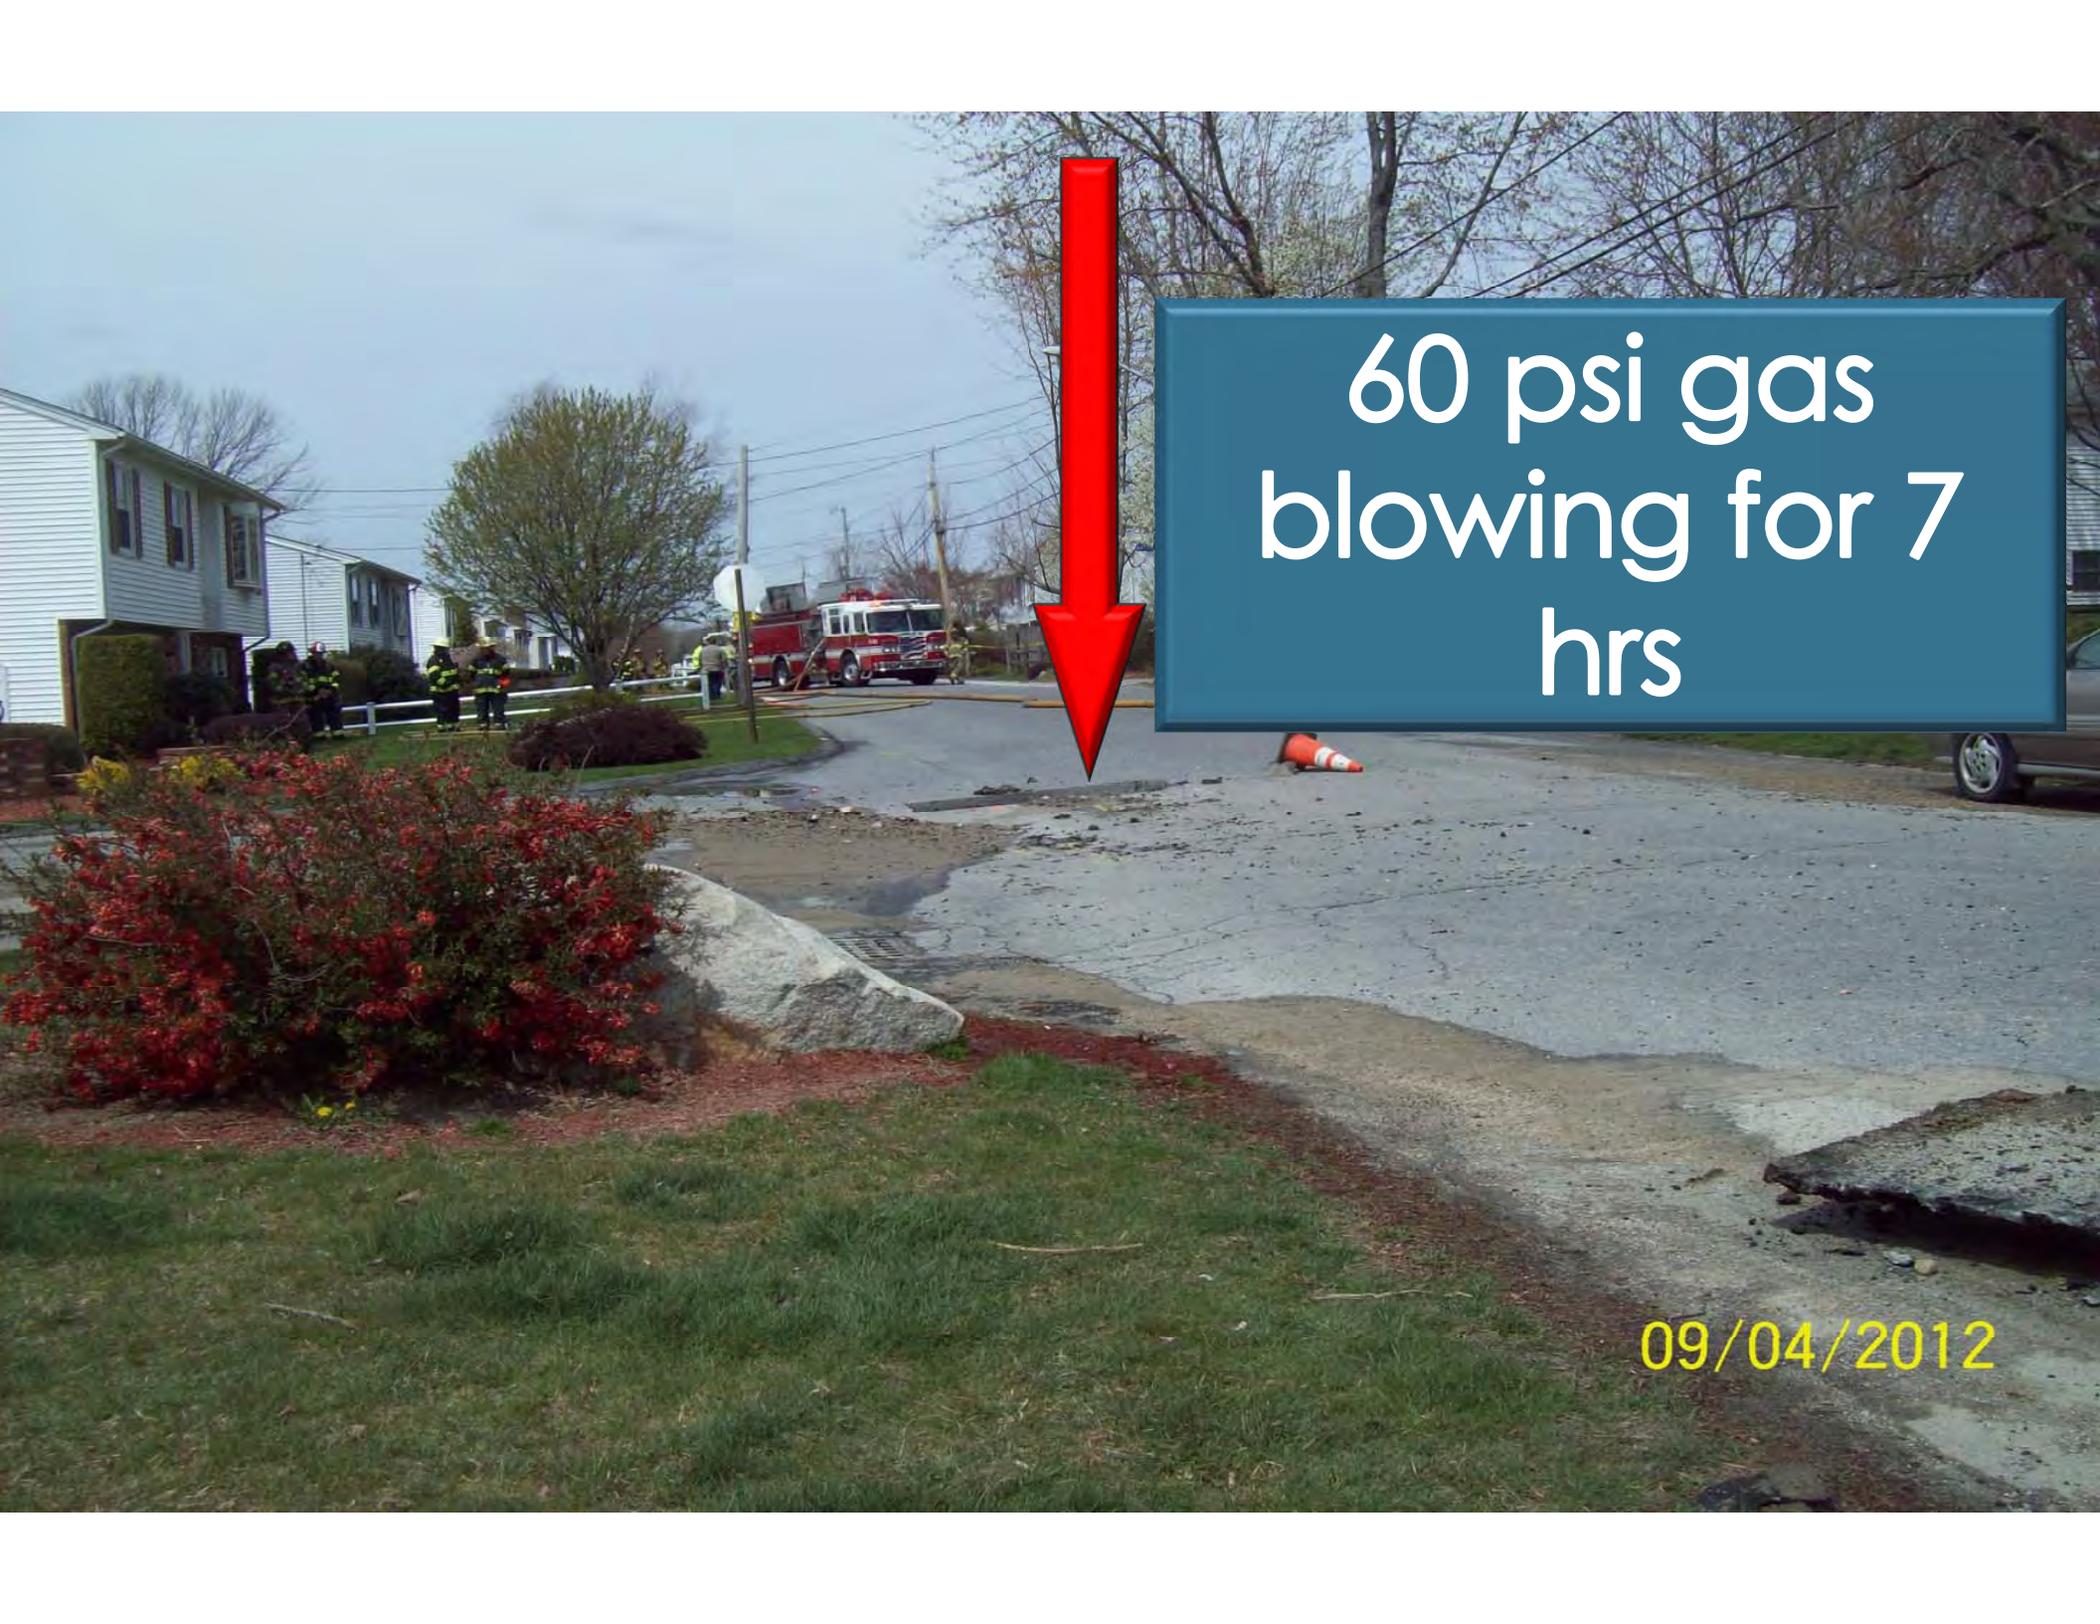
60 psi gas
blowing for 7
hrs

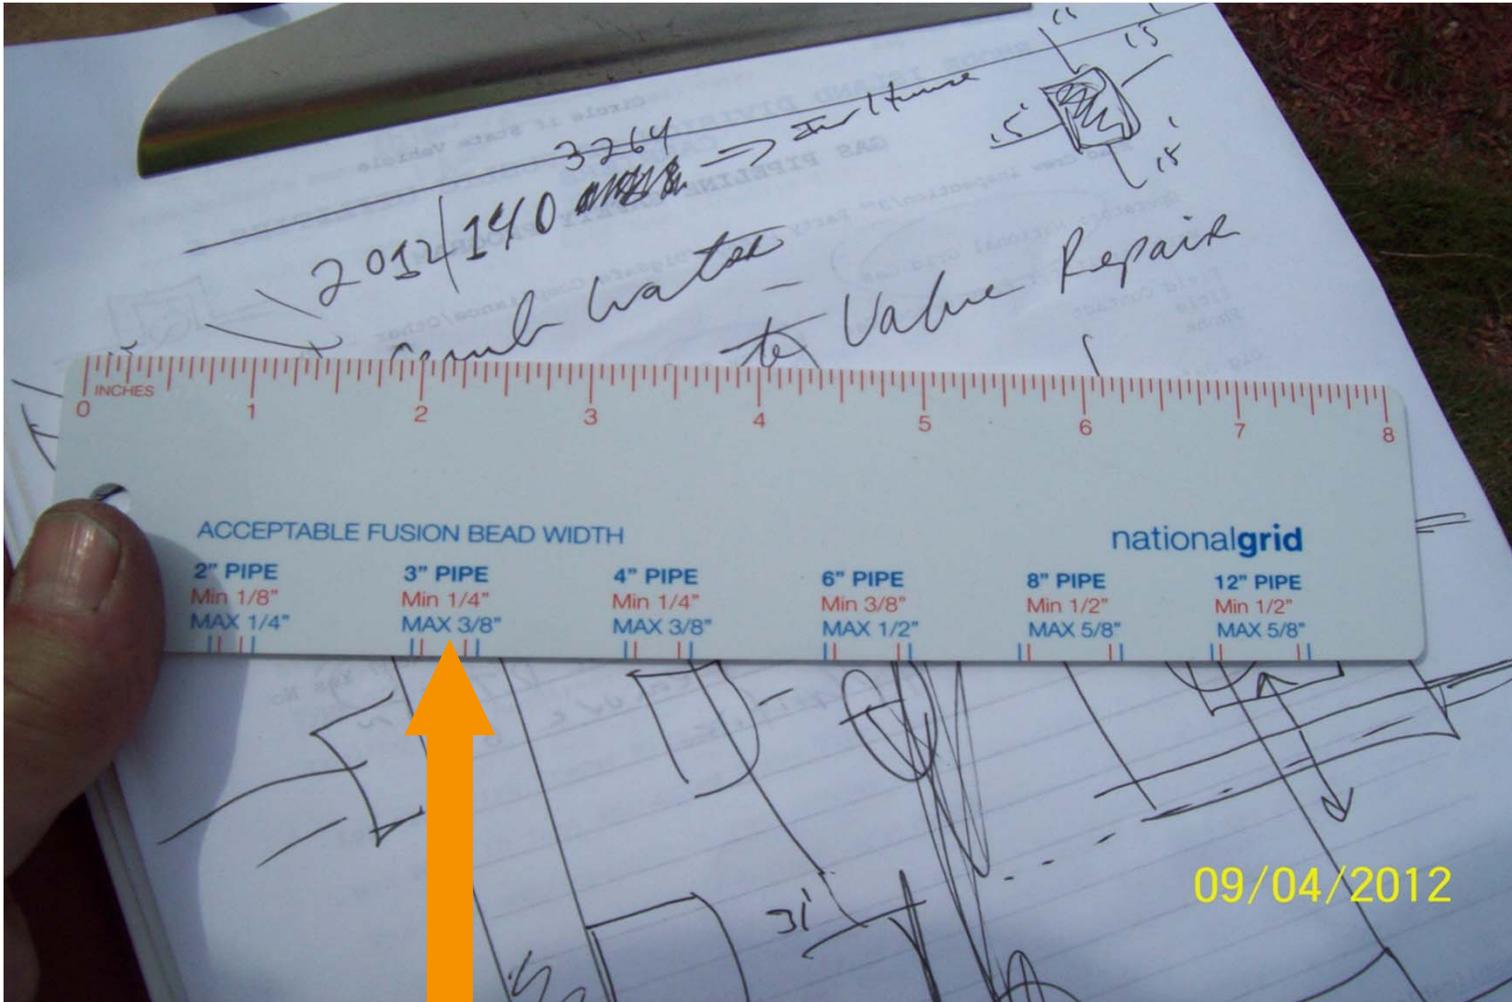
What is This?

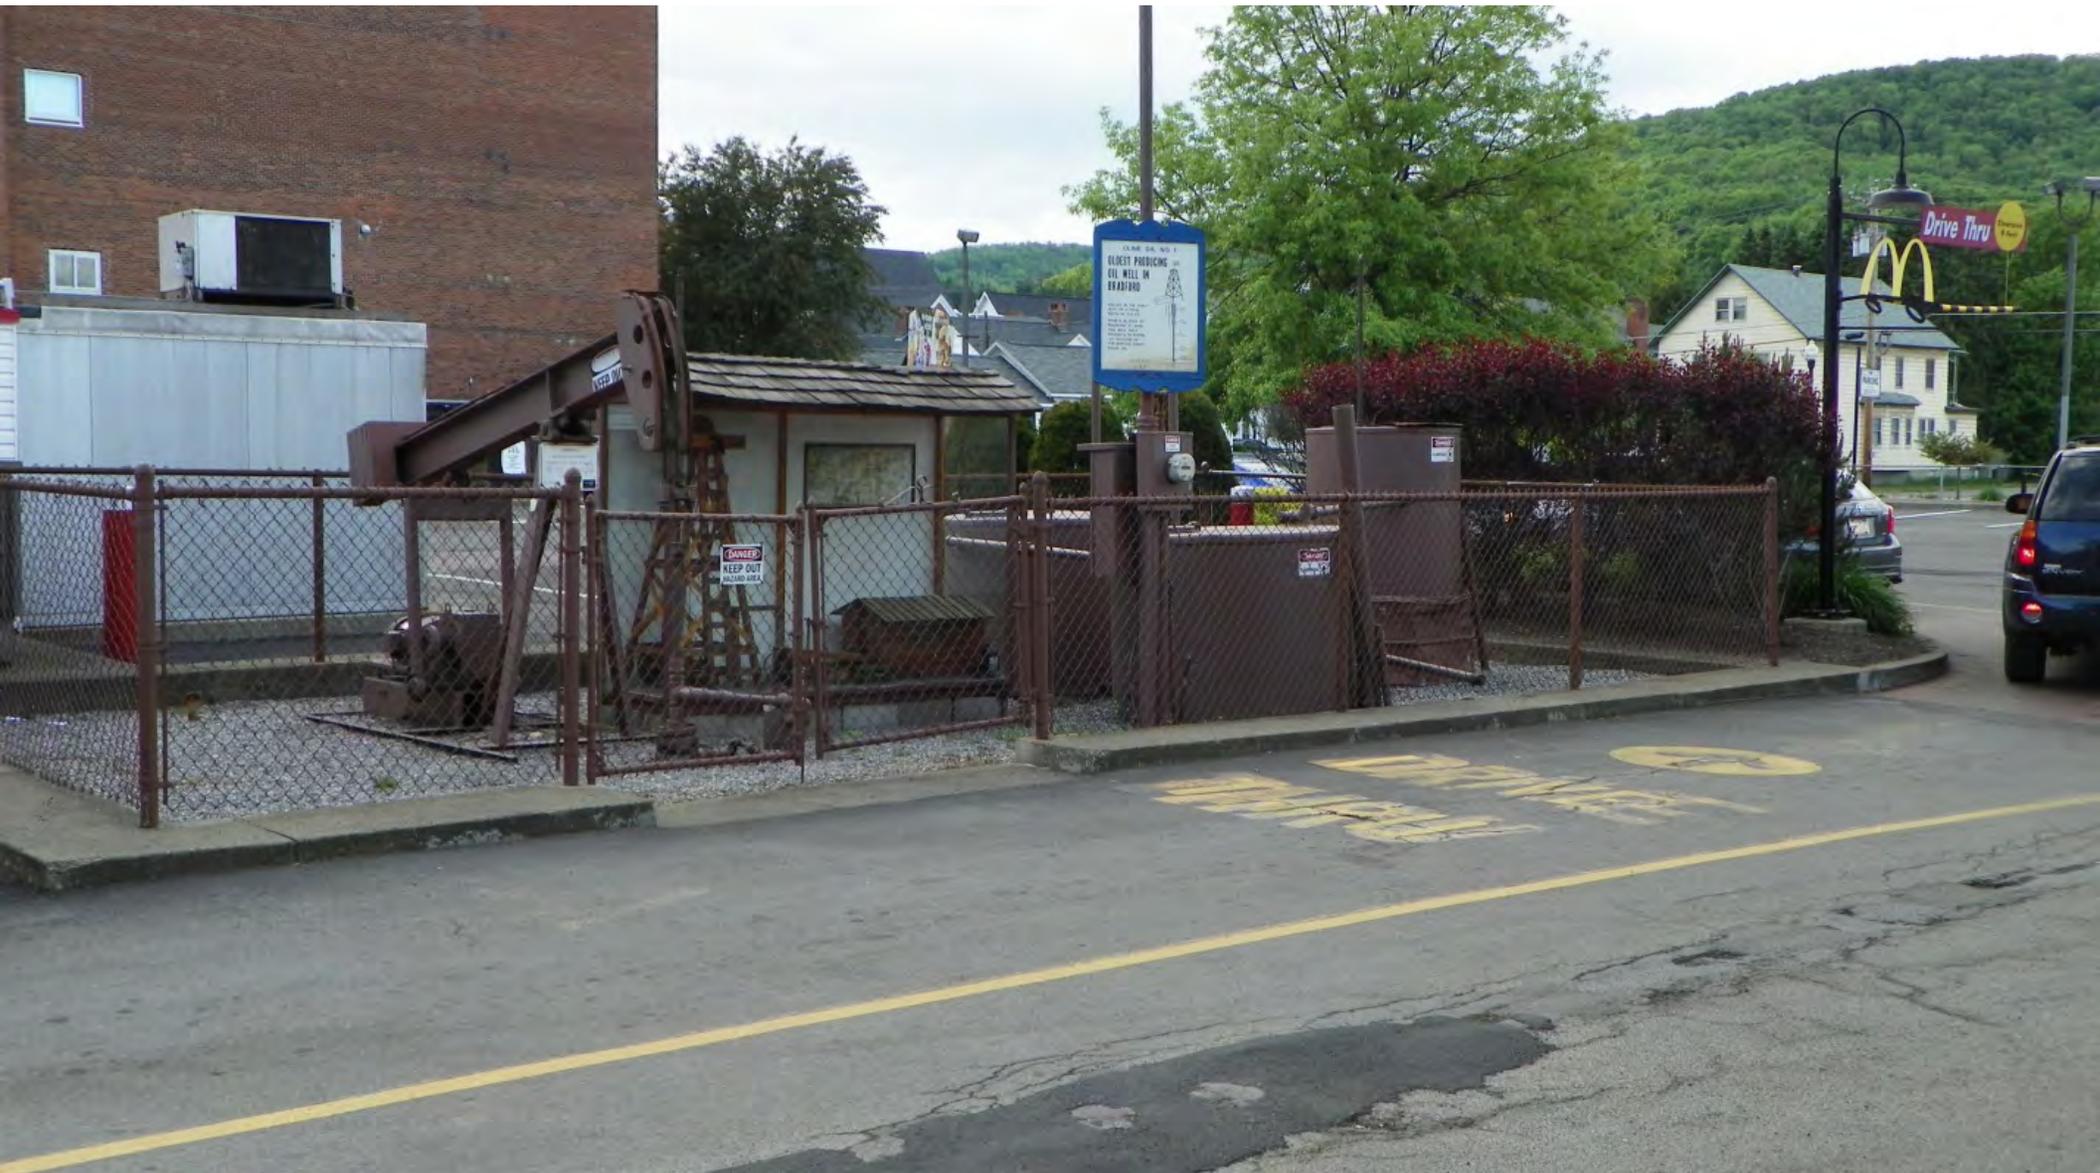
Active Oil Well at McDonald's Drive Thru – Bradford, PA
