**McCHORD PIPELINE CO.**

September 21<sup>st</sup>, 2017

**Damage to McChord Pipeline  
at 100<sup>th</sup> and A Street  
Tacoma, WA**

Nicholas D. Peelo  
Chief Engineer  
McChord Pipeline Co.

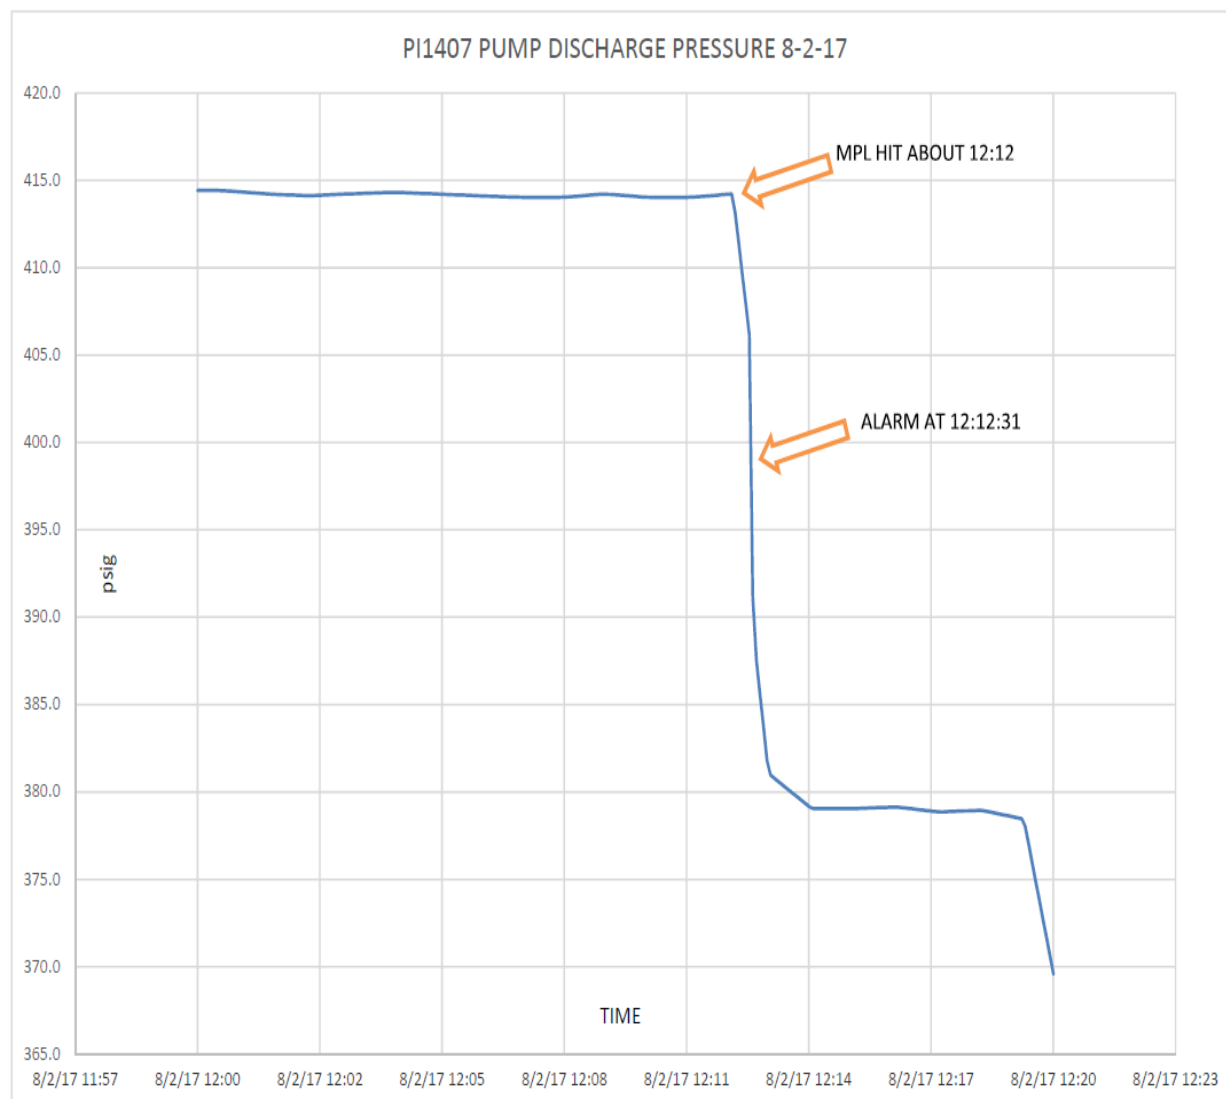
# PI-1407

- **PI-1407**, pump discharge pressure, compares current value to 15 minute average (alarms at 15 psi difference)
- **FQI-1438**, flow totalizer that compares the volume shipped by USOR to the volume received by JBLM over a 15 minute interval (alarms at 546 gallons difference)
- **FQI-1436**, flow totalizer that compares the volume shipped by USOR to the volume received by JBLM (alarms at 2000 gallons difference)

- **0658:** USOR starts a scheduled 10,000 bbl transfer to JBLM
- **1212:** SEFNCO tool punctures MPL
- **1212:** MPL alarm for sudden pressure drop, PI-1407 (~30 seconds after event)
- **1213:** MPL 15 minute alarm for 546 gal differential between USOR / JBLM, FQI-1438
- **1216:** Board Operator and Shift Supervisor determine trends look “real” indicating a leak
- **1218:** Outside Operator shuts down MPL

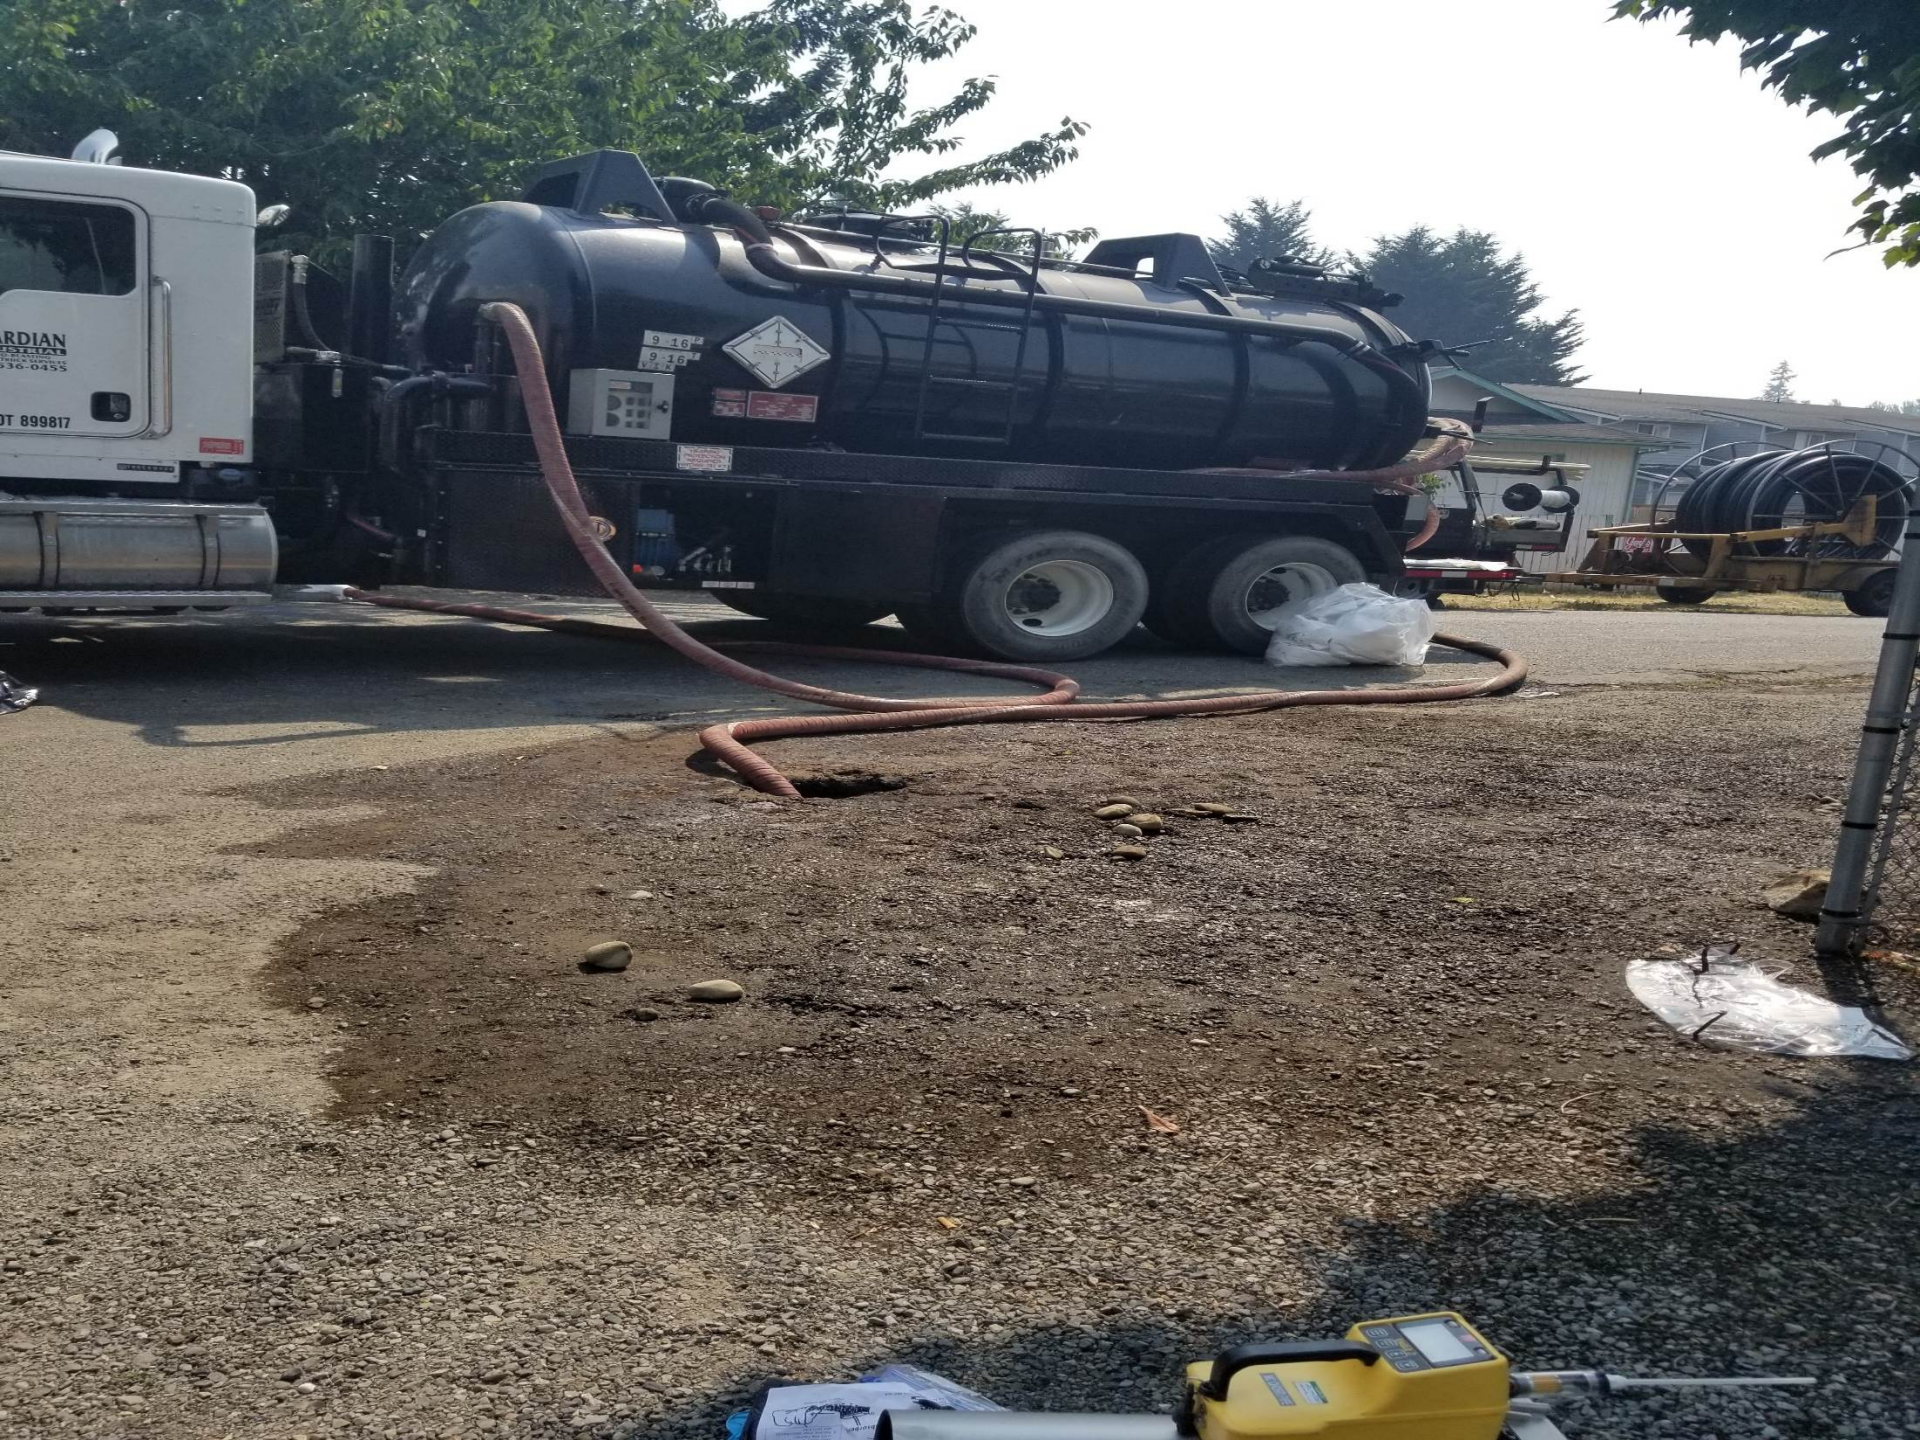
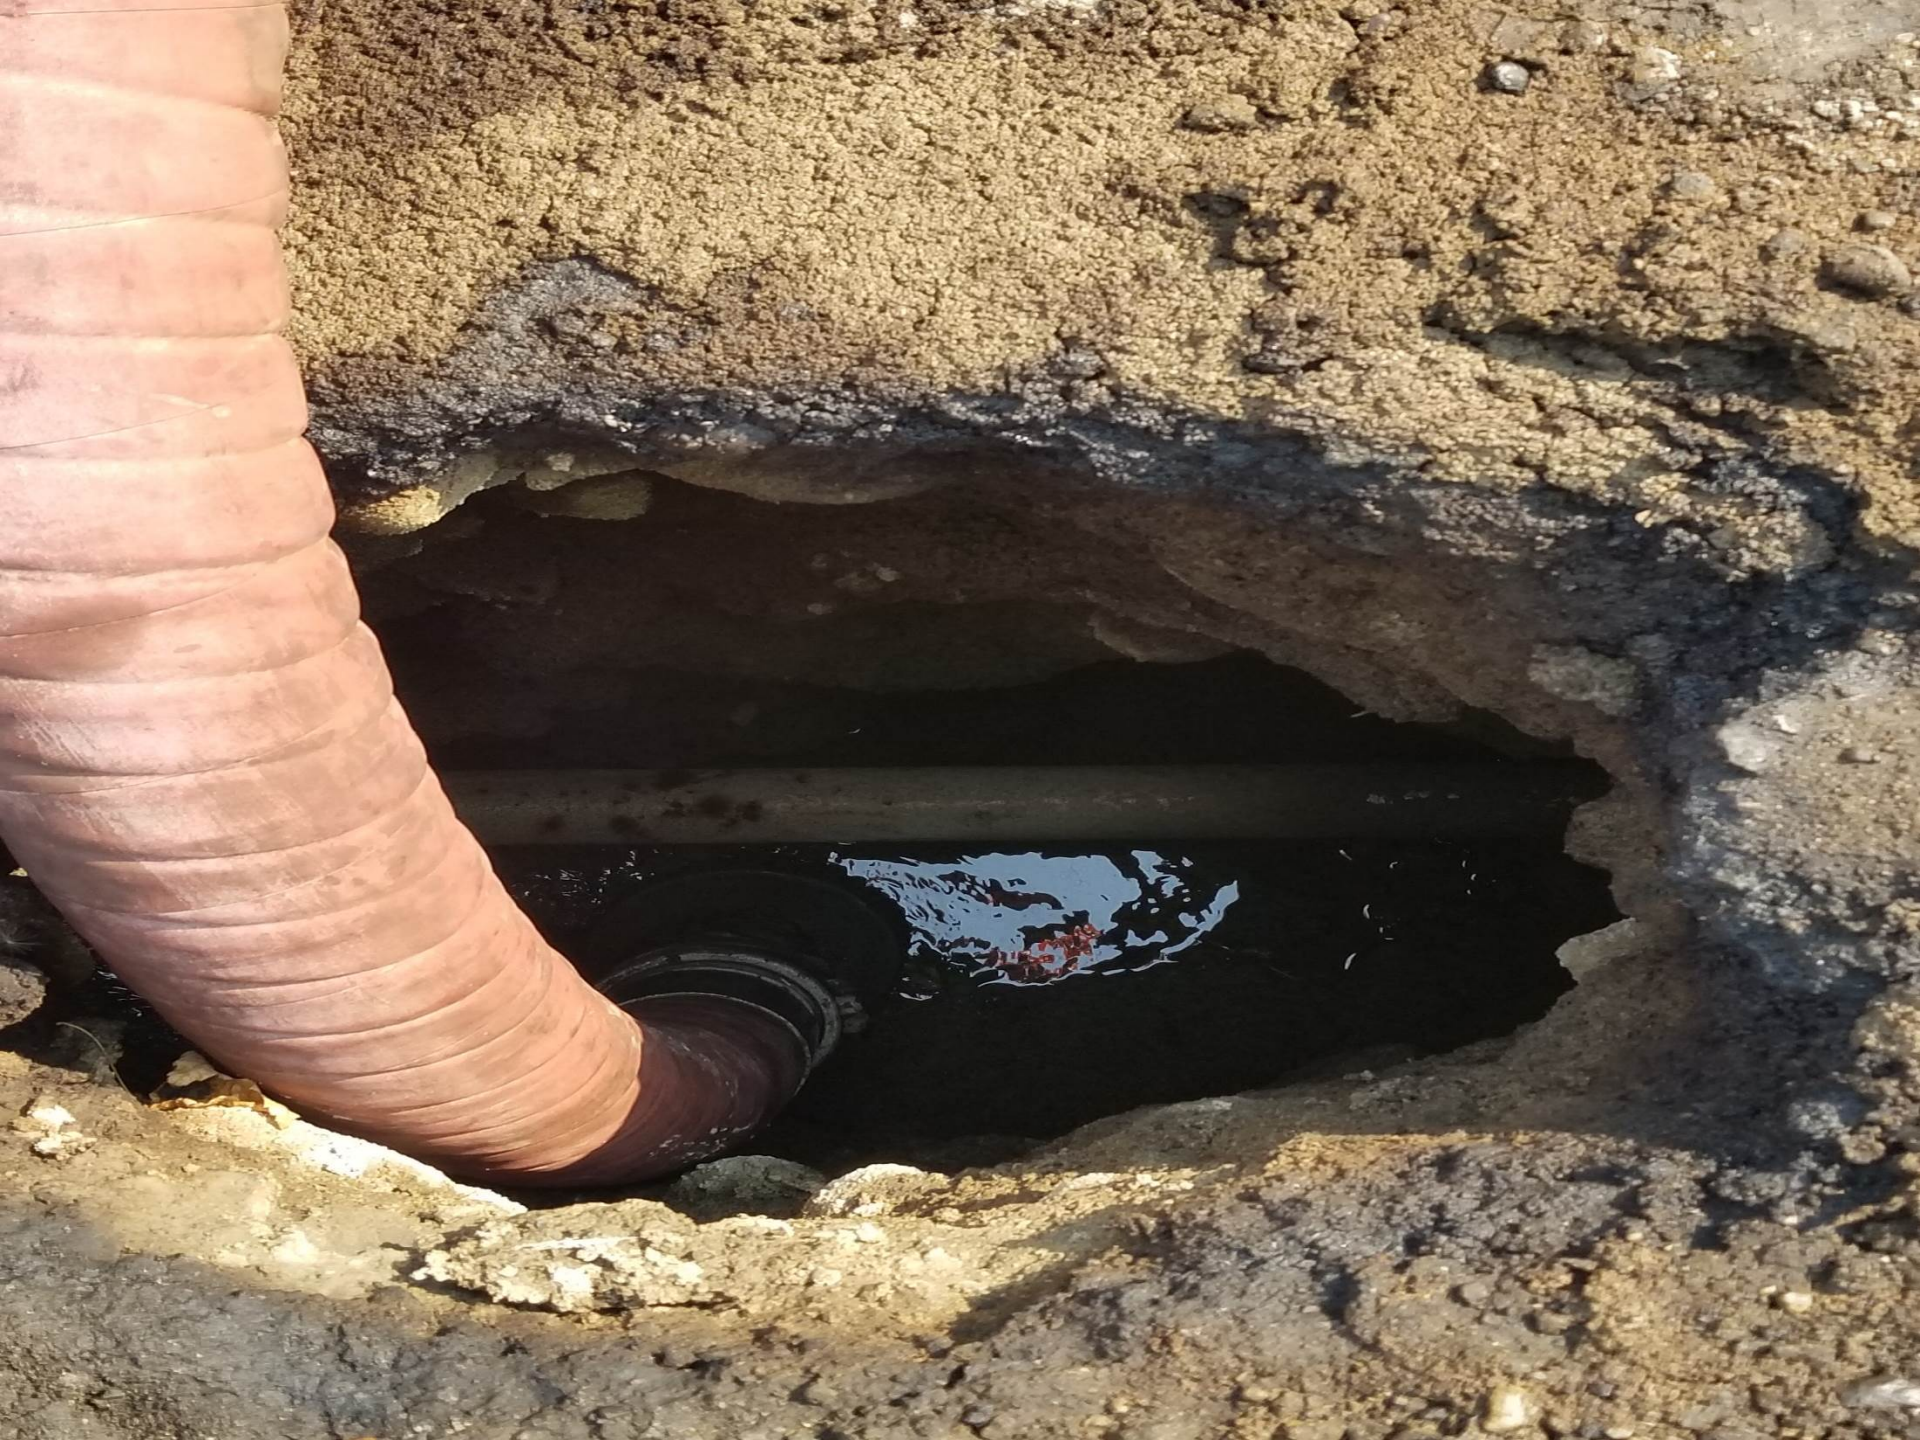
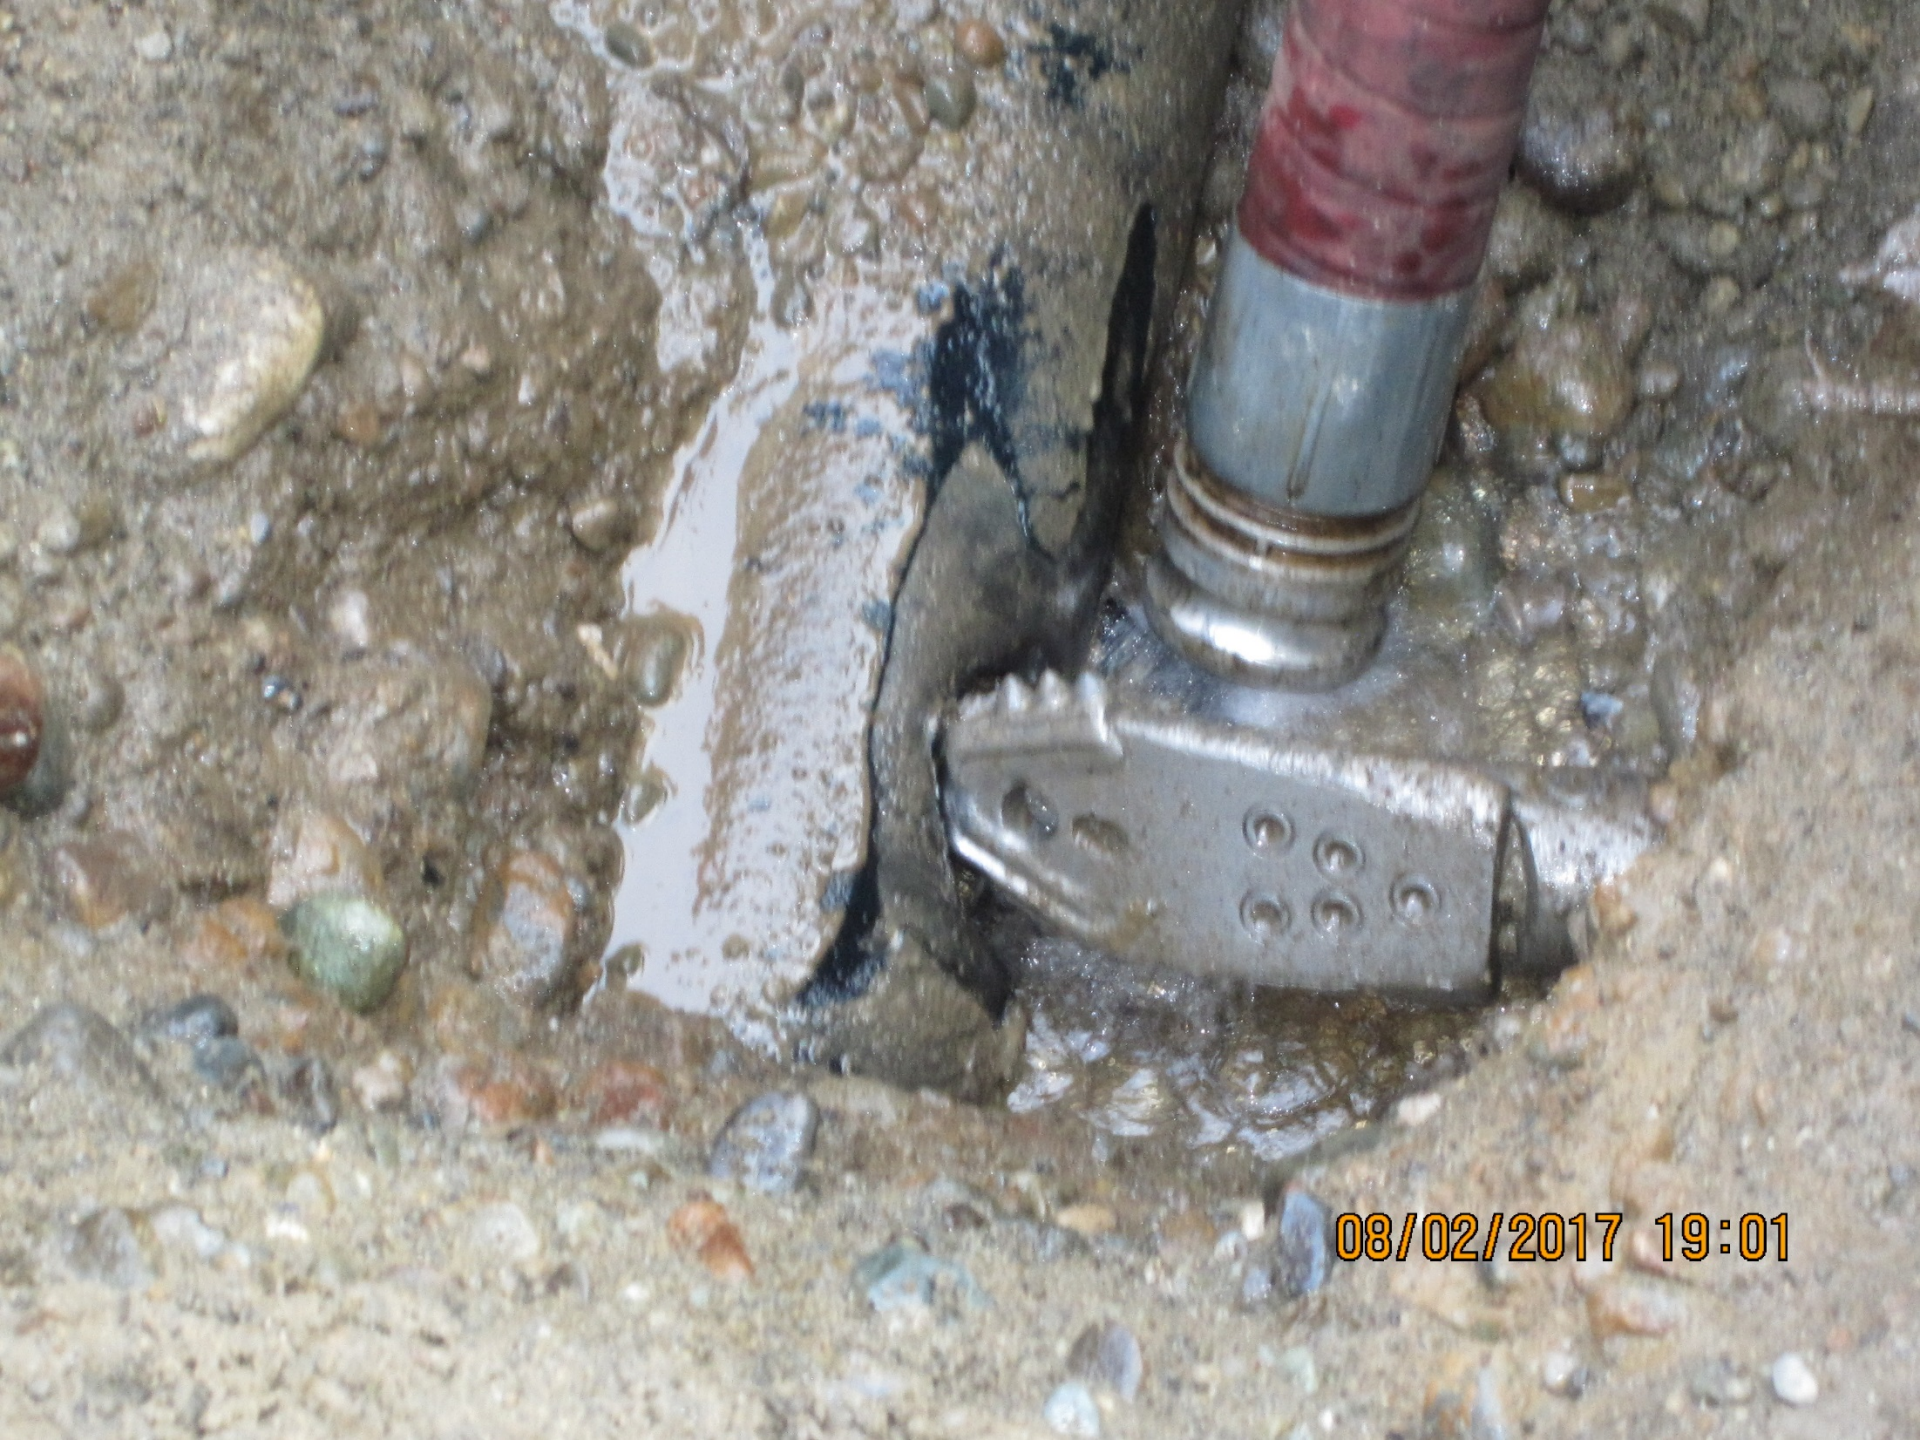
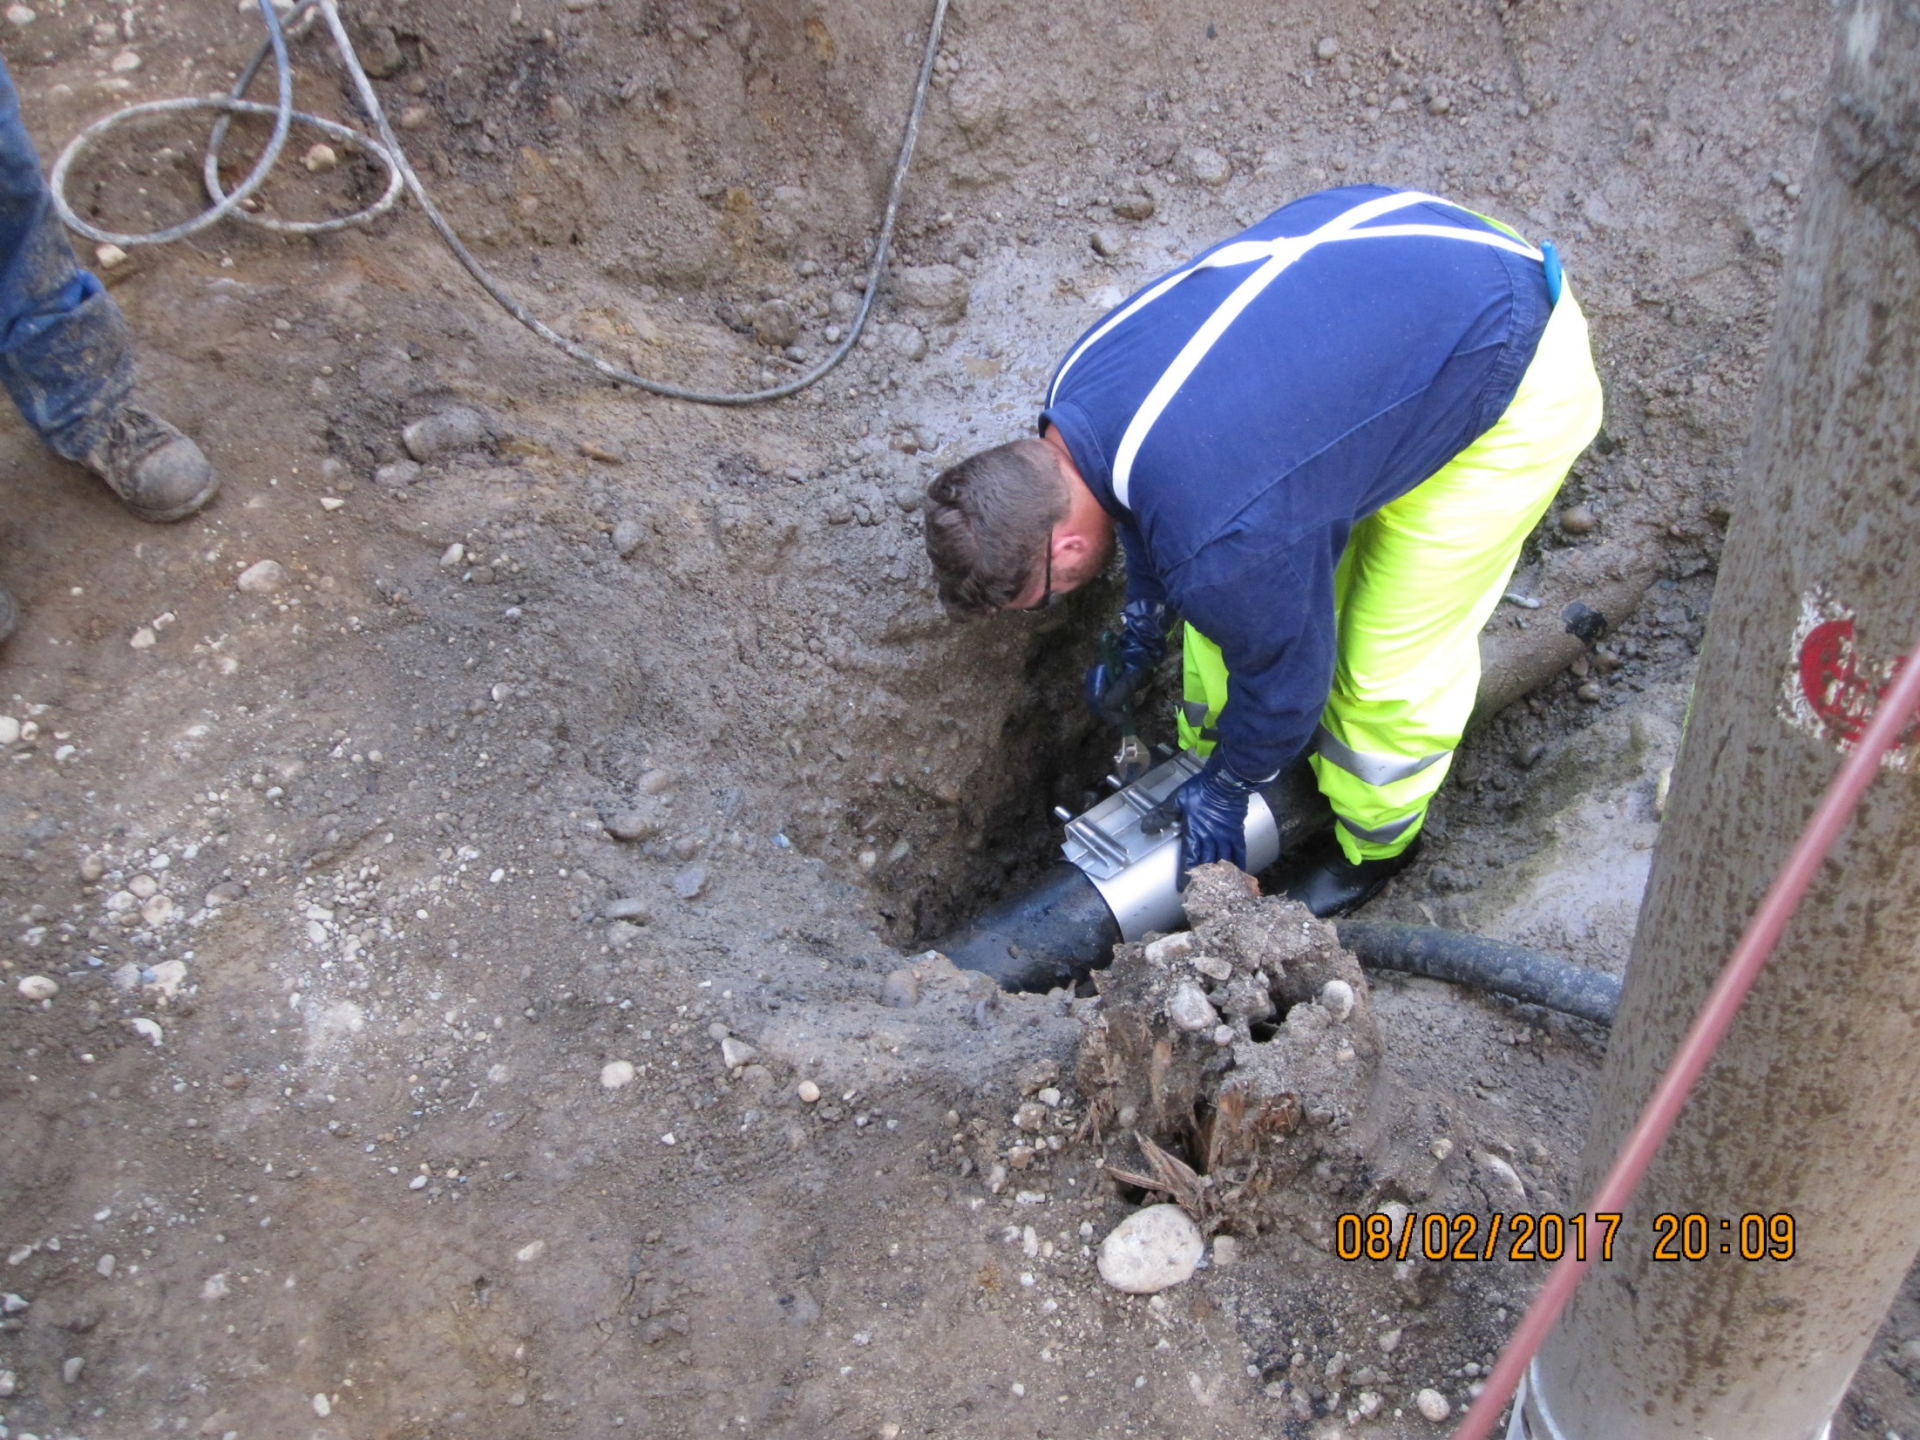
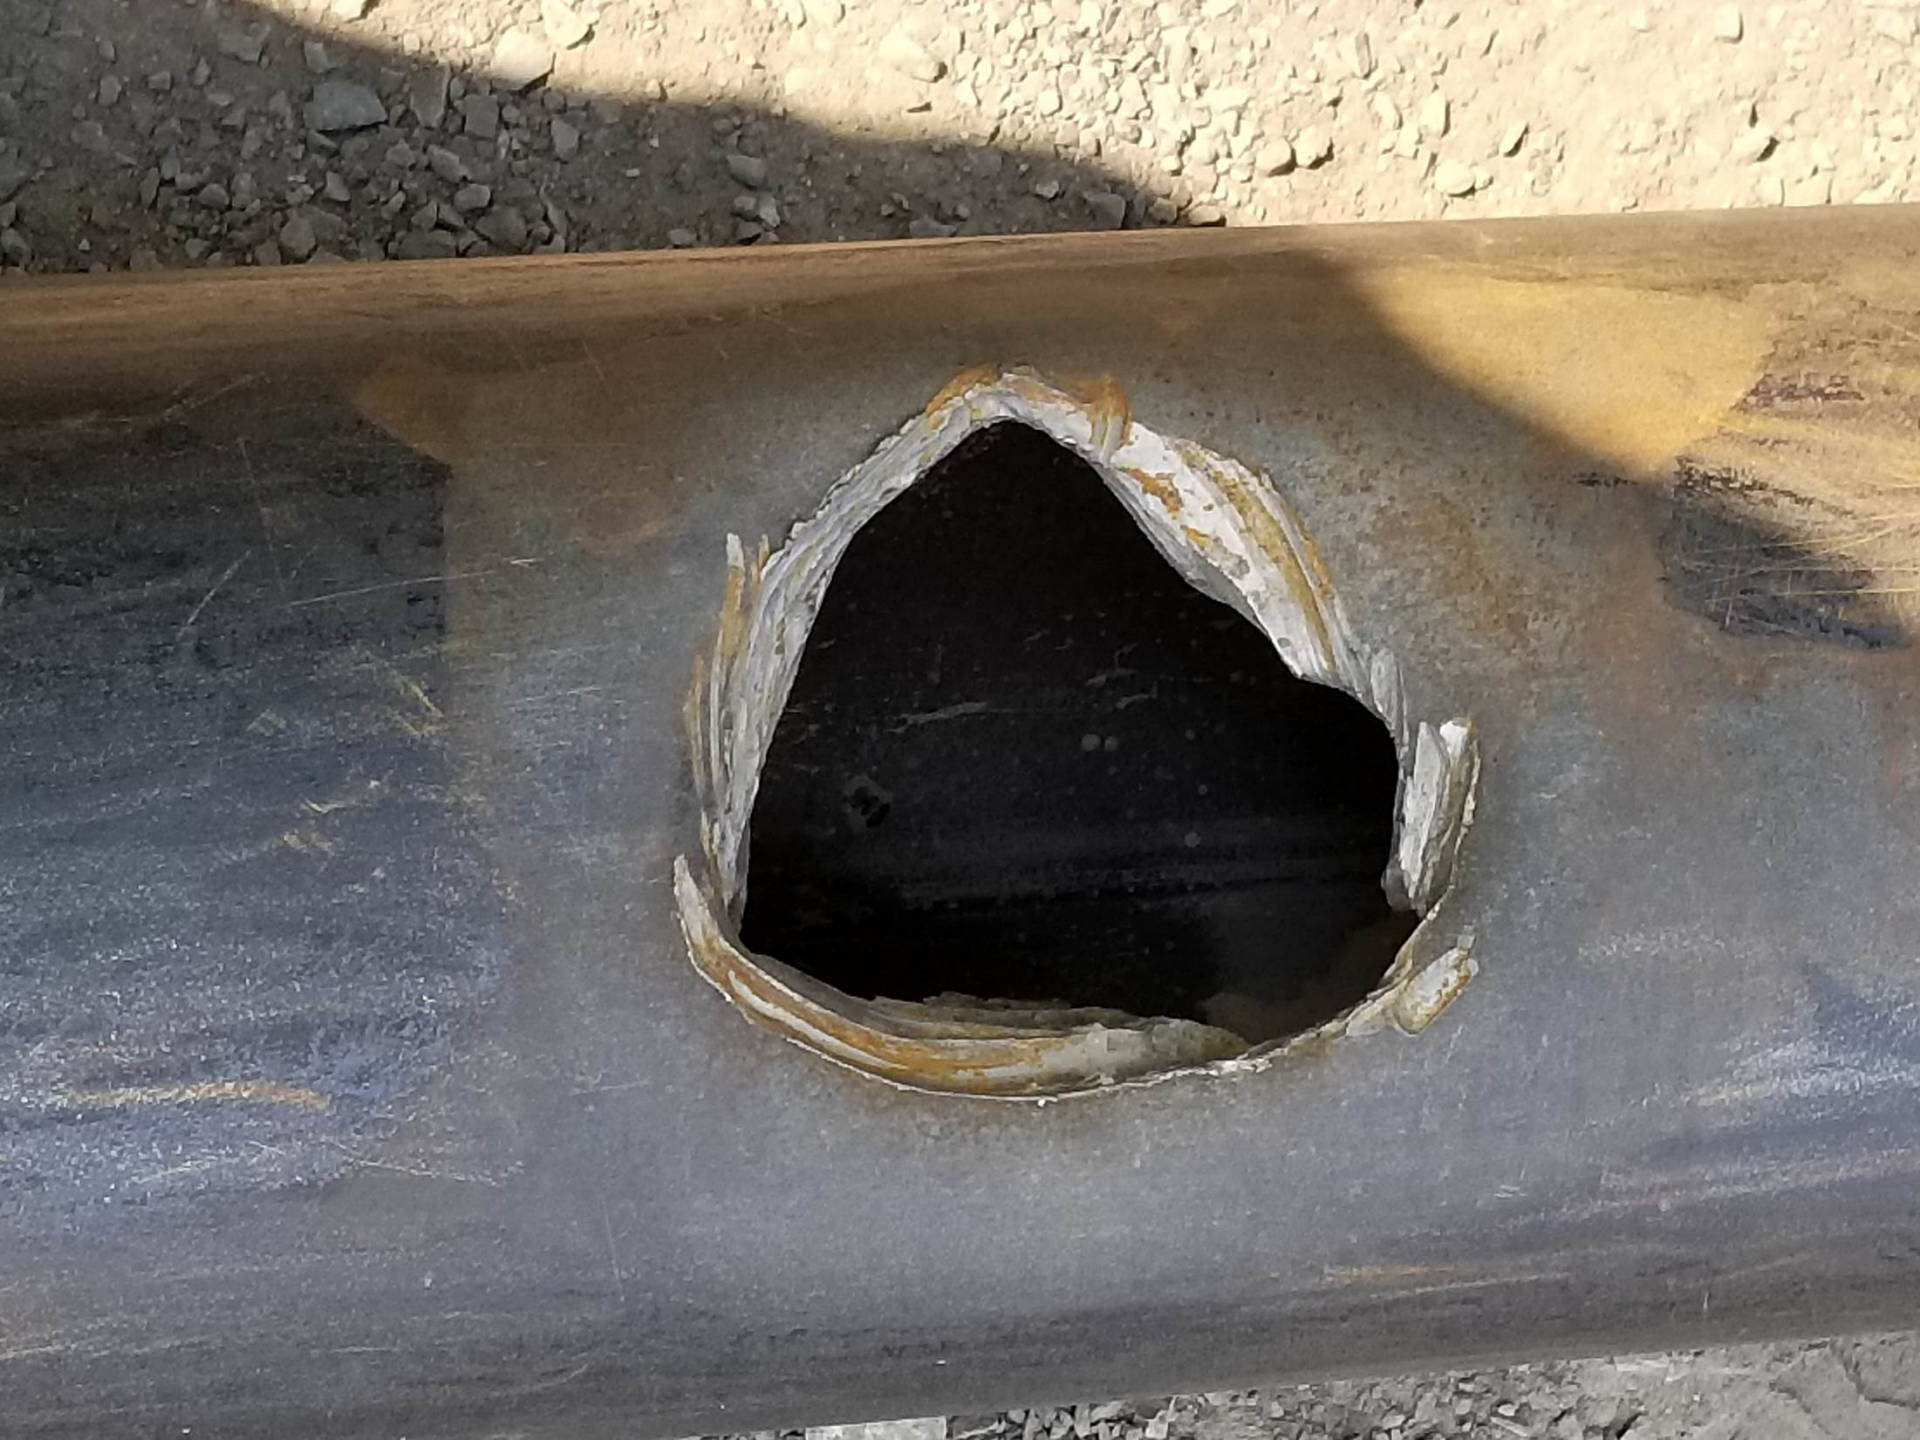
- **1300:** First vacuum trucks arrive on site, begin recovering jet through a pothole of a Tacoma Water line
- **~1430:** Staff from the Washington Utilities and Transportation Commission (WUTC) arrive on site to assess the damage and the spill
- **1600:** Hydroexcavating begins around the pipeline in order to make a temporary repair
- **2000:** A temporary clamp is installed to stop the flow of jet

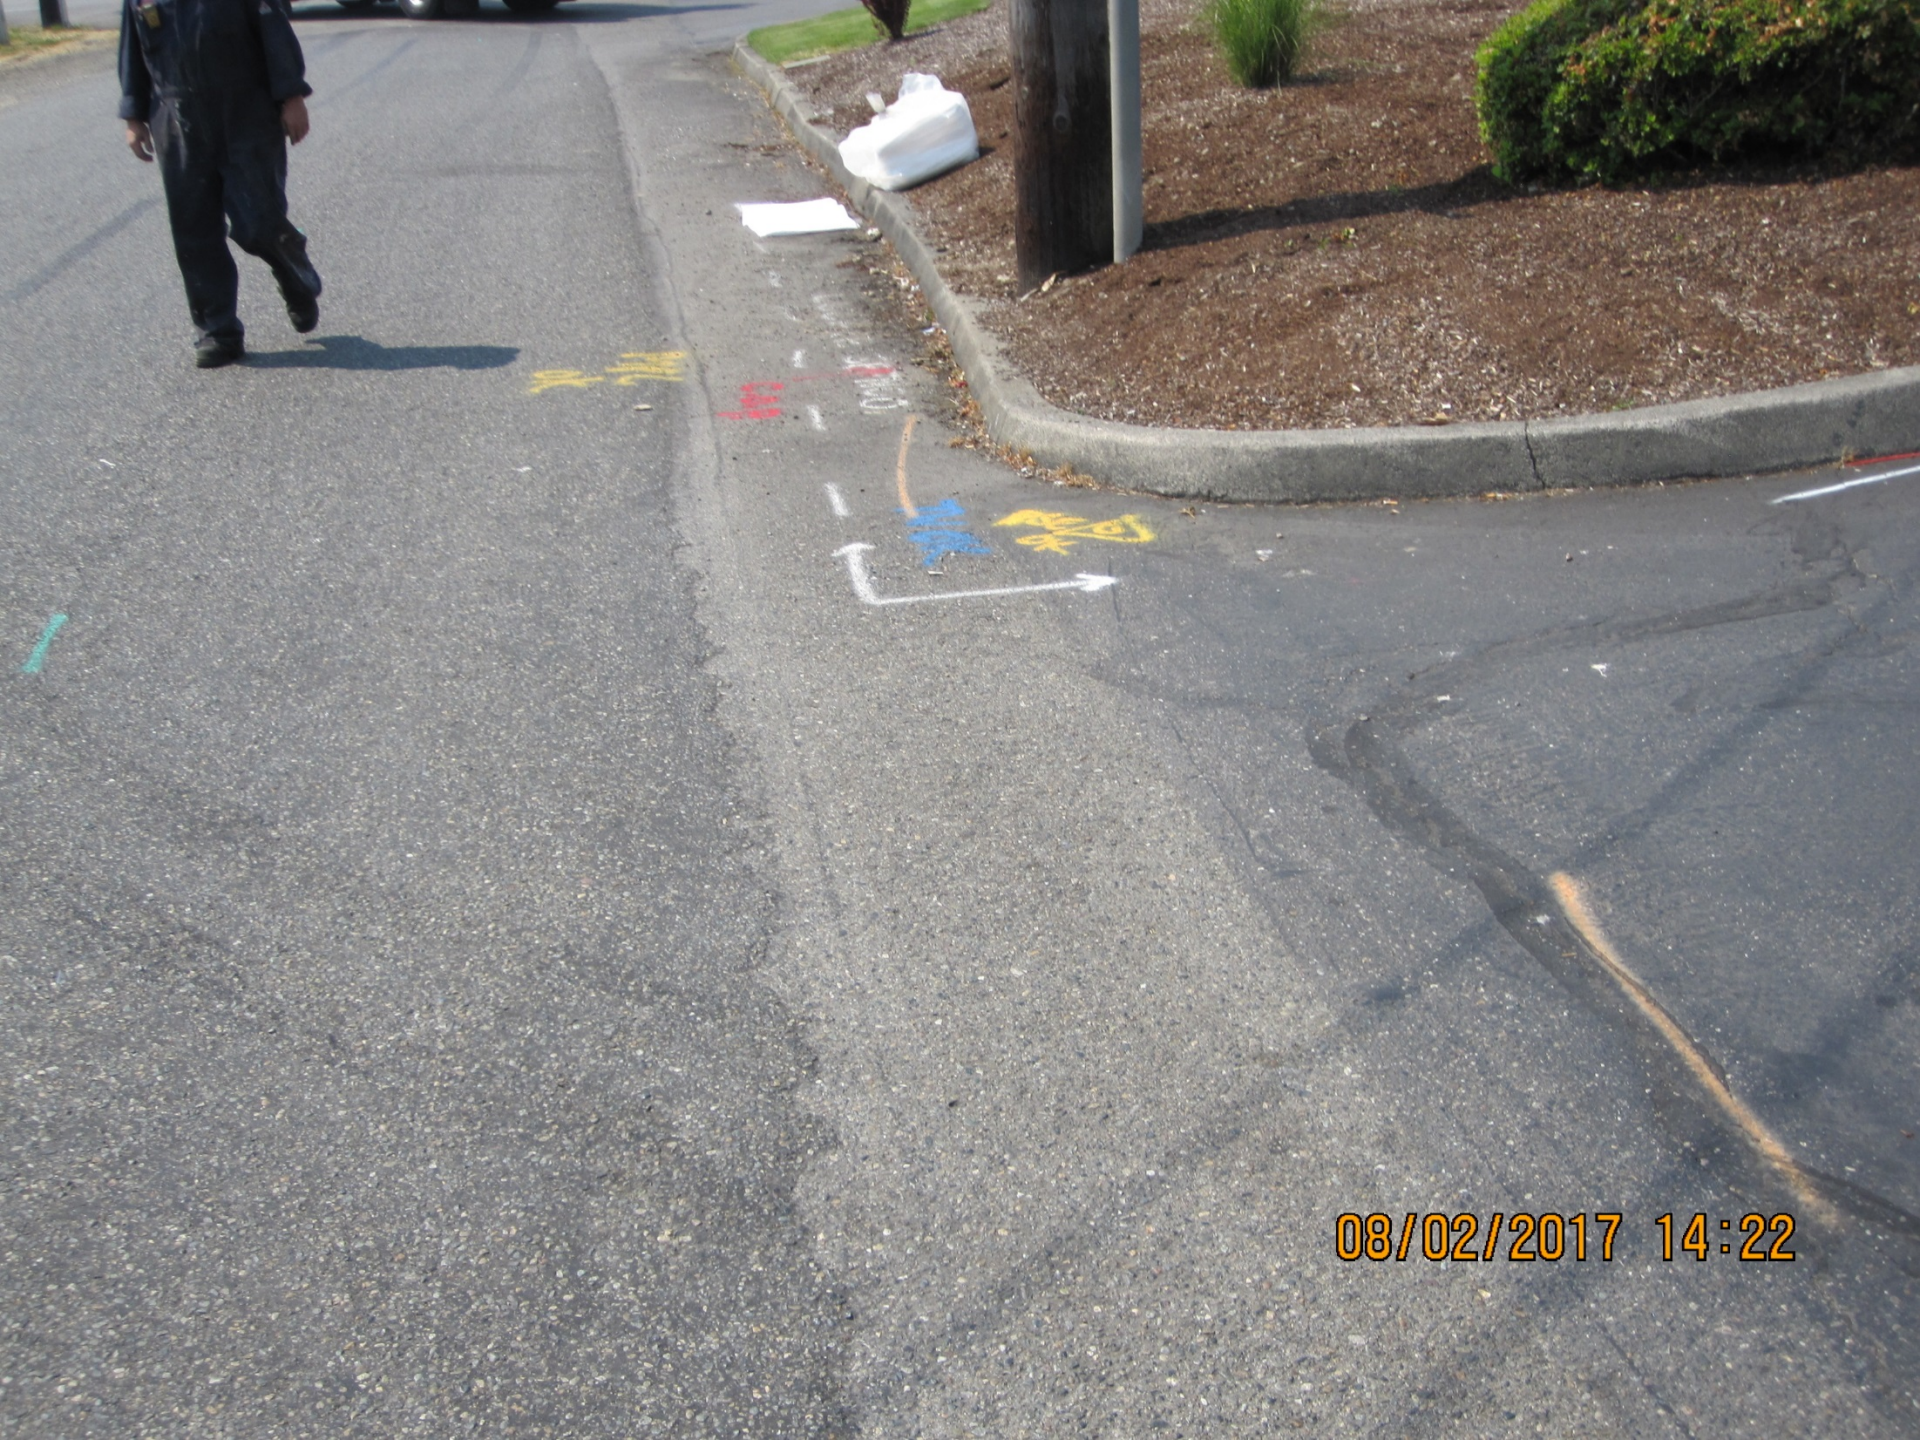
- Here is an excerpt from RCW 19.122.030:
  - ◆ ***“Excavator and facility operator duties before excavation.***
  - ◆ (1)(a) *Unless exempted under RCW 19.122.031, before commencing any excavation, an excavator must mark the boundary of the excavation area with white paint applied on the ground of the worksite, then provide notice of the scheduled commencement of excavation to all facility operators through a one-number locator service.”*

- The root cause of the damage to MPL and subsequent jet fuel leak is inadequate location marking by a third party contractor, SEFNCO
- SEFNCO did not follow the marking requirements spelled out in RCW 19.122.030, and did not contact MPL when they marked the intersection of 100<sup>th</sup> and A Street less than one day before the incident. A damage report has been filed with the WUTC to this effect
