**McCHORD PIPELINE CO.**

September 21<sup>st</sup>, 2017

**Damage to McChord Pipeline  
at 100<sup>th</sup> and A Street  
Tacoma, WA**

Nicholas D. Peelo  
Chief Engineer  
McChord Pipeline Co.

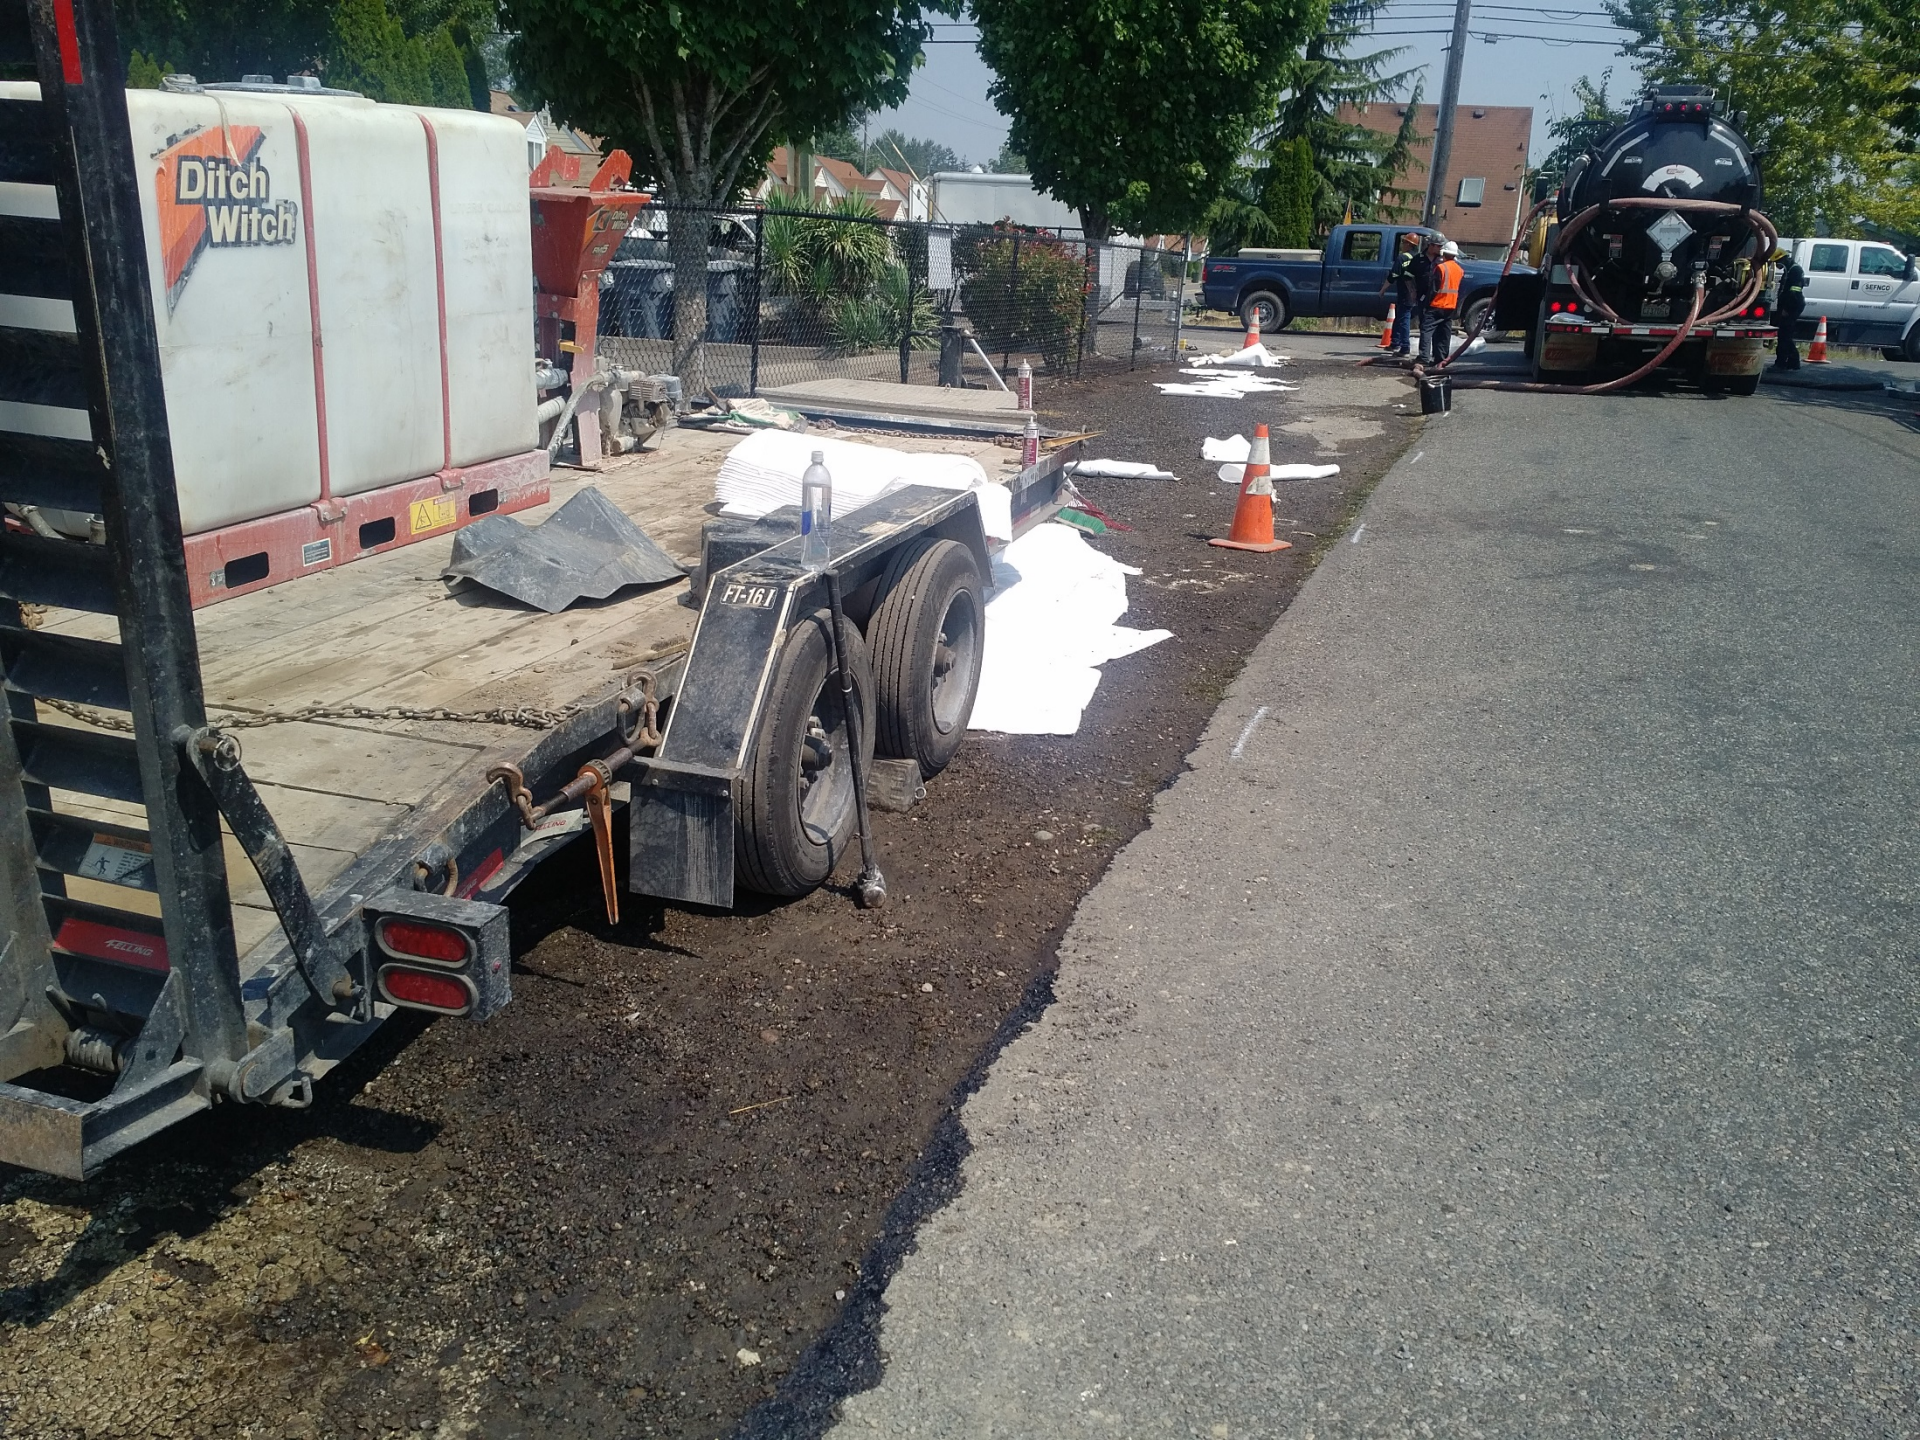
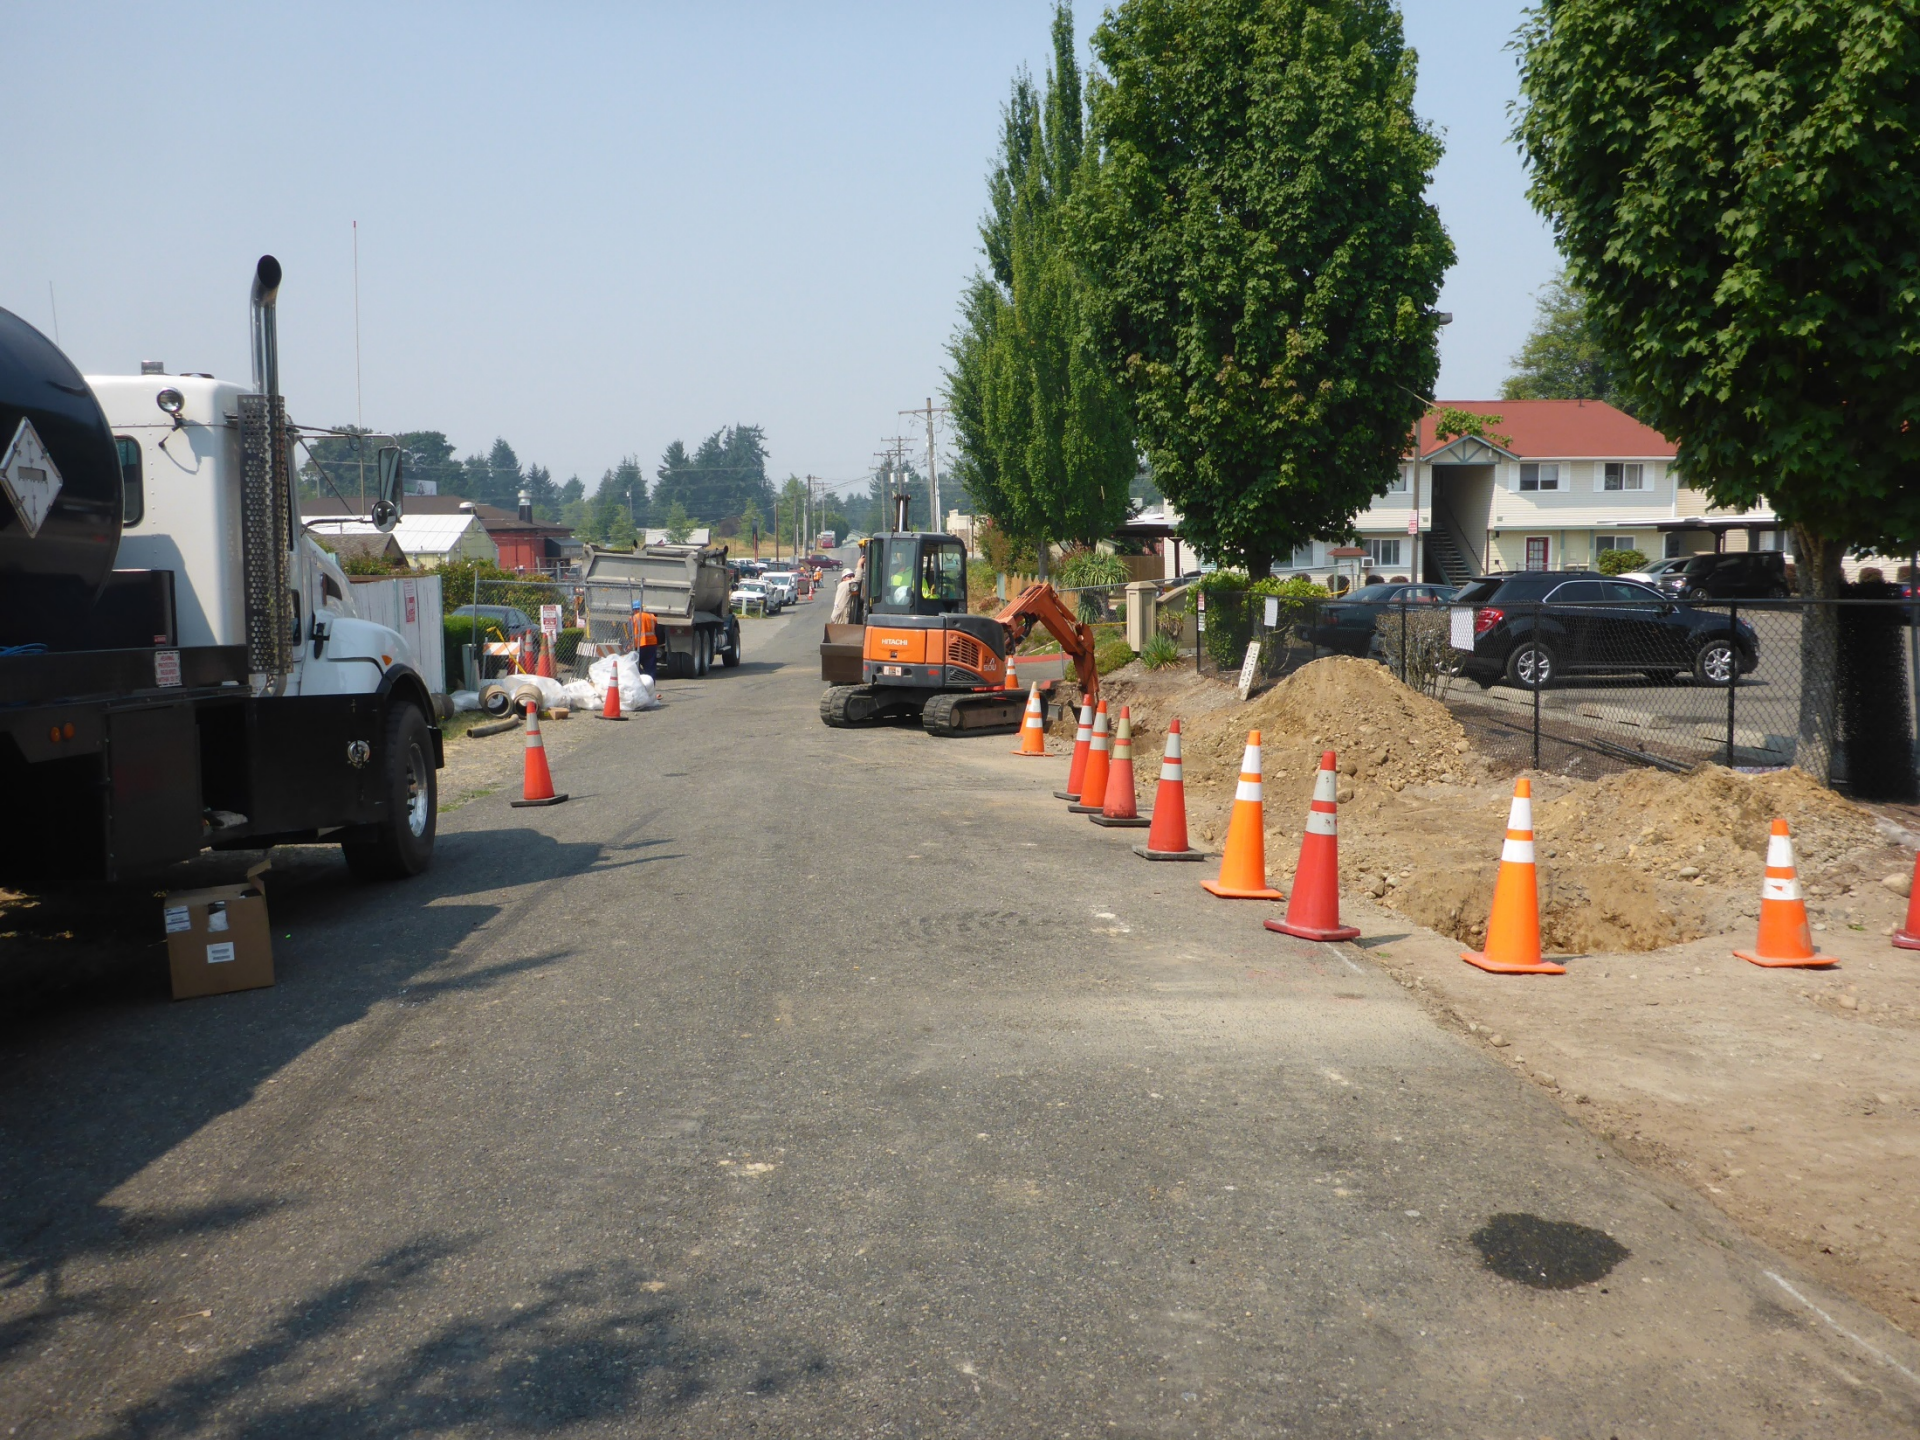
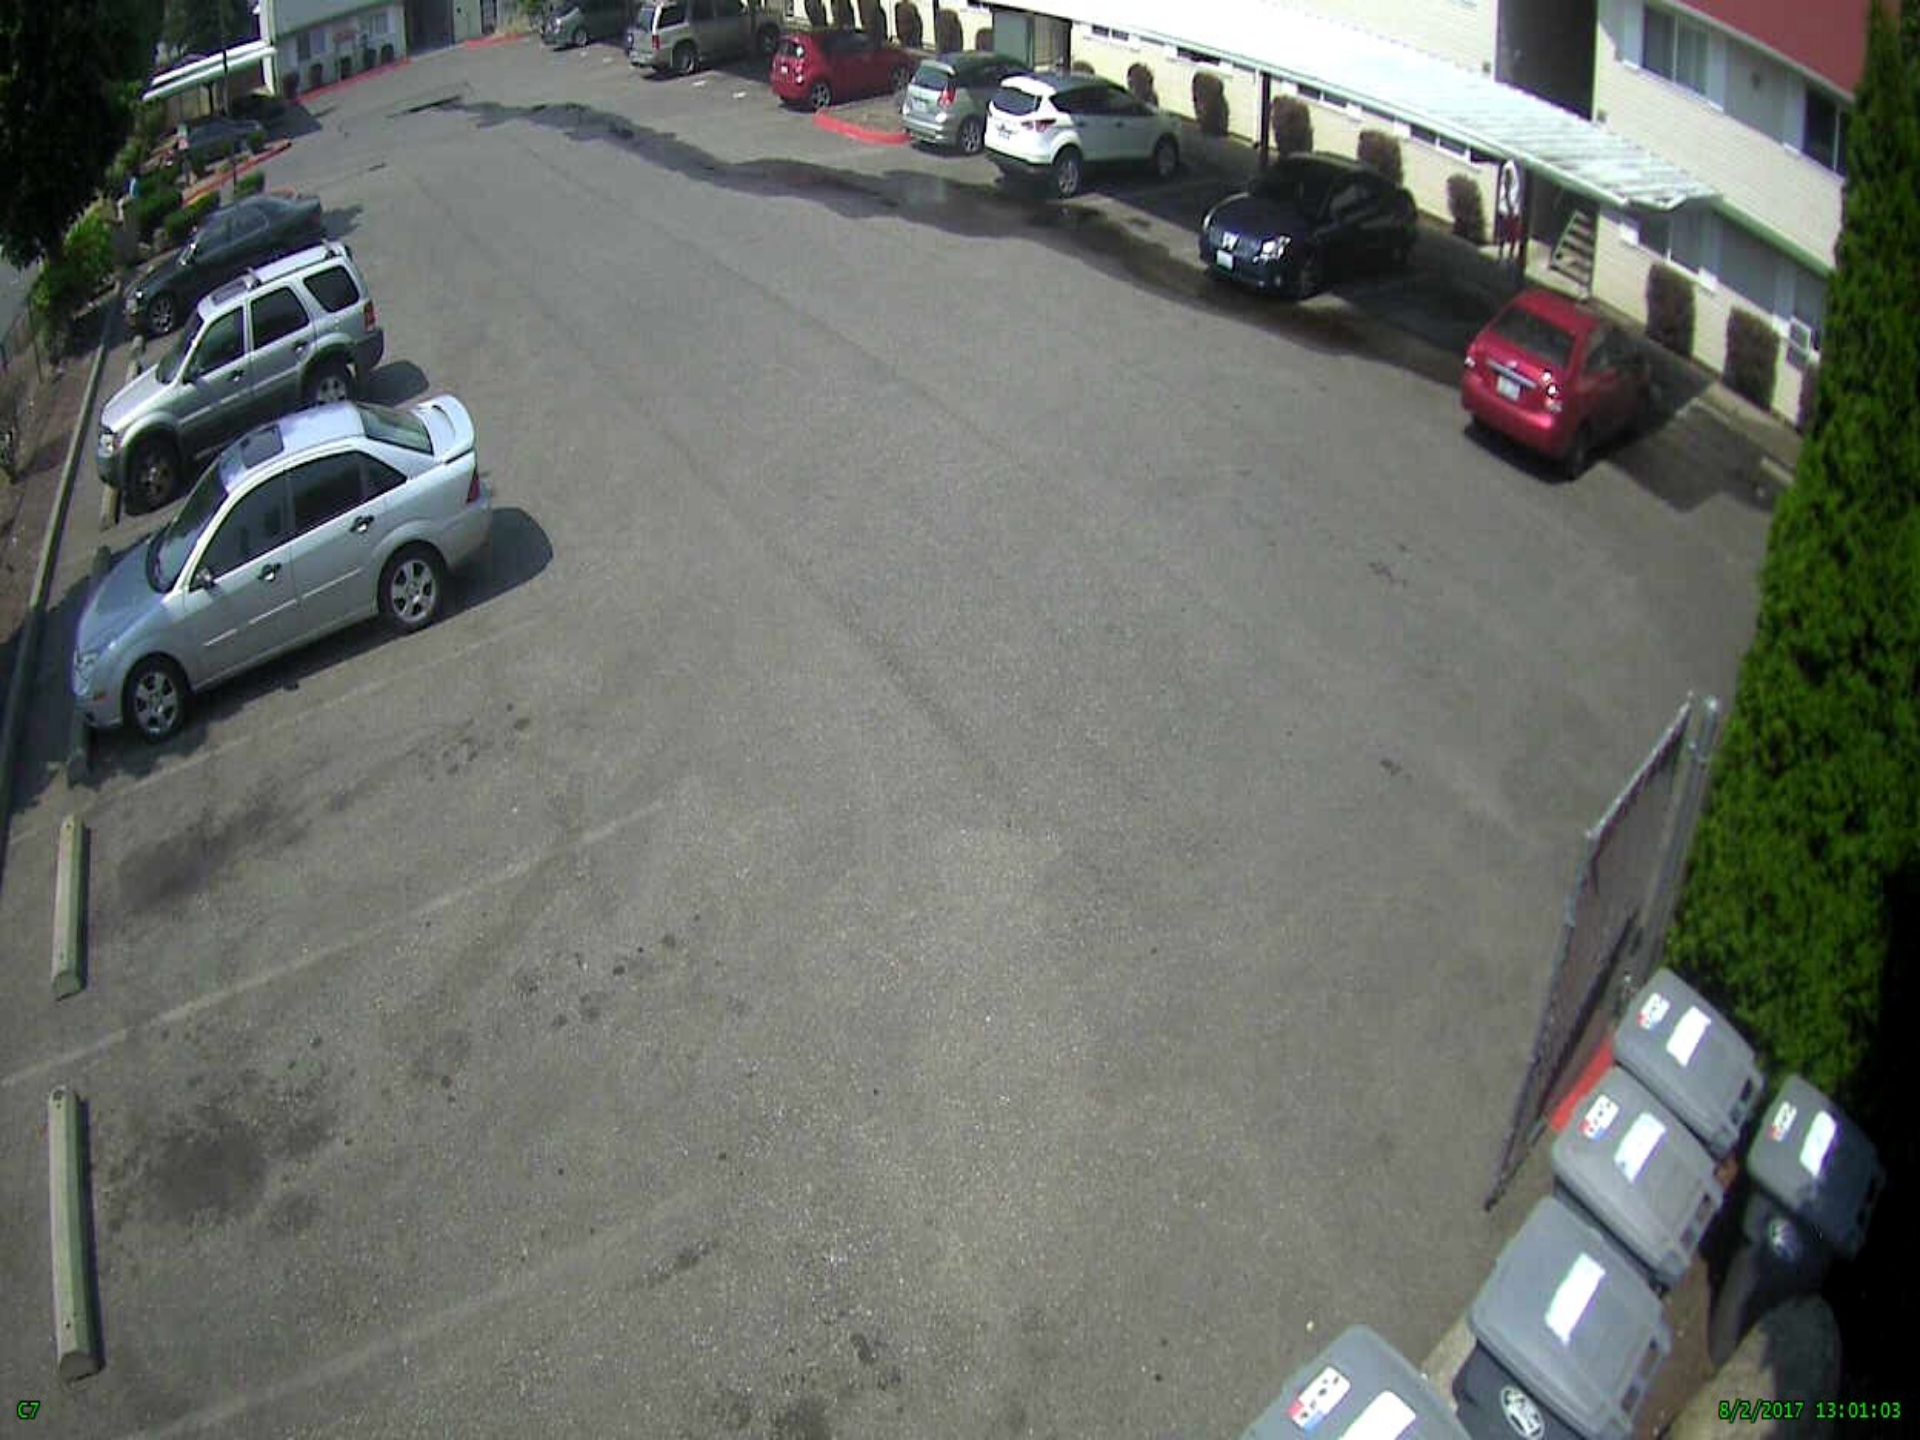
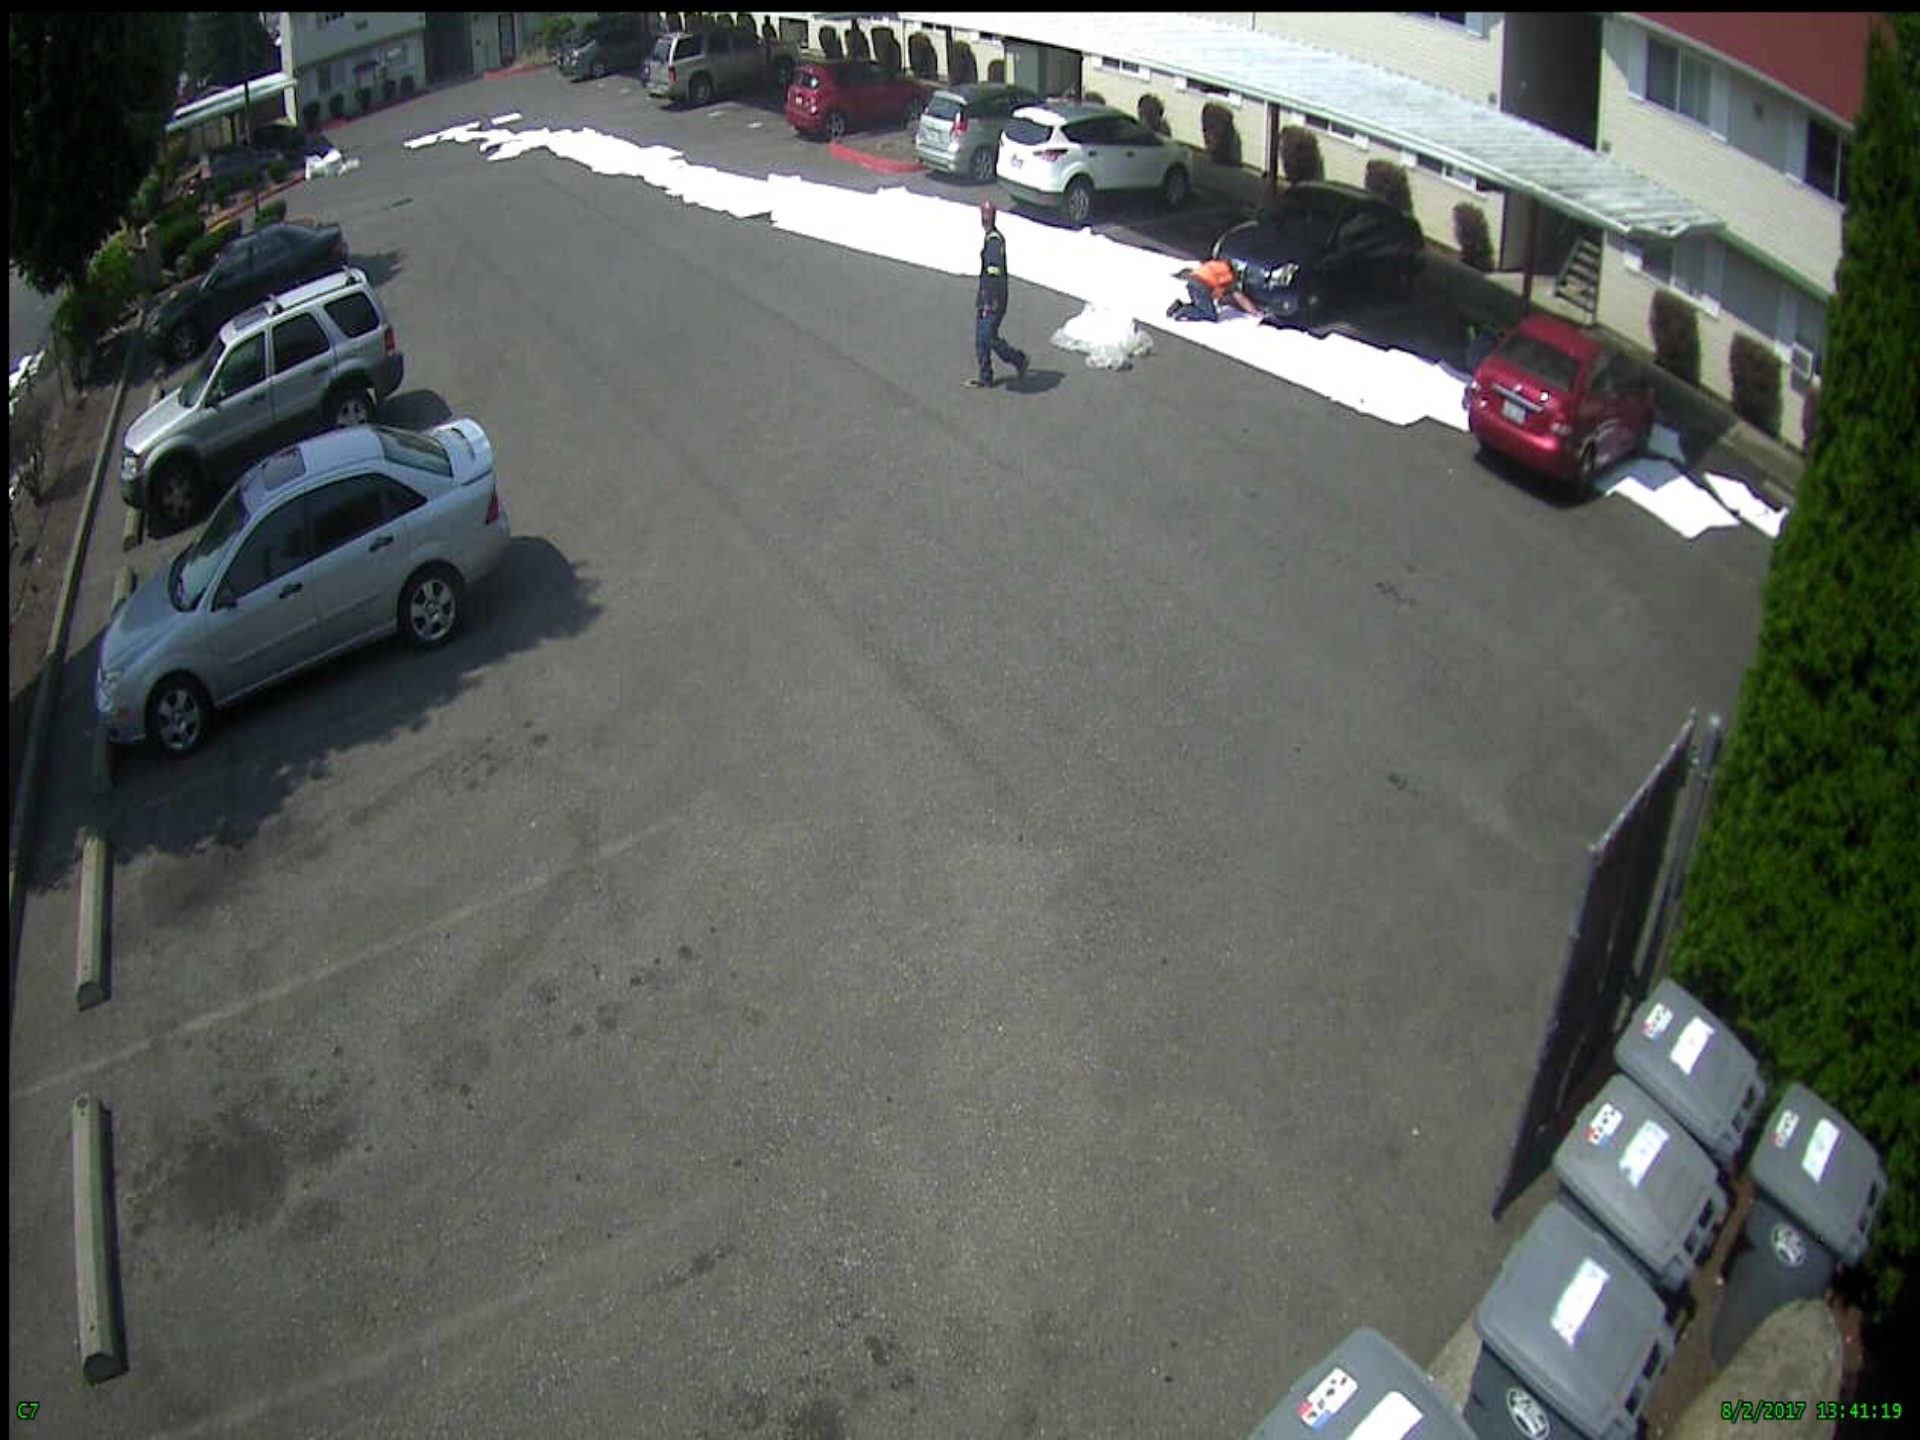
- Jet fuel recovered by vacuum trucks, hydro excavators, bucket excavators
- 180 bbl jet unintentional or controlled release
- 155 bbl jet recovered (86%)
- 15 - 20 bbl may have been lost to evaporation
- Some volume may be under asphalt in adjacent parking lot
