UTC Incident Investigation Form

Notification ID:	3606	Investigation ID:	8117
-------------------------	------	--------------------------	------

Operator:	Cascade Natural Gas Corporation (CNGC)
District/Unit:	Mount Vernon
Location:	908 E Fulton St Mount Vernon, WA
Incident Date:	November 25, 2019

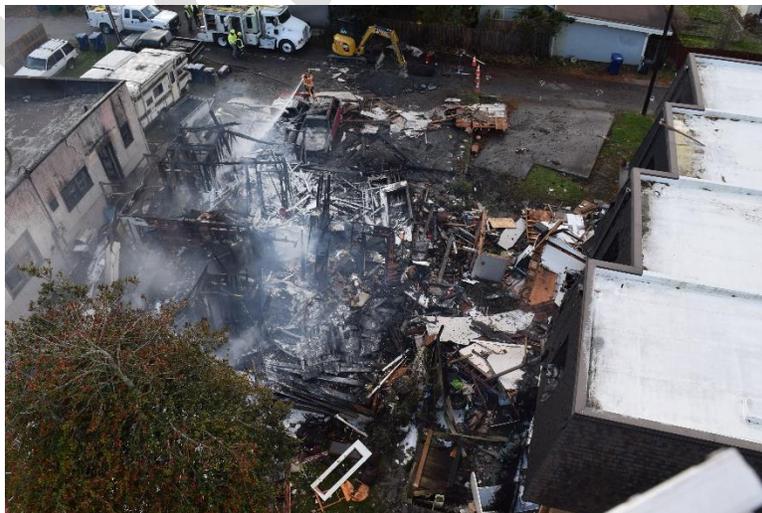
The structure fire was due to an explosion in Unit 2 of a duplex at 908 E Fulton St (**Figure 1**). The occupant from Unit 2 was taken to Skagit Valley Hospital and then Harborview Medical Center for treatment of burns. The occupant in Unit 1 was treated and released at the scene. No deaths and no other injuries were sustained from the explosion/fire.

Figure 1 – Aerial view of the duplex following the explosion. Image provided by MVFD

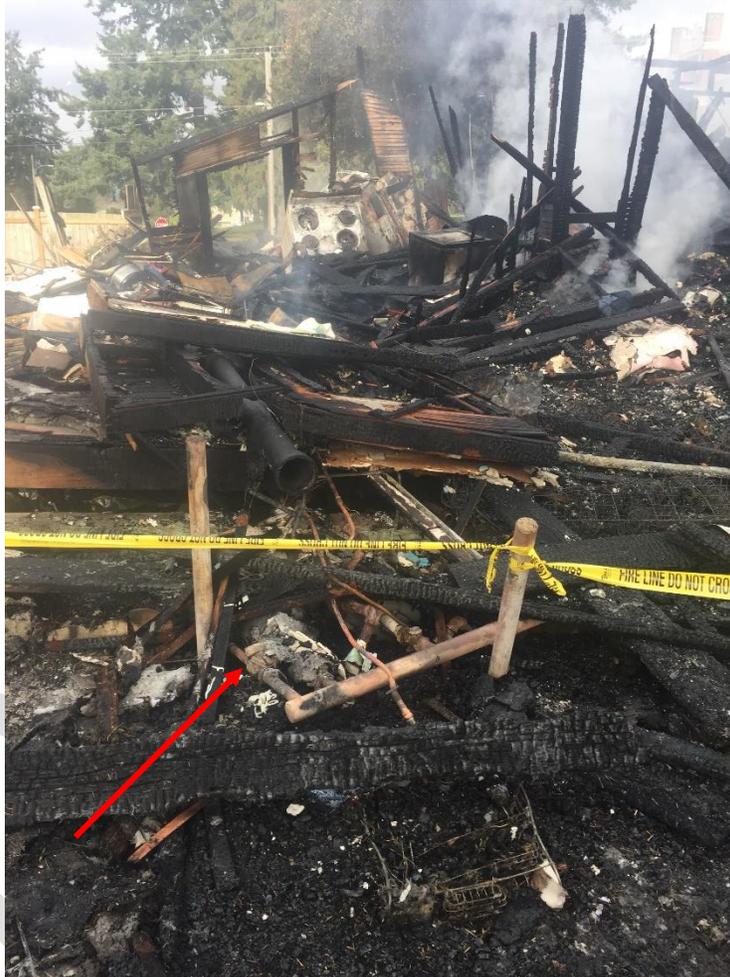
Figure 2 – View of the damaged two-meter manifold covered in debris

Although CNGC facilities and operations did not cause the explosion, their facilities did contribute to the fire following the explosion. The meter and riser were damaged during the explosion and fed the fire. This caused additional property damage to the duplex, other buildings and vehicles. This damage exceeded the \$50,000 reporting threshold.

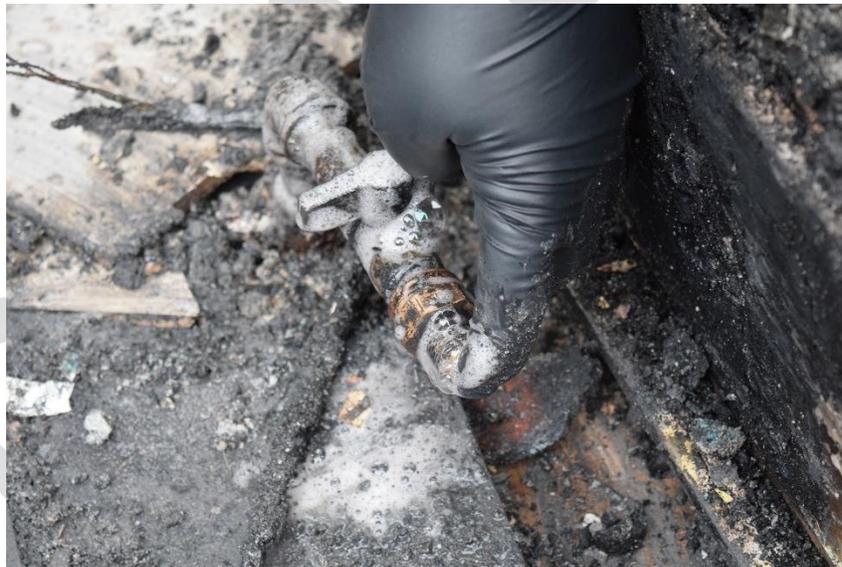
- CNGC and MVFD attempted to air test house piping but the test failed. CNGC soaped the line and saw bubbles forming at the gas valve to the gas furnace. **(Figure 5)**

Figure 5 – Soap test on house piping showing bubbles forming near valve. Image provided by MVFD.

The only system that failed an air test following the explosion was the internal house piping. The house piping was unable to hold air and could be seen leaking at the gas valve to the gas furnace when CNGC soap tested the line. On November 8, 2019, the occupant of Unit 2 had the gas turned back on. At this time the occupant refused access to CNGC personnel to perform a re-light on gas equipment and there do not appear to be any records indicating the occupant had the house piping or furnace inspected by a qualified person prior to gas turn on.
