Federal Reportable Incident Investigation Form

Notification ID:	2720	Investigation ID:	6089
-------------------------	------	--------------------------	------

Operator:	Cascade Natural Gas
District/Unit:	Yakima
Location:	Regulator R-28 behind Wapato Irrigation District off Camas Ave Wapato, WA
Incident Date:	2/22/2014

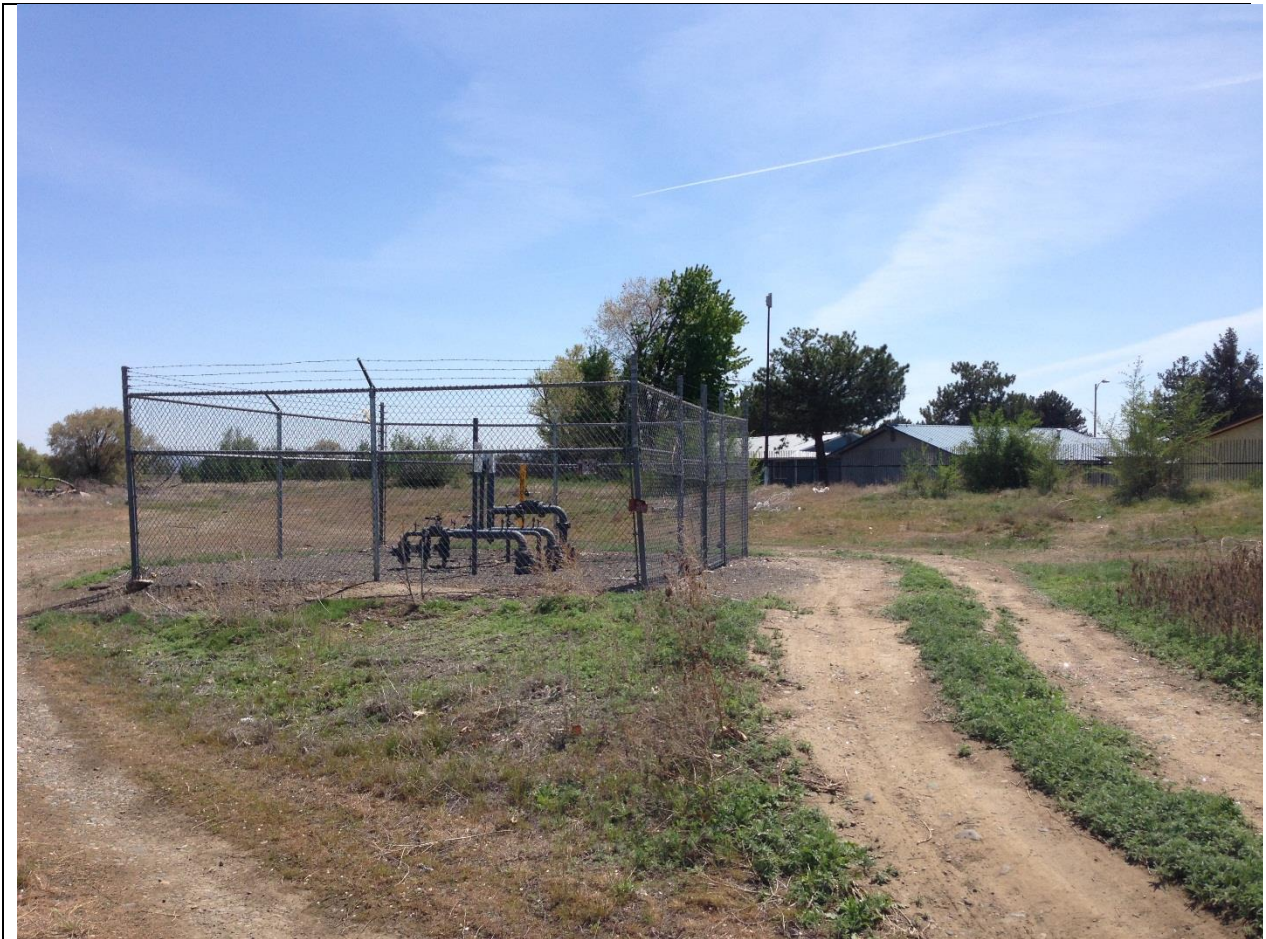
- Regulator R-28 is located adjacent to active railroad tracks on an un-improved frontage road (see photos below). It sits behind the Wapato Irrigation District yard and is approximately 100 feet north of a mobile home development.

Looking East-note closest structures are approximately 100 ft south.

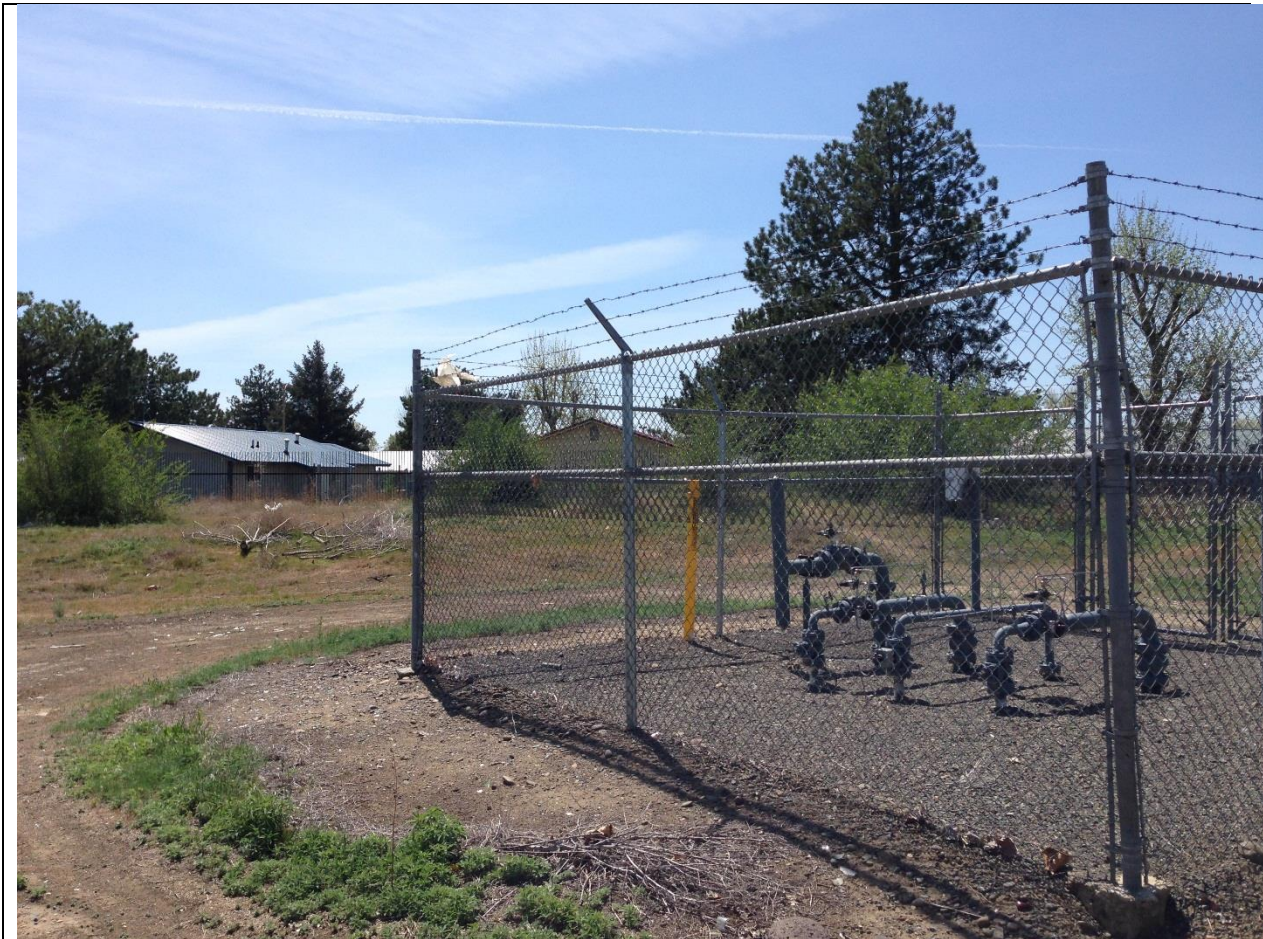
Looking South toward nearest structure
