UTILITIES AND TRANSPORTATION COMMISSION

**RE: Natural Gas Incident Investigation: 3400 11th Street, Bremerton, Washington
– August 18, 2015 (Insp. No. 6542)**

UTC Incident Investigation Form

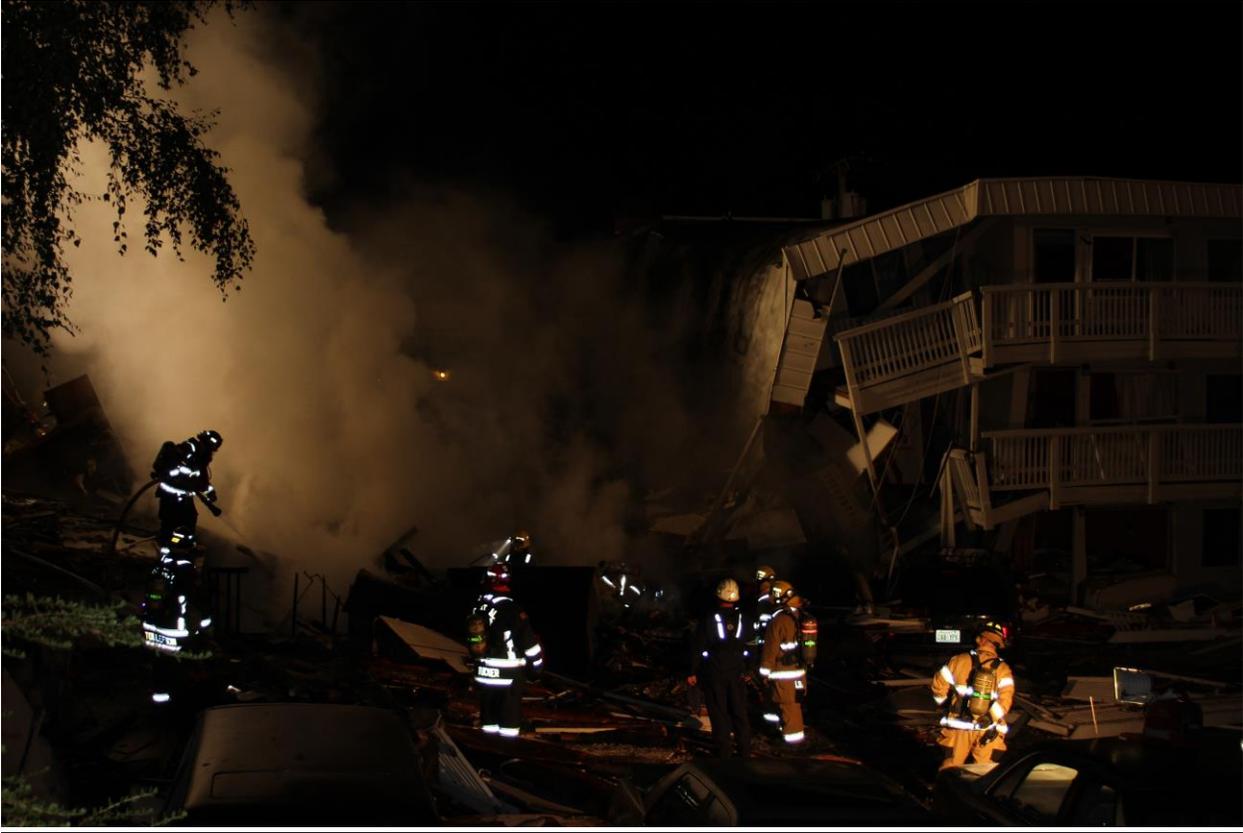
Photo 1: Looking south, 8/19/15 early morning, from Motel 6 parking lot.

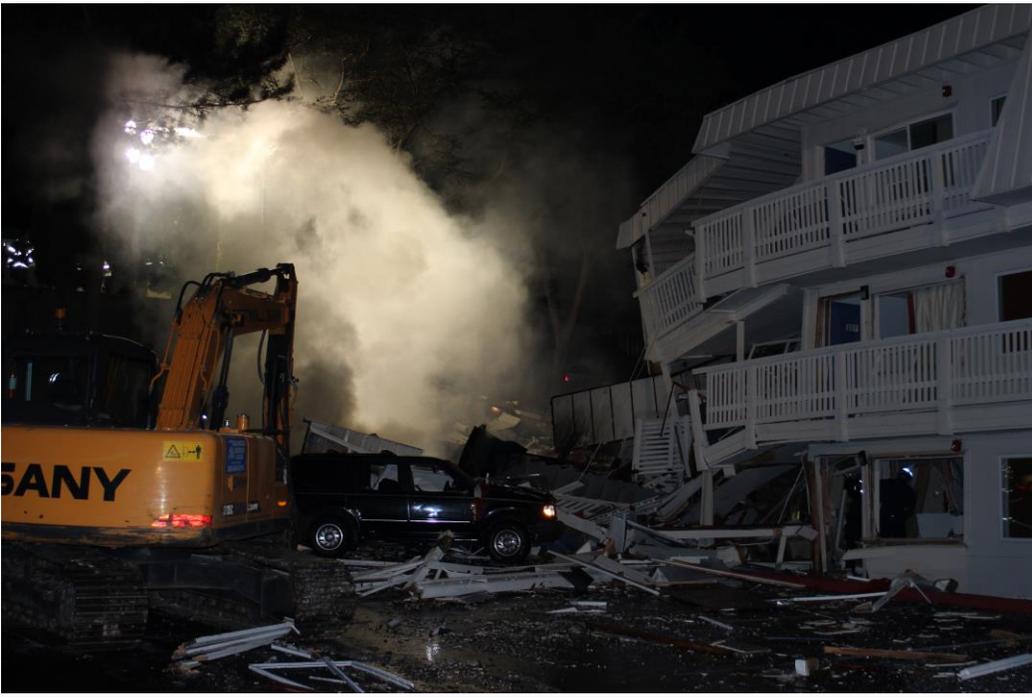
Photo 2: Looking southeast, 8/19/15 early morning, from Motel 6 parking lot.

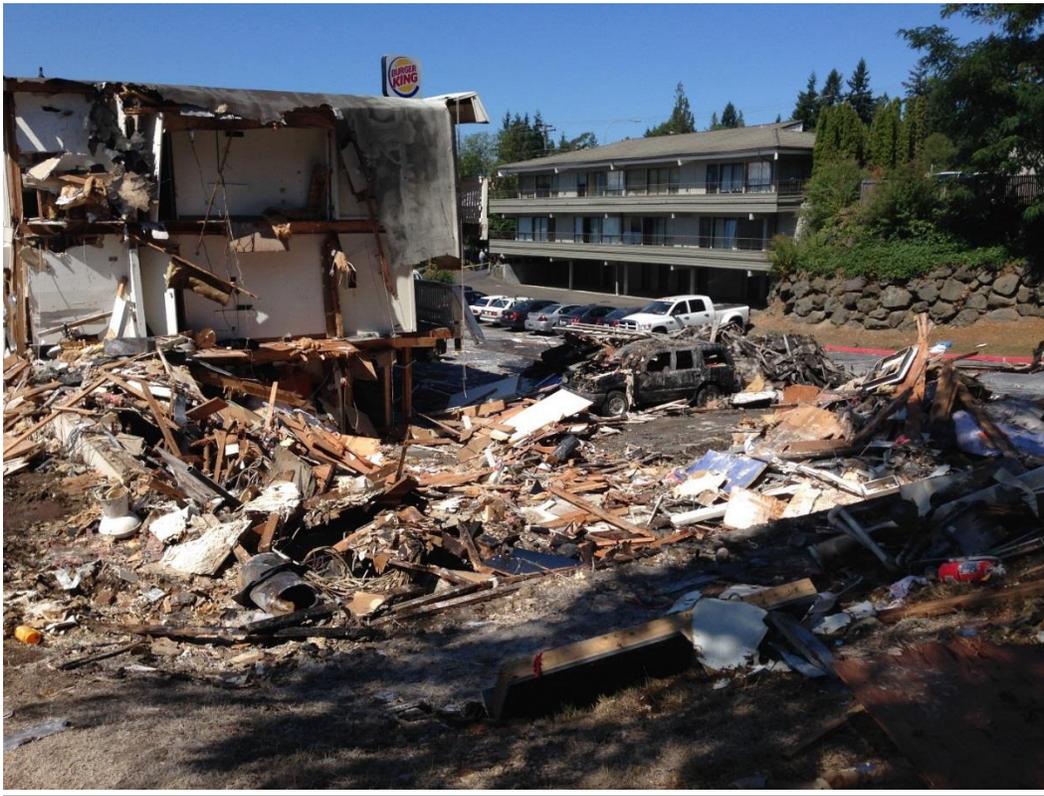
Photo 3: Looking northwest 8/19/15 late morning, from 11th St at east end of building. 15 rooms and the laundry room were destroyed.

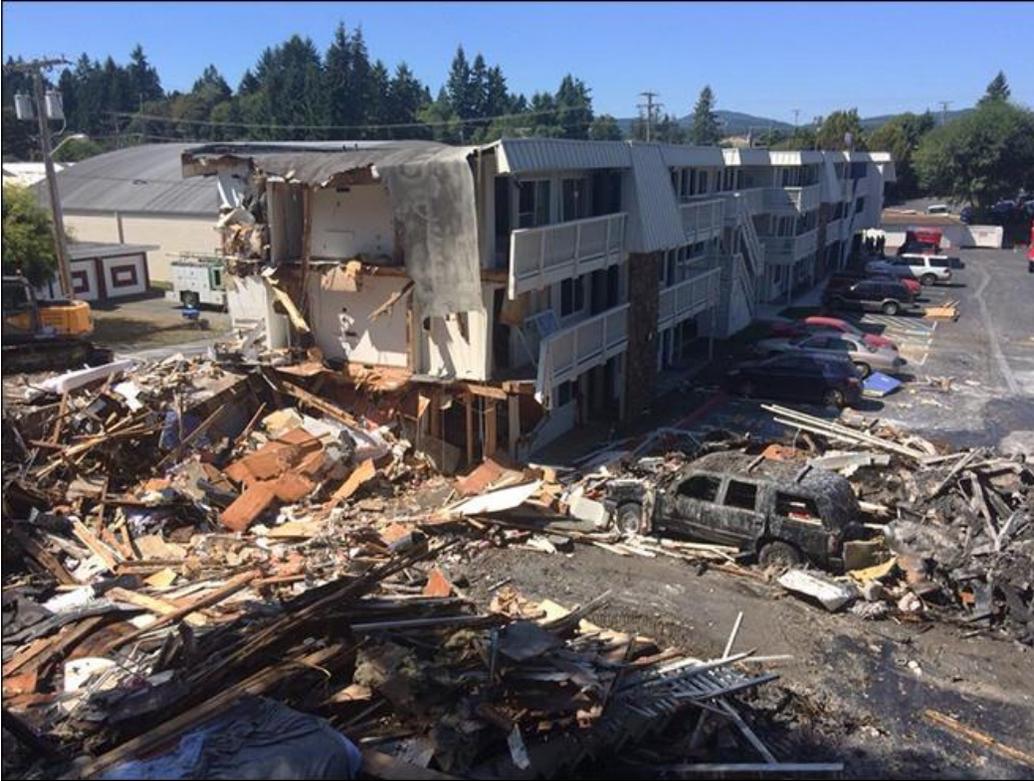
Photo 4: Looking southwest from hill at east end of building. Note collapsed roof and second floor structure has been removed by track-hoe and piled behind damaged SUV.

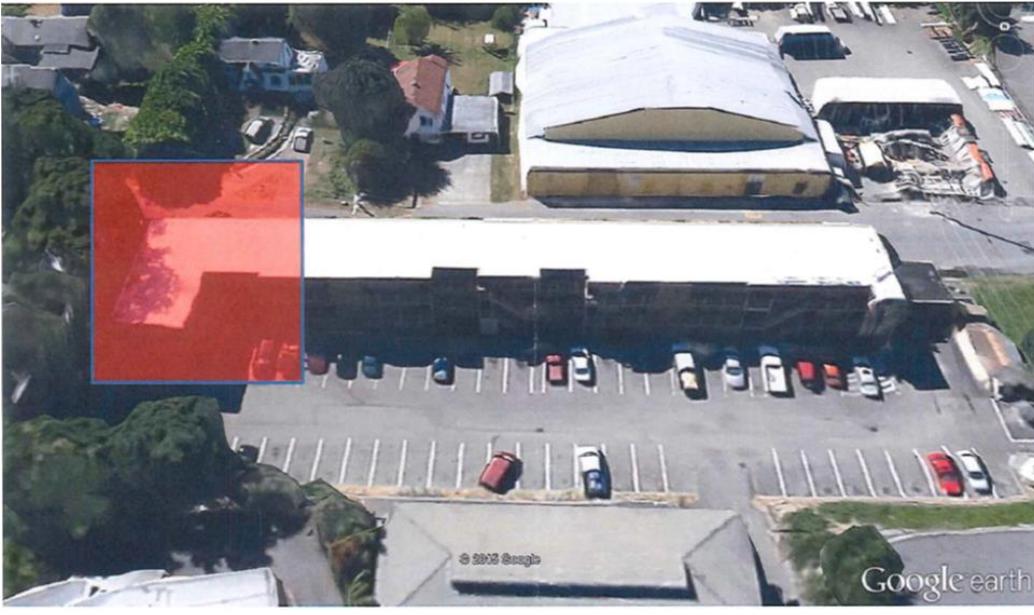
Photo 5: Google photo supplied by Bremerton Police Department looking south showing Motel 6 pre explosion. Red area was destroyed by the explosion.

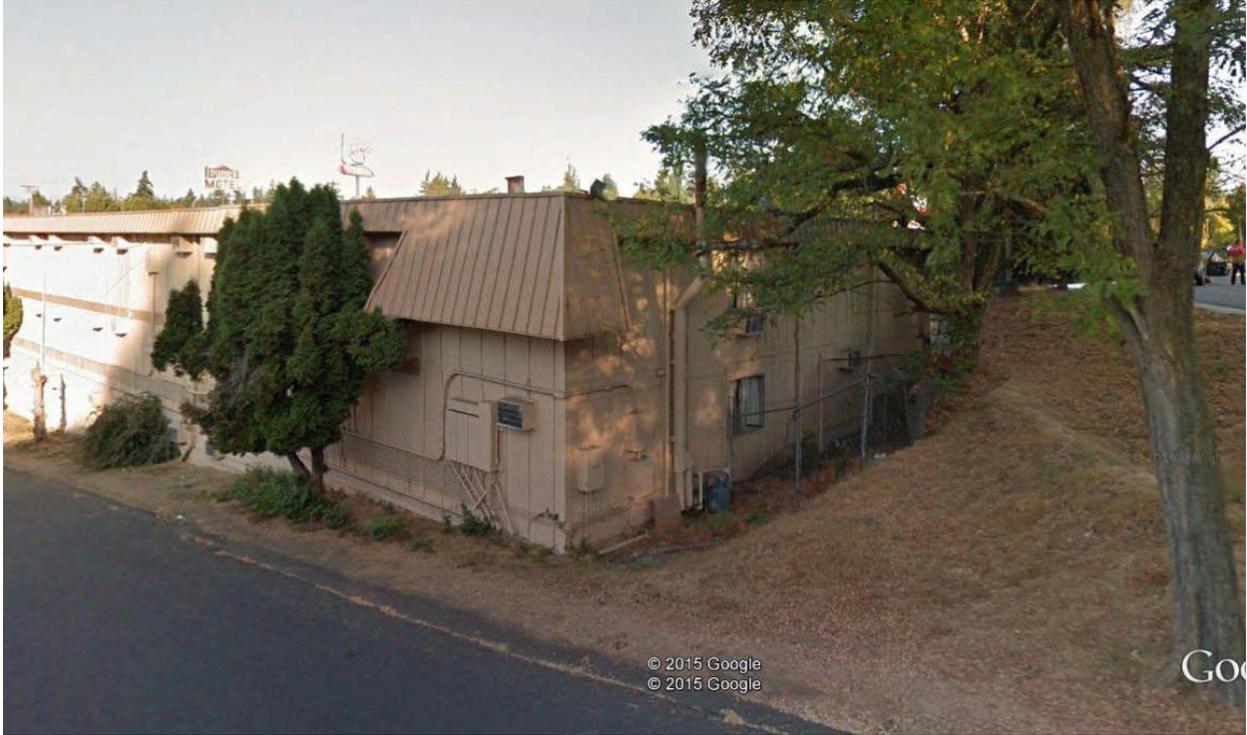
The cause of the above ground leak on the steel riser was an outside force. The Motel 6 had a 1000 CFH meter, supported by the ¾-inch Grade B steel riser pipe and the two-inch fuel piping into the building (**photos 6, 8**). As can be noted in **photo 8**, the fuel pipe and meter sat adjacent (north) of the riser pipe where it came up out of the ground. The Bremerton police confirmed that several people used the meter as a step stool in leaving the third story window above the meter. The weight of several people standing on the meter/fuel piping resulted in a force (torque) being applied to the riser pipe.

Photo 6: Google photo looking northwest from 11th St. at east end of building pre-explosion. Note gas meter location (gray object under lower window). Because of the hill, lower window is actually 2nd floor, with third floor above. Gas meter sits at approximately the ceiling level of the laundry room.

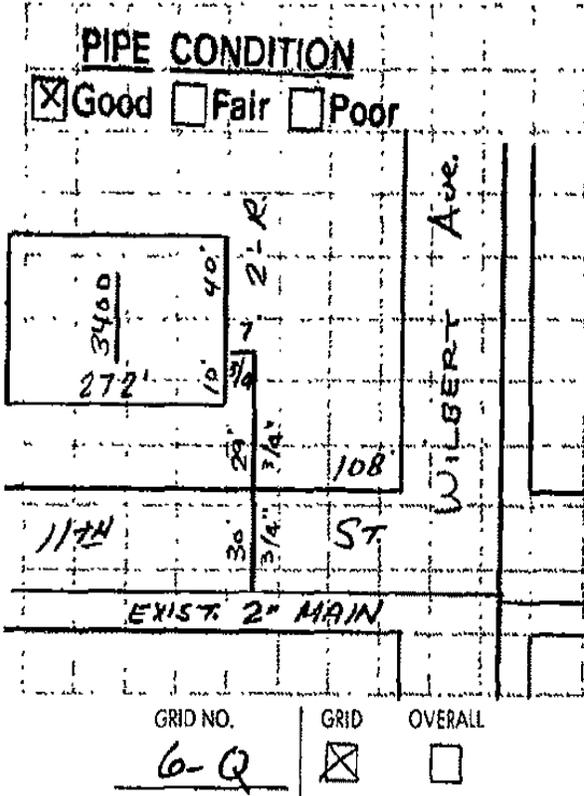
Natural gas blew from the crack at 56 psi for 34 minutes. This would result in approximately 2810 cubic feet (CF) of gas being released (*Engineering Tool Box Simple Gas Calculator*). As shown in **Figure 1 and Figure 3**, the laundry room is somewhat of an inverted L shape. Dimensions taken from the **Figure 1** give a volume of the room (conservatively assuming an 8 foot ceiling height and an empty room) of approximately 1384 CF. The flammable range for natural gas is typically between 5 and 15% gas in air. To reach the lower flammable range, approximately 69 CF of gas would have to have entered the laundry room or about 2.5% of the total gas released. It's plausible that enough gas entered the laundry room from the break via the vent and/or mechanical fan to have reached the lower explosive limit.

Figure 1: Original CNG service card installation record for 3400 11th St. showing length of service and location relative to the building.

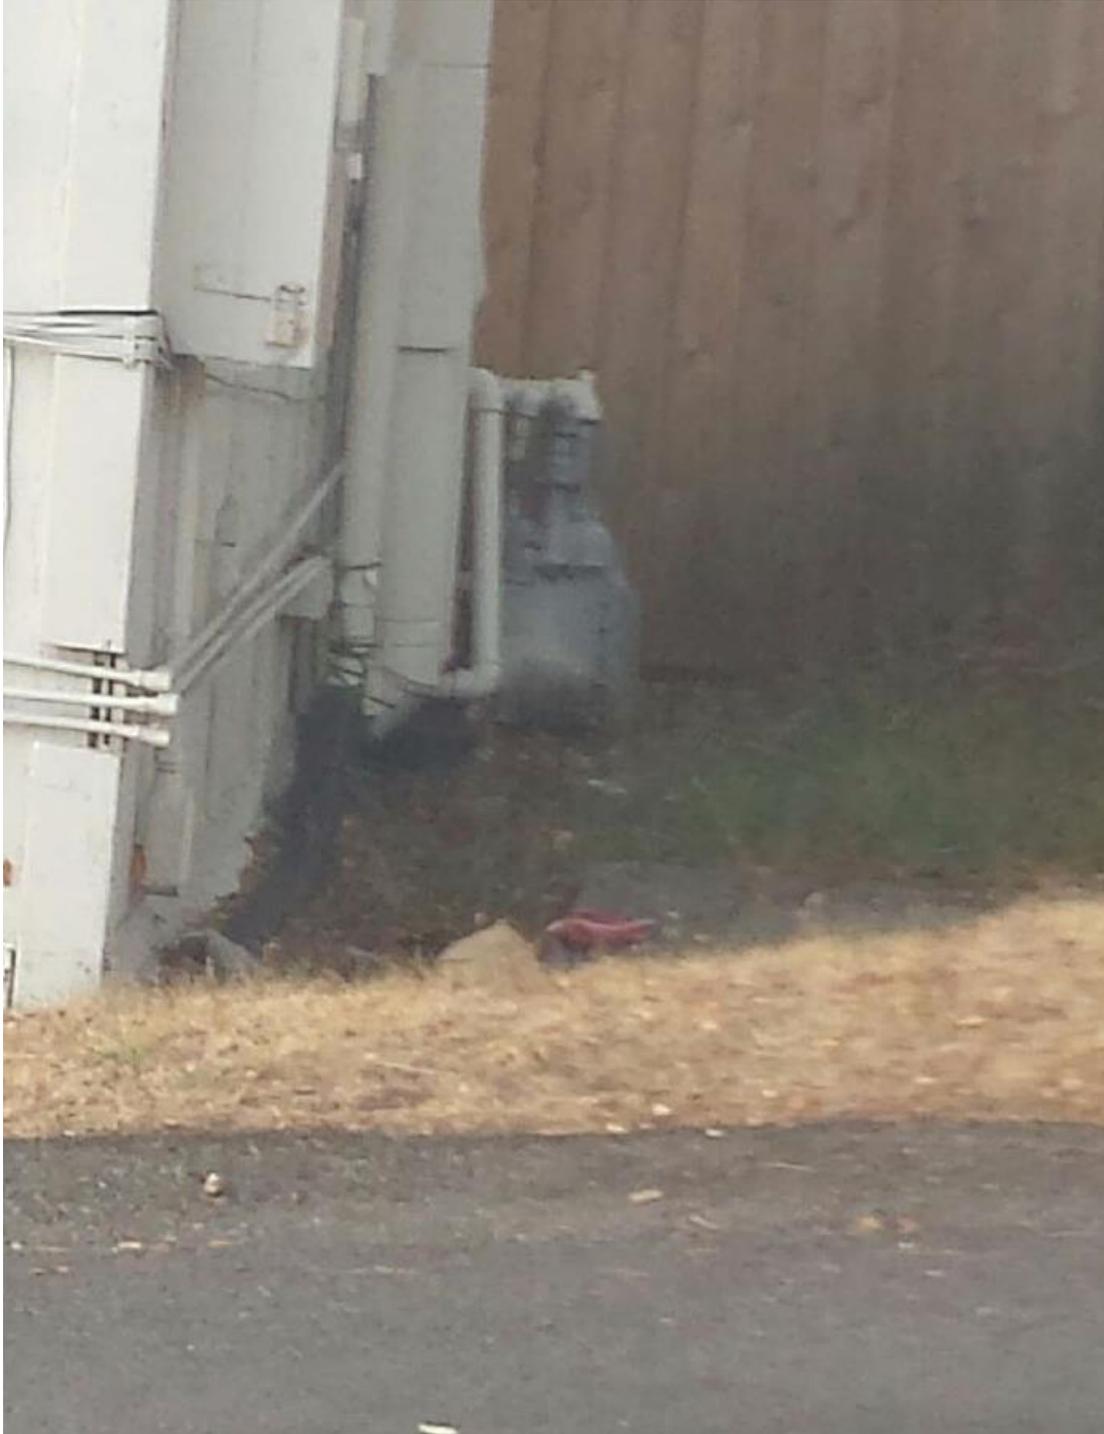
Photo 7: Motel 6 owner's photo looking north at east end of motel. Meter and fuel pipe. Large pipe duct adjacent to meter is the exhaust for the gas dryers (from laundry room to roof). In 2014, new owners replaced cyclone fence (shown in previous Google picture) with a wood fence.

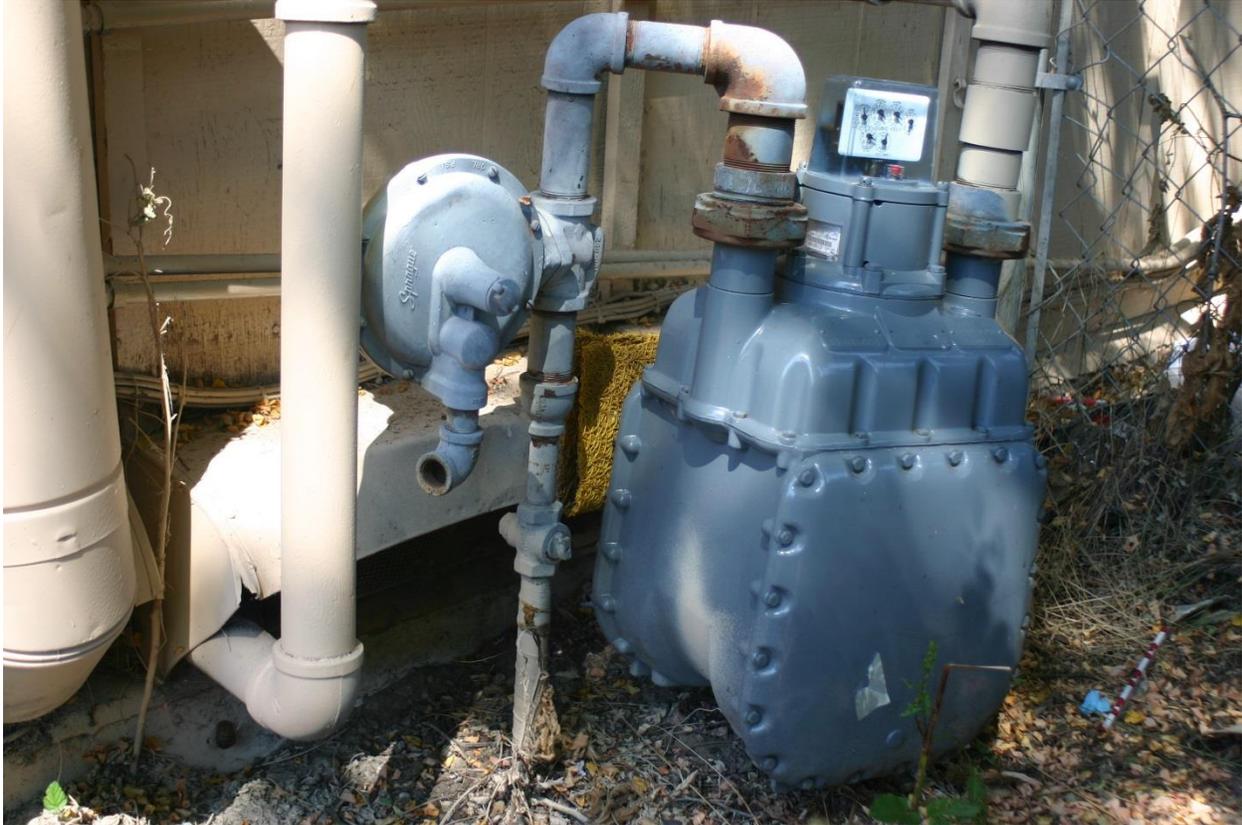
FD first responder Lt. Rex Hinkle (LT), immediately found the leak as he said it was very loud. He noted the leak was above ground, on the riser pipe just below the shut off valve (**photo 8, 8A show the shut off valve and riser pipe**). The LT placed his boot up against the leak to determine which way gas was blowing. He determined it was blowing away from the building (southeast) and the crack was approximately half way around the pipe as you could see the dark area in the threads. The gap was approximately 1/16 of an inch wide. The riser was not straight up and down-was "out a bit from the building" (bent slightly away from the building) according to the LT (**photo 14**). About this time, approximately 20:19, CNG service mechanic Larry Jennings arrived.

The most probable route for gas to have entered the motel is through the wall vent (**photos 8, 8A, 18**). The vent duct was found in the debris on the hill east of the building (**photo 17**). Based on the orientation of the paint (which matches the outside wall paint) on the vent, it appears to be a through wall vent from the outside to the inside with the inside duct facing down to attach to internal duct work. There was a rectangular duct oriented in the vertical position on the laundry room wall which the vent would have attached (**photo 19, 22**). Gas was blowing for 34 minutes at 56 psi. The initial break in the service line according to Case Forensics almost severed the line. Case also believes the break to have initiated in the 10 o'clock position (if standing behind the meter looking due south, the 10 o'clock position on the pipe would be in the southeast direction). Aligning the "notch" in the riser pipe with the actual location in situ, with Case's break initiation point, the severed arc would allow gas to blow directly into the vent. The resisting force on the gas would be the atmospheric pressure at sea level or 14.7 psi. It would therefore be plausible for gas blowing at 56 psi to overcome this "back pressure" and force its way down the duct to the laundry room (**photo 13**).

Photo 8: Looking west at motel meter on east end of building pre-explosion. This photo was taken by the UTC on 7/21/2009 during the CNG Kitsap Standard Inspection. There is a fresh air vent behind the meter which sits on the foundation wall and then leads into the first floor laundry room. The tan fuel piping follows the vent into the building. Note the location of the vent in relation to the steel riser pipe. The assembly from the threaded riser connection to the meter was changed out at some point after this photo, however, the riser location, meter and fuel piping did not change (see photo X below).

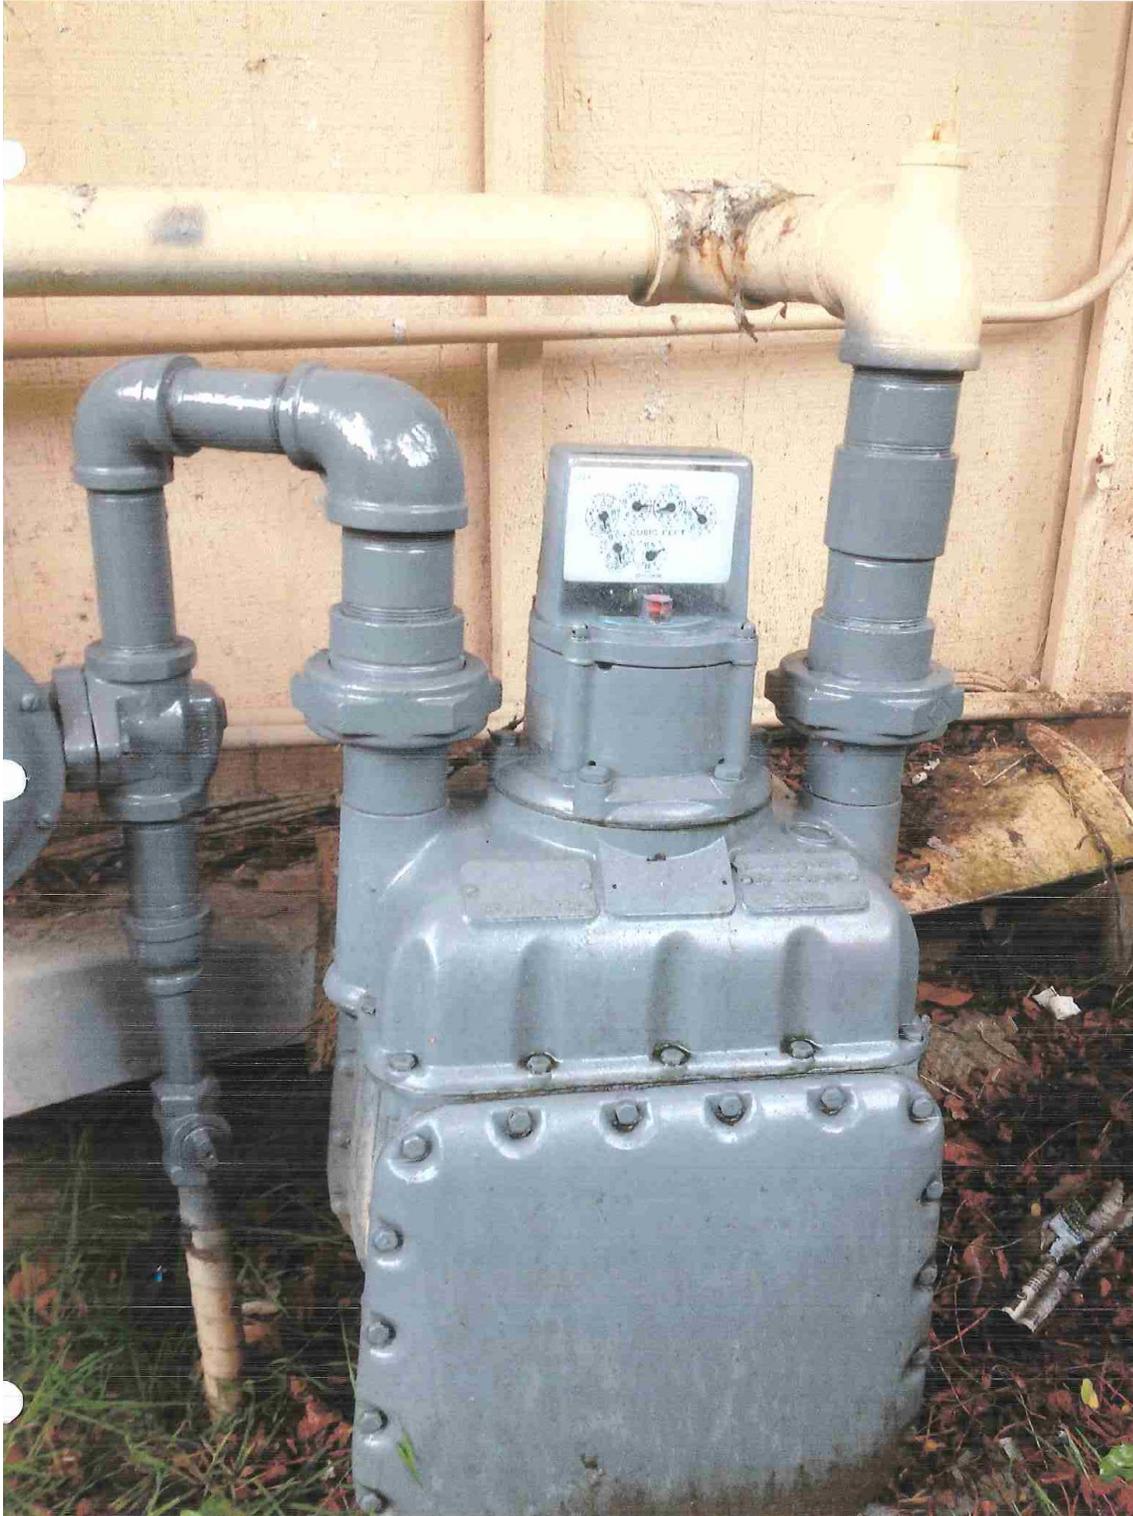
Photo 8A: CNG photo taken 5/22/12 of meter at east end of motel as part of CNG work order 9173110941. CNG painted part of meter pipe assembly to the left of meter. This photo shows either an additional fresh air vent behind and to the right of the meter, or an extension to the vent to the left of the meter (see photo 8).

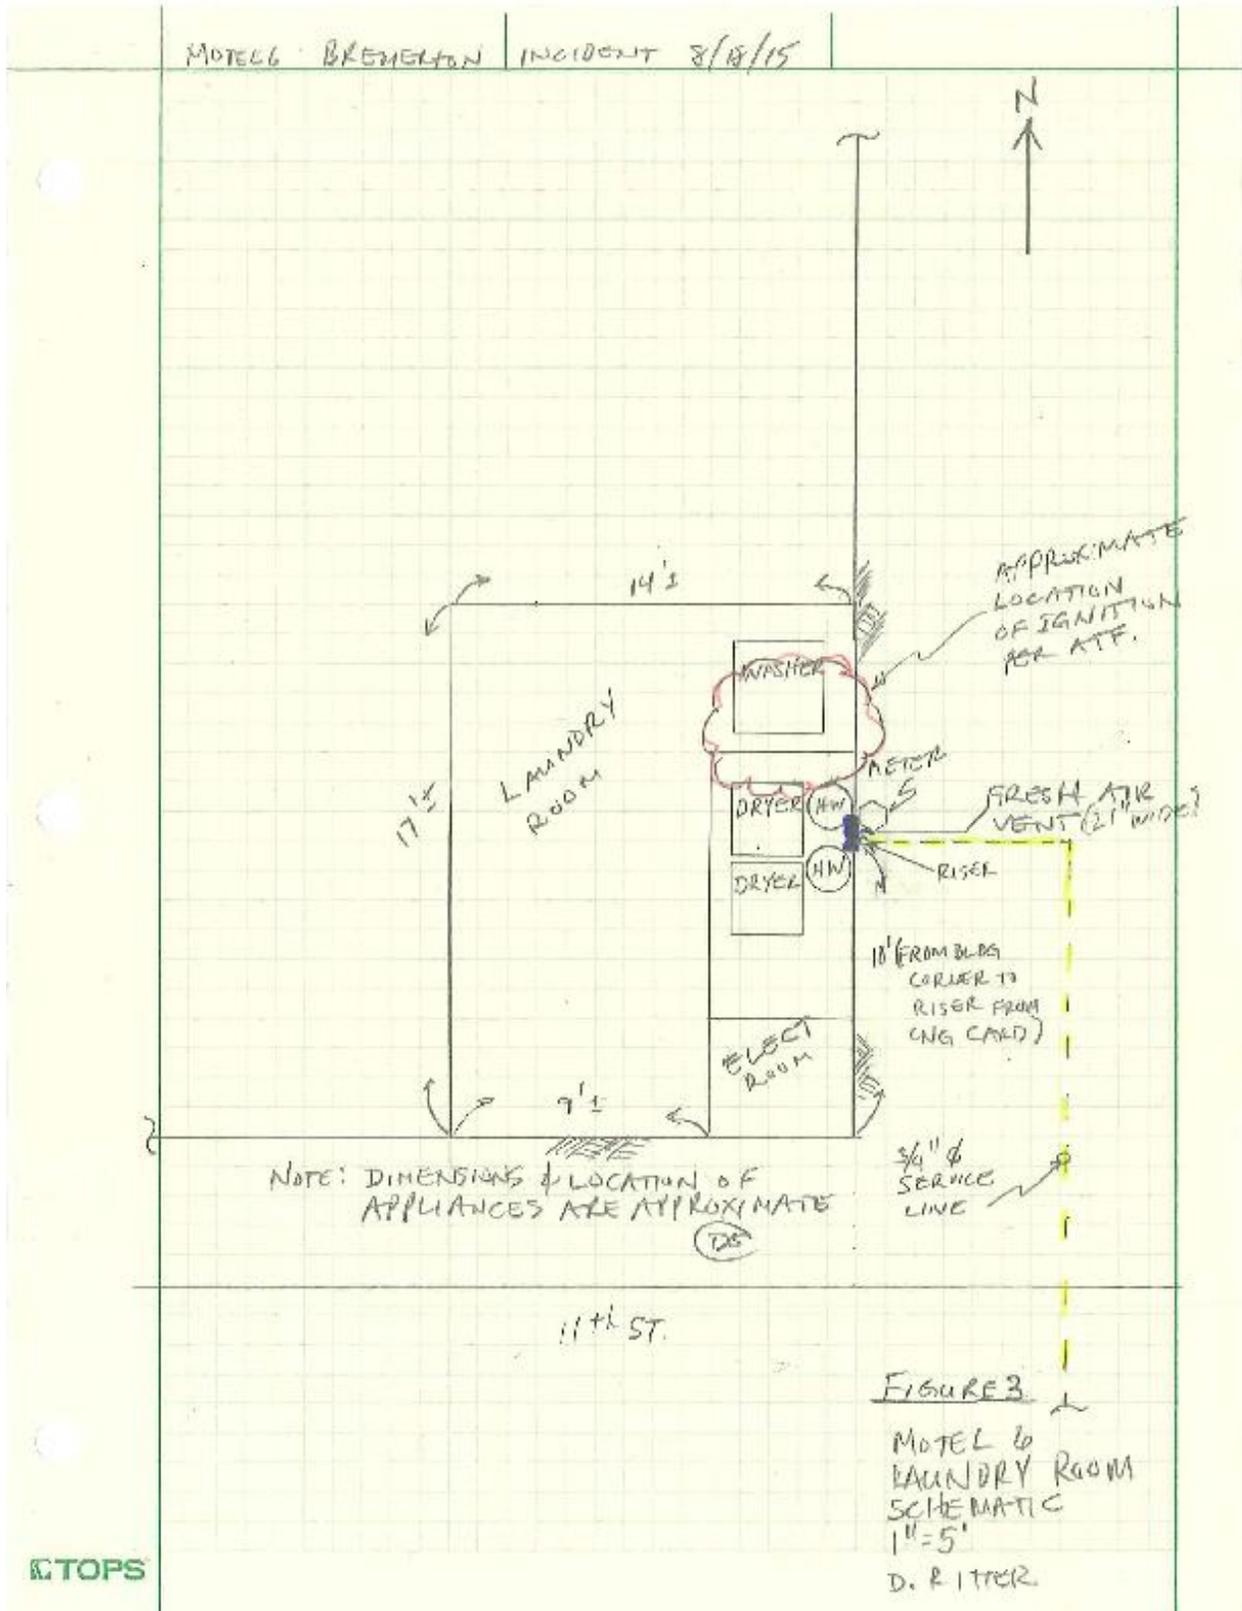
The ignition point has preliminarily been identified by the AFT to have occurred above the washing machine/dryers, below the second story floor, near the east exterior wall of the motel (**Figure 3**). The explosion blew out the lower supporting walls at the foundation wall and the upper floors fell in.

At 20:25 on 8/18/15, accumulated gas in the first floor laundry room (ATF believes this to be the ignition point-see **Figure 3**) and ignited resulting in an explosion and fire. (Note: the laundry room is below the elevation of the meter and gas riser on the first floor. There is a foundation wall on this end of the building due to the ground topography rising to the east) (**photos 6, 9, 21**). The explosion sheared off the already damaged gas riser pipe just below the meter shut off valve (**photos 10, 12**). CNG crews could not shut off the gas until emergency locates were completed so they could excavate the service tee. The service tee and main was then excavated and at 22:10 on 8/18/15. The gas was eventually shut off at the service tee by reinserting the auto-perf pin. The service was then cut and capped.

Figure 3: Schematic of laundry room with approximate location of appliances. Information

was supplied during interview with owner Ramesh Rabadia and hand drawn by UTC inspector D. Ritter.

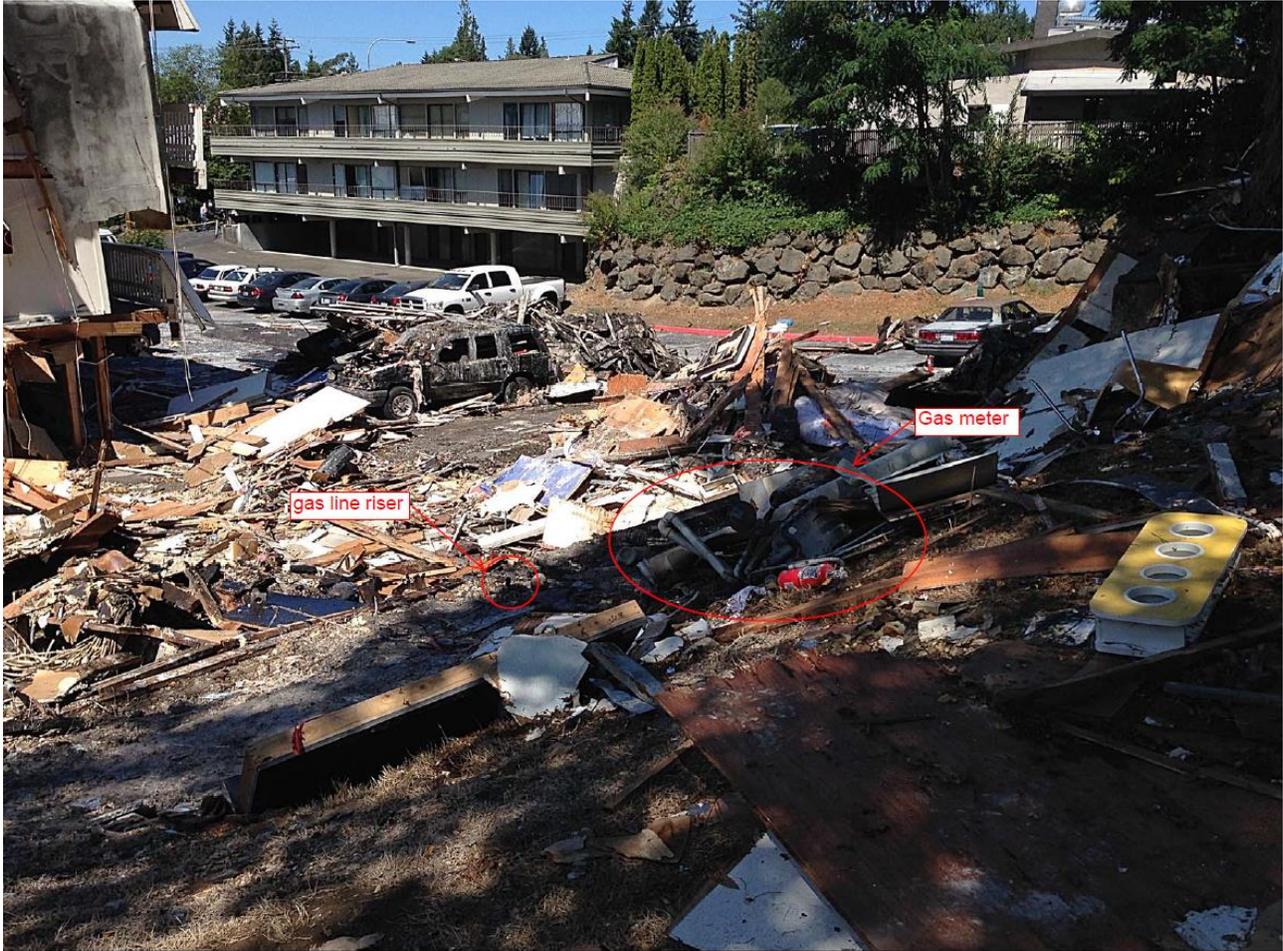
Photo 9: Looking northwest. Note location of gas riser and meter. Meter is approximately 10 feet east of riser and upside down. This is also where CNG service mechanic was found after blast.

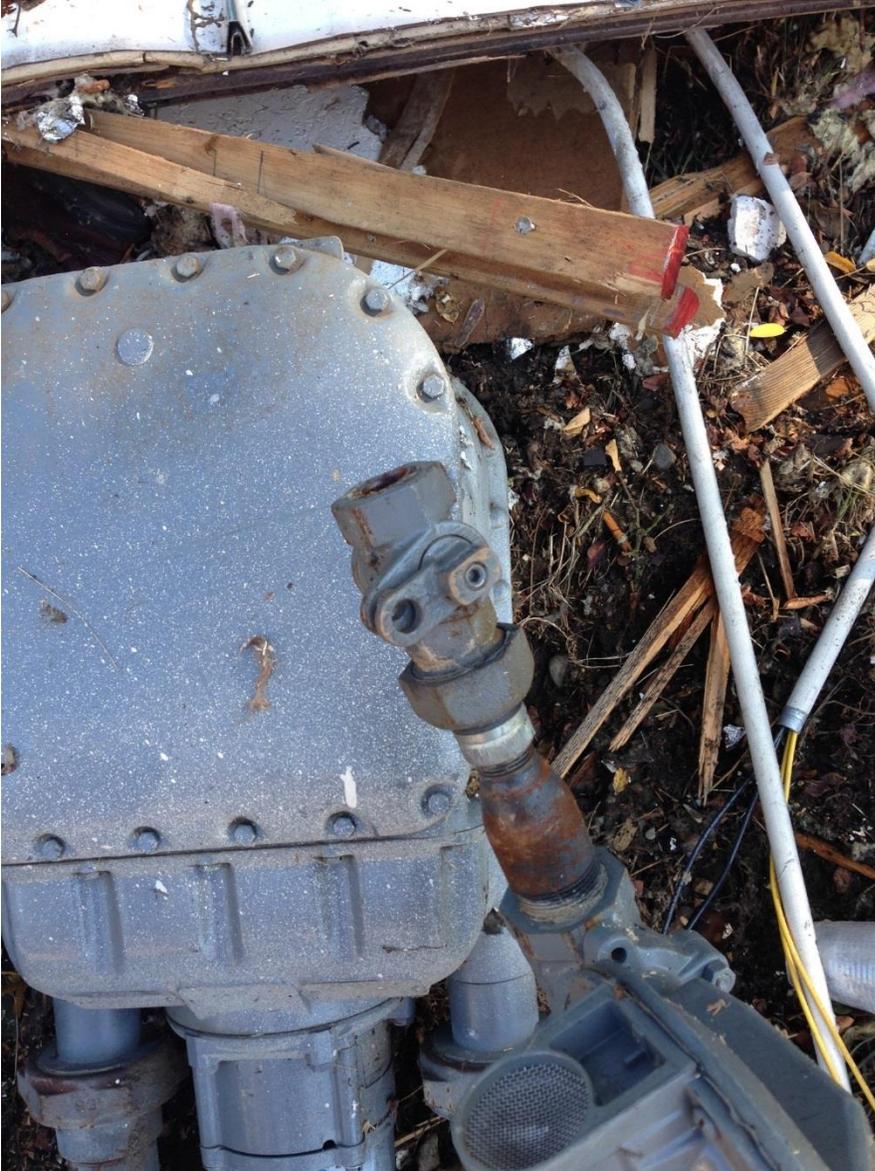
Photo 10: Looking east. Meter valve is in closed position as CNG service mechanic closed it when he arrived. Note, meter and service riser are upside down in this picture.

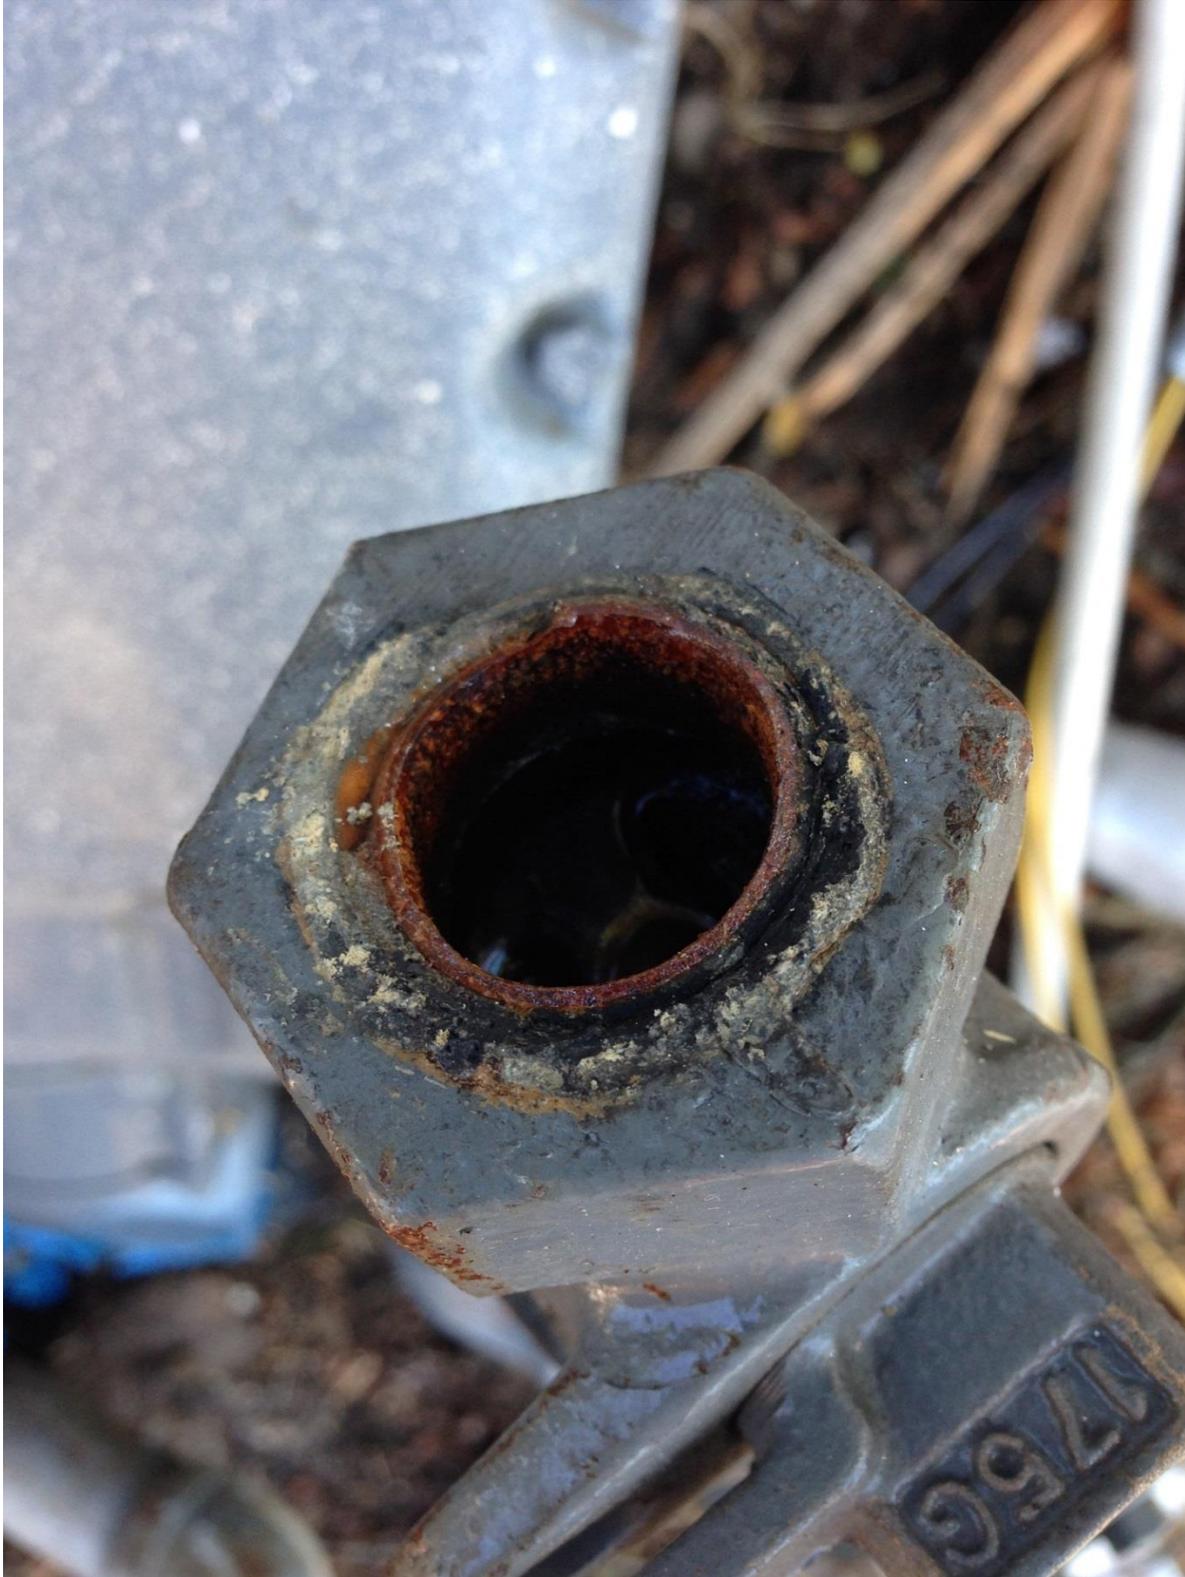
Photo 11: Threaded portion of riser pipe inside threaded nut portion of meter valve. Note notch in threaded riser pipe at top of photo. This notch mates to a corresponding notch on riser pipe. Note rust is surface rust from fire suppression water.

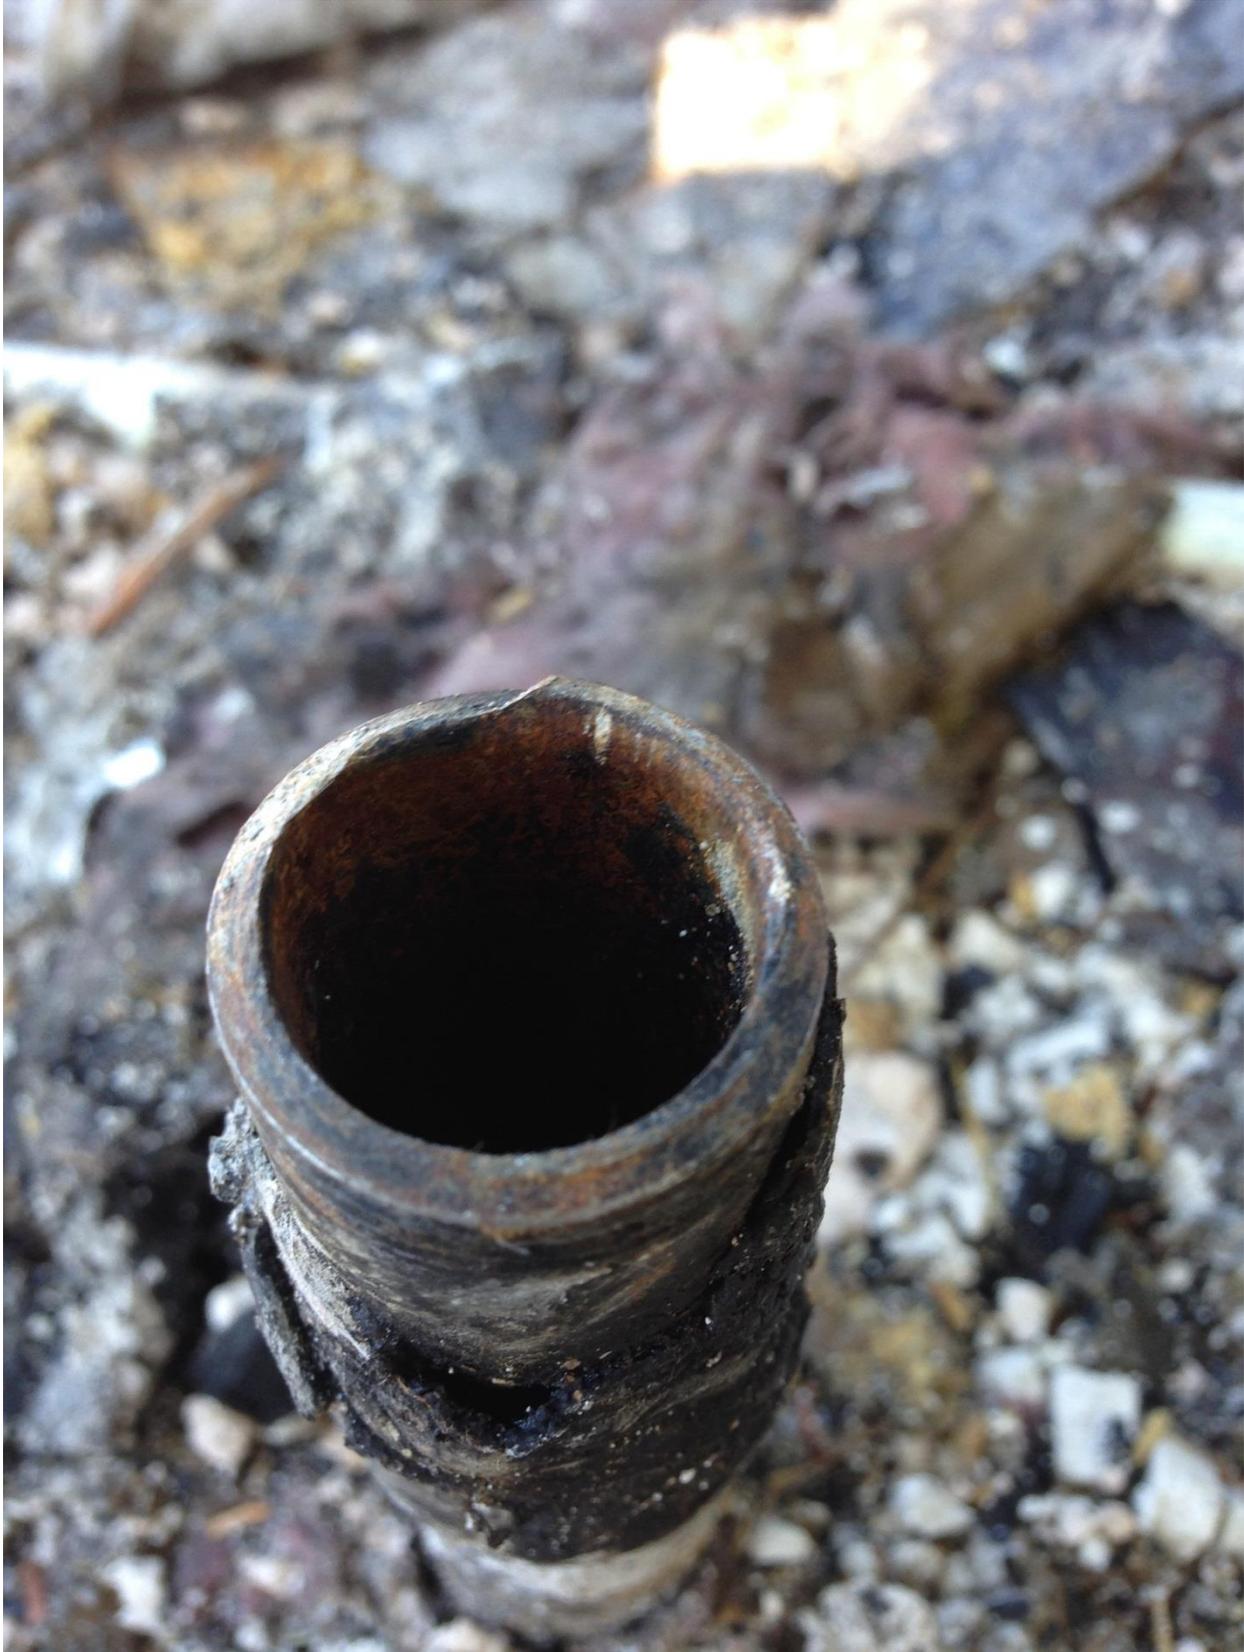
Photo 12: Looking north at ¾-inch steel riser after explosion. Note pipe lip is notched where blast tore remaining connected material.

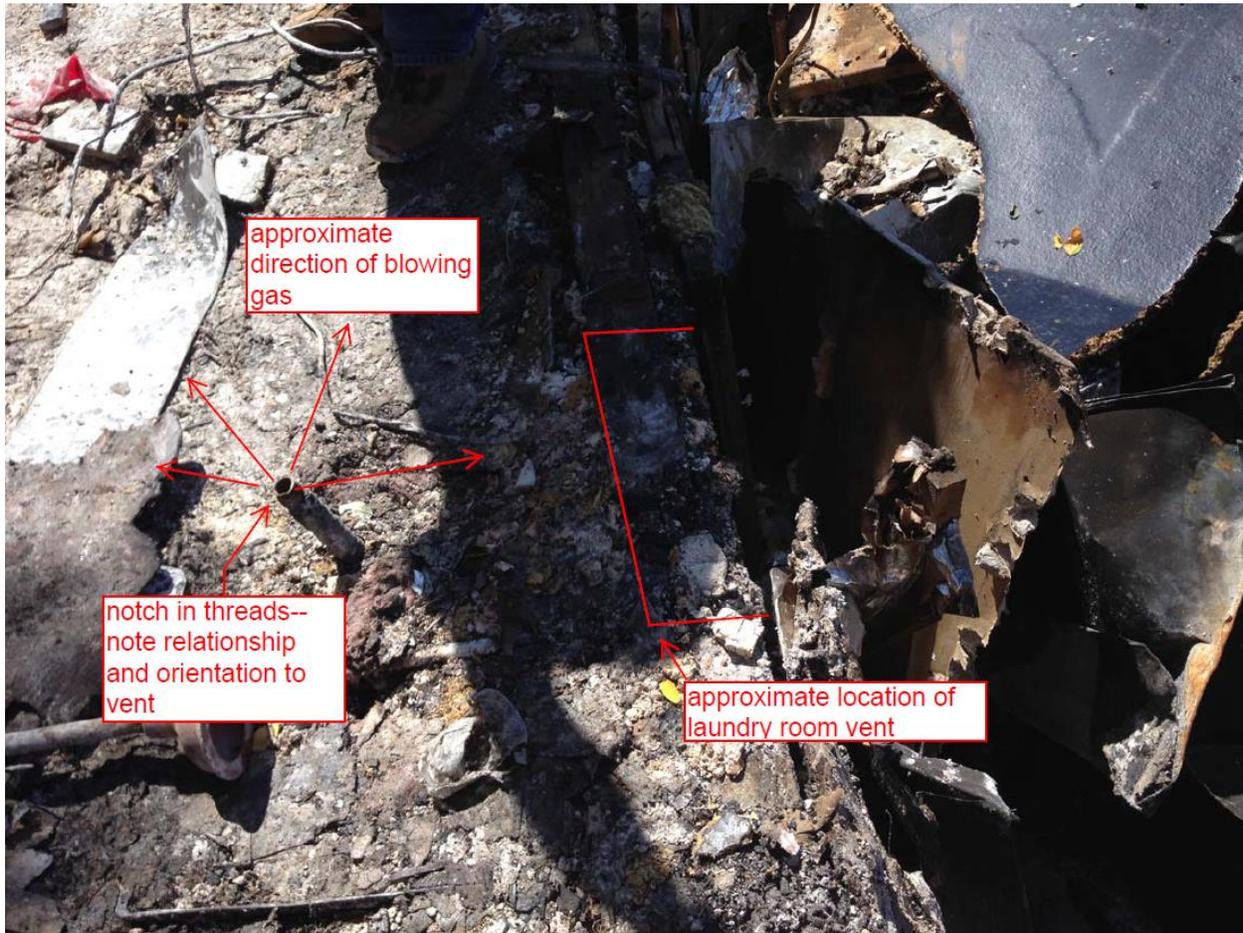
Photo 13: Looking south. UTC inspector's depiction of how releasing gas entered building via the fresh air vent as shown. Initial break according to Case Forensics initiated at approximately the 10 o'clock position (southeast in this picture) and extended almost 360 degrees of pipe circumference. The gap according to first responders was "approximately 1/16" and halfway around the pipe". (note: text boxes and red layout added by D. Ritter).
