UTILITIES AND TRANSPORTATION COMMISSION

**RE: Natural Gas Incident Investigation: 3400 11th Street, Bremerton, Washington
– August 18, 2015 (Insp. No. 6542)**

UTC Incident Investigation Form

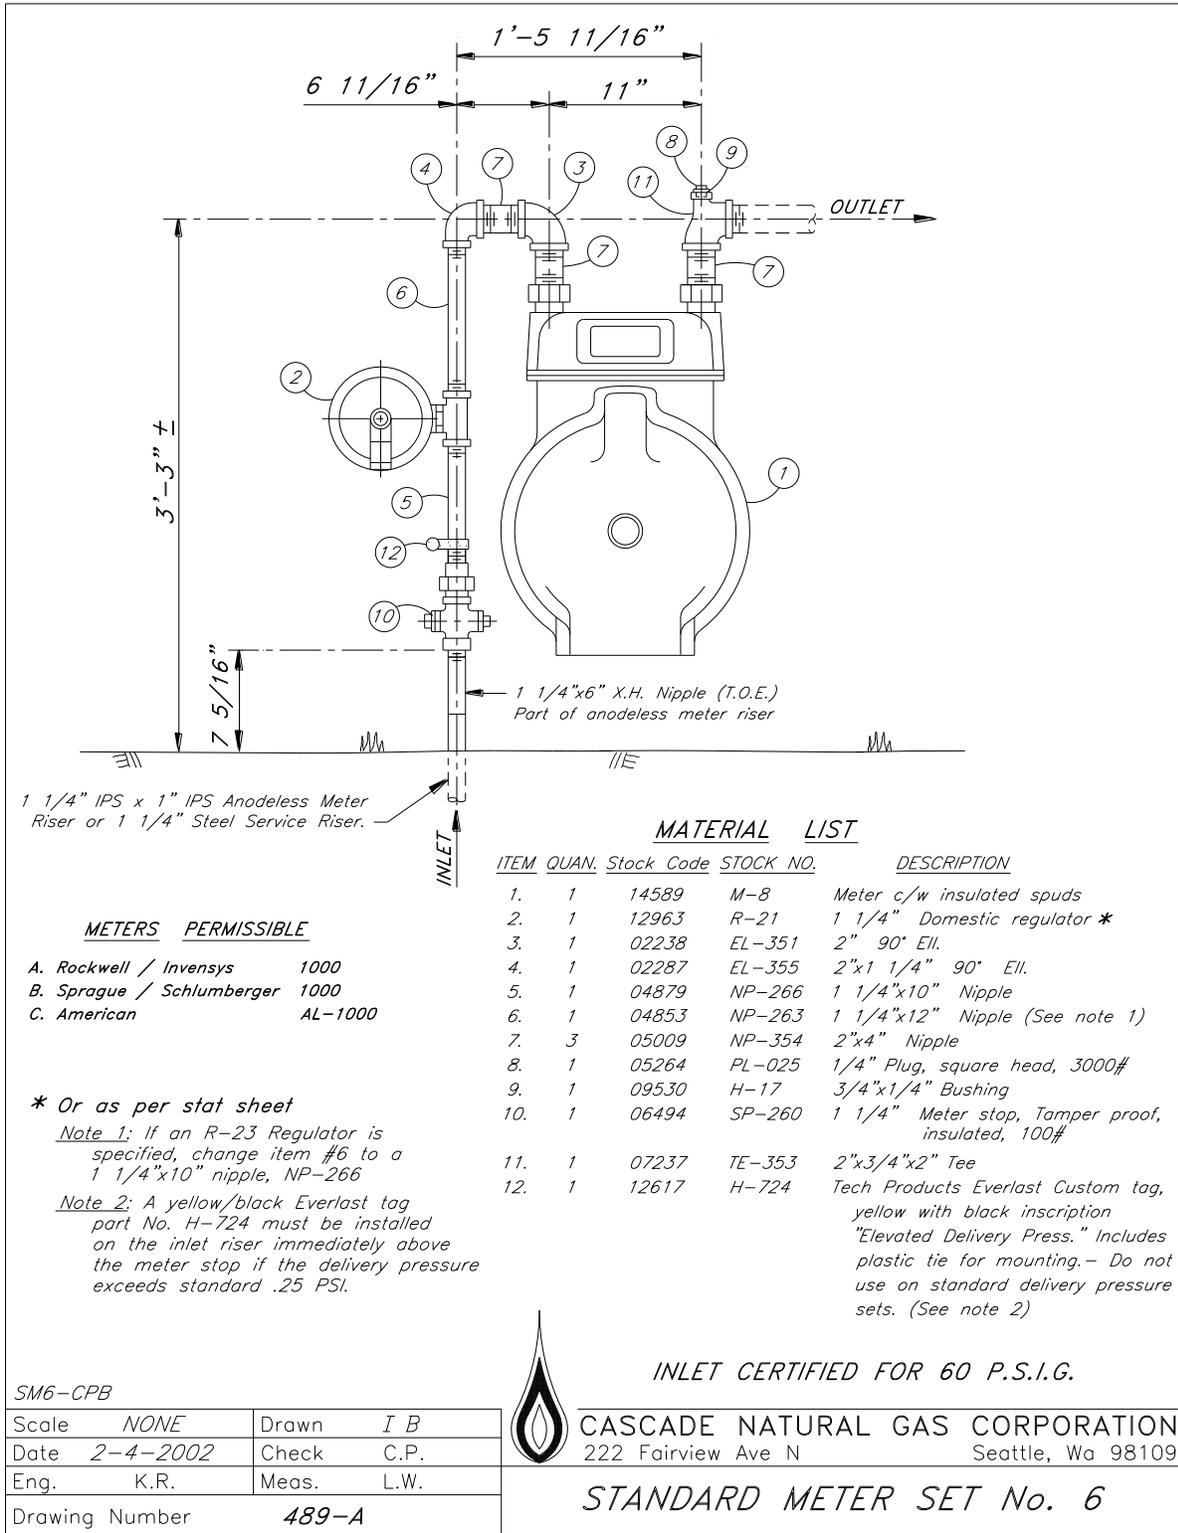
- 11/12/15-reviewed CNG Meter Set No. 6 standard drawing dated February 4, 2002. The original meter set in 1978 was replaced in Nov 17, 2008 so this newer standard would apply. Two items noted: 1) no support stand is required; 2) the riser pipe is identified as an 1-1/4" IPS reflecting the new standard for riser pipe.

Figure 4: CNG Standard Meter Set drawing for a meter similar to Motel 6 installation (note a standard meter set drawing is not available for the time when the service was installed in 1978).

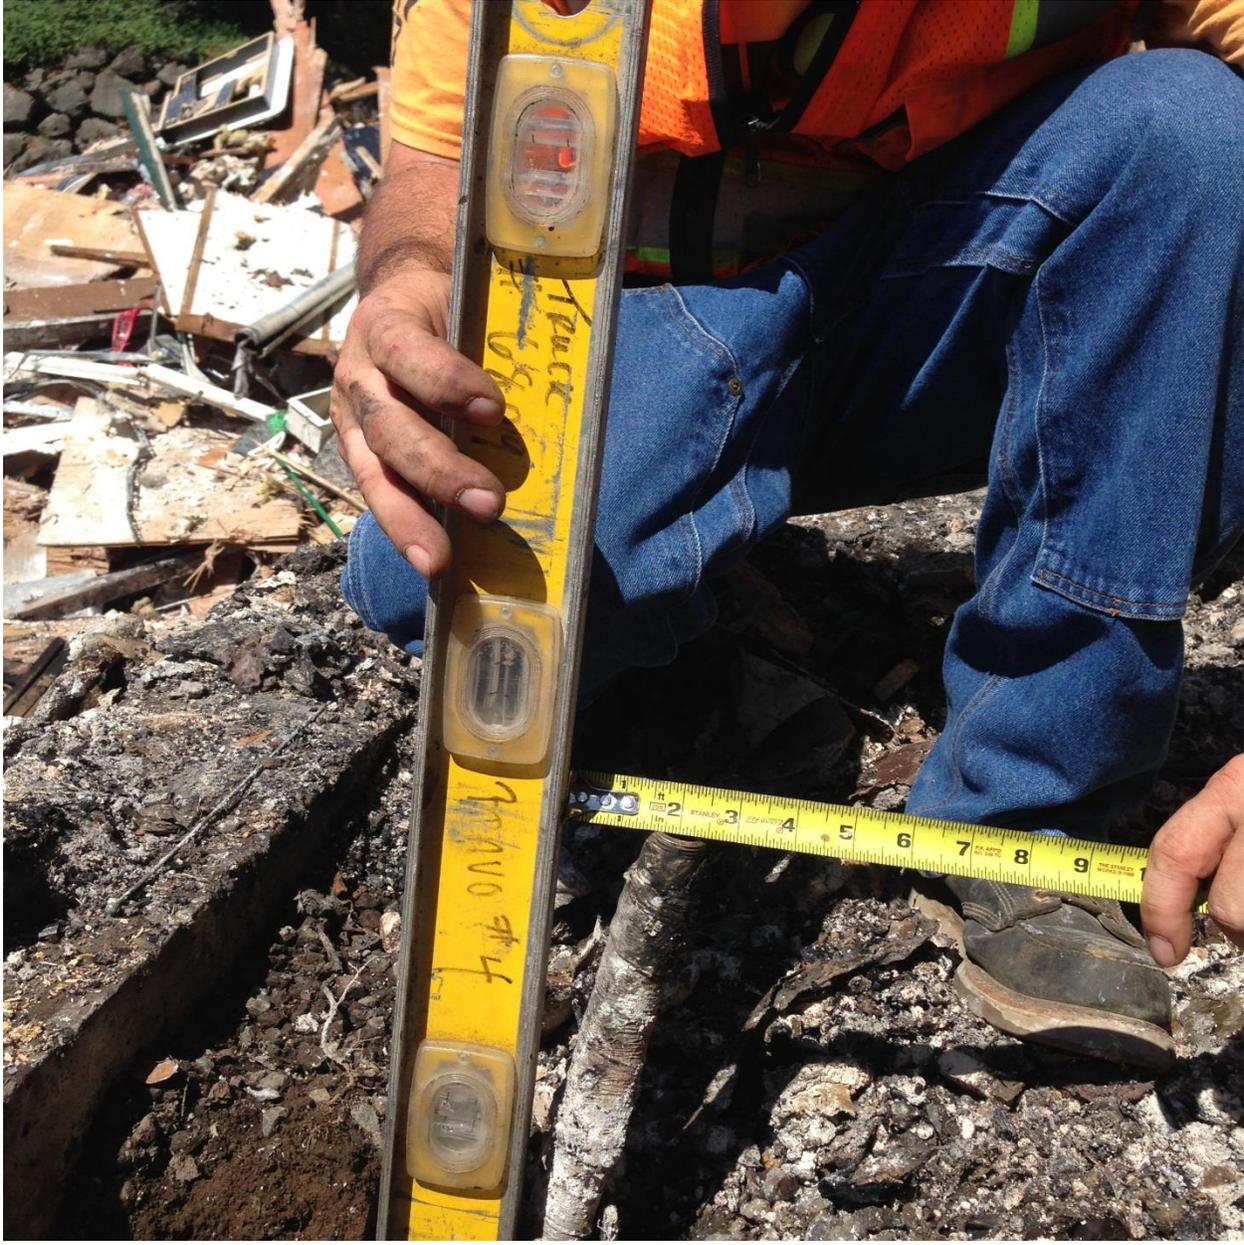
Photo 14: Looking north. Service riser is bent away from building. Possibly bent by outside force of people standing on meter and/or from explosion. First responders noted the riser was “out from the building” prior to explosion.

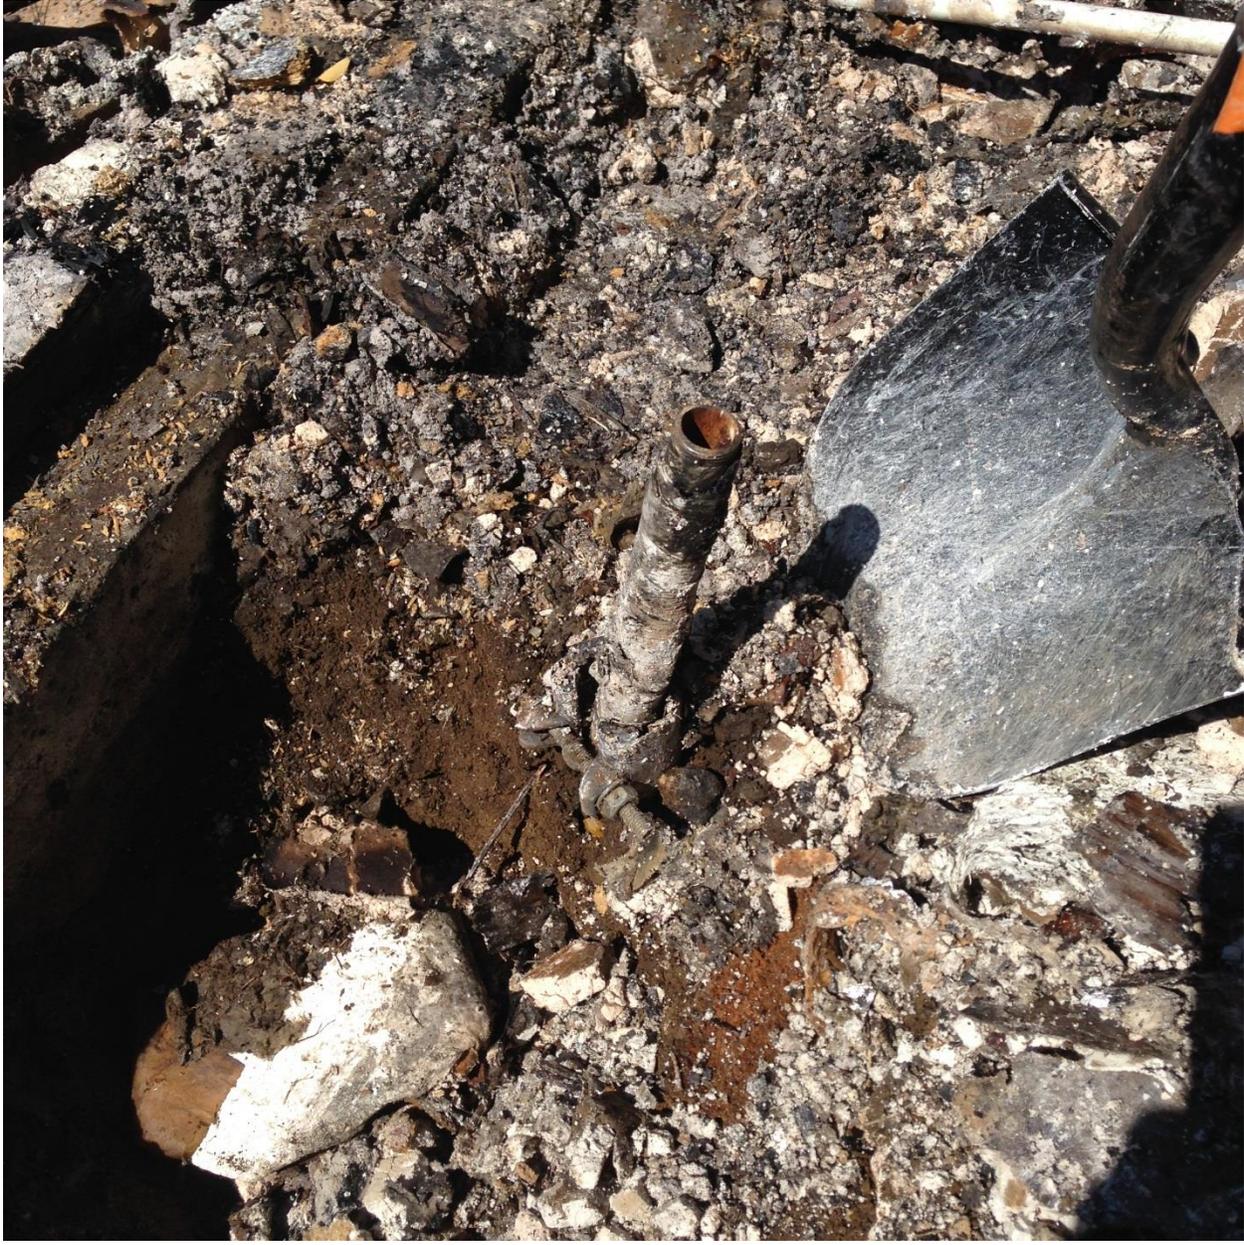
Photo 15: Looking north at CNG service riser being excavated on 8/19/15. Note leak clamp at base of riser which was being installed by CNG employee when building exploded.

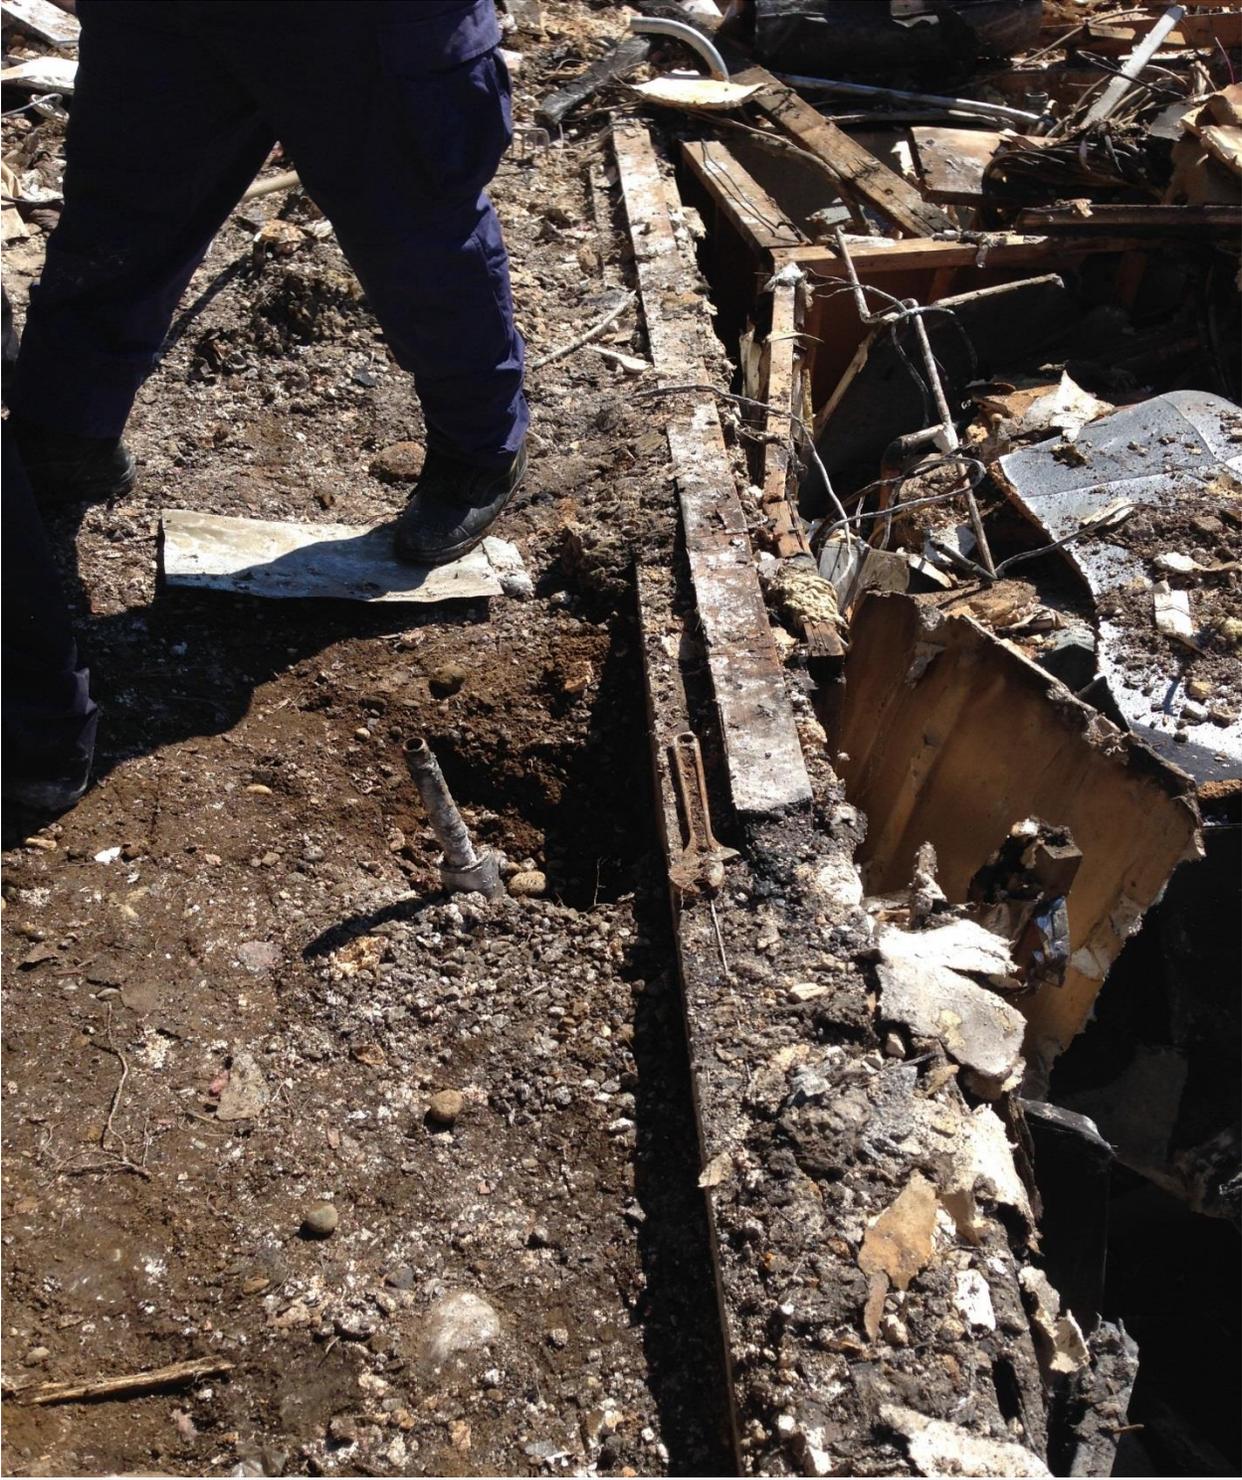
Photo 16: Looking south at gas riser pipe. Note CNG employee crescent wrench adjacent to riser. Wrench was found a few feet east of riser.

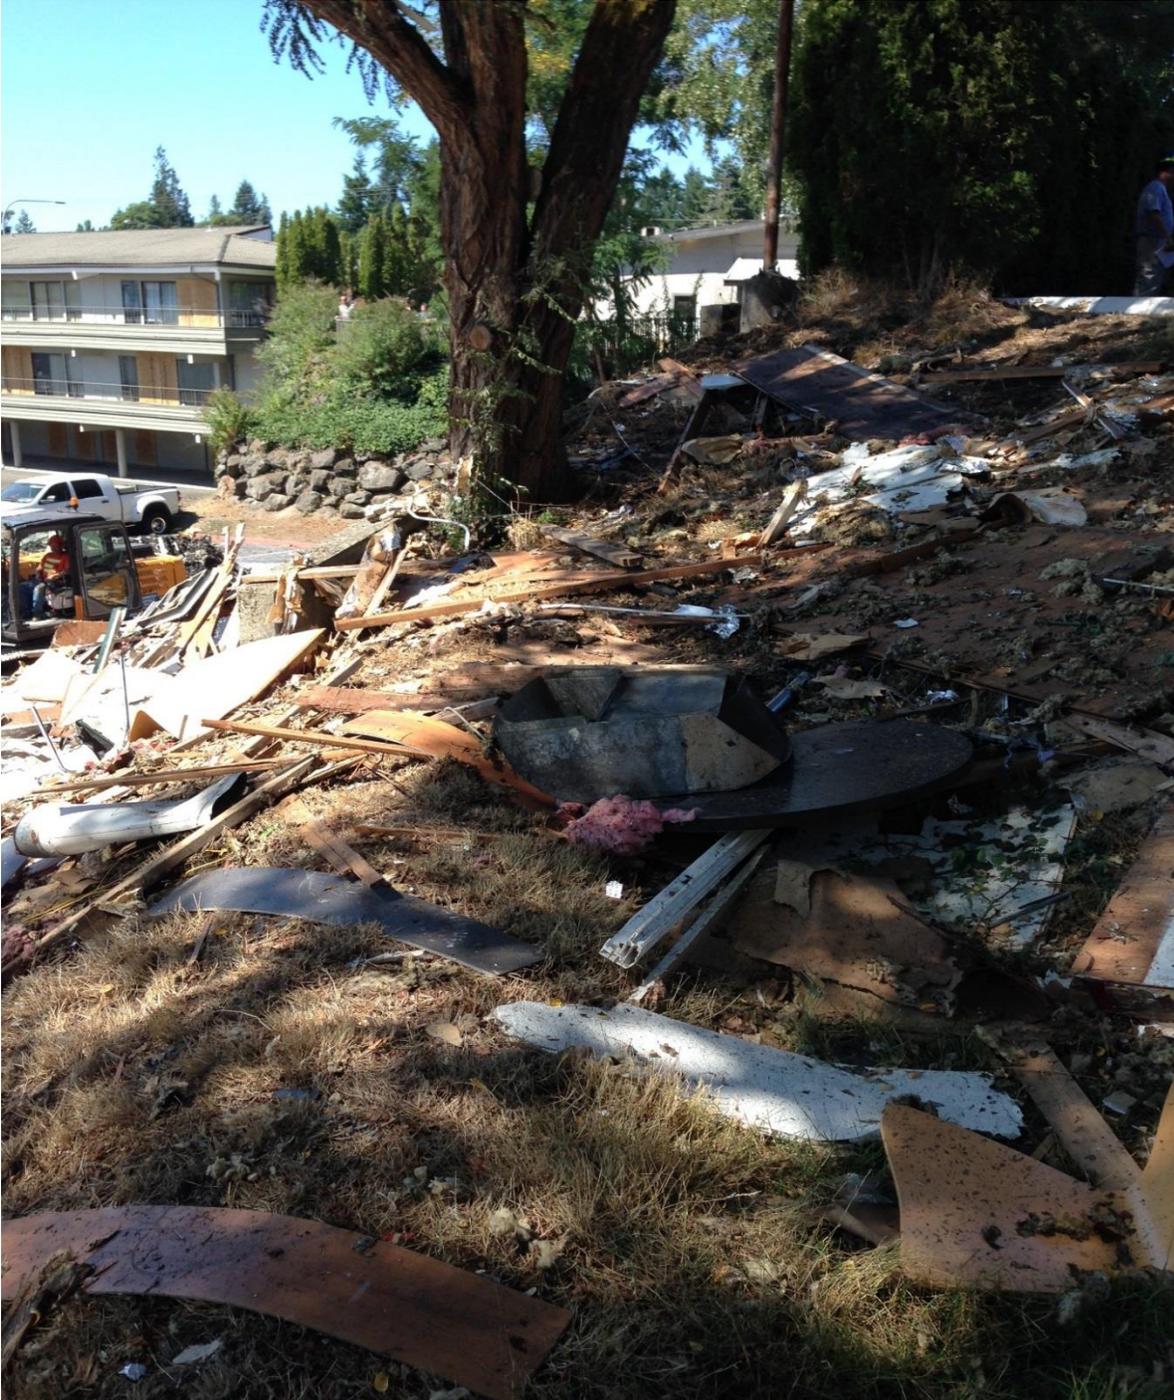
Photo 17: Looking NW from hill east of motel at air vent which is suspected to be the gas pathway into the laundry room. The vent was found in the debris on the hill just east of the building. It is suspected to have been a fresh air vent (there is no debris or lint in the vent and it has bird screen). A picture of the east side of the building prior to the explosion shows the vent immediately behind the riser and meter. The paint on the duct indicates its orientation on the building. The downward facing portion of the duct is believed to have tied into a rectangular duct shown attached to the building wall inside the laundry room below.

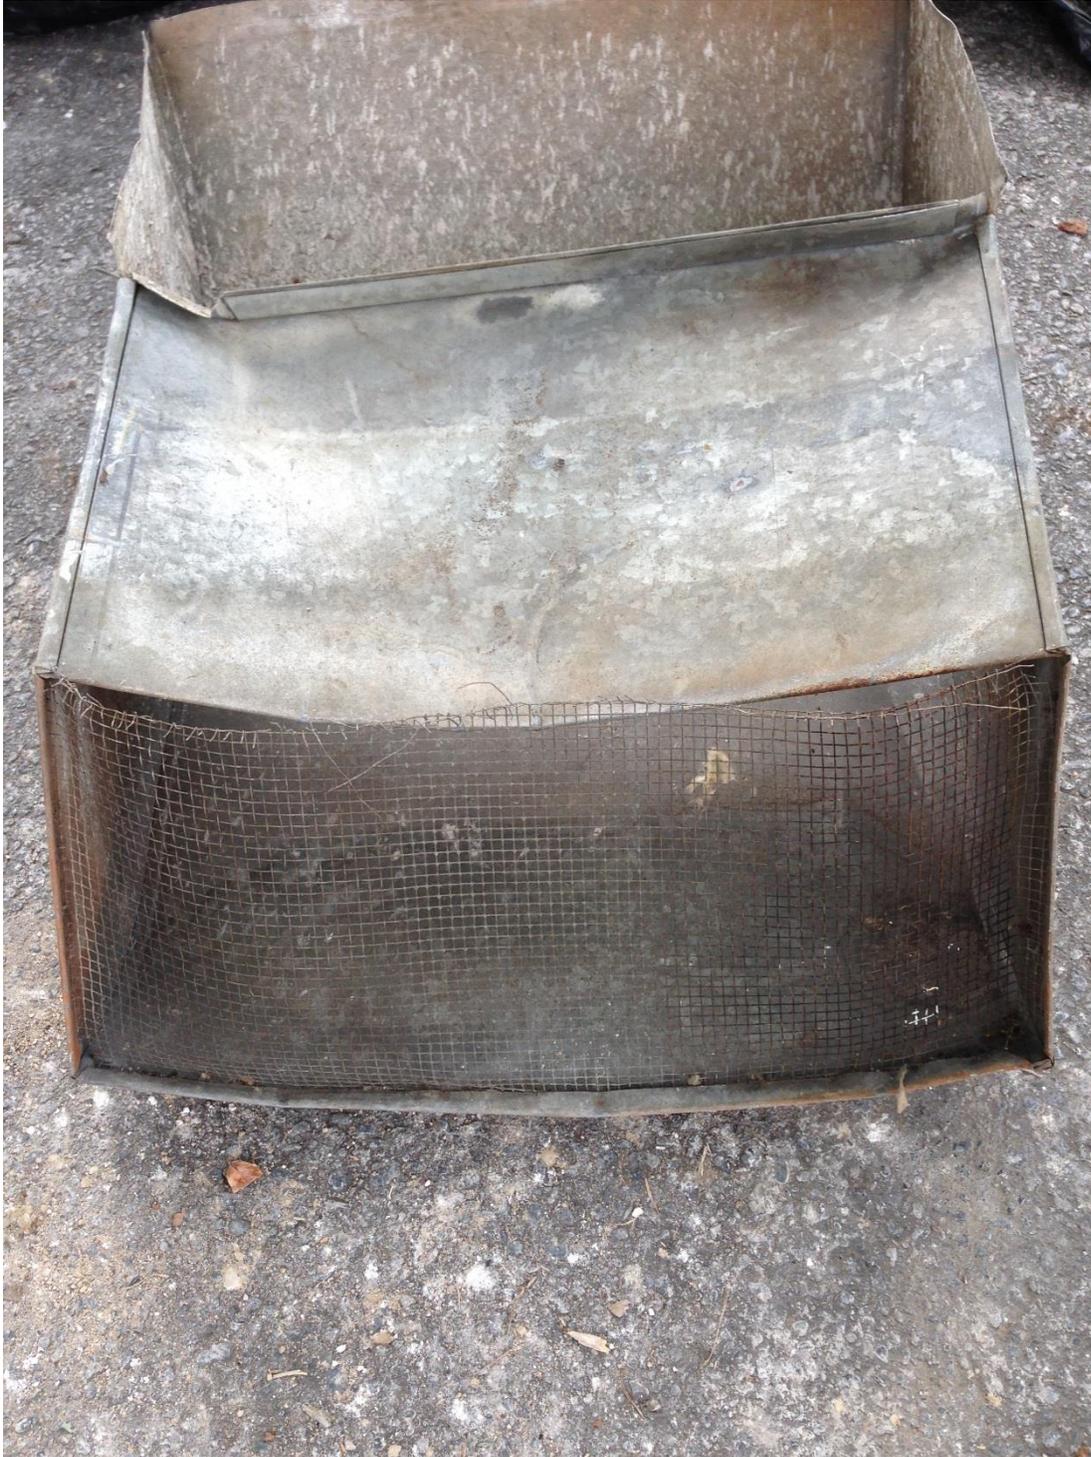
Photo 18: Through wall fresh air vent which connects to duct to laundry room on east wall of motel.

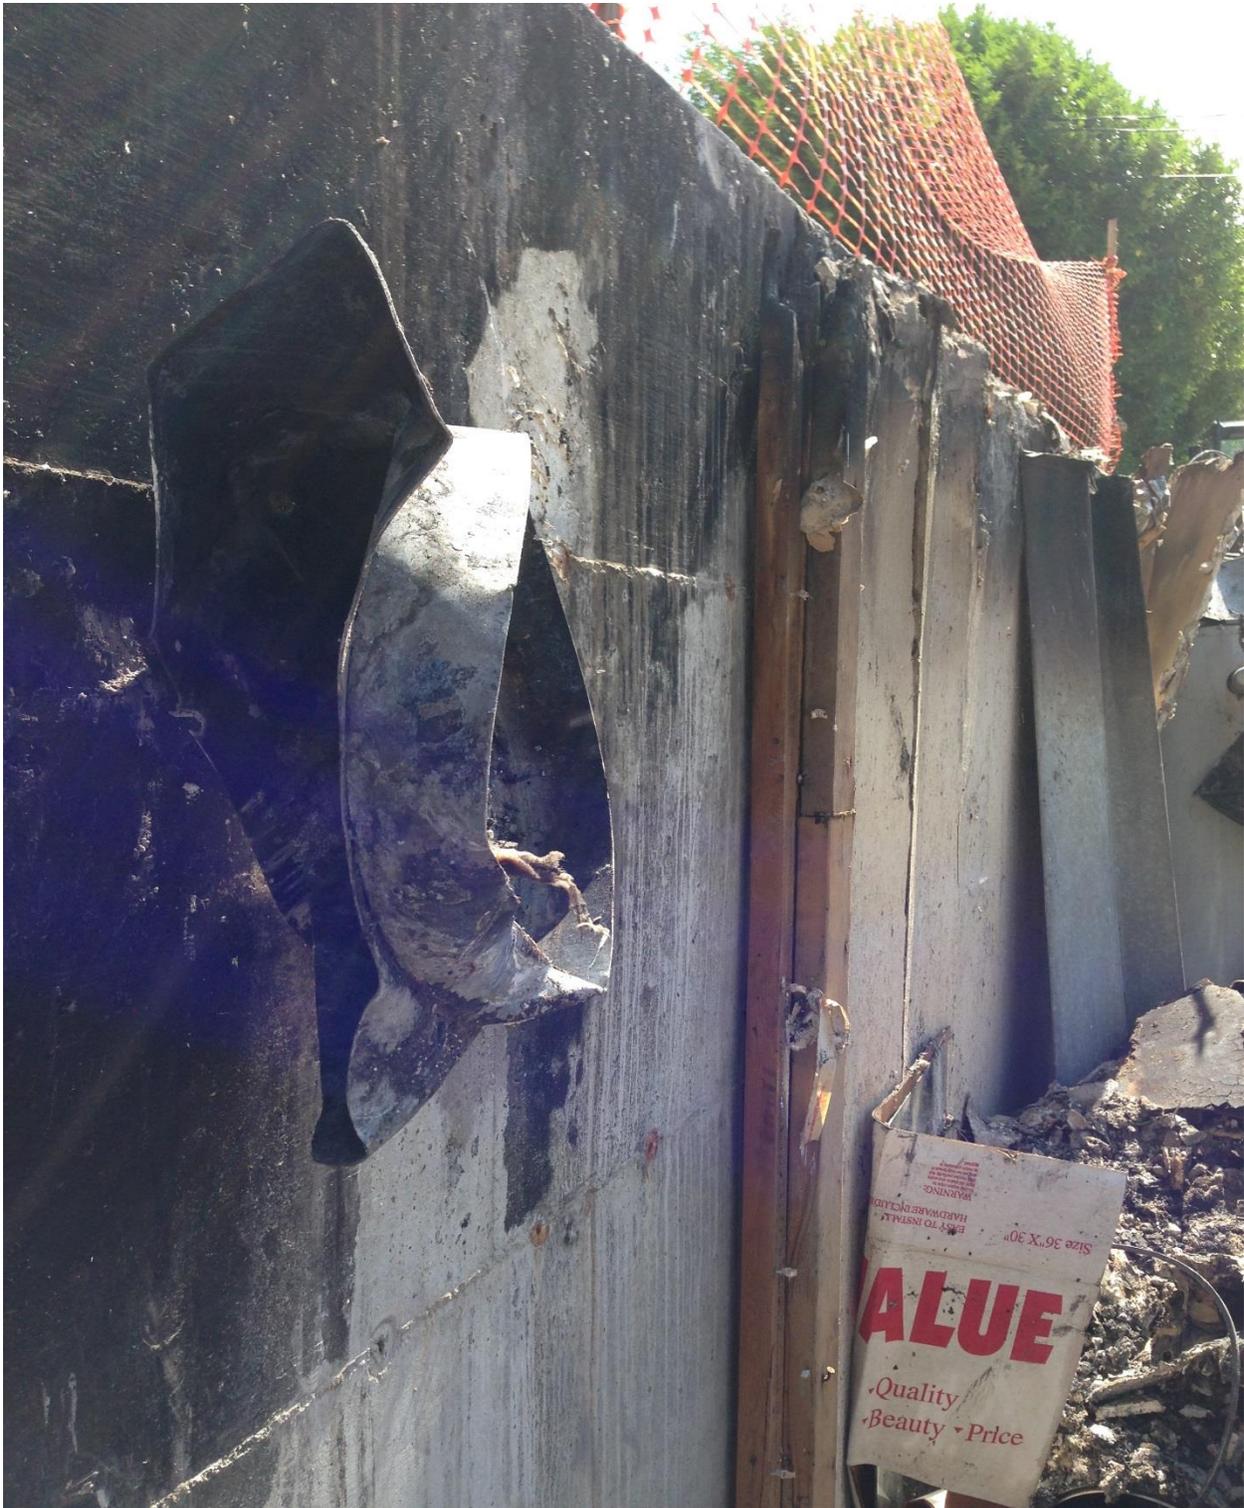
Photo 19: Looking south at laundry room retaining wall and rectangular ductwork in background which is suspected to have been connected to rectangular fresh air vent. This ductwork would sit immediately adjacent to the hot water tanks and behind the gas dryers.

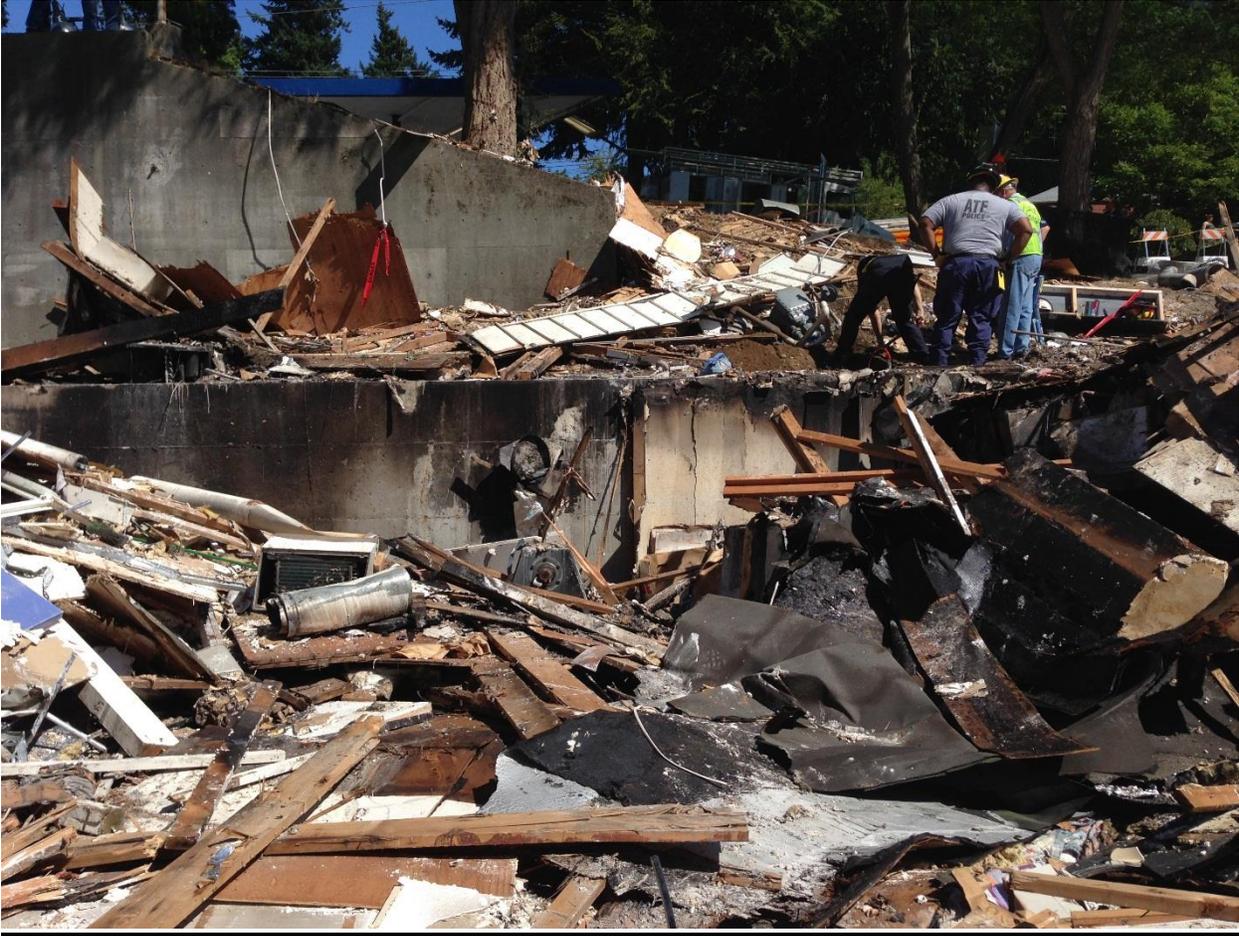
Photo 20: Looking SE at what is left of laundry room from first floor. Note fire discoloration on walls and how it increases moving away from laundry. This is an indicator of where fire started.

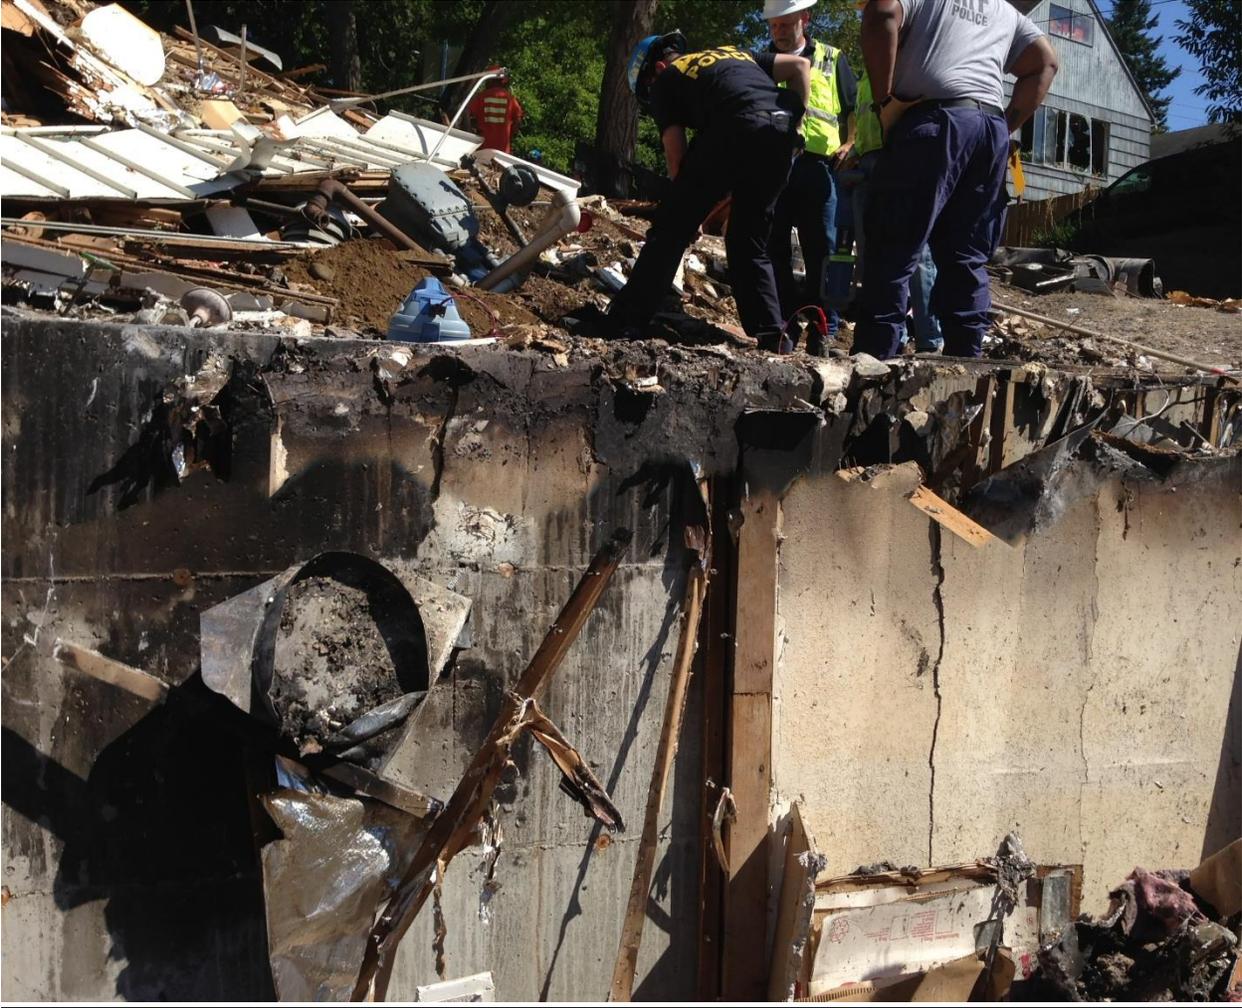
Photo 21: Looking SE at retaining wall at laundry room from first floor. Vertical two by four stud is what's left of a wall separating the washing machine room on the left and the dryer/hot water tanks on the right. Note how burn/soot marks increase away from dryer/hot water tank location.

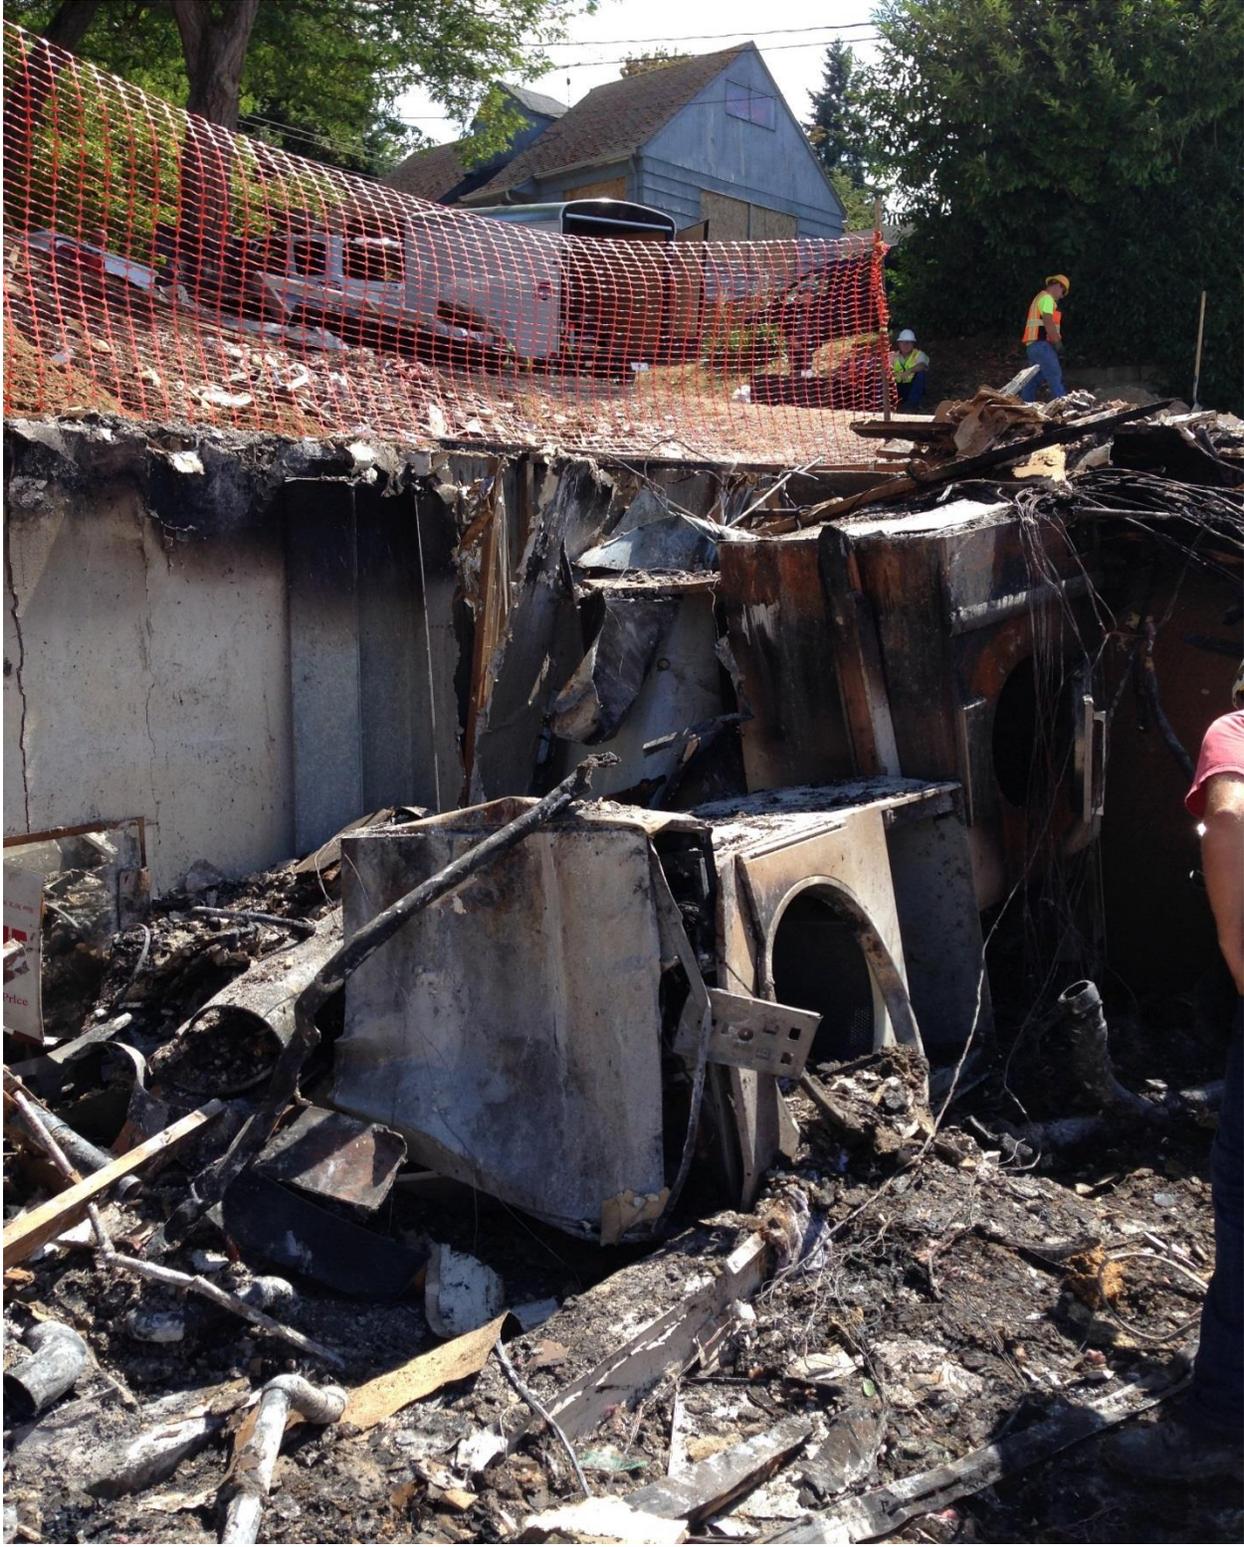
Photo 22: Looking SE at two industrial gas dryers from first floor. The one in foreground is laying on its side having been pushed down and over from the top (explosion is thought to have originated above this dryer).

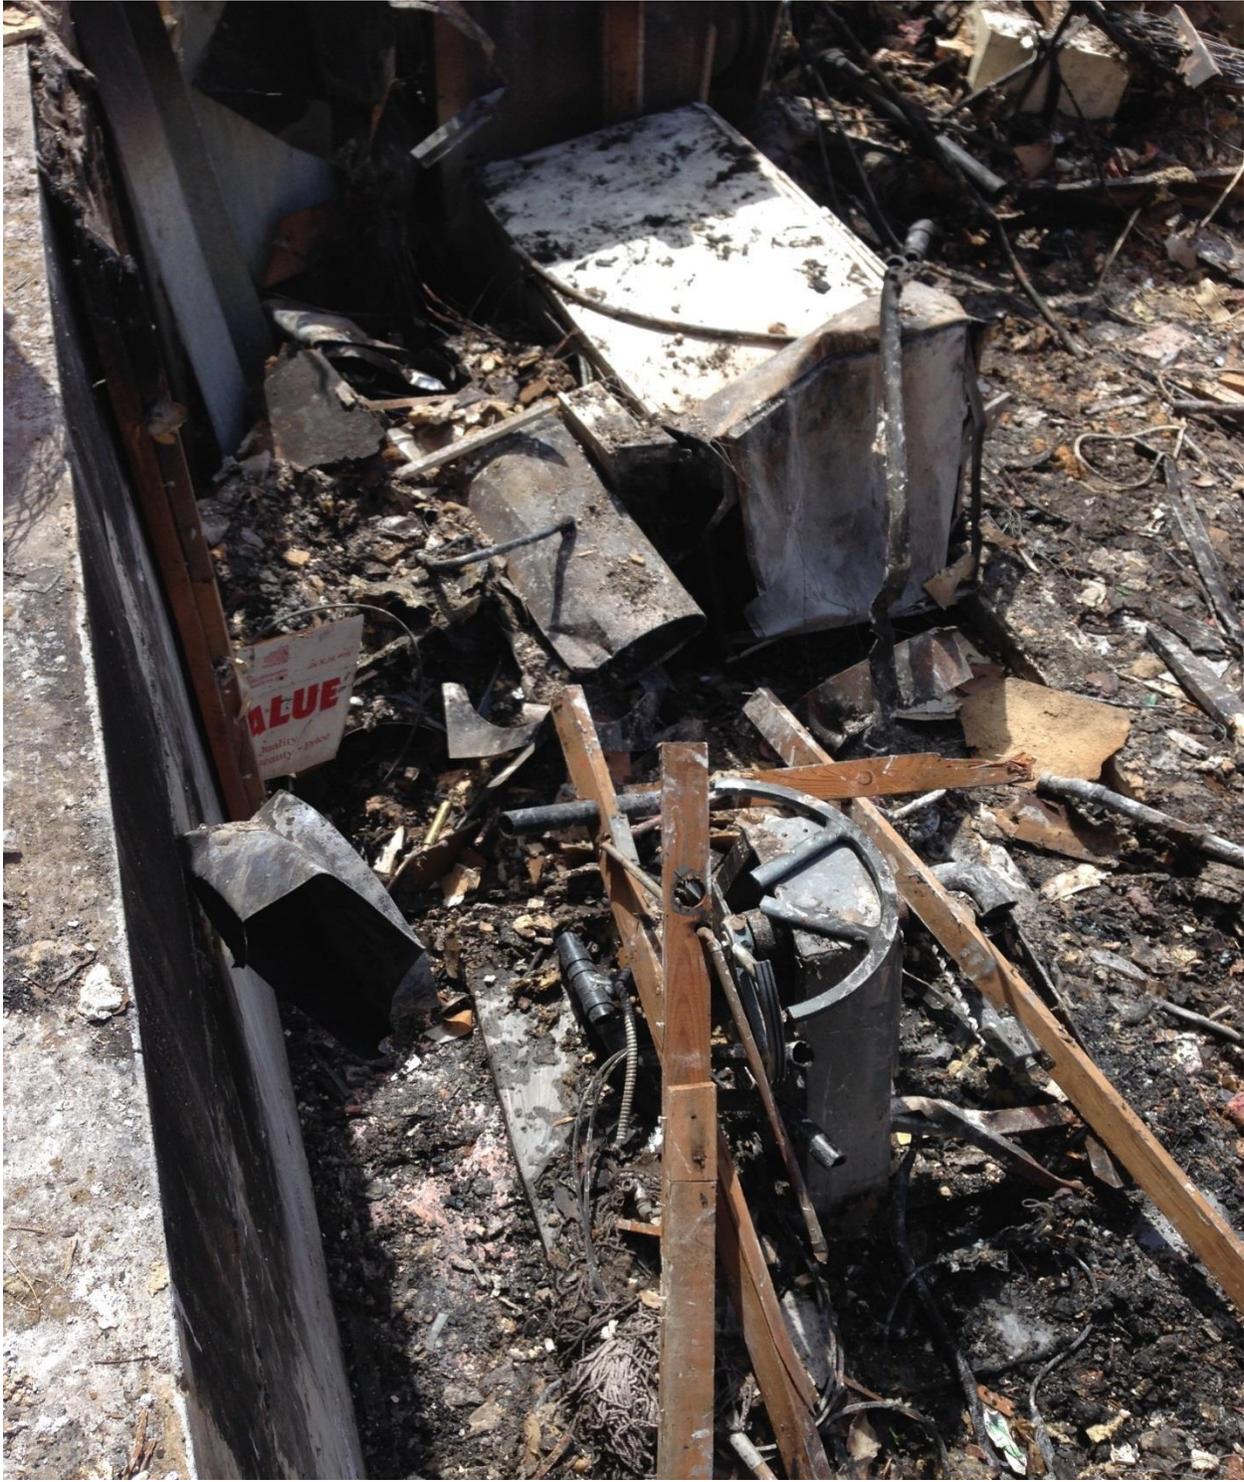
Photo 23: Looking South at remnants of industrial washing machine with gas dryers in background. Two by four studs are part of wall between dryers and washing machine. It is believe the explosion originated immediately above these appliances in this room.

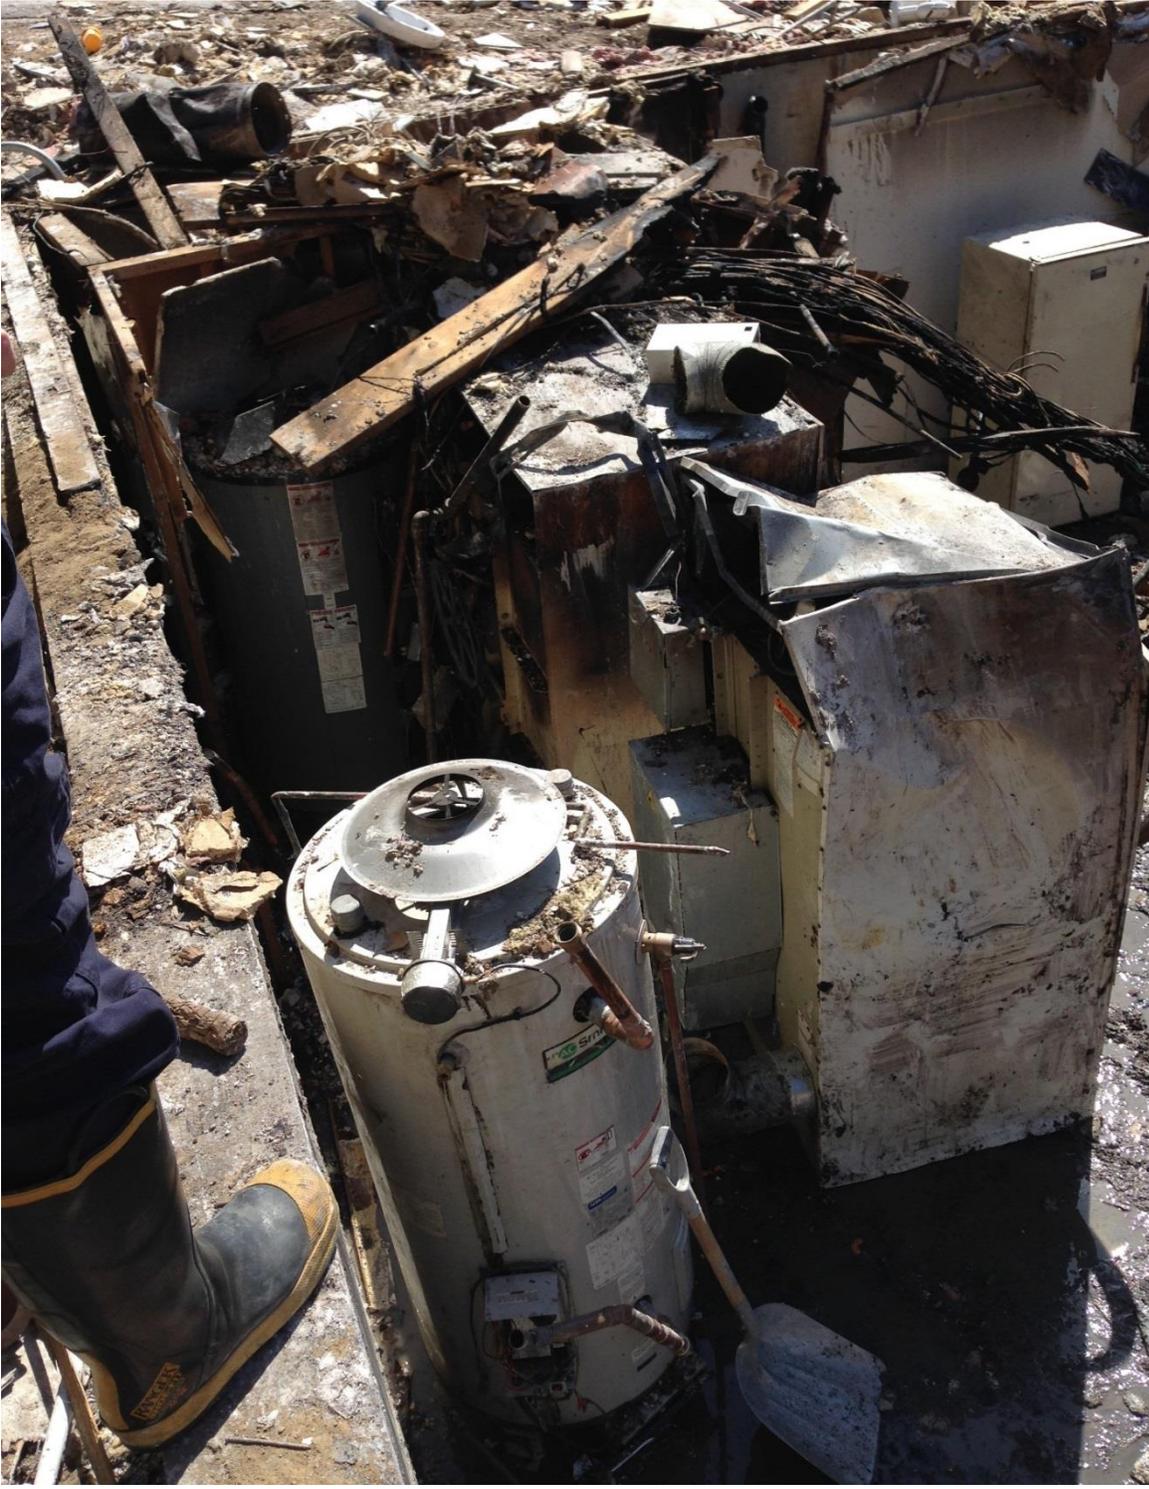
Photo 24: Looking South at one of two hot water tanks in foreground and two gas dryer behind after significant debris removal. Dryer has been set upright. Note how dryer top and side are pushed in.

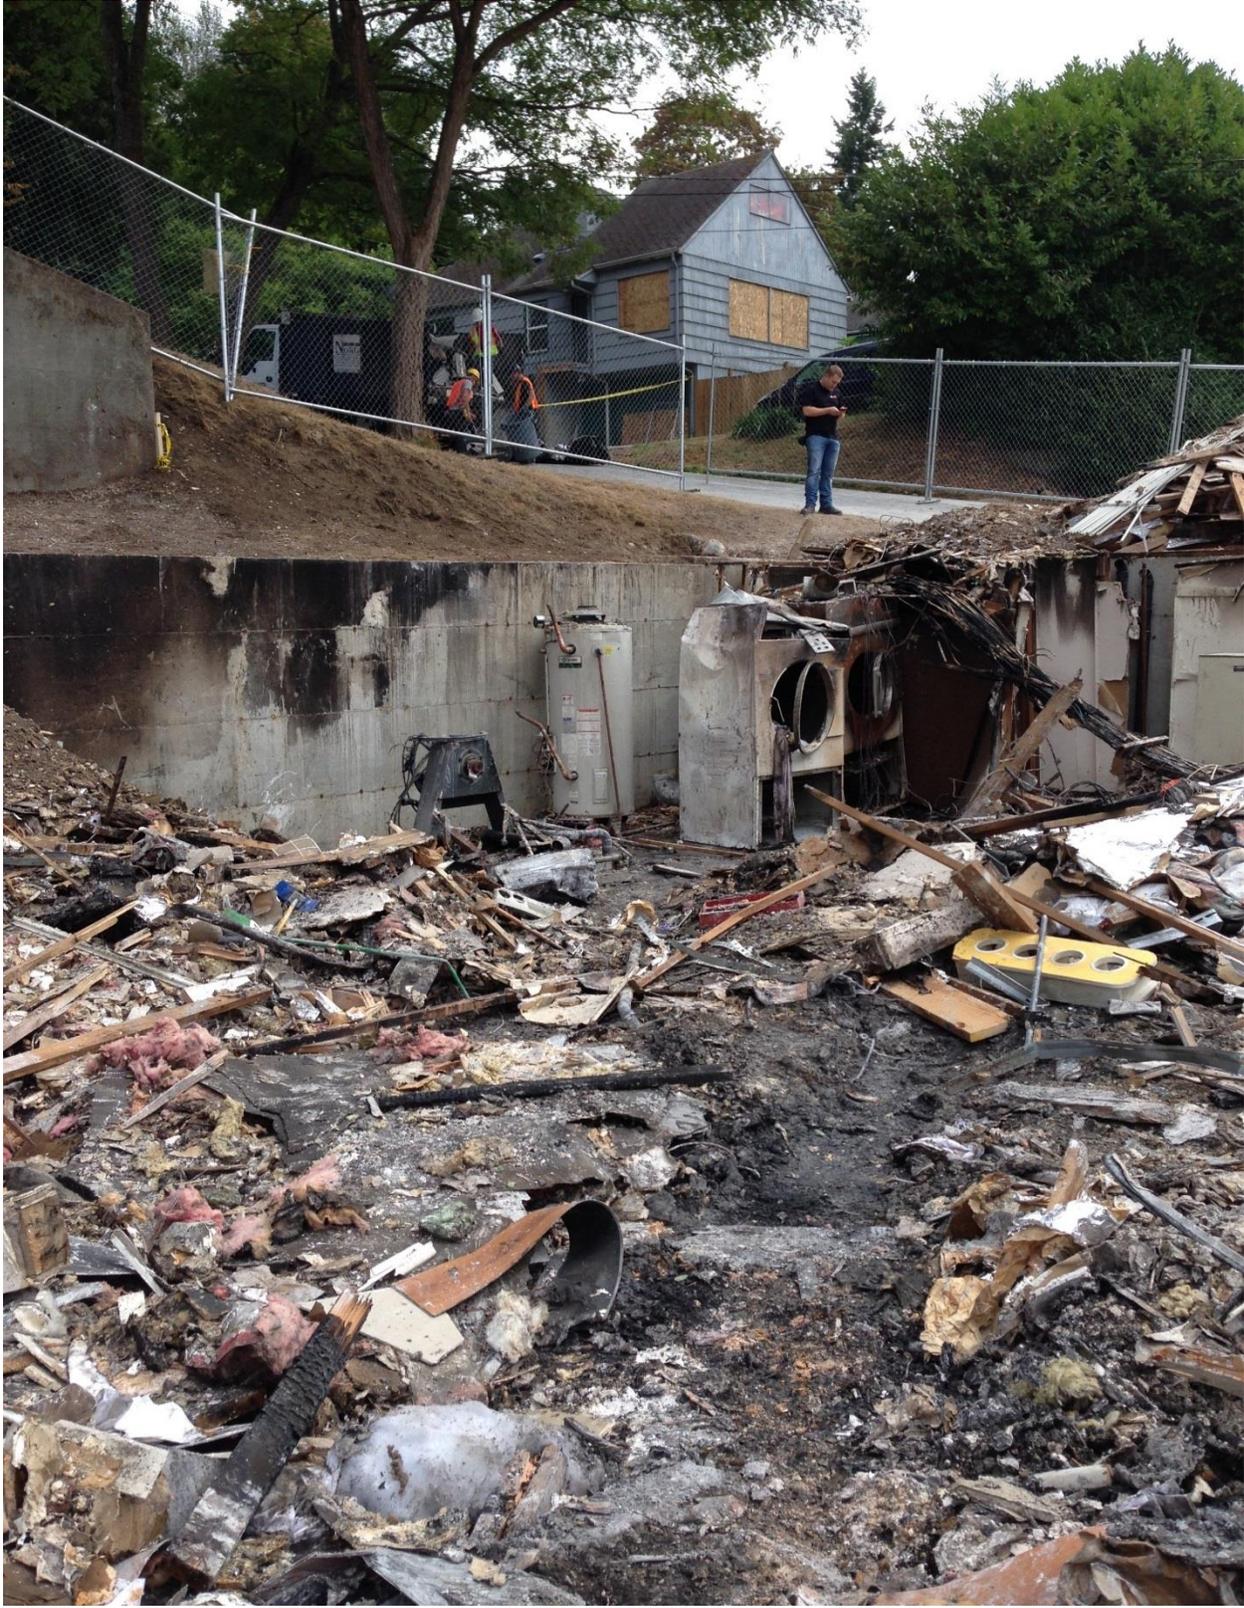
Photo 25: Looking east from first floor at laundry room after significant debris removal. Washing machine on left, hot water tank and two dryers on the right. This is approximately the location of these appliances prior to explosion.

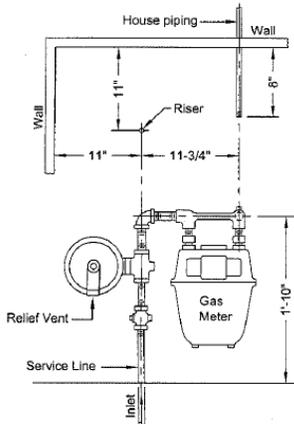
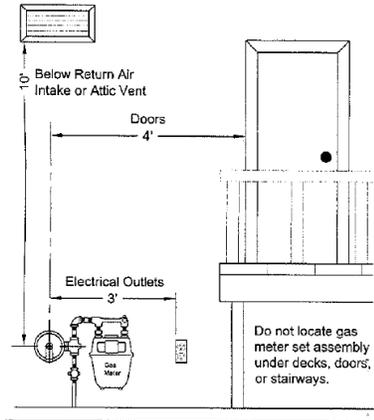
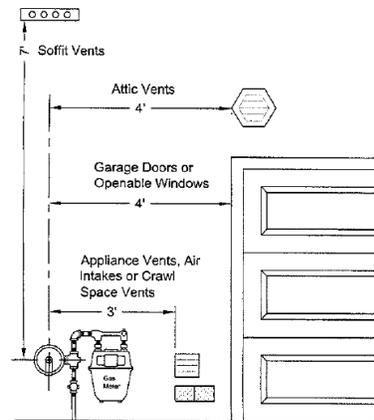
Figure 5: New Construction Service Requirements (CNG pamphlet from 2002) showing clearances from building openings to meter and regulator vent
