UTILITIES AND TRANSPORTATION COMMISSION

**RE: Natural Gas Incident Investigation: 3400 11th Street, Bremerton, Washington
– August 18, 2015 (Insp. No. 6542)**

UTC Incident Investigation Form

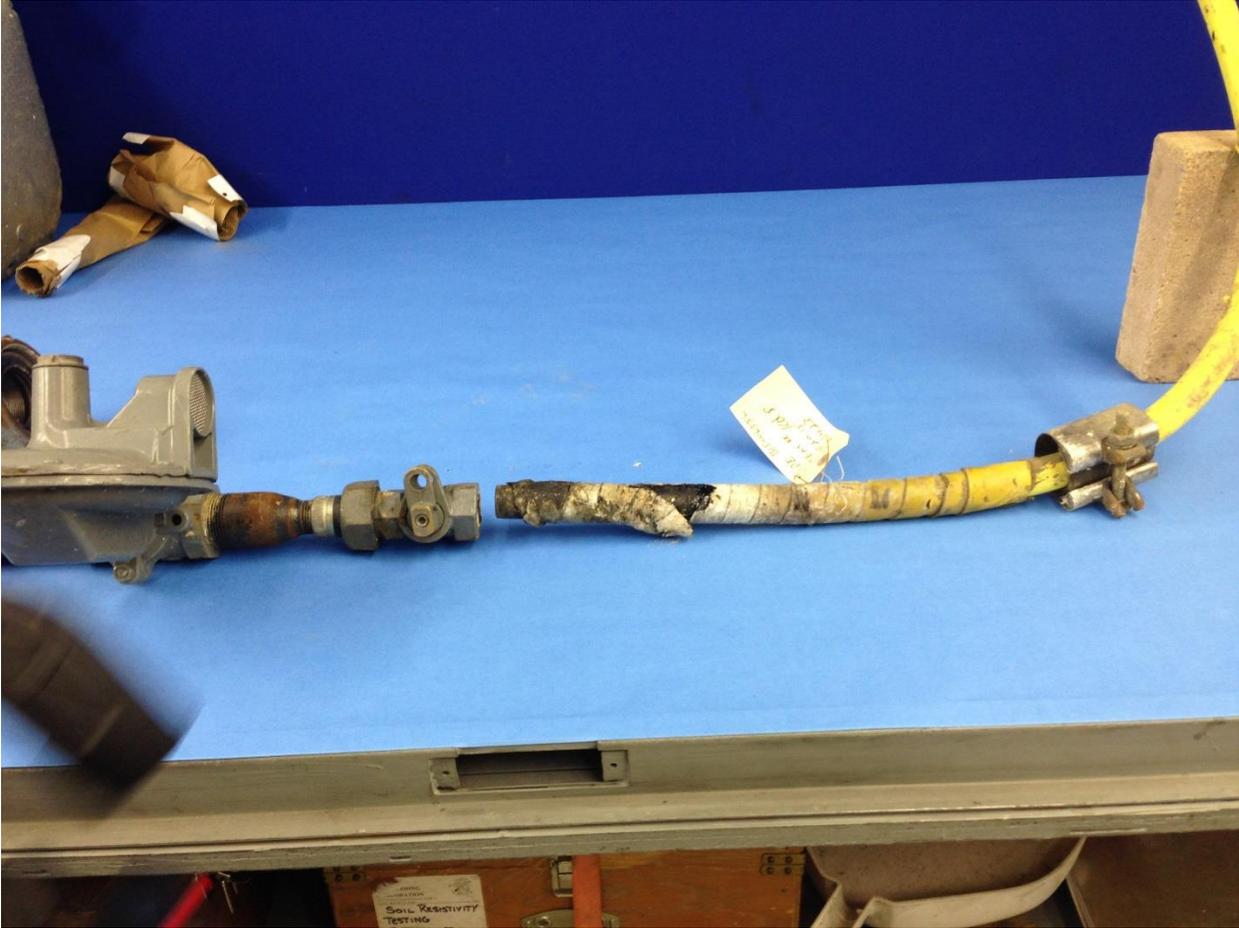
Photo 26: Riser pipe and valve assembly as set up at Case Forensics. Photo depicts relative alignment of assembly to the left and riser pipe to the right in the positions prior to explosion.

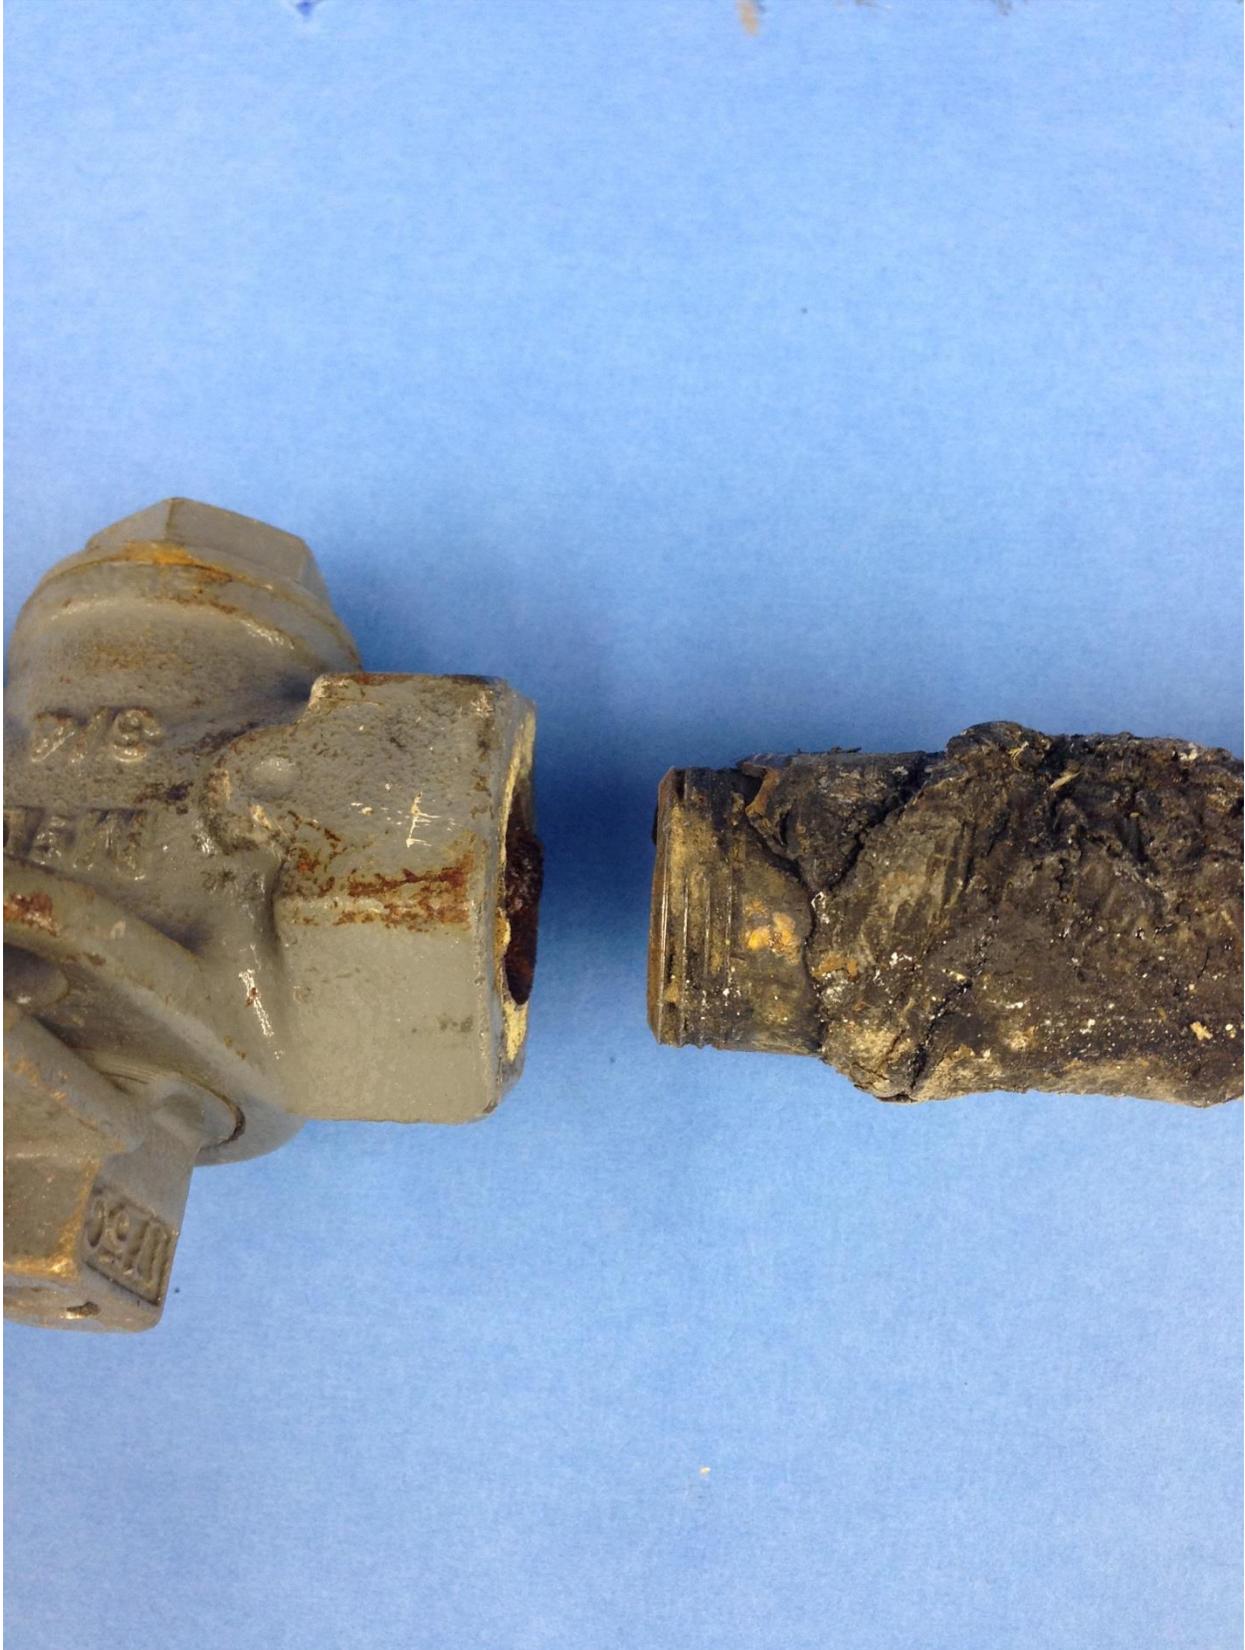
Photo 27: Close up of meter valve nut to the left and riser pipe to the right. Pieces are positionally accurate as laid out at Case Forensics.

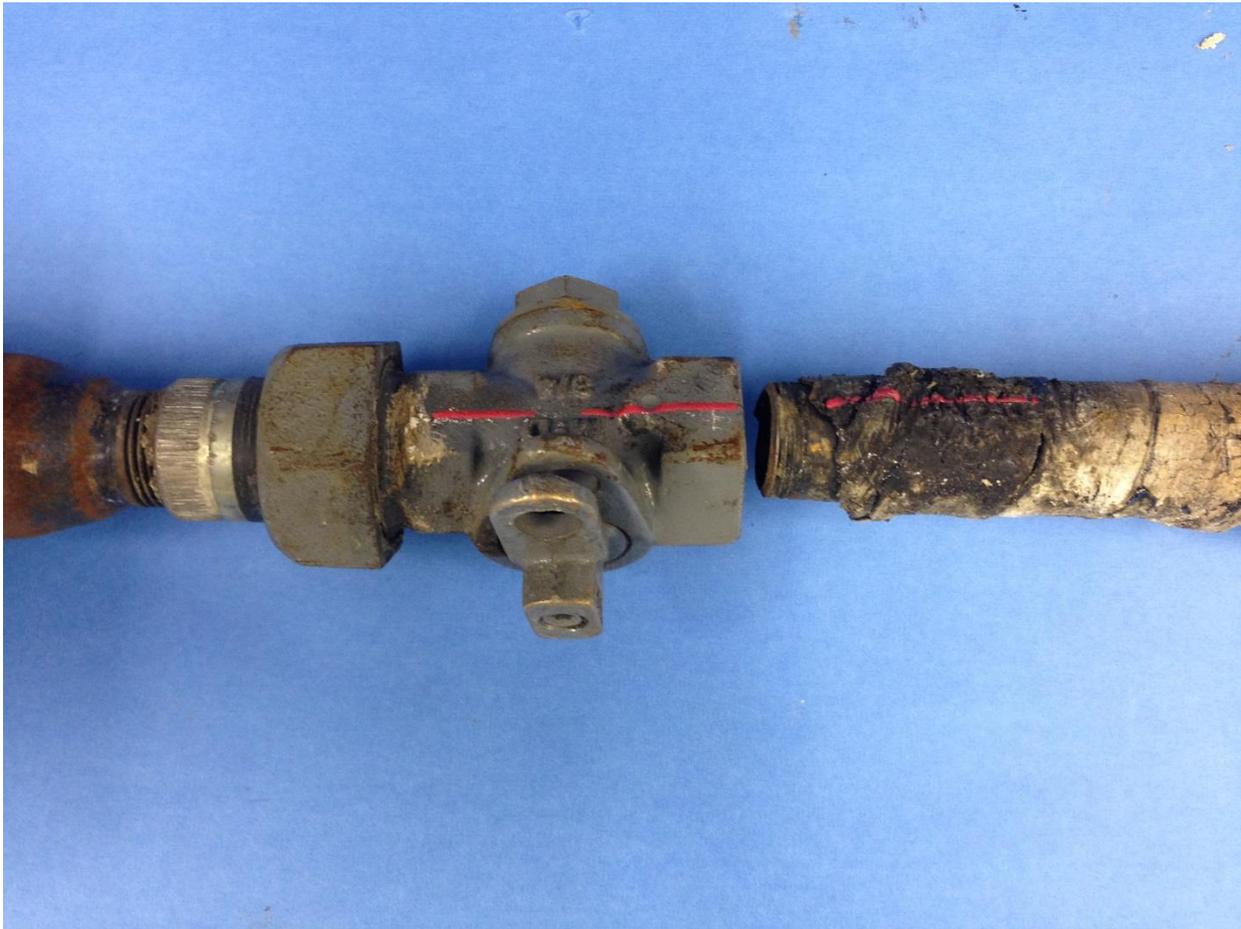
Photo 28: Case Forensics photo of meter valve assembly to the left and riser pipe to the right with an orientation line drawing between the two to allow for positional orientation in subsequent photos.

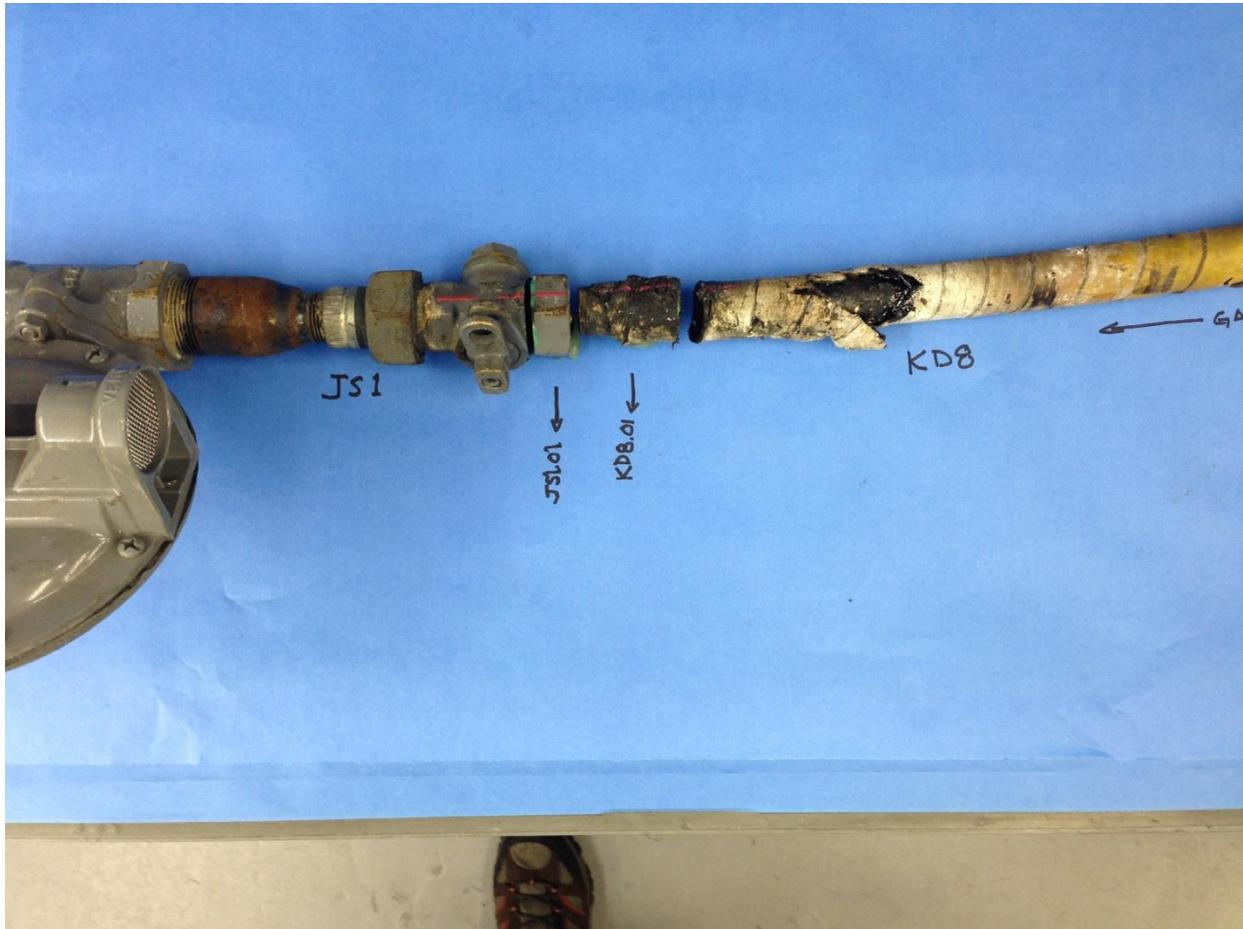
Photo 29: Relative position of cuts to valve nut and top of riser pipe. These pieces were subsequently analyzed in more detail to determine fracture mechanics.

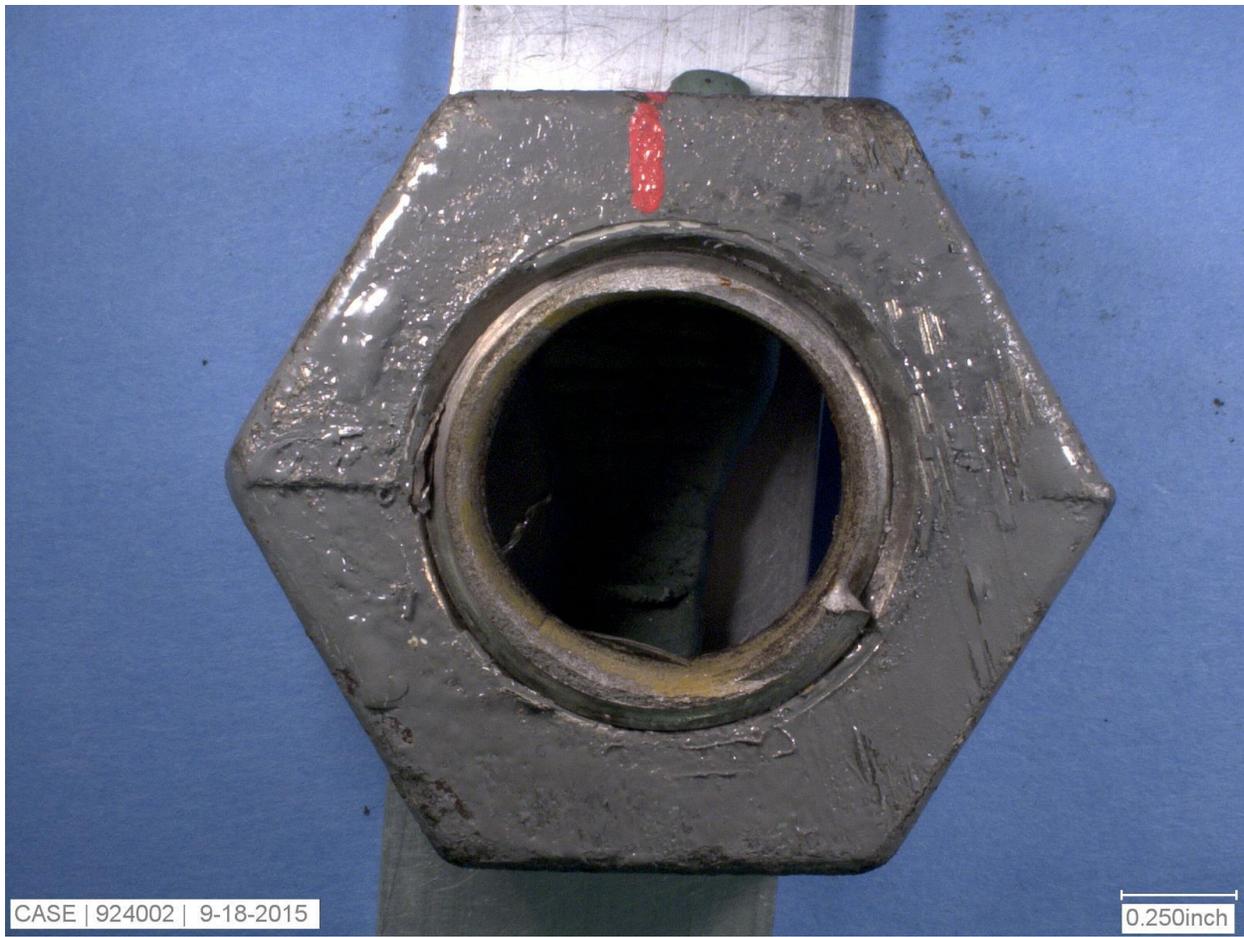
Photo 30: Case Forensics photo showing cleaned riser valve nut with sheared off riser pipe still threaded inside. Note “notch” portion of pipe to the lower right. Red orientation line references line is previous photos.

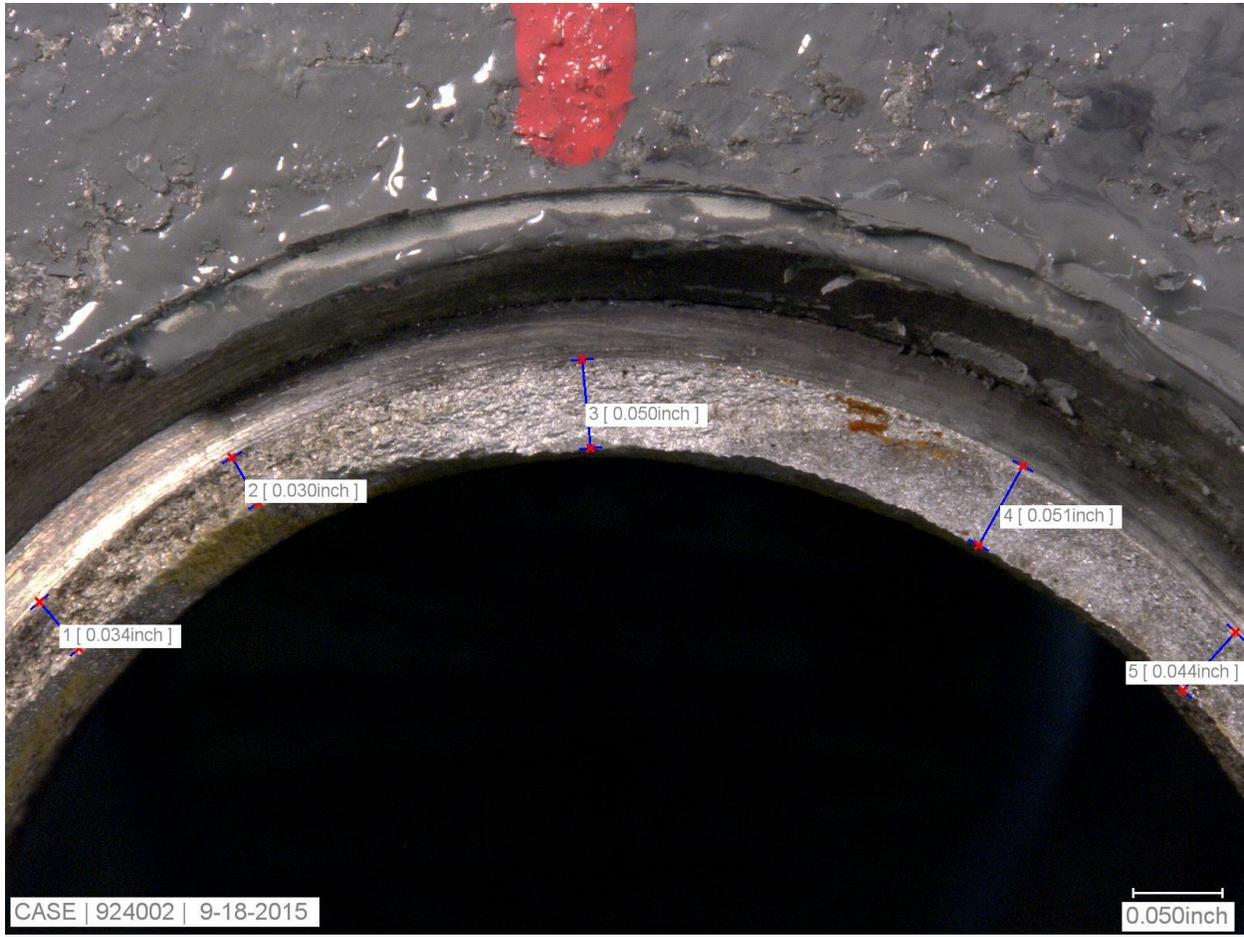
Photo 31: Case Forensics photo (cleaned) showing remaining wall thickness of threaded riser pipe. Wall thickness narrows as steel yields (stretches) to the outside force in a ductile manner (non brittle). Eventually it reached a critical point and snapped (tensile point). Case believes break initiated at 10 o'clock position. Note red orientation mark to align with layout on Photo 28.

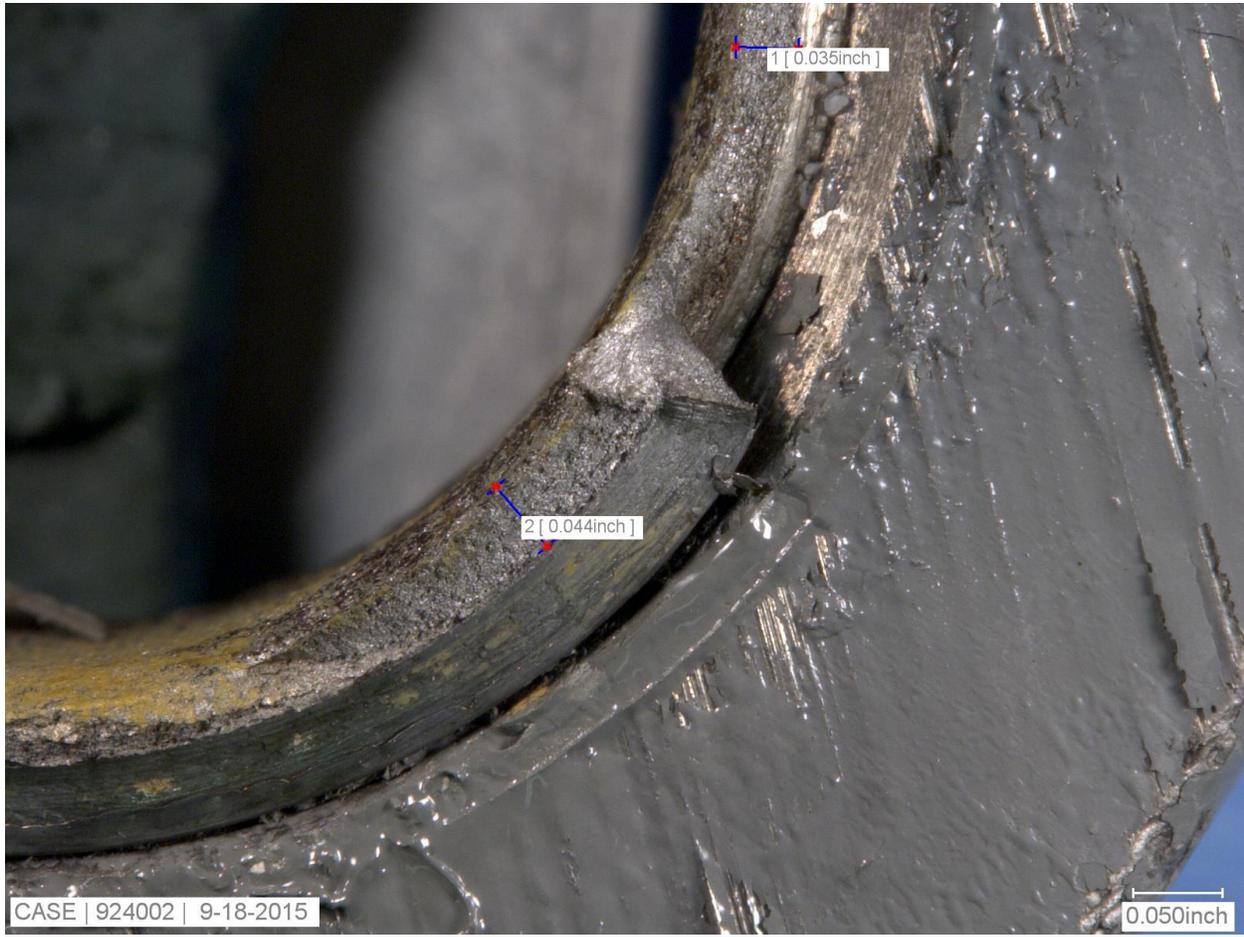
Photo 32: Case Forensics photo (cleaned) showing the area where original break propagation may have cracked pipe but did not separate. The jagged notch is where the blast simply tore off the remaining steel of the riser pipe.

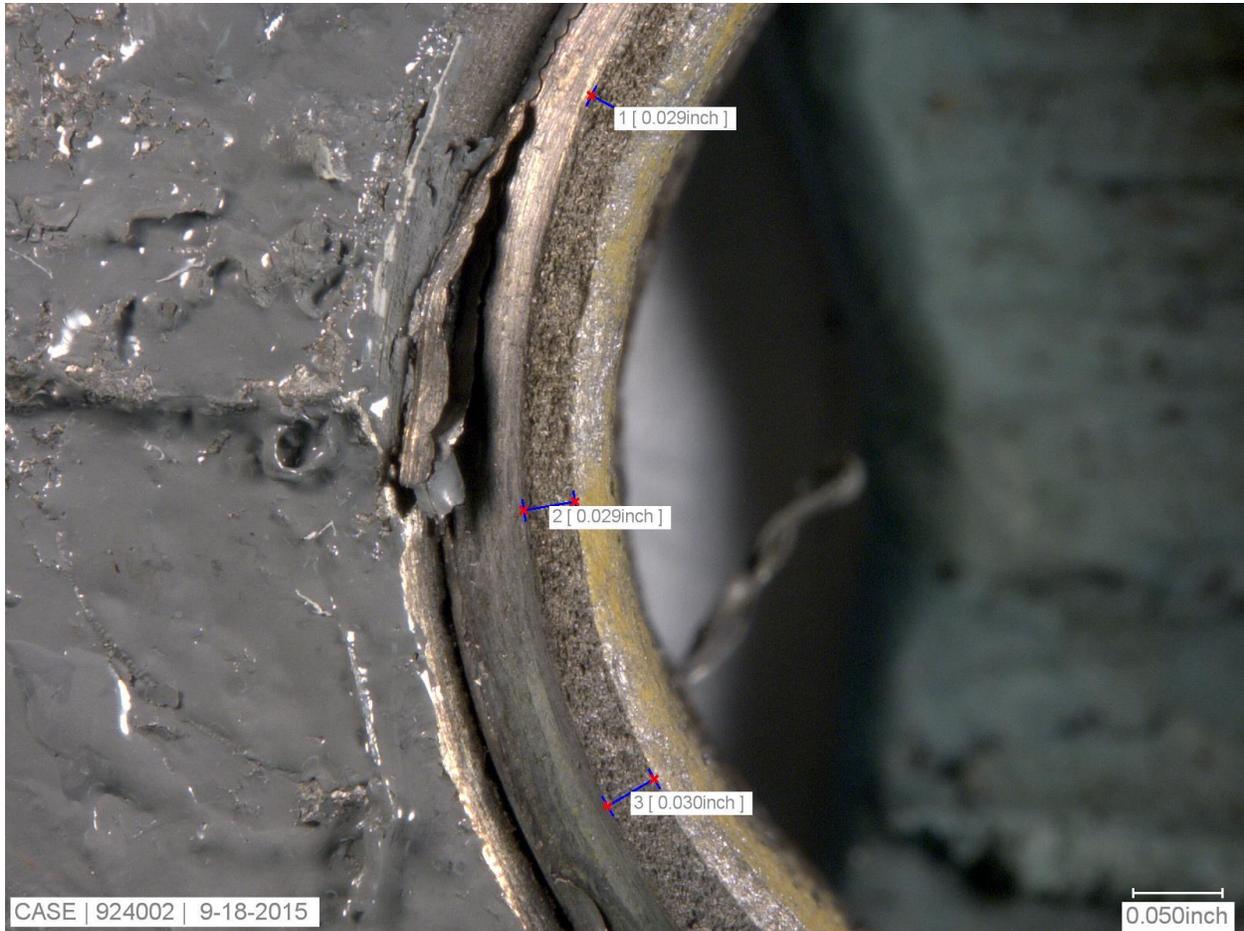
Case Forensics, Seattle WA (Case) did a failure analysis on the ¾-inch steel riser pipe for the Bremerton FD and the Bureau of Alcohol, Tobacco, Firearms and Explosives (ATF). Bremerton FD called in the ATF to assist with the explosion investigation. The meter and riser pipe were taken from the Bremerton Police Department Impound Room and delivered to Case. Case then laid out the pieces on a table and aligned them (**photos 26-28**). Case then cut the meter valve nut away from the rest of the meter assembly as well as the top section of the riser pipe from the remaining piece for handling purposes (**photo 29**). The preliminary results (the final report has not been released due to a criminal investigation) of the analysis showed a ductile failure (the metal stretched until reaching its maximum tensile strength and then failed versus a brittle failure where little or no stretching occurs) (**photos 31-33**). The minimum wall thickness was measured at 0.029 inches (**photo 33**). This would be consistent

Photo 33: Case Forensics photo (cleaned) showing remaining wall thickness of threaded riser pipe. Wall thickness narrows as steel yields (stretches) to the outside force in a ductile manner (non brittle). Eventually it reached a critical point and snapped (tensile point). Case believes break initiated at 10 o'clock position-0.029" is narrowest measured thickness at approximately 10 o'clock position.

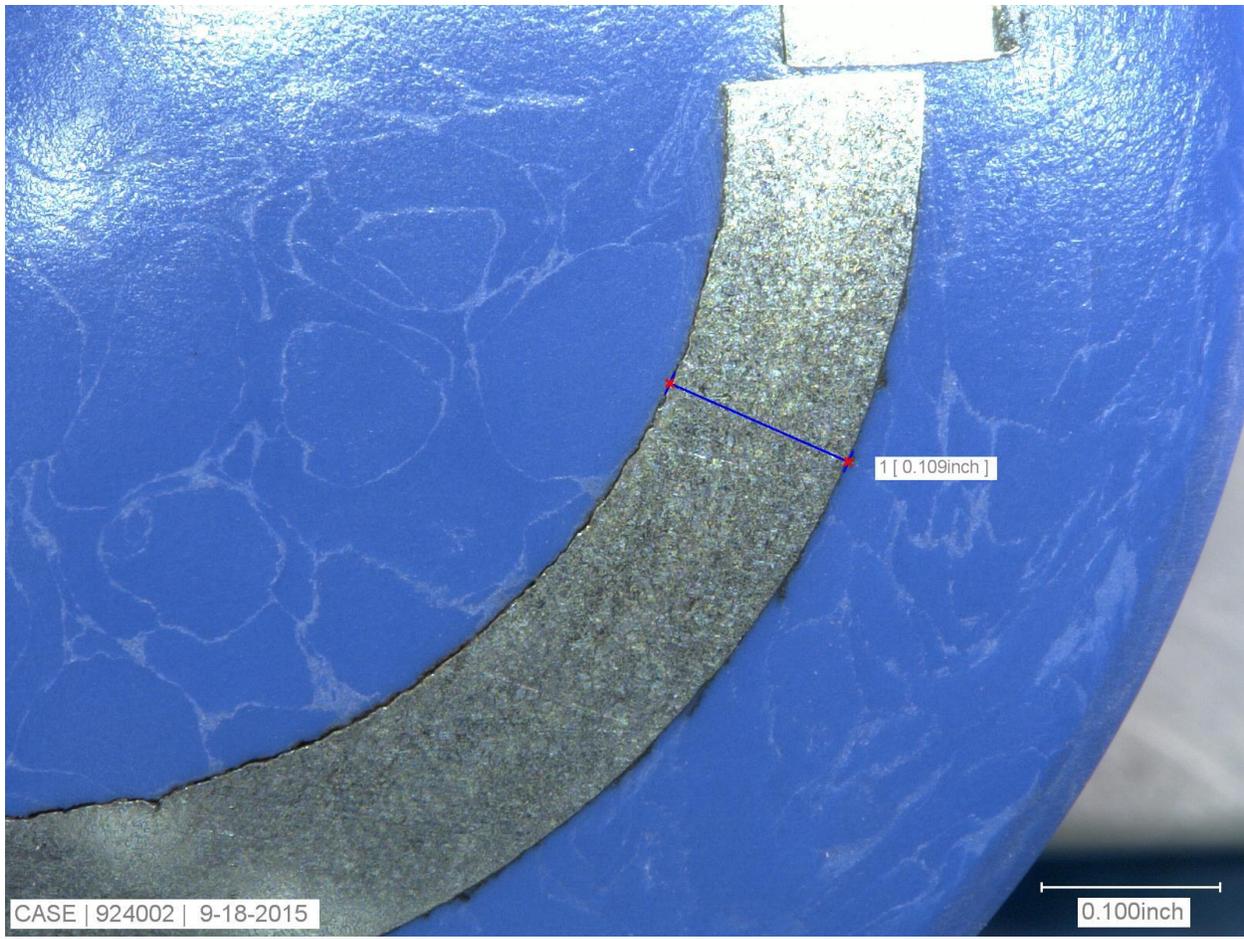
Photo 34: Case Forensics photo showing wall thickness of riser pipe. Nominal wall thickness for standard Class B pipe is 0.113 inches with a minimum of 0.0991 inches.

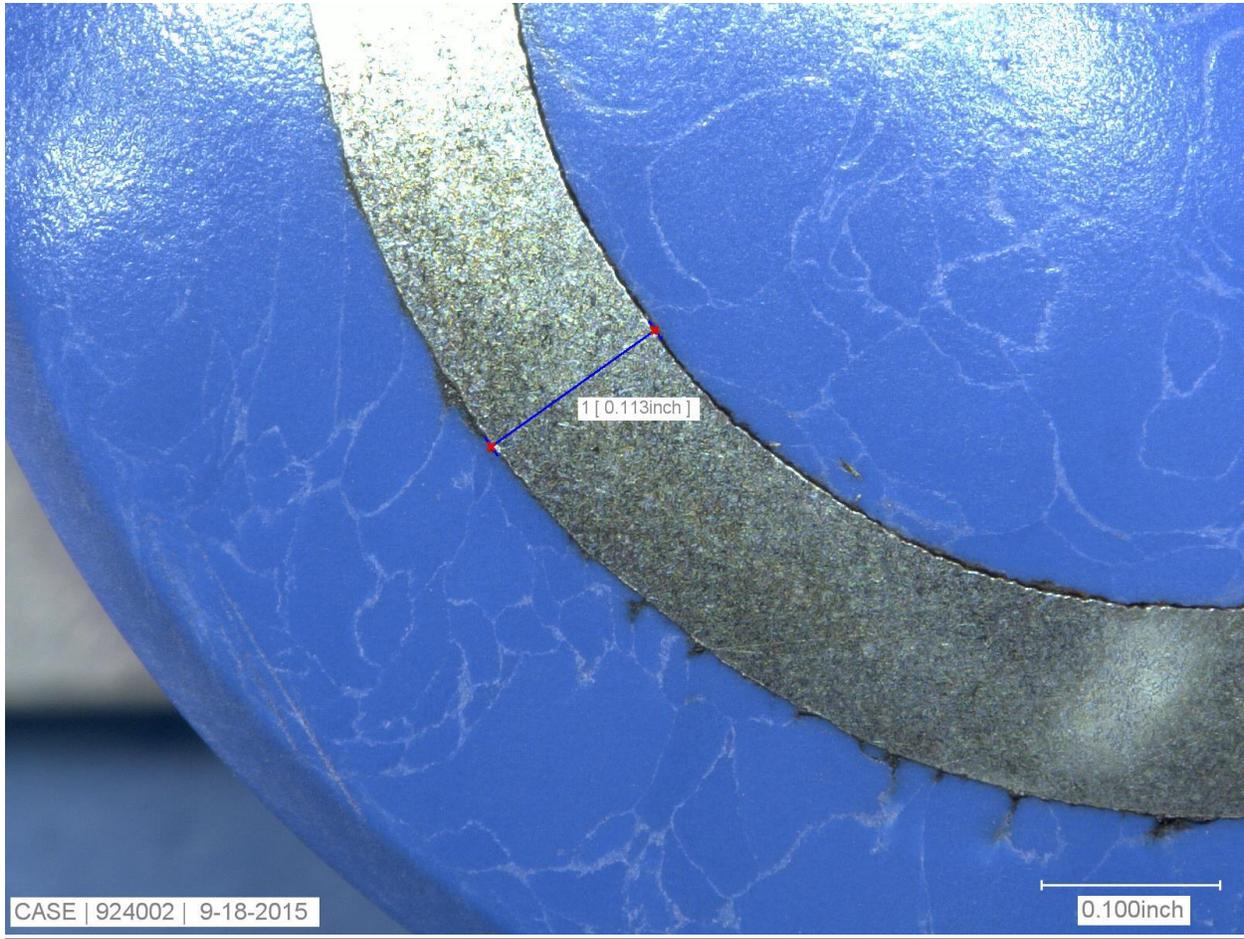
Photo 35: Case Forensics photo showing wall thickness of riser pipe. Nominal wall thickness for standard Class B pipe is 0.113 inches.

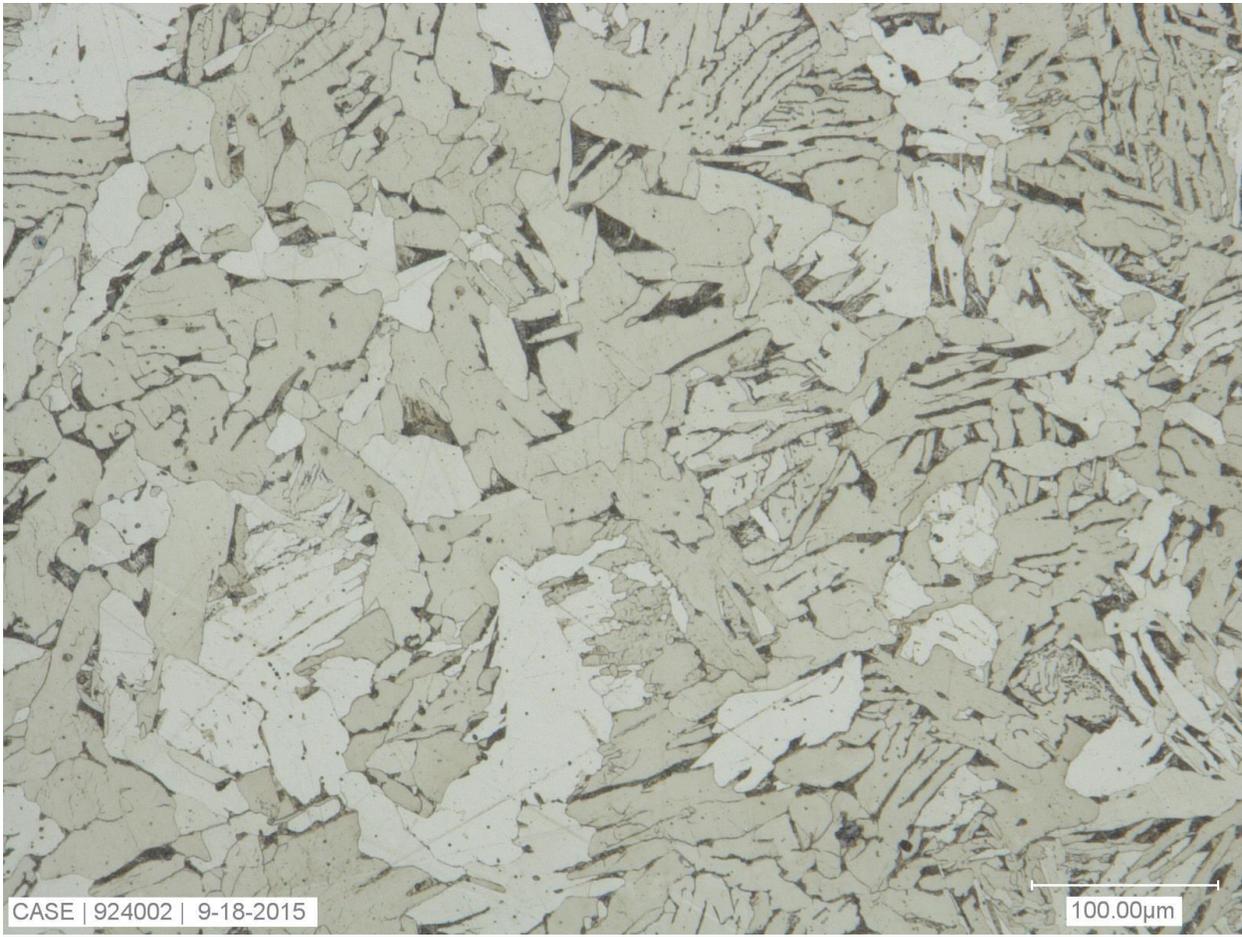
Photo 36: Case Forensics scanning electron microscope image showing grain structure of steel in riser pipe near break location. Image shows normal crystalline structure for steel. No indications of abnormal conditions.

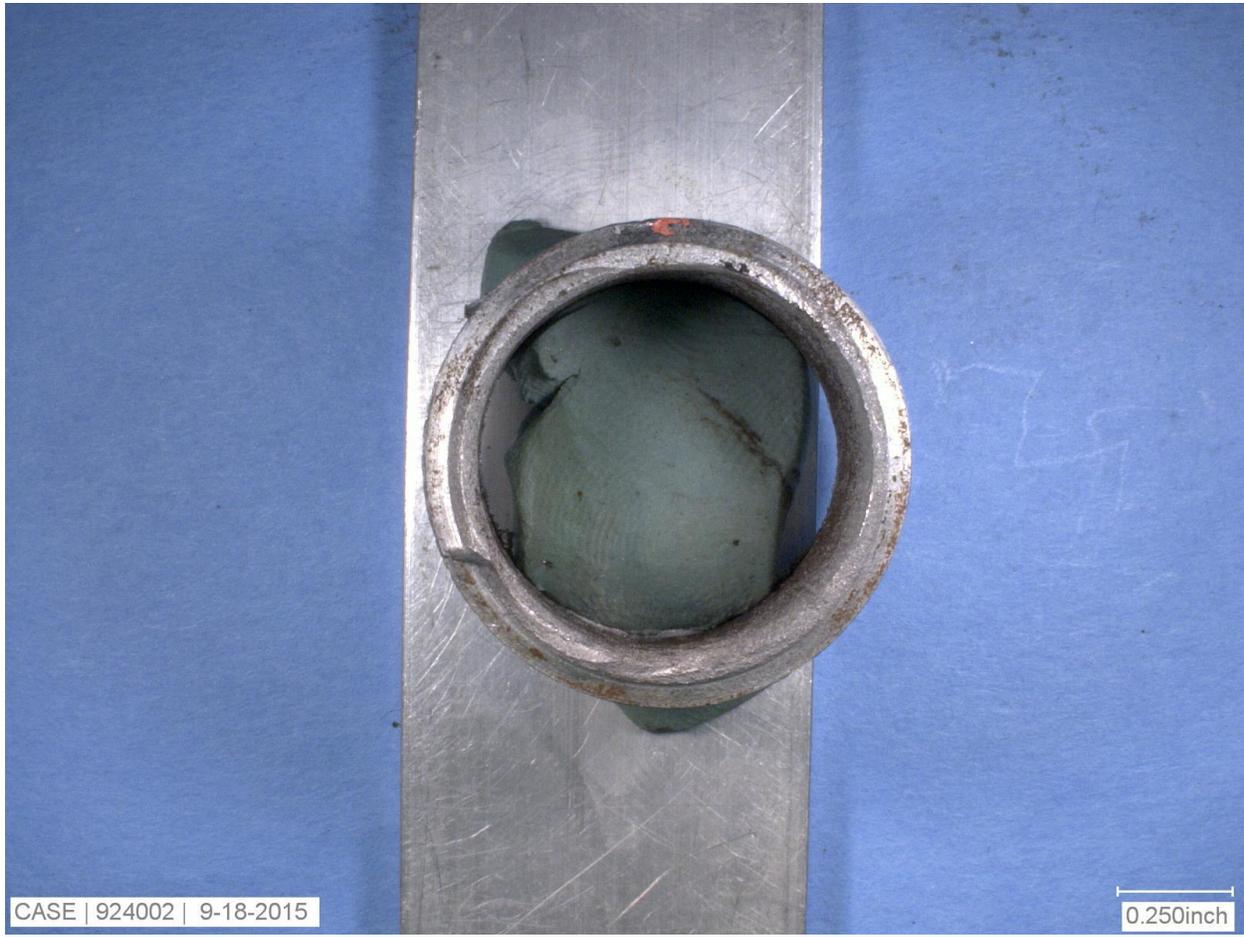
Photo 37: Case Forensics photo (cleaned) of riser pipe section remaining in ground after meter assembly was torn off by explosion. Note red orientation line. Notched section on lower left aligns with notched section on remaining riser in valve nut shown on photo 30.

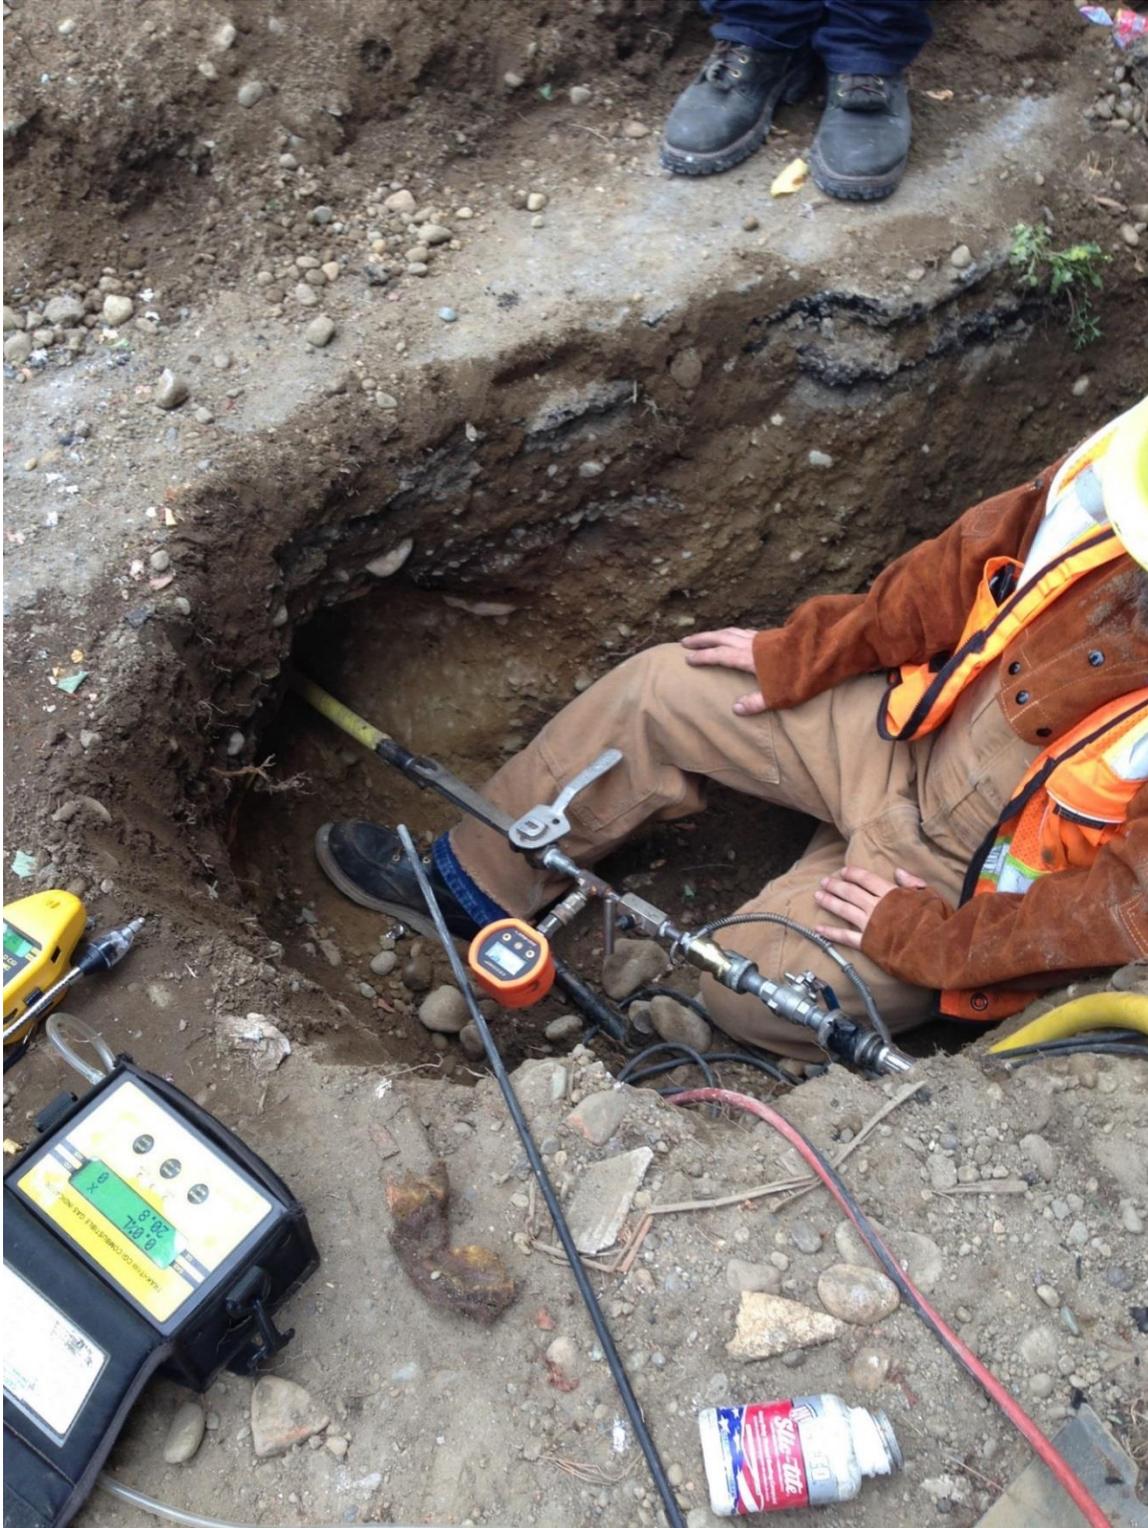
CNG performed a leak test (**photos 38, 39**) on the existing service line to ensure a leak in the line was not a cause or contributor to the incident. Due to the Bremerton FD/ATF investigation, this test did not occur until Thursday, 8/20/15. The plan was to test the line in-situ to ensure minimal disturbance of the pipe and surroundings soils. The service line was plugged on each end and compressed air introduced into the pipe. The pressure was increased up to the CNG operating pressure prior to the incident of 56 psi. The air test was successful-55.9 psi held for 30 minutes

Photo 38: Pressure testing of service line. Looking east at end of service line at the 2" main on 11th St. Pressure test was held at operating pressure of 56 psi for 30 minutes with compressed air.

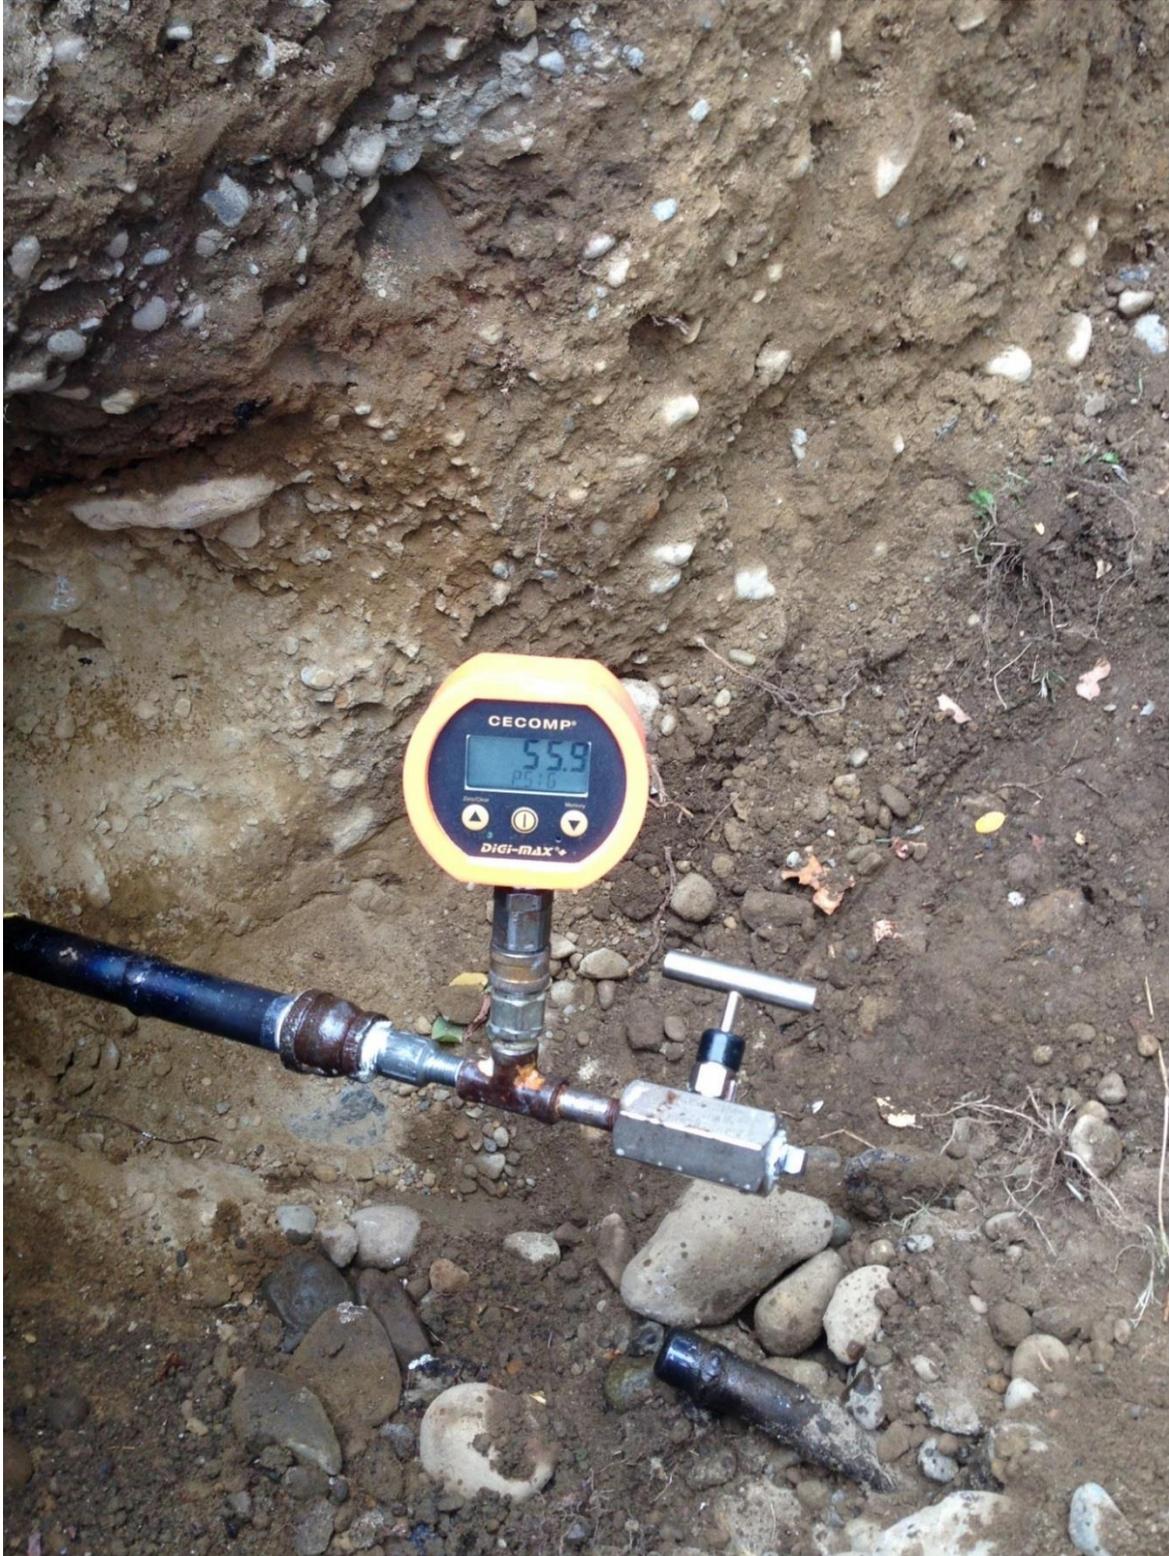
There were no leaks in the service line below ground which contributed gas to the explosion.

Photo 39: Pressure testing of service line. Looking east at end of service line on 11th St. Pressure test was held at operating pressure of 56 psi (55.9) for 30 minutes with compressed air.
