**POST INSPECTION MEMORANDUM**

**Operator Inspected:** **OPID: 15014** **Region:** Western  
Gas Transmission Northwest LLC  
U.S. Western Pipe Region  
1400 SW 5<sup>th</sup> Ave  
Suite 900  
Portland, OR 97201

**Unit Inspected:** Rosalia District **Unit ID:** 66685  
**Unit Type:** Interstate Natural Gas  
**Inspection Type:** 3/14/2013 Leak Investigation - NRC #1041089  
**Record Location:** Spokane, WA  
**Inspection Dates:** March 19 – 21, 2013  
**AFOD:** 3  
**SMART Activity Number:**

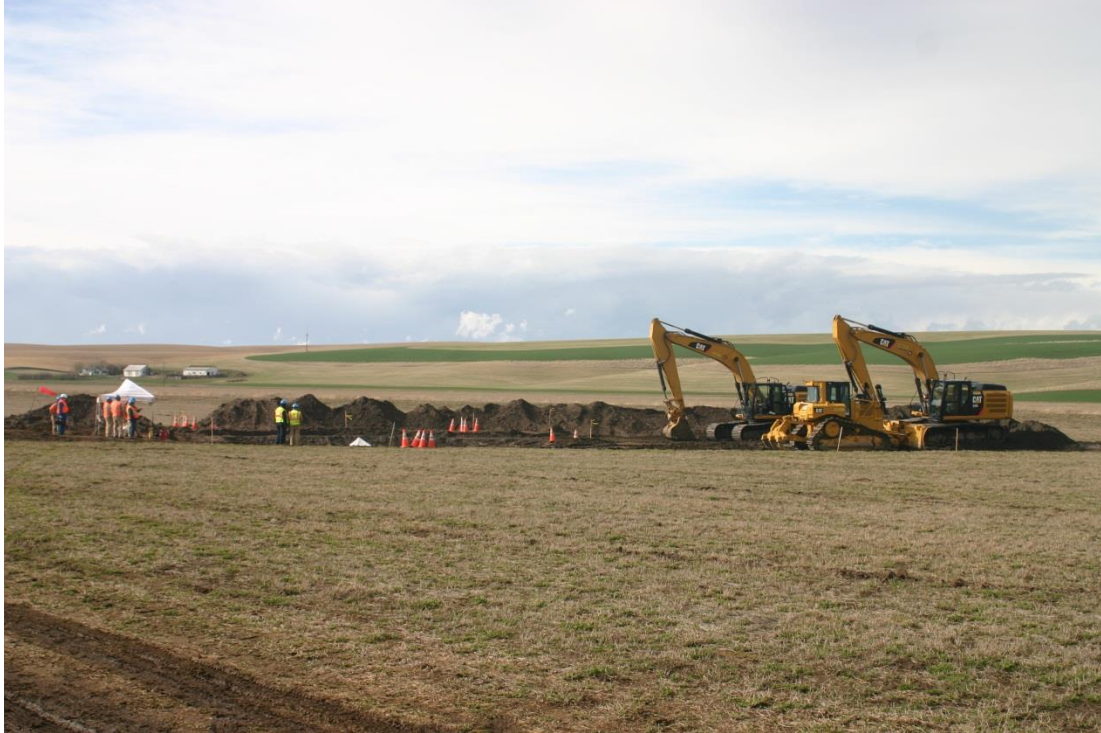
**Facilities Inspected:**  
The portion of the District where the leak was discovered on the 42-inch diameter pipeline (B-Line) is located in Whitman County about 4 miles NW of La Crosse, WA. The leak is about 2,050 feet from the nearest house and 1,300 feet from Union Flat Creek Road (County Rd

Photo A: Site location of leak on 42-inch Gas Transmission Northwest LLC pipeline, La Crosse, WA  
Photo taken by Al Jones / UTC, March 20, 2013

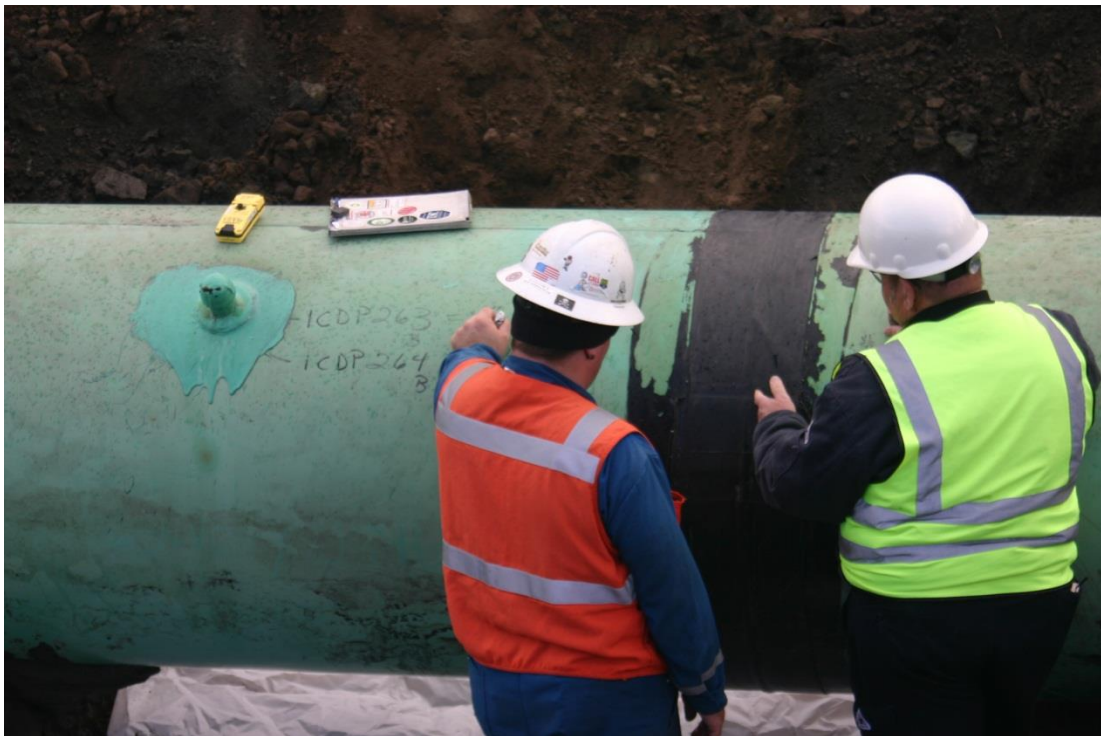
Photo B: 42-inch Gas Transmission Northwest LLC pipeline at threaded cap fitting.  
Photo taken by Al Jones / UTC, March 20, 2013

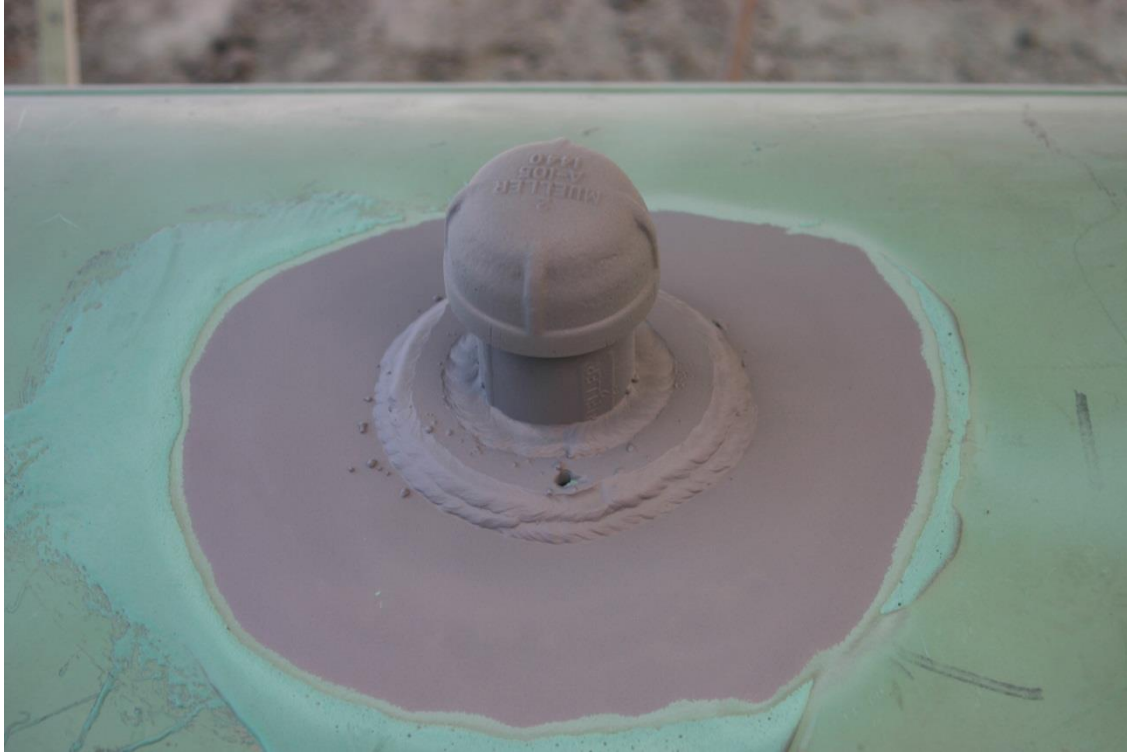
#6010) (See photo A, below). The leak is located at Lat. 46.855857 and Long. -117.809636. The leak was discovered by the land owner and he called GTN because the ground over the pipeline was wet from a liquid in the pipeline. The field where the leak was located was not cultivated. The leak was at the 2-inch threaded pipe cap fitting and likely the result of the thread dope drying out. The pipe is attached to a 4-inch Mueller fitting (A-105/1440) attached to the 42-inch pipeline (See photos B & C, below). The leak was stopped by welding the cap to the 2-inch pipe. The 2-inch pipe was used as a port to purge air prior to hydro testing the pipeline. Weather permitting the line is patrolled weekly by aircraft and nothing unusual was reported. The location is about 30 miles downstream from the compressor station and near mainline valve 6-2. At the time of the leak discovery the line pressure was 860 psig (911 MAOP) and lowered to 100 psig. The pipeline upstream of the port was constructed in 1980-81 using long seam pipe and about ten years later the pipeline was extended south using spiral seam pipe (See photo D, below).

Photo C: 42-inch Gas Transmission Northwest LLC pipeline leak at threaded cap fitting with coating removed.

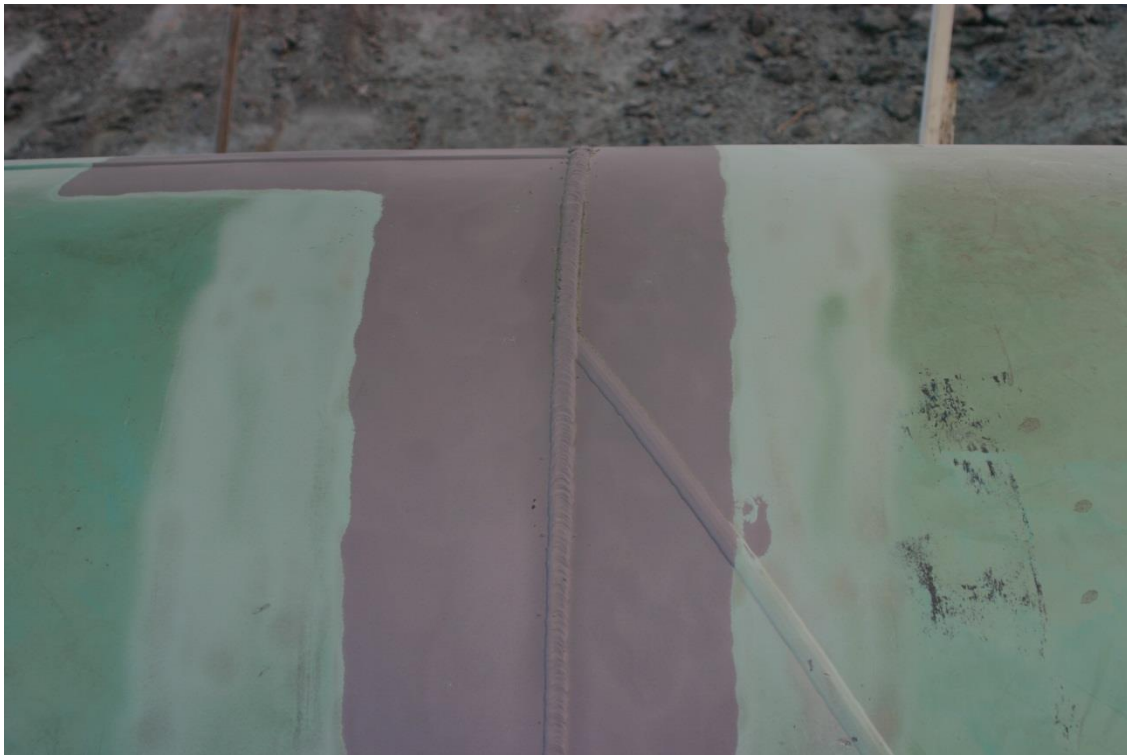
Photo D: 42-inch girth weld and transition between long and spiral seam pipe.
