UTC Incident Investigation Form

Notification ID:	3639	Investigation ID:	8155
-------------------------	------	--------------------------	------

Operator:	BP - Olympic Pipeline's (BP-OPL)
District/Unit:	Olympic Pipeline (North)
Location:	Bothell/Woodinville, Washington Mile Post 86.79 (Site 9) and Mile Post 89.84 (Site 11)

Incident Date:	2/22/2020

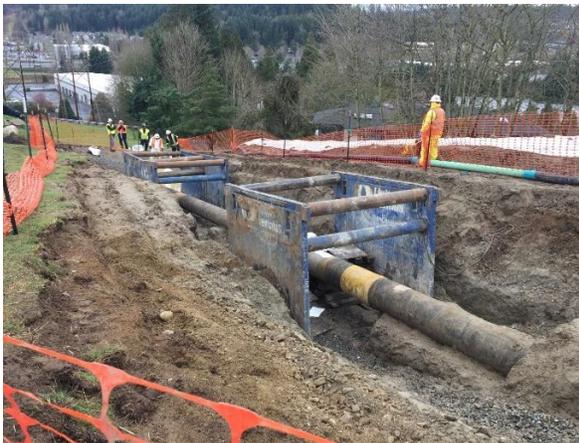
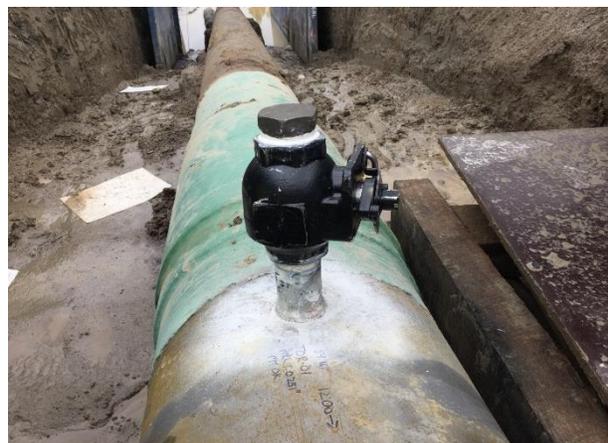
On February 23, 2020, during the assessment of both releases, product was observed seeping from the threads on the TORs. This was due to inadequate tightness on the threads during the installation. Once the pipeline reached normal operating pressures, this forced product through the threaded connection which caused the loss of primary containment."

Site 11 – Photos taken on 2/23/2020 – The TOR fitting and valve shown on the right that leaked are located in the right trench box in the center of the left image above.

The release at Site 11 was confirmed by Mike Monen indicating the 2” valve was leaking at the threads. (Source - Mike Monen 2/23/2020 interview)

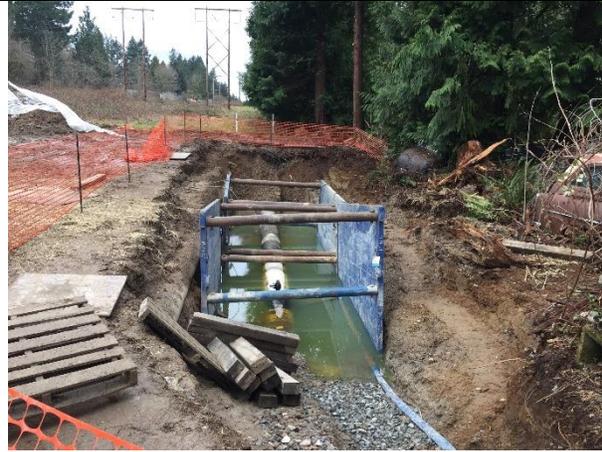
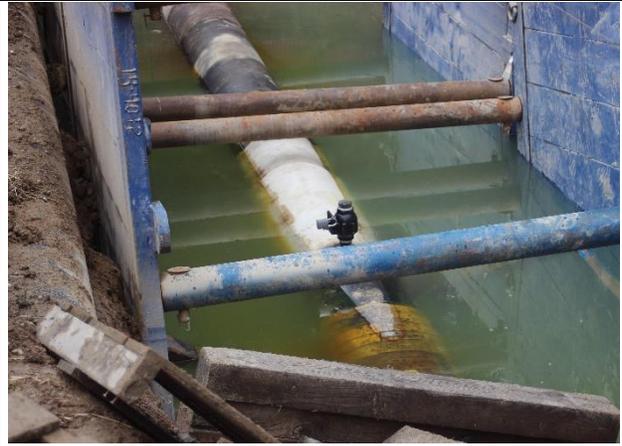
Site 9 – Photos taken on 2/23/2020 – The TOR fitting and valve shown with released product before recovery.

John Lazerini (BP-OPL) found the second fitting that was tapped leaking at Site 9. An estimated 14.7 gallons leaked from this site. (Source - Mike Monen 2/23/2020 interview)
