# UTC Incident Investigation Form

<b>Notification ID:</b>	3588	<b>Investigation ID:</b>	8112
-------------------------	------	--------------------------	------

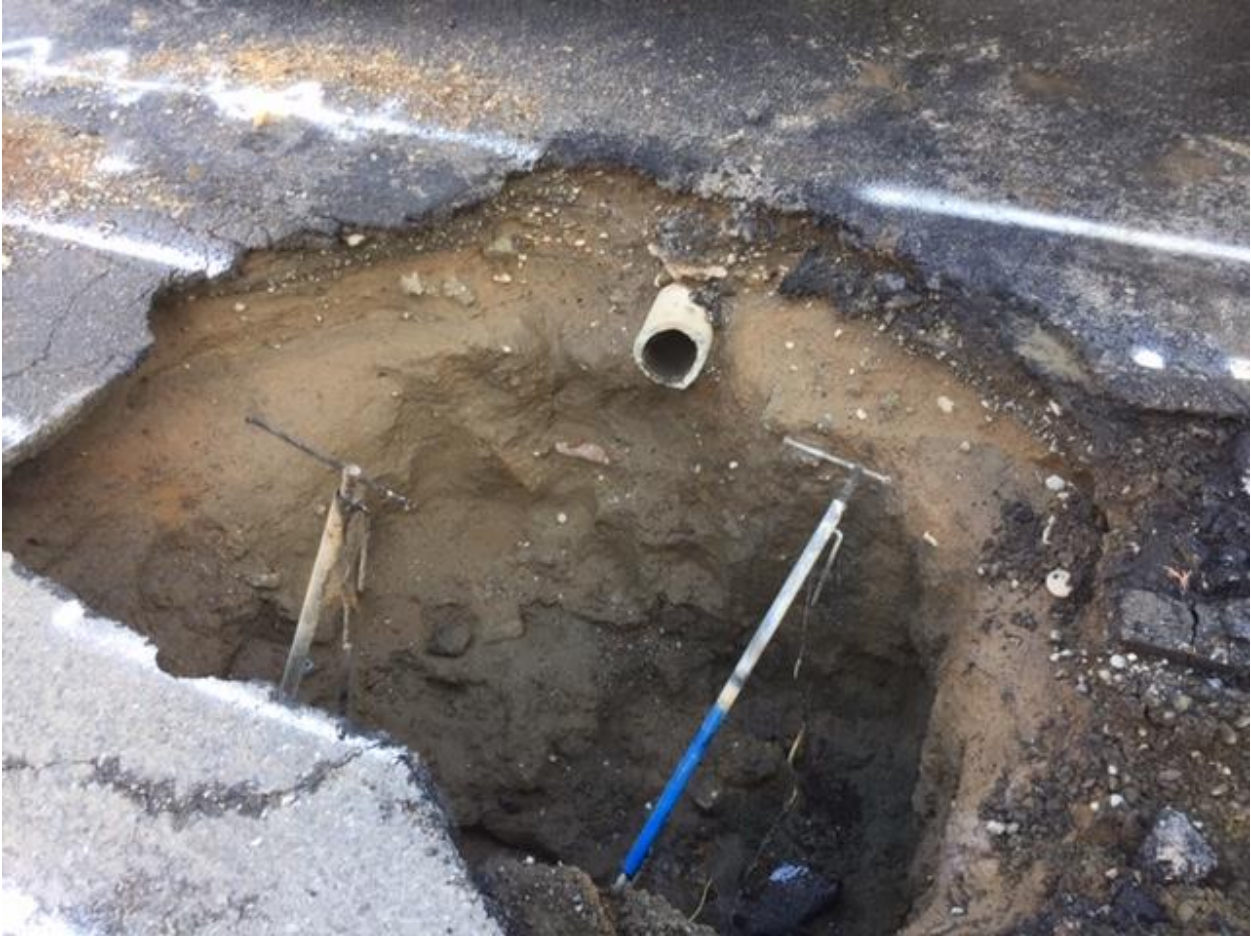
2-Picture of excavation showing the location of the abandoned steel line with visible rust, down and to the left of the gray drain pipe.

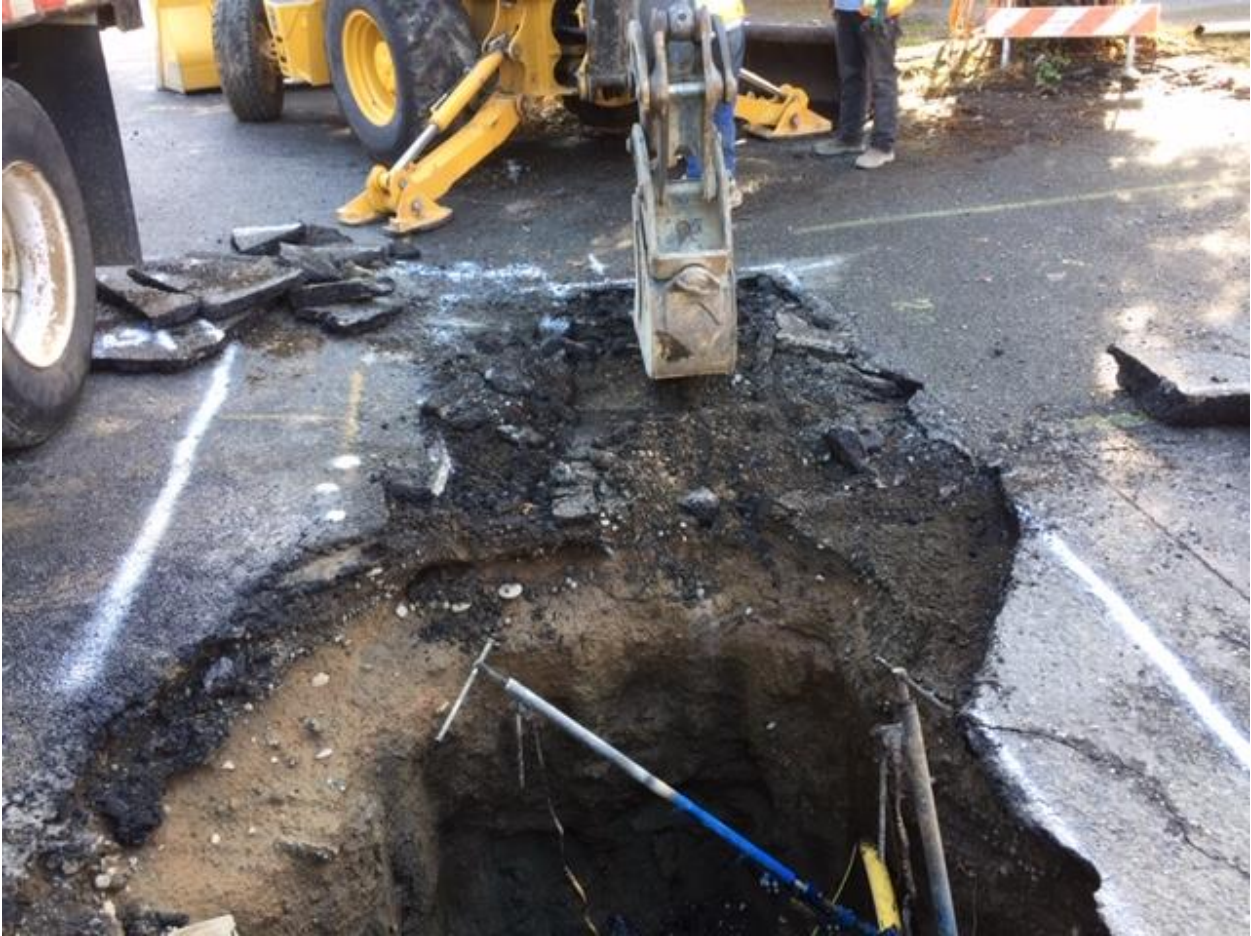
3-Come around some more to the north and photo from north to south. Still showing the location of the incorrect locate marks.
