# UTC Incident Investigation Form

<b>Notification ID:</b>	3465	<b>Investigation ID:</b>	7961
-------------------------	------	--------------------------	------

<b>Operator:</b>	Puget Sound Energy
<b>District/Unit:</b>	King County West
<b>Locations:</b>	5503 Seaview Ave NW, Ballard
<b>Incident Dates:</b>	February 6, 2019

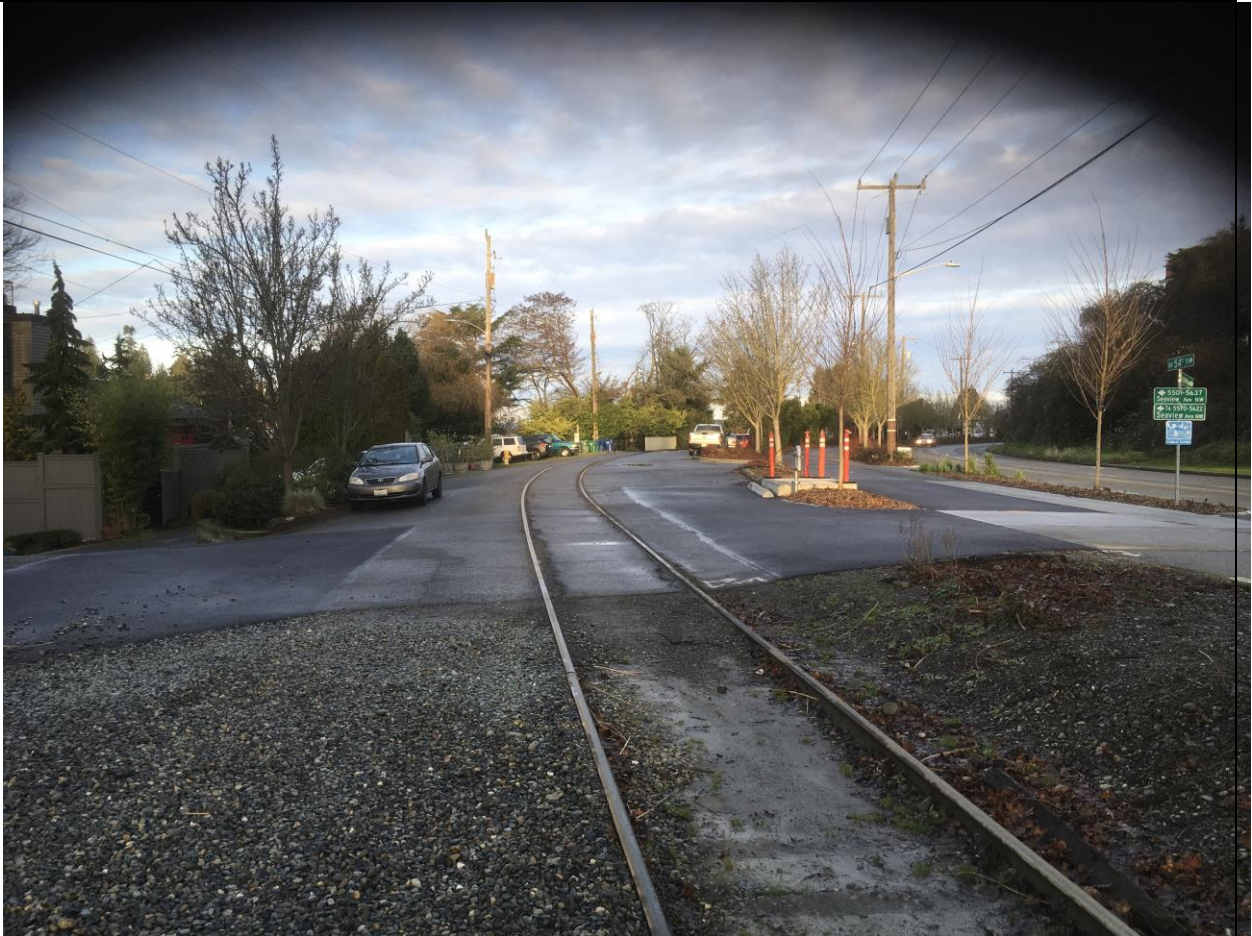
Photo 1- 5503 Seaview Ave NW looking north across area of excavation post incident

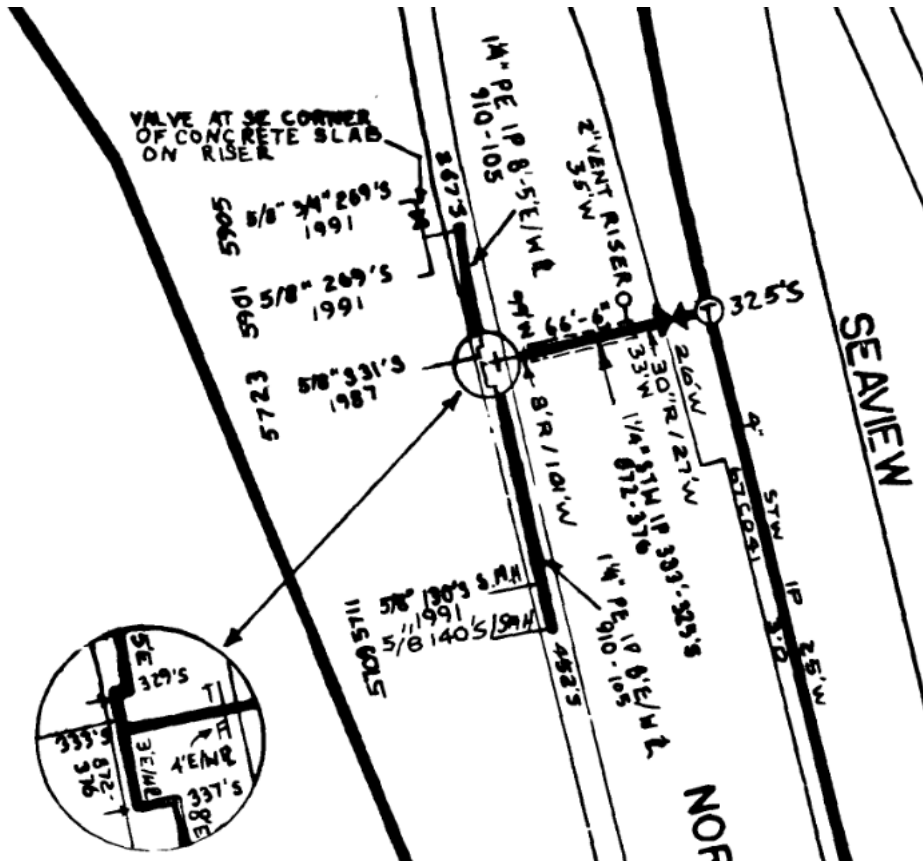
- The 1-1/8-inch PE pipe inserted into the 2-inch STW was not plated and the existing map indicated only the 2-inch STW pipeline. (see map below)  
(InfraSource interview)

Item#1 -Portion of PSE distribution map of the area involved in the incident

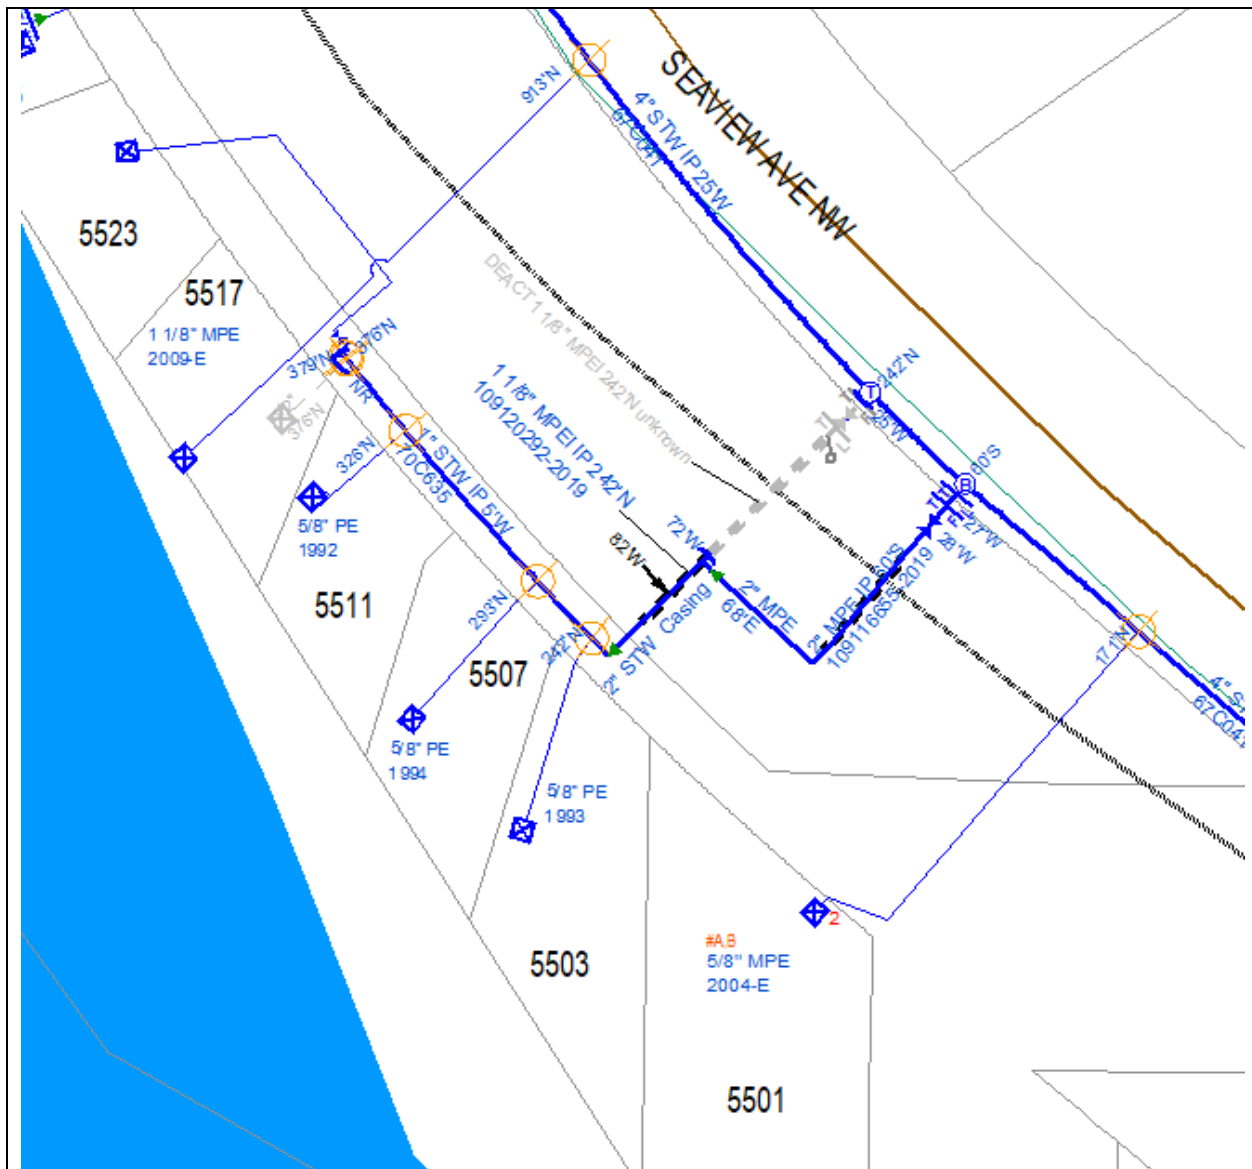
Item#4 Portion of the updated PSE distribution map of the area involved in the incident

Staff requested PSE update the specific operations and distribution maps involved in the incident and reviewed the results of a comprehensive root cause analysis investigation implemented by PSE following the incident on December 11, 2019. (see map below)
