# UTC Incident Investigation Form

<b>Notification ID:</b>	3139 NRC# 1177100	<b>Investigation ID:</b>	7509
-------------------------	----------------------	--------------------------	------

<b>Operator:</b>	Northwest Pipeline LLC (Williams)
<b>District/Unit:</b>	Redmond District
<b>Locations:</b>	15209 24 <sup>th</sup> Street East
<b>Incident Date:</b>	March 29, 2017

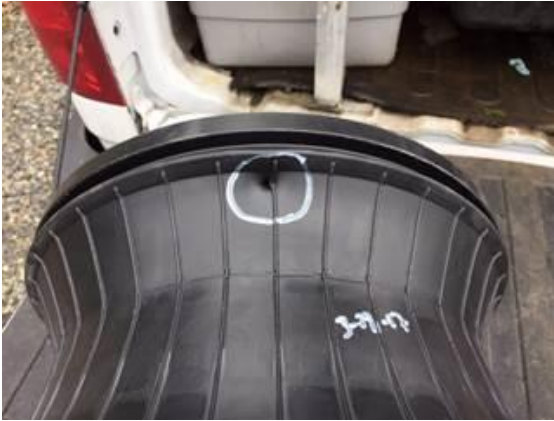
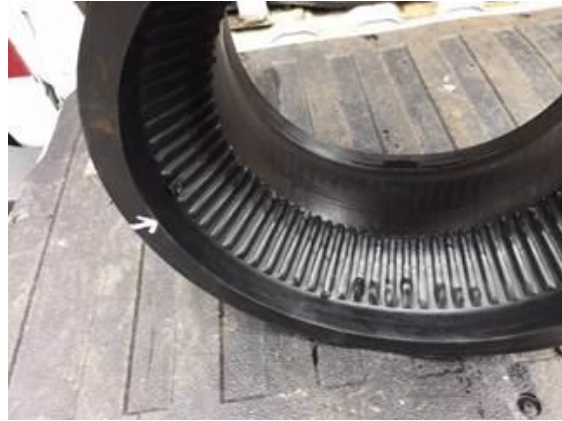
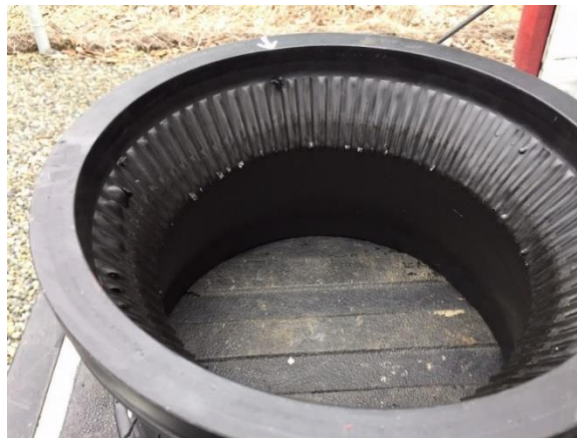
<b>Causes/Contributing Factors:</b>
The axial flow regulator sleeves show indications of two separate failure methods: erosional failure ("vampire bit") and manufacturing inclusion. The vampire bit (shown below), is seen in flexible element regulators when there is a high differential pressure and low flow rates. The flowing surface area is reduced and vibrates rapidly between the sleeve and the cage creating a heat zone that causes the rubber to fail.

According to Williams, the manufacturer inclusion has also been present in several of the failed boots. The manufacturer (American Meter) informed Williams that the chemical make-up of the sleeve has changed due to some of the chemicals in the rubber no longer being in production. American Meter thought they sourced acceptable replacements with the newly designed sleeves they provided. The newly designed sleeves were installed and were the sleeves that failed. The sleeve failed after 9 days of service. American Meter also communicated to Williams that they were experiencing about 25% pass rate on internal QA/QC of the sleeves. The most recent sleeve failure has been sent back to the vendor for failure analysis.

Staff agrees with Williams follow up in response to this incident. Williams has replaced the sleeves at North Tacoma Meter Station and South Seattle Meter Station. They have also adjusted the differential pressure across the meter stations to reduce stress on the sleeves by allowing the allowing a wider operating range. Along with replacing regulators and adjusting pressures, Williams has converted and commissioned both stations to worker monitor configurations as of July 13, 2017. Although no other meter stations use the same size sleeve from American Meter, Williams is continuing to monitor other stations that have axial flow regulators.
