Northwest Pipeline LLC, White Salmon Damage, 12-20-2020 11:28 PM

UTC R H
Incident / Failure / Investigation Report

Incident Title Northwest Pipeline LLC, White Salmon Damage, 12-20-2020 11:28 PM	3 Word Summary White Salmon Damage
Incident No. 3802	Investigation ID: 8329
Lead Inspector Name: Derek Norwood	Assistant Inspector Name: Additional Inspector:

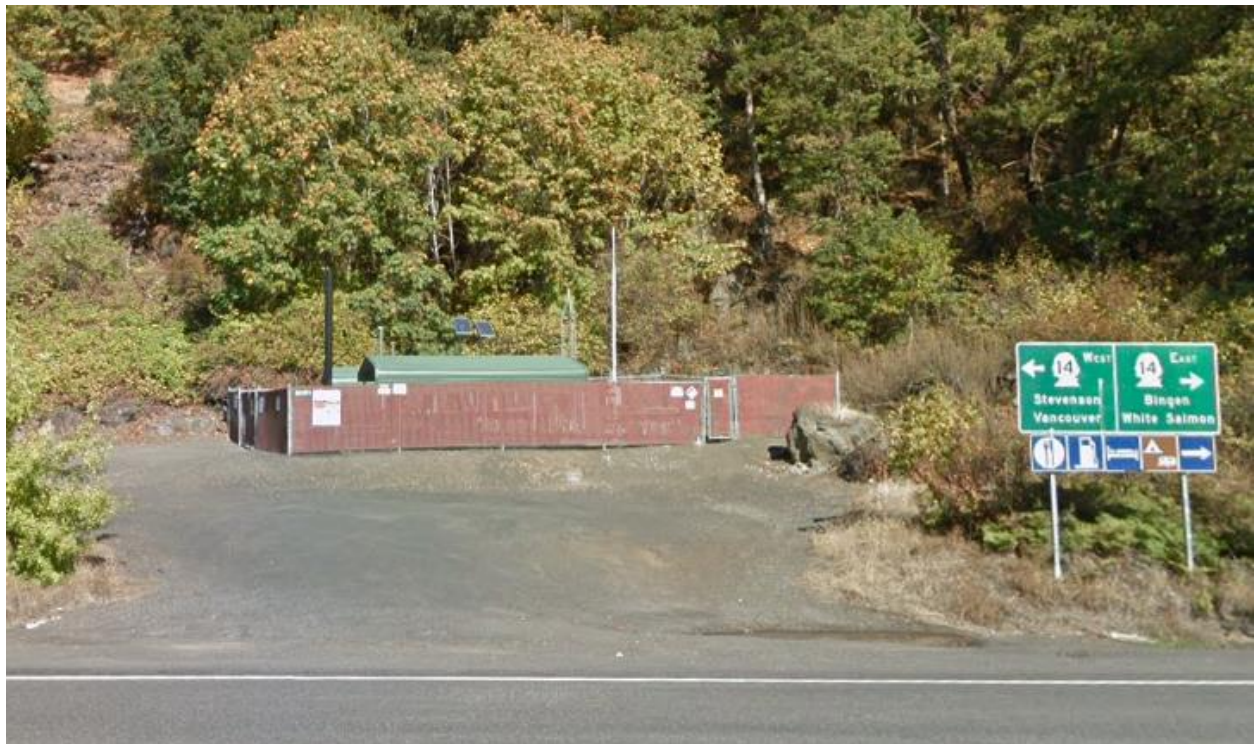
Figure 2: Street View of Hood River Meter Station Before Damage

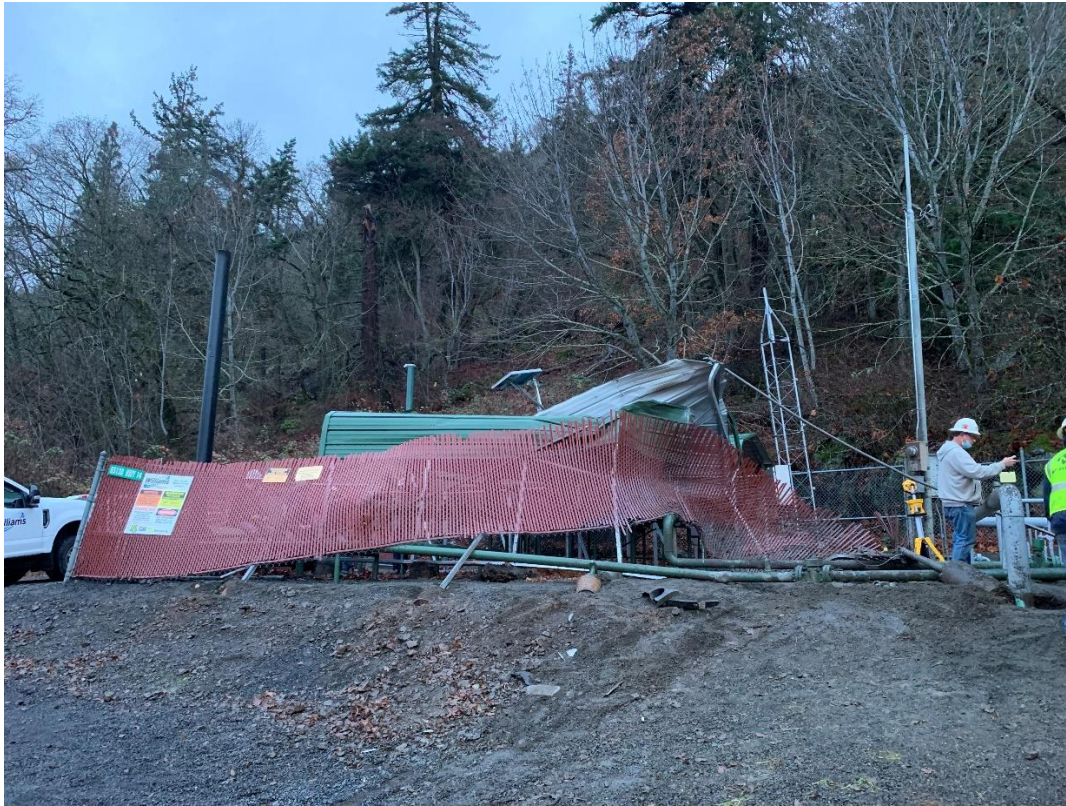
The damaged pipeline was above ground and was 6" outside diameter pipe. The leak occurred at two above ground fittings that were sheared off due to the collision. The approximate size of each leak was 1" in diameter

Figure 3: Photo taken at Hood River Meter Station on December 21, 2021 showing damage from the vehicle collision.

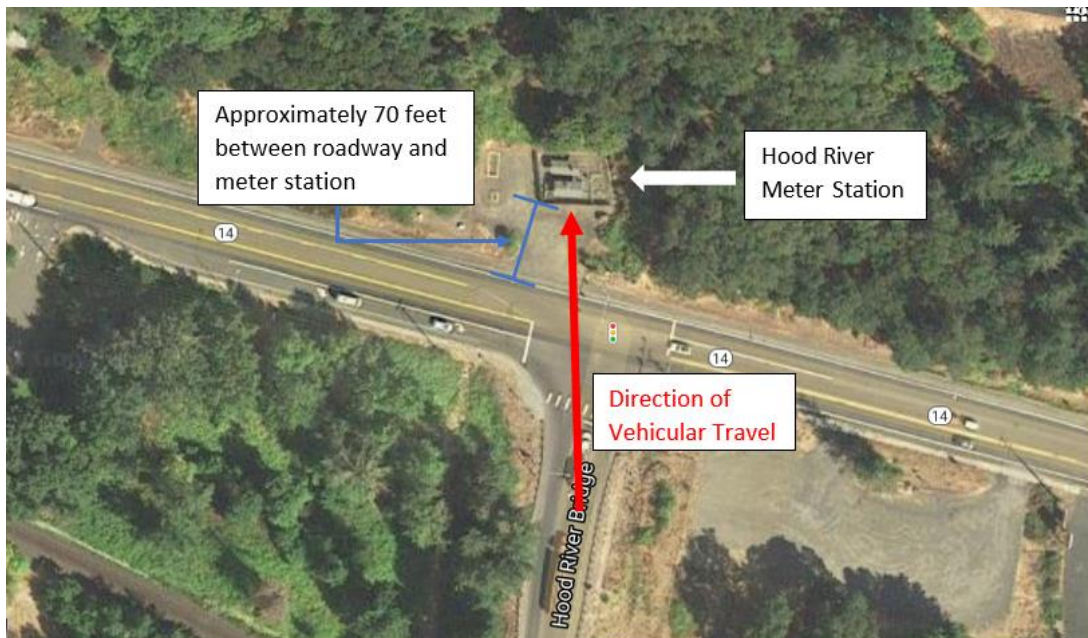
According to personnel on site, a vehicle had collided with the meter station when coming across the Hood River Bridge. Washington State Patrol had determined exceeded the speed limit and was under the influence of alcohol. Based on Williams' NRC report, the shortest distance from the roadway to the meter station was 70 feet and no protections were in place to limit damage from vehicles.

Figure 4: Diagram showing direction of travel and approximate distance to the meter station.

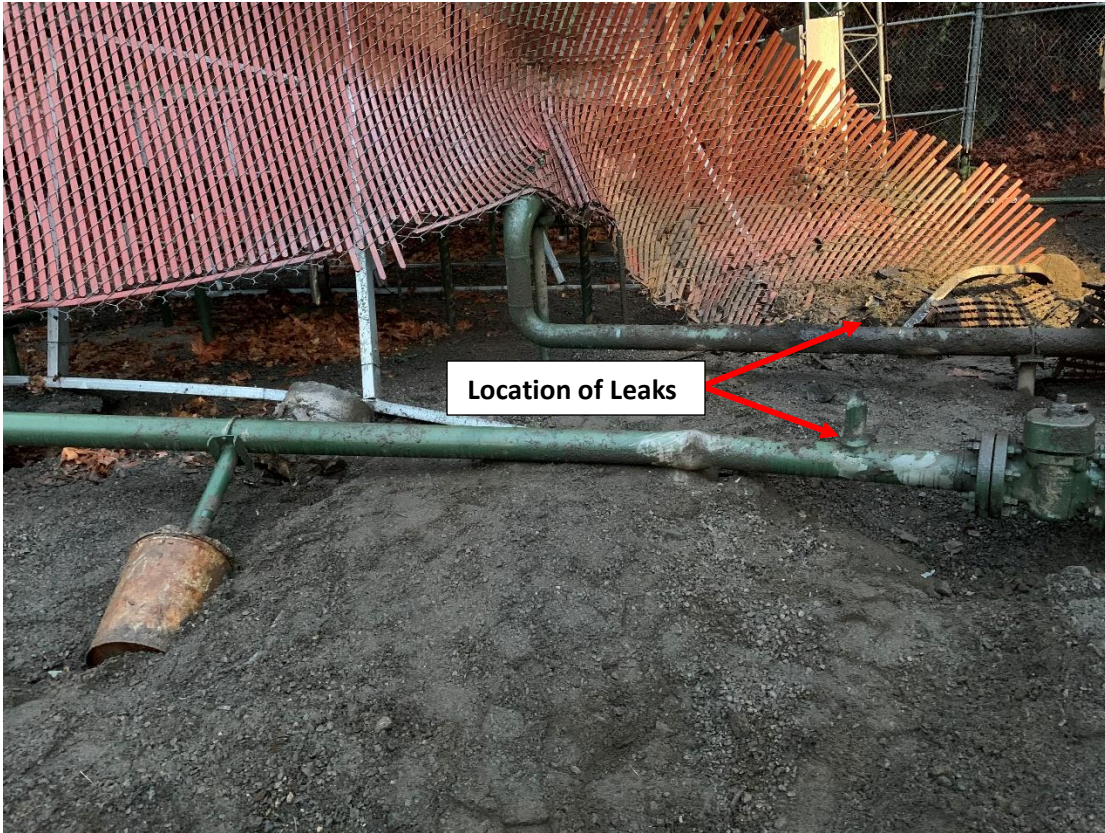
Figure 5: Photo showing location of gas release.

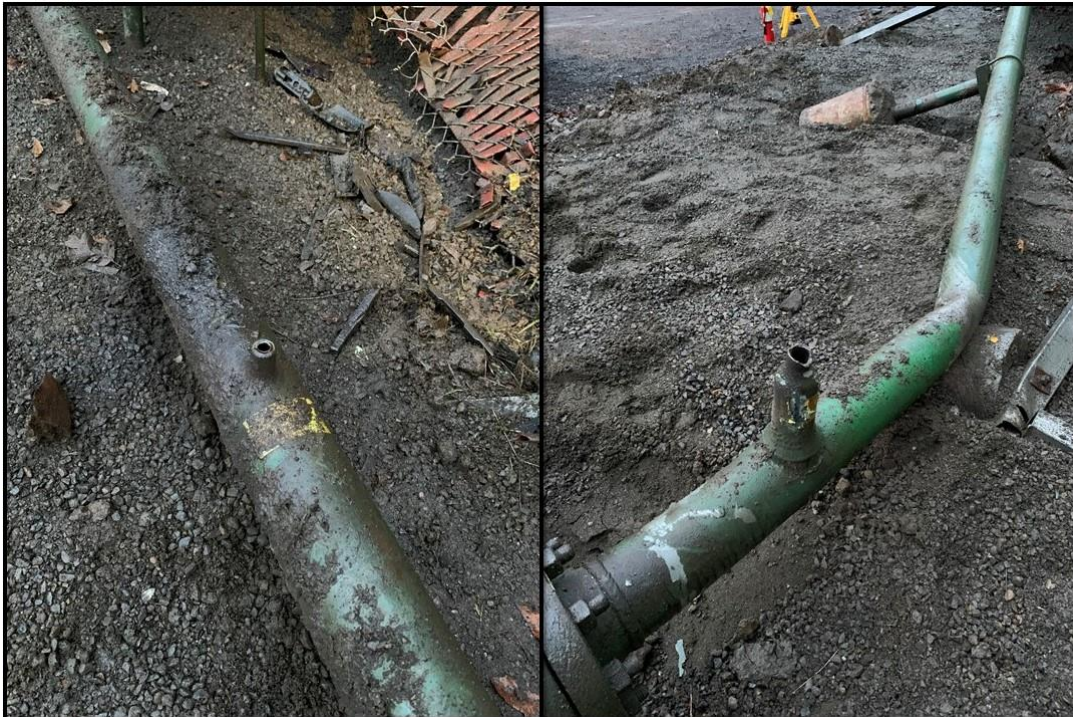
Figure 6: Close up photo of leak locations.
