# UTC Incident Investigation Form

| <b>Operator:</b> | Olympic Pipeline Company, OPID 30781<br>30 South Wacker Drive<br>Chicago, IL 60606 |
| <b>Locations:</b> | Allen Pump Station<br>16292 Ovenell Road, Mount Vernon, WA 98273 |
| <b>Incident Dates:</b> | August 5, 2022 |

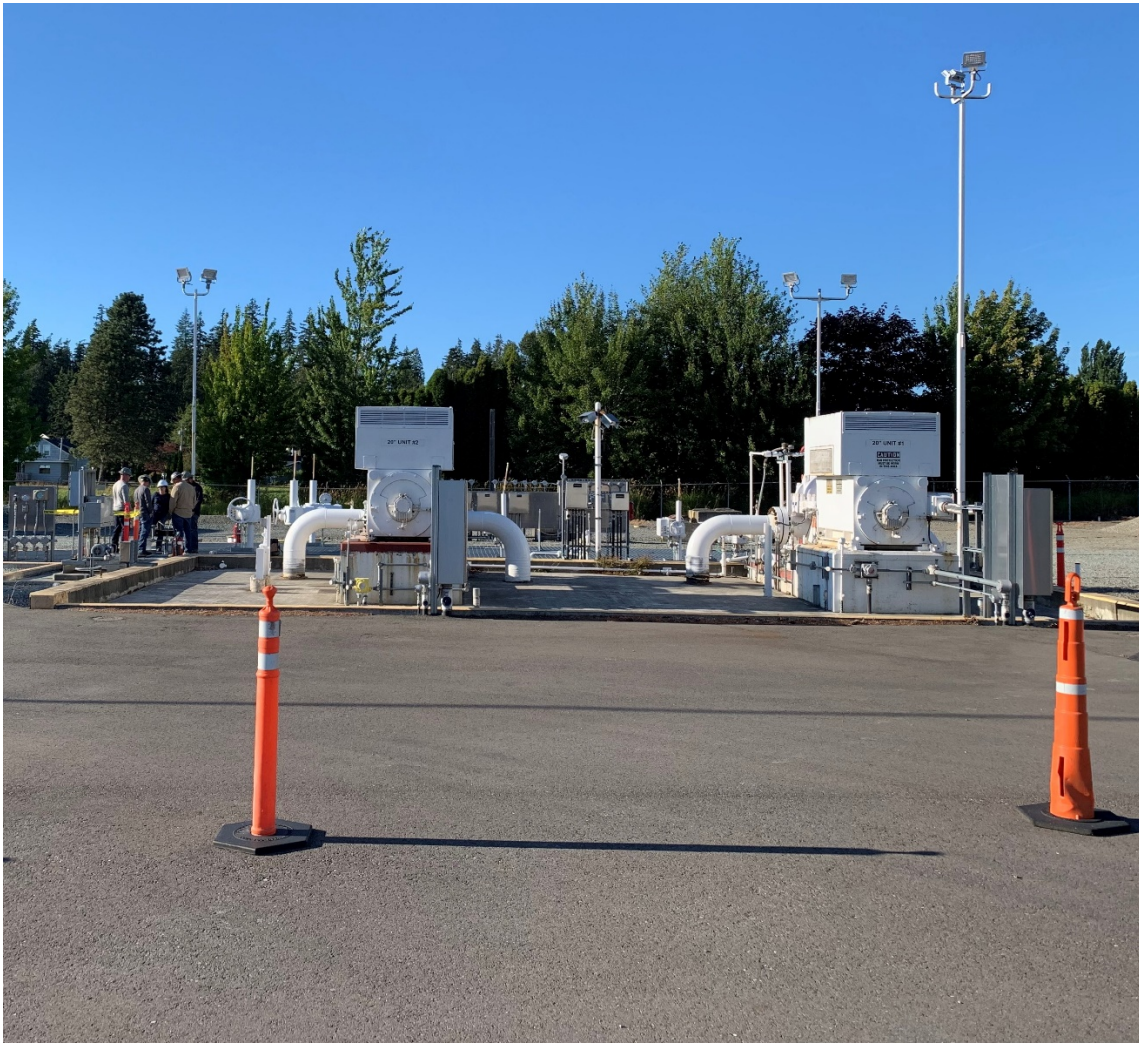
**Photo 2**—looking north across 20-inch valve location and containment area.

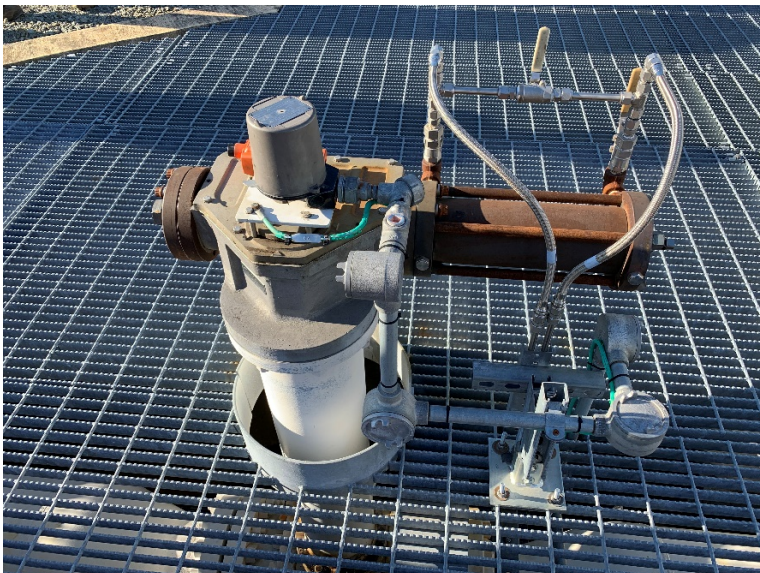
**Photo 3**—looking north at Valve actuator and grating over containment area.

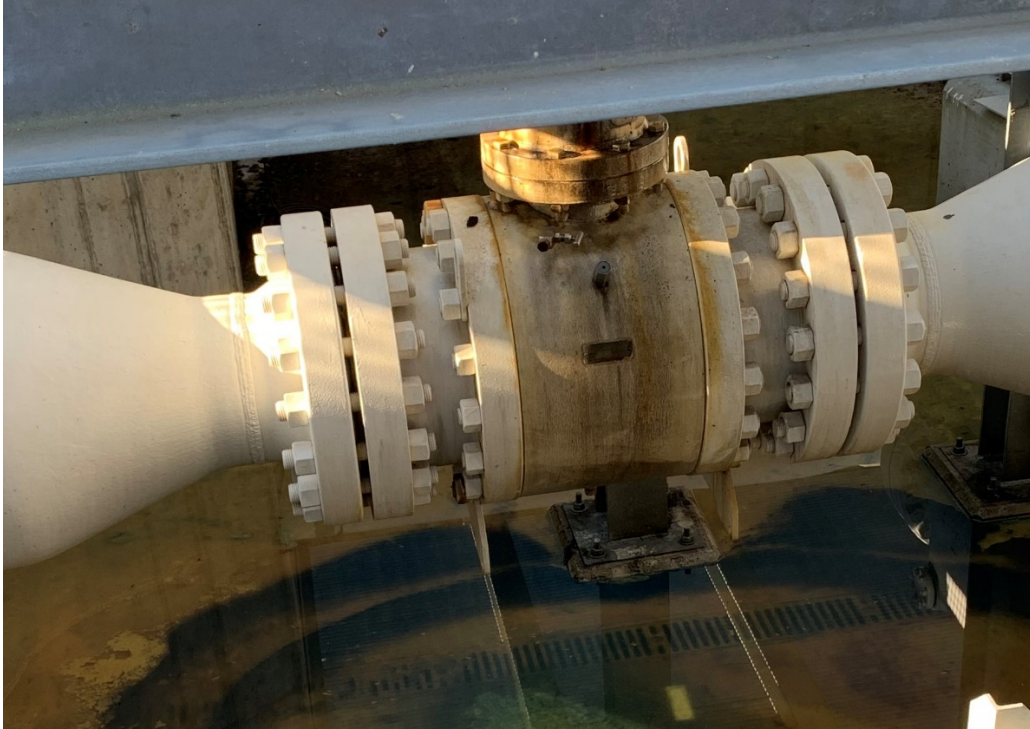
During a routine inspection, it was discovered that a control valve on a distribution pipeline was slightly leaking diesel fuel into a containment area (**Photo 1-6**). The initial 48-Hour report to NRC indicated [443] gallons diesel was released. The F-7100-1 Accident Report submitted to PHMSA on August 24, 2022, indicated [10.50] barrels. It appears this accident was unpreventable with a failed O-ring as the root cause.

**Photo 4**—Looking north at 20-inch main line carbon steel ball valve with leaked product in containment area. Manufacturer: Grove.

| The root cause for this incident was due to equipment, a failed O-ring. |

| During the next standard inspection, review records to determine whether or not more of these type of O-ring failures occurred, which may indicate a systemic problem. |

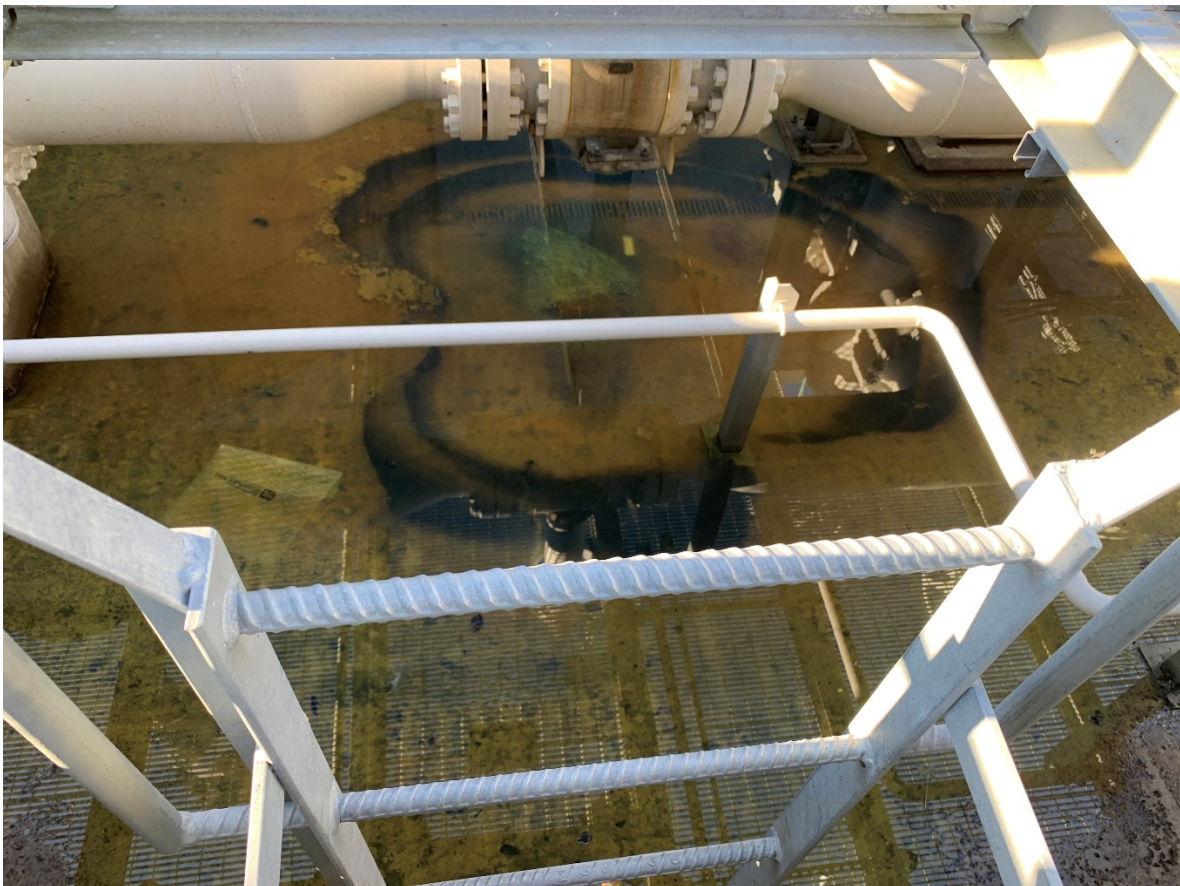
**Photo 5**—looking north into containment area with leaked product.

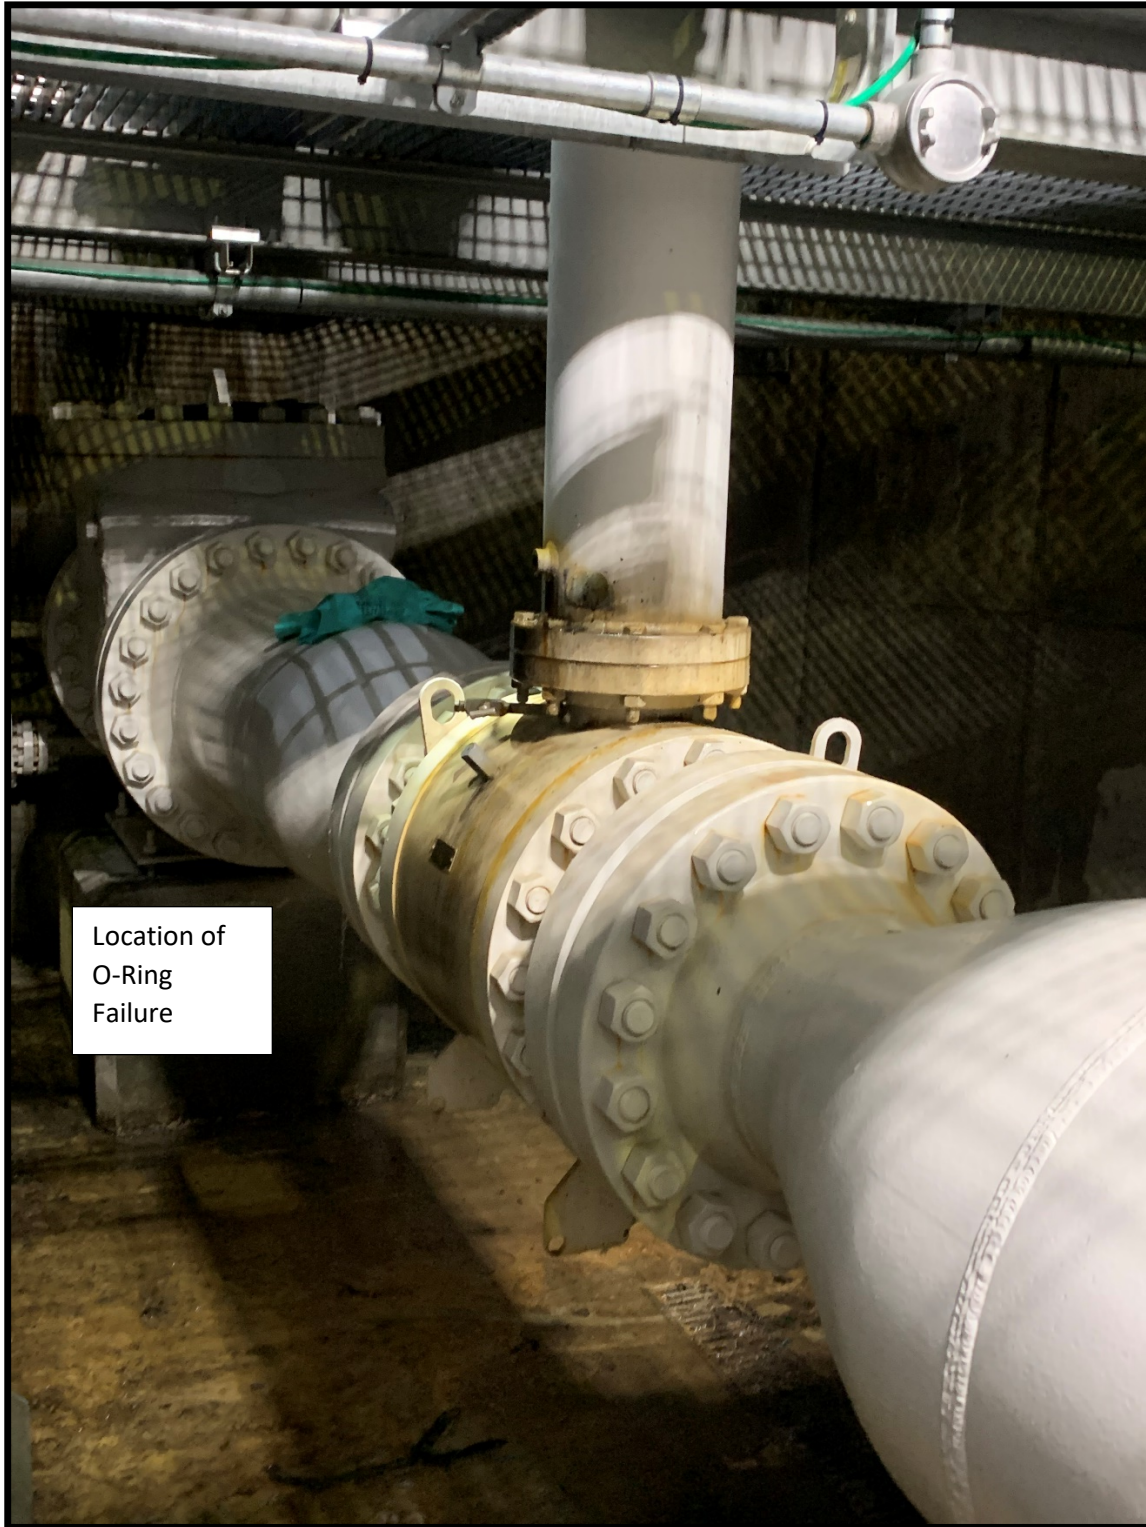
**Photo 6**—looking west at 20-inch valve from within the containment area after clean-out.
