# UTC Incident Investigation Form

<b>Notification ID:</b>	4050	<b>Investigation ID:</b>	8552
-------------------------	------	--------------------------	------

<b>Operator:</b>	Northwest Pipeline (Williams) OPID 13845 Tayler Jensen Pipeline Safety Engineer Larry West Operations Supervisor Battleground District
<b>District/Unit:</b>	Battleground
<b>Location:</b>	MP 1175.17 (Willard Compressor Station)
<b>Incident Date:</b>	Discovery date 7/28/22 23:00 Determination date: 7/29/2022 00:09

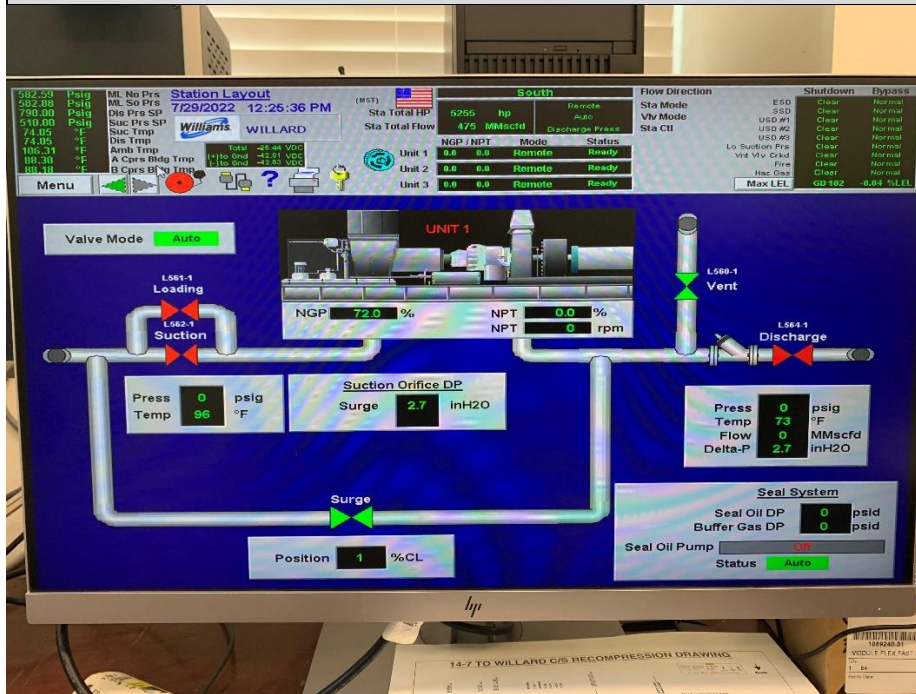
Local HMI showing Unit 1 suction valve closed.

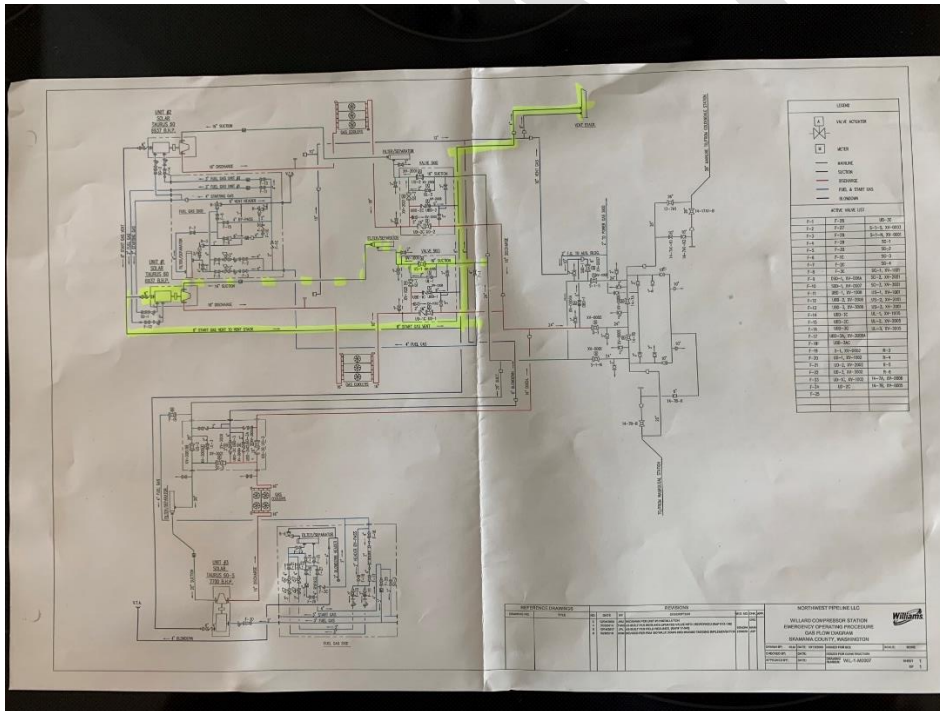
P&ID drawing showing schematic of Unit 1. Yellow highlight is flow path to vent stack

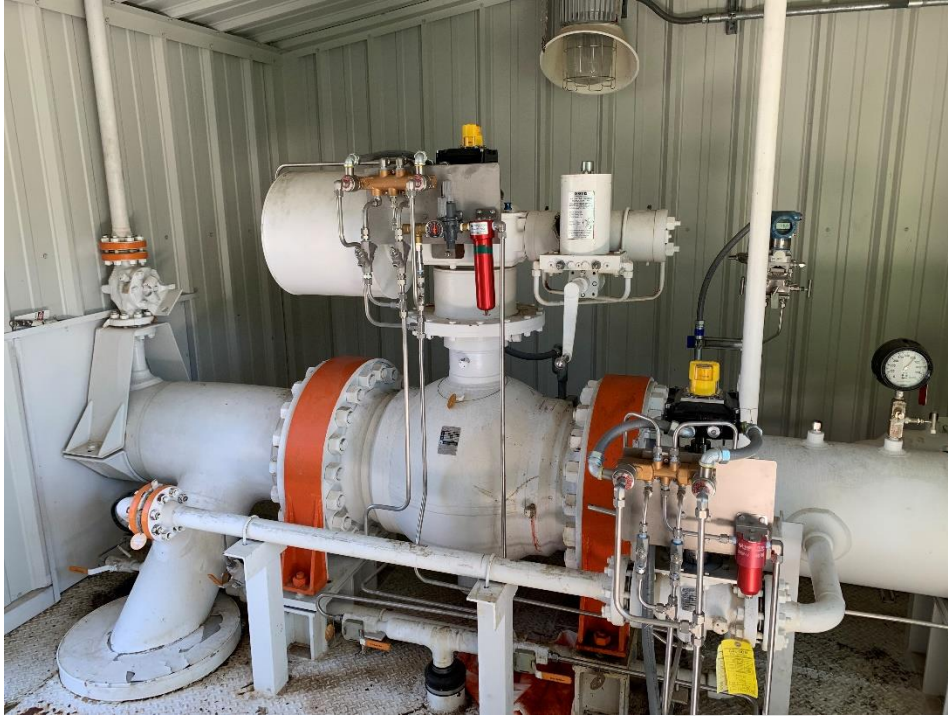
- Loading or suction valve failed to close fully.
- Power turbine percent speed and suction / discharge pressures were indicated on local HMI and observable by Gas Control but were not specifically reviewed.

1. Debris in the seat of the valve. (Hypothetical; no discoverable debris)  
Recommendation: Communication between Operations and Construction to keep debris free of the pipeline (housekeeping) during projects.
2. Specific observation of turbine speed and S&D pressures not required.

Unit 1 Suction valve. Note indicator is showing closed.

Recommendation: Implement a continuous venting unit alarm within SCADA, station, or unit control systems.

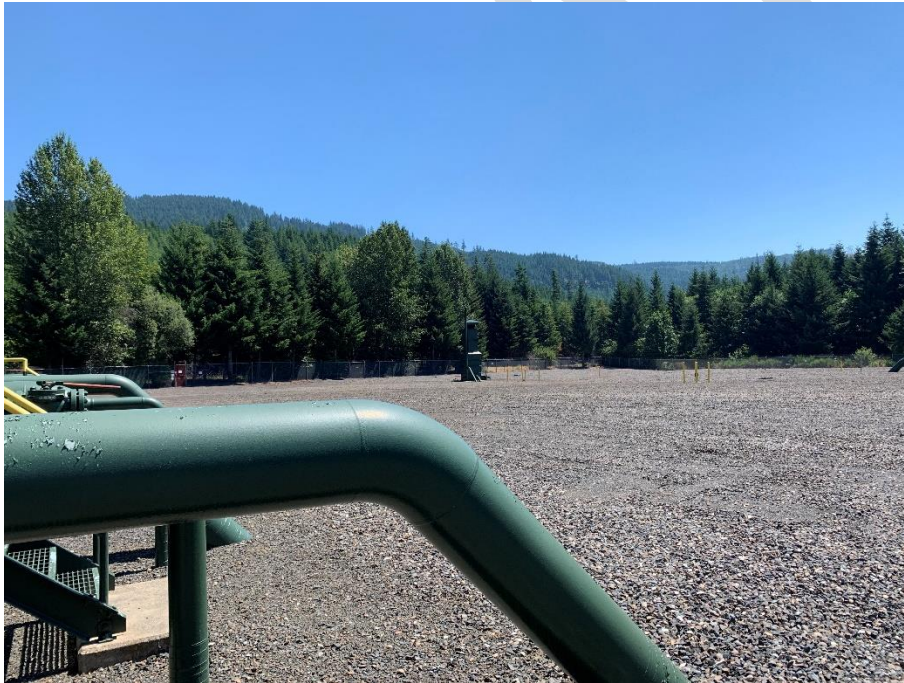
Looking east from outside Unit 1 suction valve building at vent stack. Pipe in foreground is 16" Unit 1 inlet.

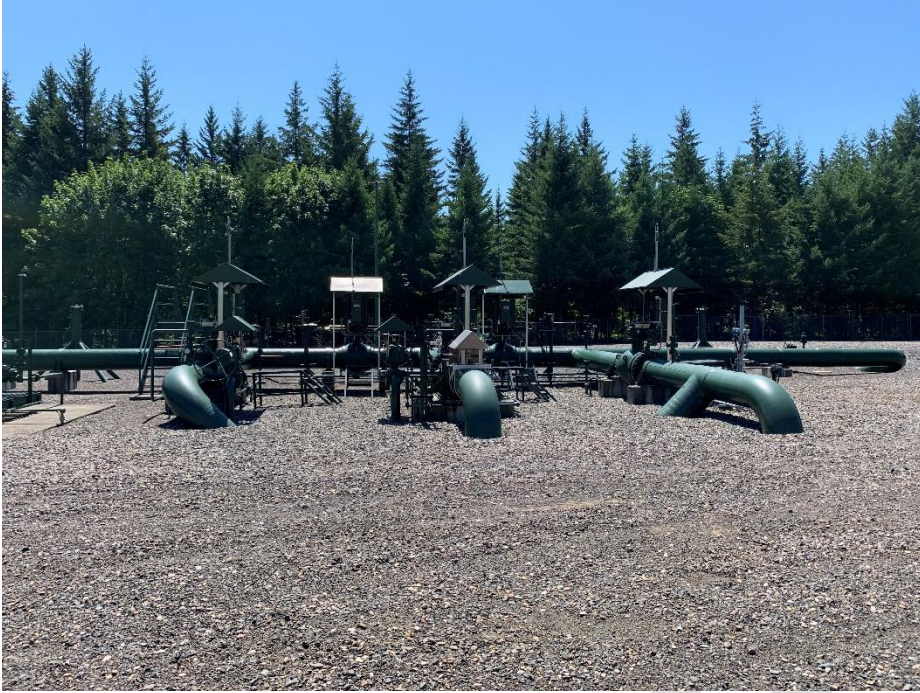
Looking south at inlet piping for three compressors at Willard station.
