STATE OF WASHINGTON

UTILITIES AND TRANSPORTATION COMMISSION

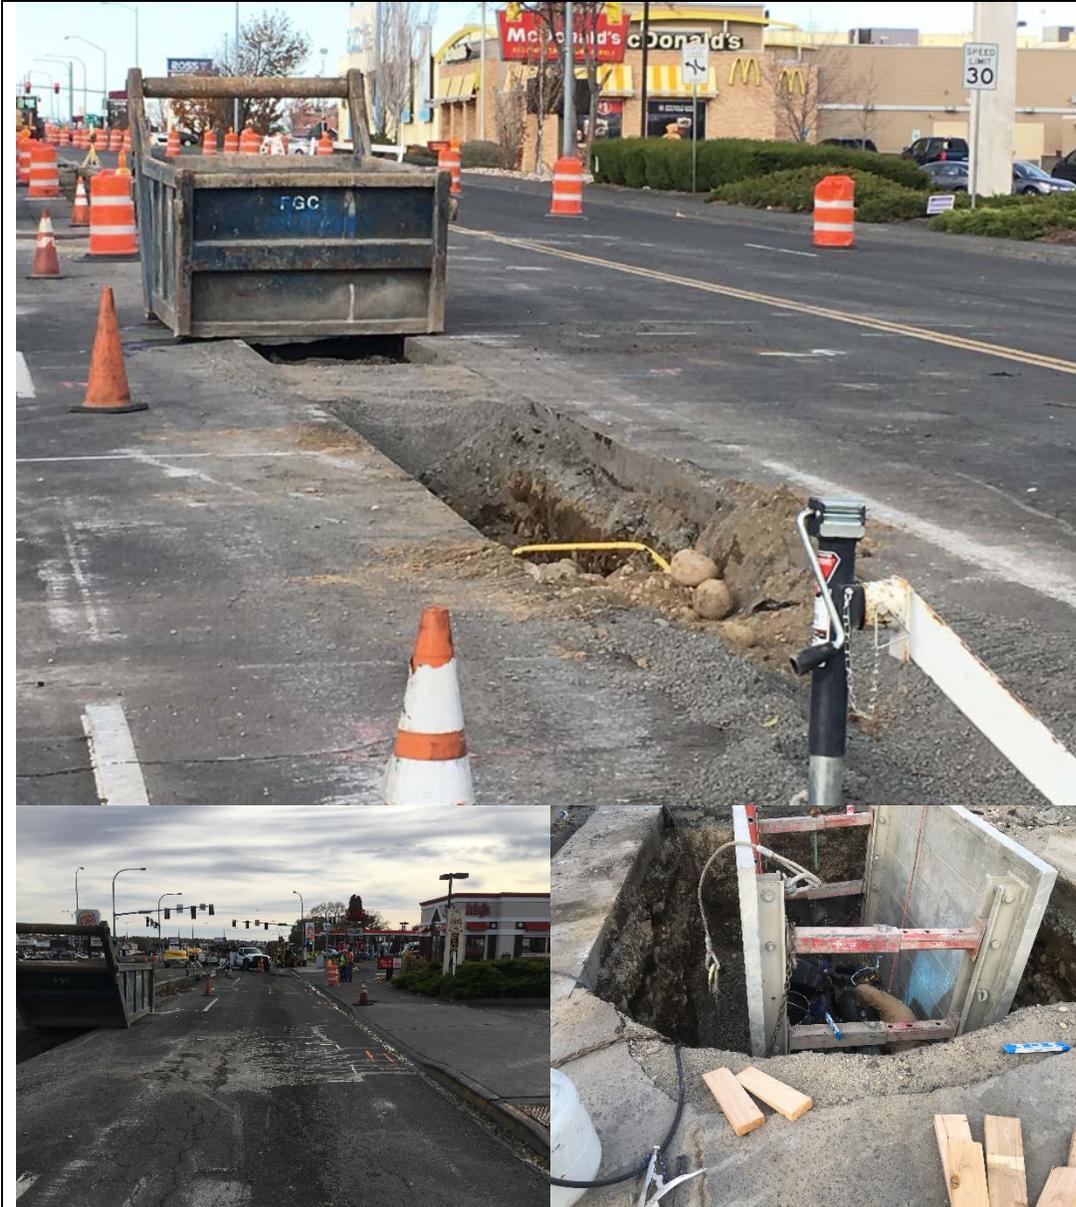
Causes/Contributing Factors:
