UTC Incident Investigation Form

Notification ID:	3706	Investigation ID:	8204
-------------------------	------	--------------------------	------

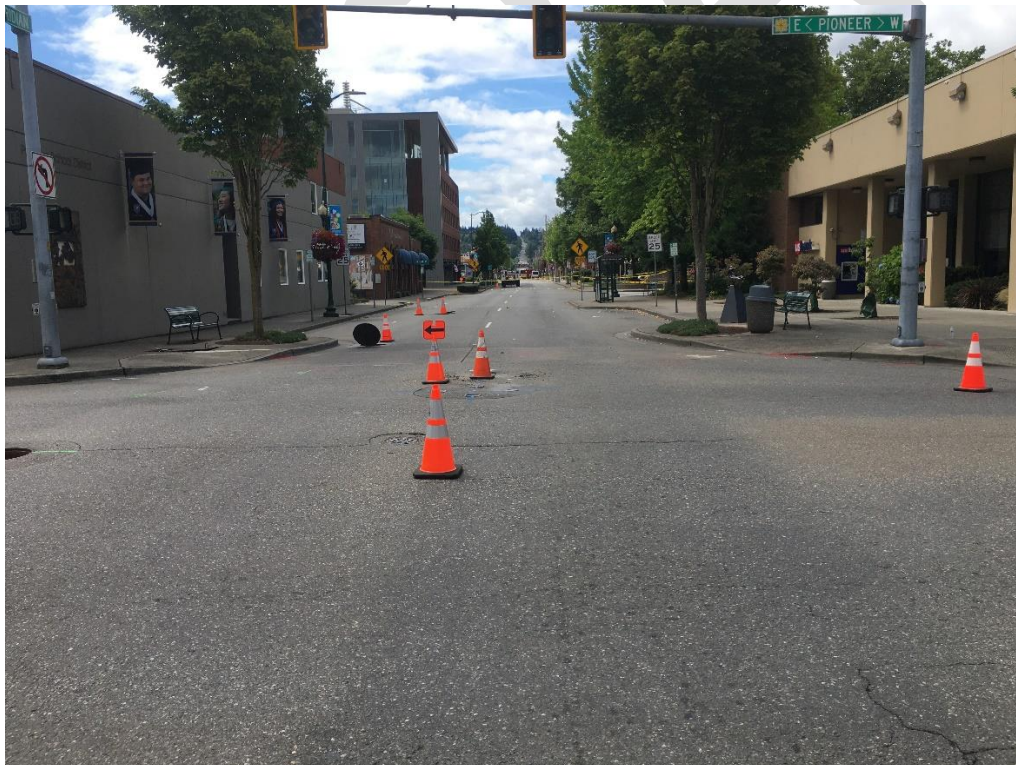
1343-looking S no PSE locates in bore path-cone with arrow is leak location

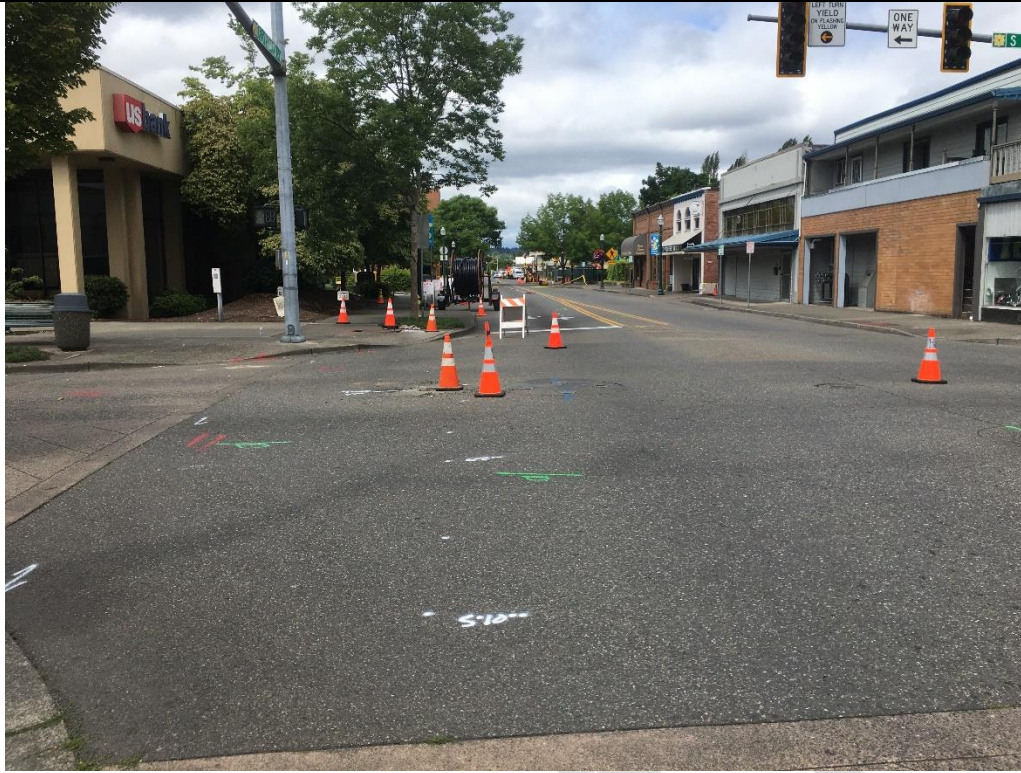
1345-looking W at bore path no PSE locates- SEFNCO marked drill path with white dots

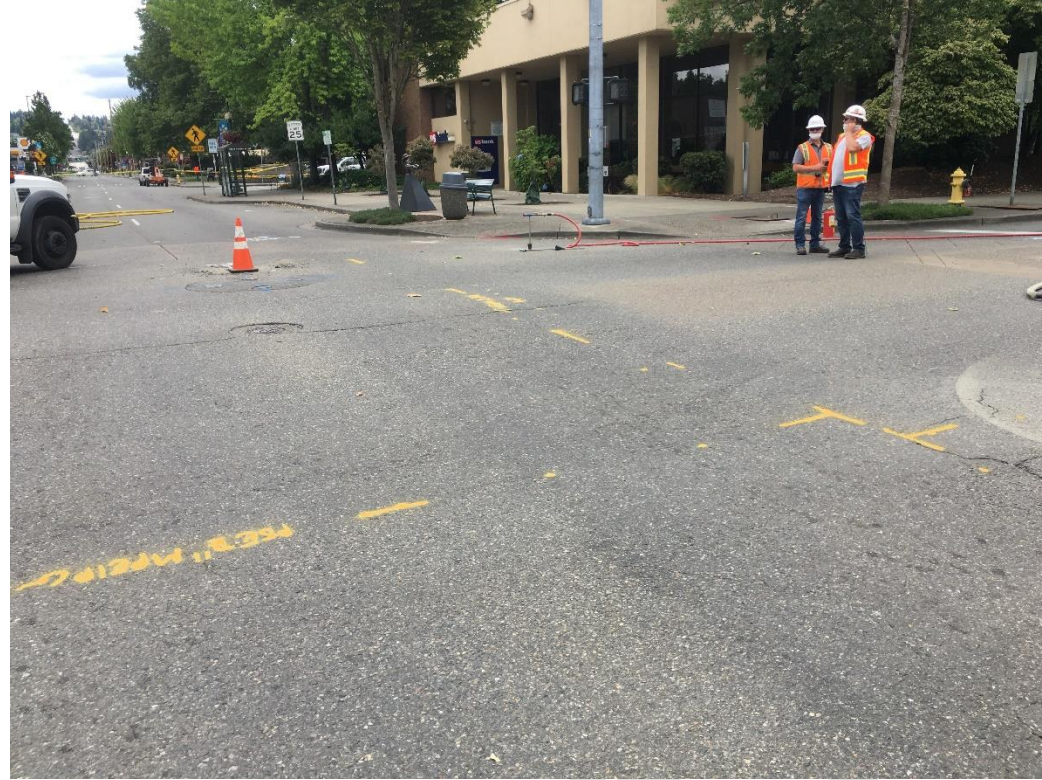
1424 looking SW, locates after incident show PSE assets-orange cone is leak location
