UTILITIES AND TRANSPORTATION COMMISSION

**RE: 2017 National Response Center Incident No. 1178094 – Cascade Natural Gas Corporation, Mount Vernon District – (Investigation No. 7447)**

# UTC Incident Investigation Form

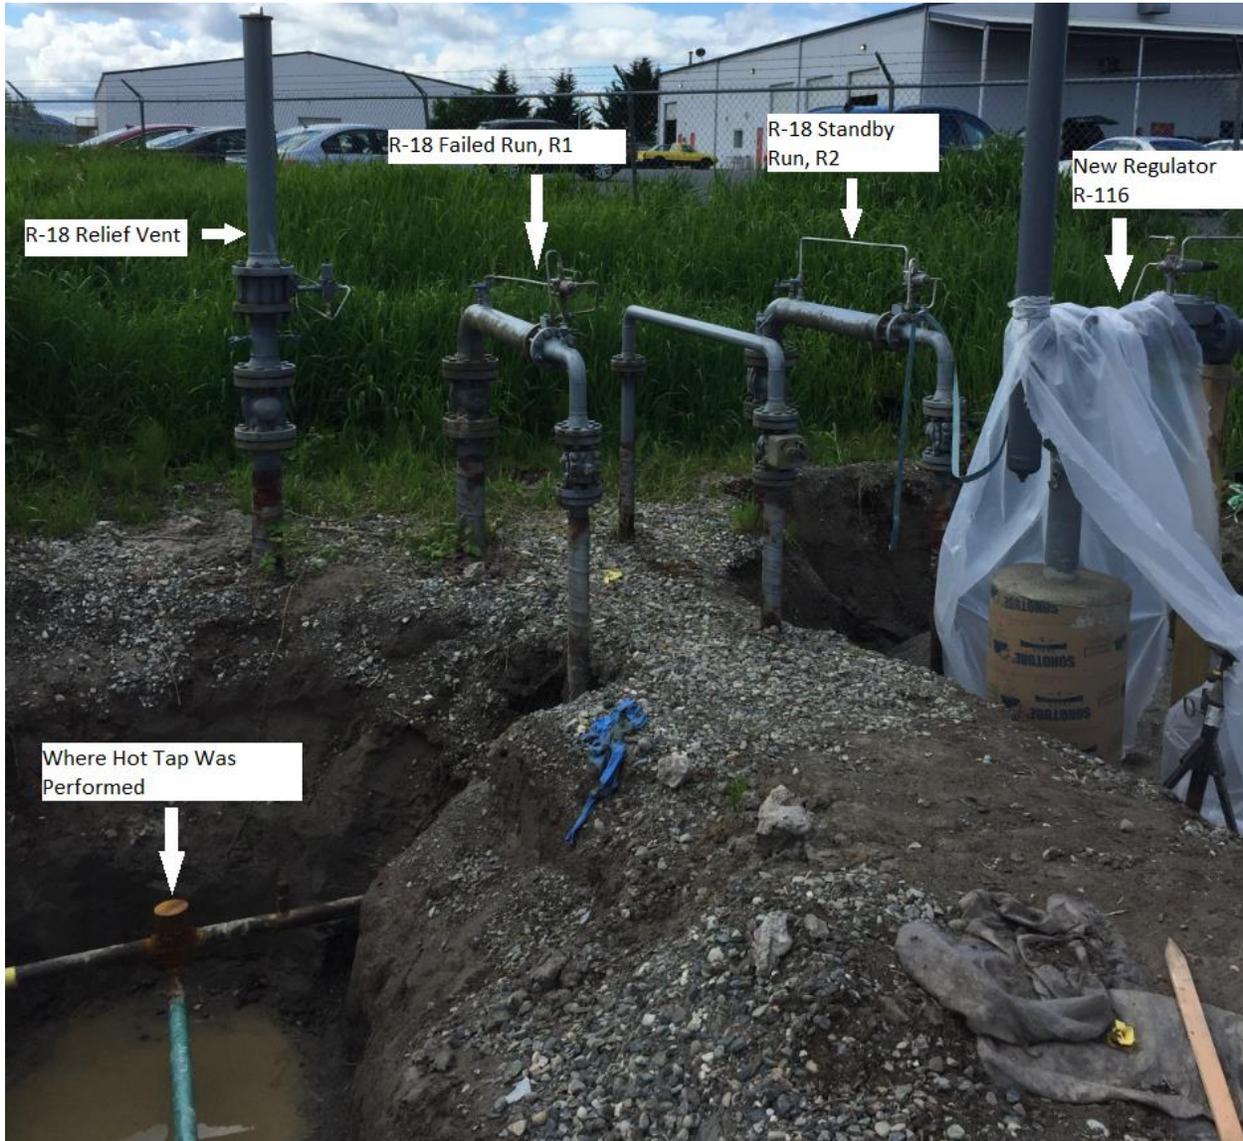
## Attachment 1

<b>Description:</b>
<p>On May 8<sup>th</sup> a CNGC contract crew (Snelson’s) was in the process of constructing a new dual run regulator, R-116. The new station would be replacing the existing dual run axial flow regulator R-18 at Gear Rd. east of Old Hwy 99 in Burlington, WA (see attachment 1). In the process of construction a hot tap was performed on a 2” steel main by Eric Rex (see attachment 2). The 2” main was currently connected to R-18, but would later be connected to the new regulator once it was up and running. The metal shavings from the tap remained in the line due to the tap being done on a live gas main.</p> <p>On May 10<sup>th</sup> at approximately 23:41 CNGC was made aware by an outside source that the relief stack to R-18 was venting gas. Upon arrival CNGC maintenance staff found that the working run of the regulator, R1, was flowing at an operating pressure of 273.25 pounds per square inch gauge (psig). After bypassing R1 to the standby run, R2, CNGC staff were able to take apart R1 to find an excessive amount of the metal shavings from the nearby hot tap in the diaphragm (see attachment 3).</p> <p>According to CNGC maintenance records (see attachment 4): Inlet pressure of R1, 278 psig. Inlet MAOP of R1, 360 psig. Outlet MAOP was 249 psig. Lockup set pressure of R1 was set at 246 psig after the overpressure event. The relief blew at 270 pounds psig at the time CNGC staff arrived, and was later set to a lower pressure of 260 psig.</p>
