POST INSPECTION MEMORANDUM

Operator Inspected:
Northwest Pipeline Corp (WGP)

Inspection Type: I-03 – Failure Investigation **NRC#1068710**

Photos for the Williams' Wenatchee Lateral Leak Report

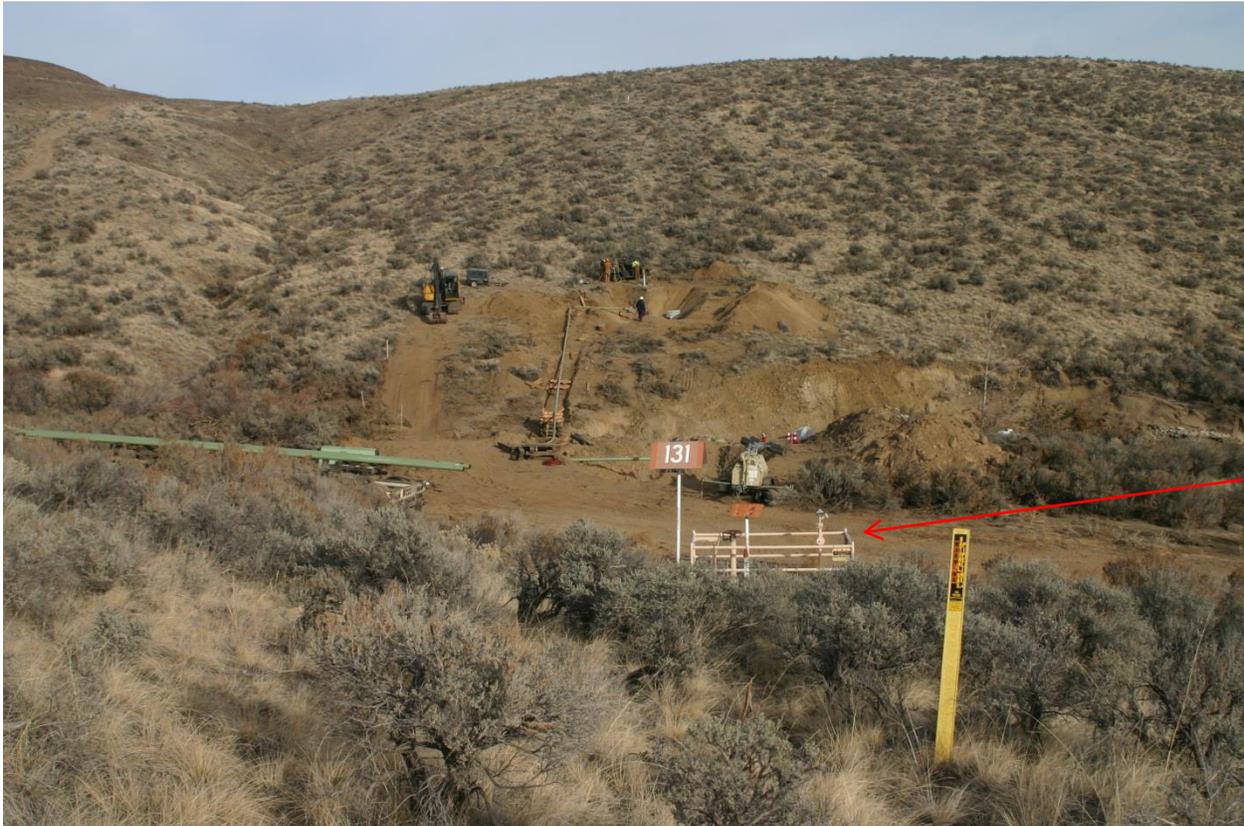
Photo #1 of 6

View to the north of the ROW at the Wenatchee Lateral crossing at Dry Gulch near MP 131. Remediation included placement of large rocks in the stream bed on each side of pipeline crossing at Dry Gulch.

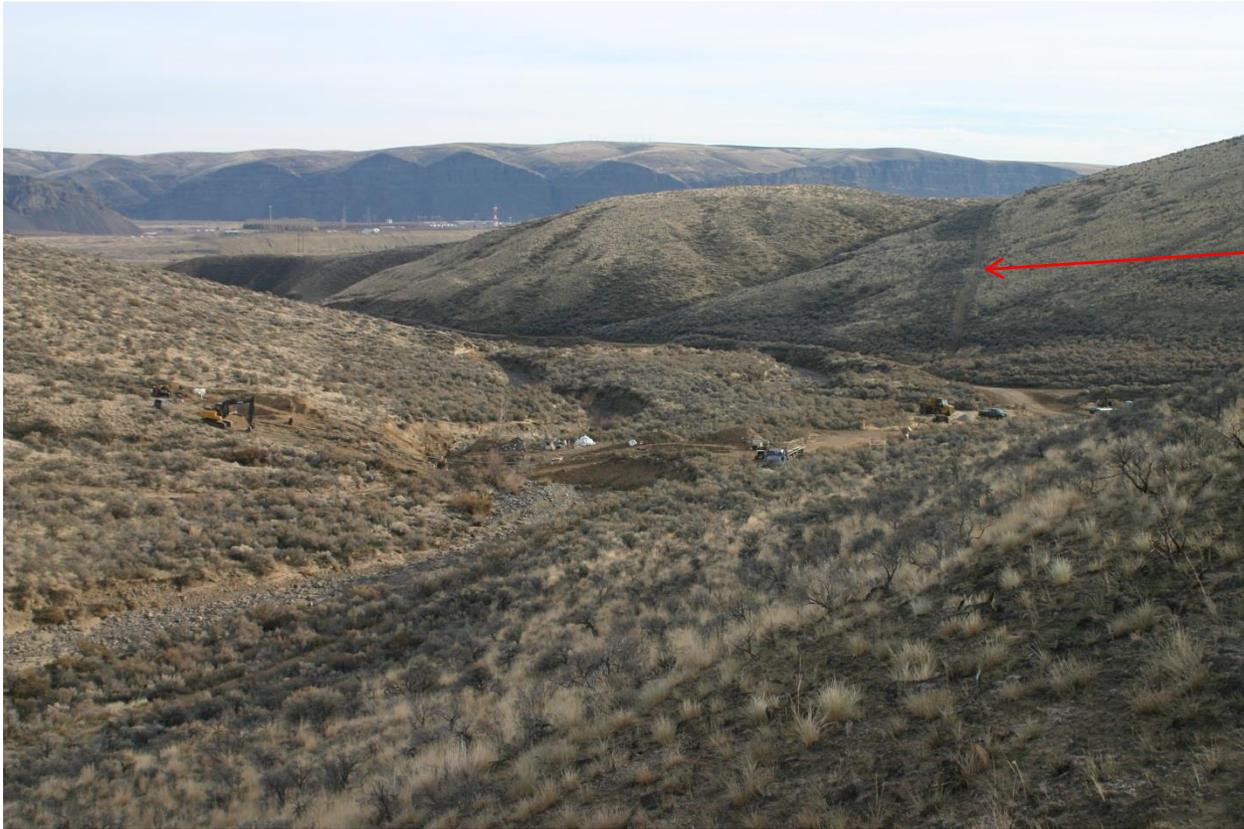
Photo #2 of 6

View to the southeast at the terrain and drainage basin for Dry Gulch and the Quincy lateral connection at the Wenatchee lateral.

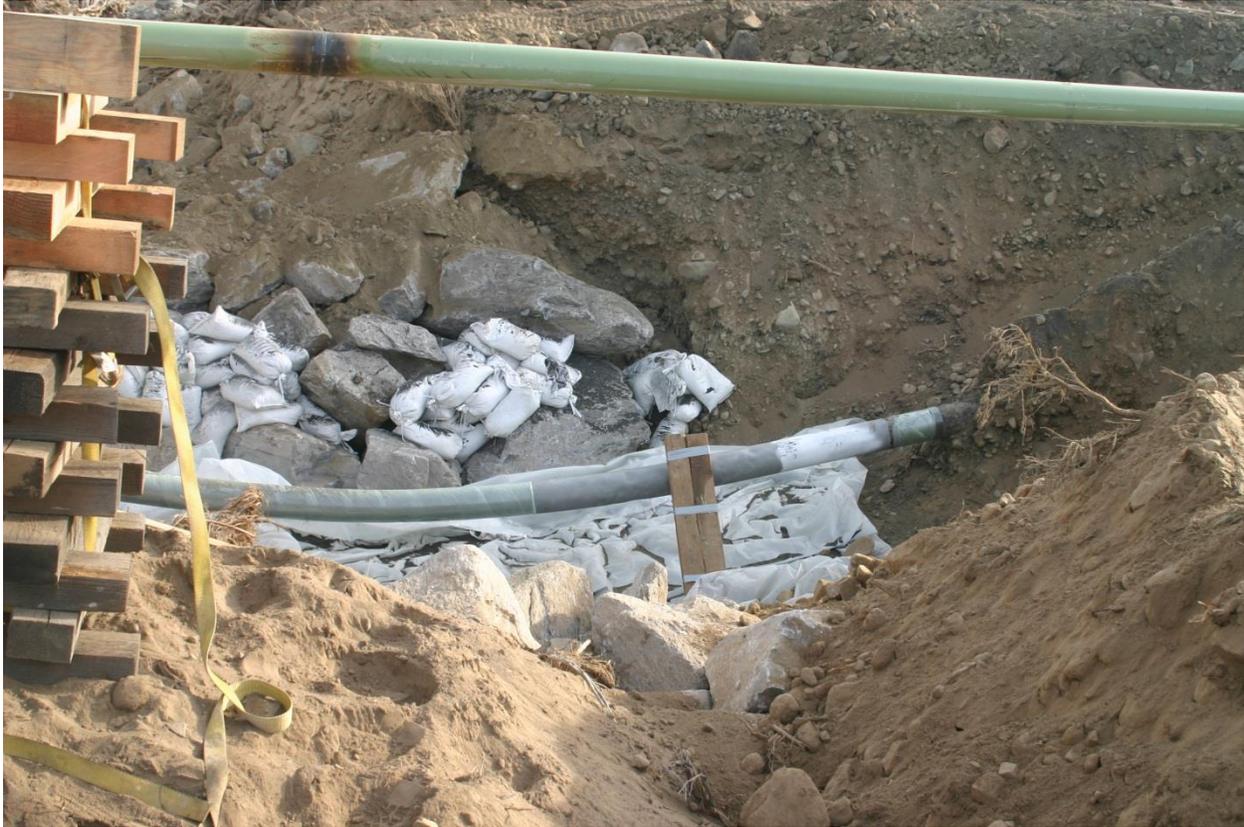
Photo #3 of 6

Looking east at Williams' 8-inch Wenatchee Lateral exposed in Dry Gulch. Remediation included placement of large rocks in the stream bed at pipeline crossing and replacing the pipe. The leak was at about the nine o'clock position on the pipeline where the wooden timbers are located. The timbers deflect gas from the work area. About 31 dents were discovered on the exposed pipe section. At the top of photo is the temporary bypass pipe.

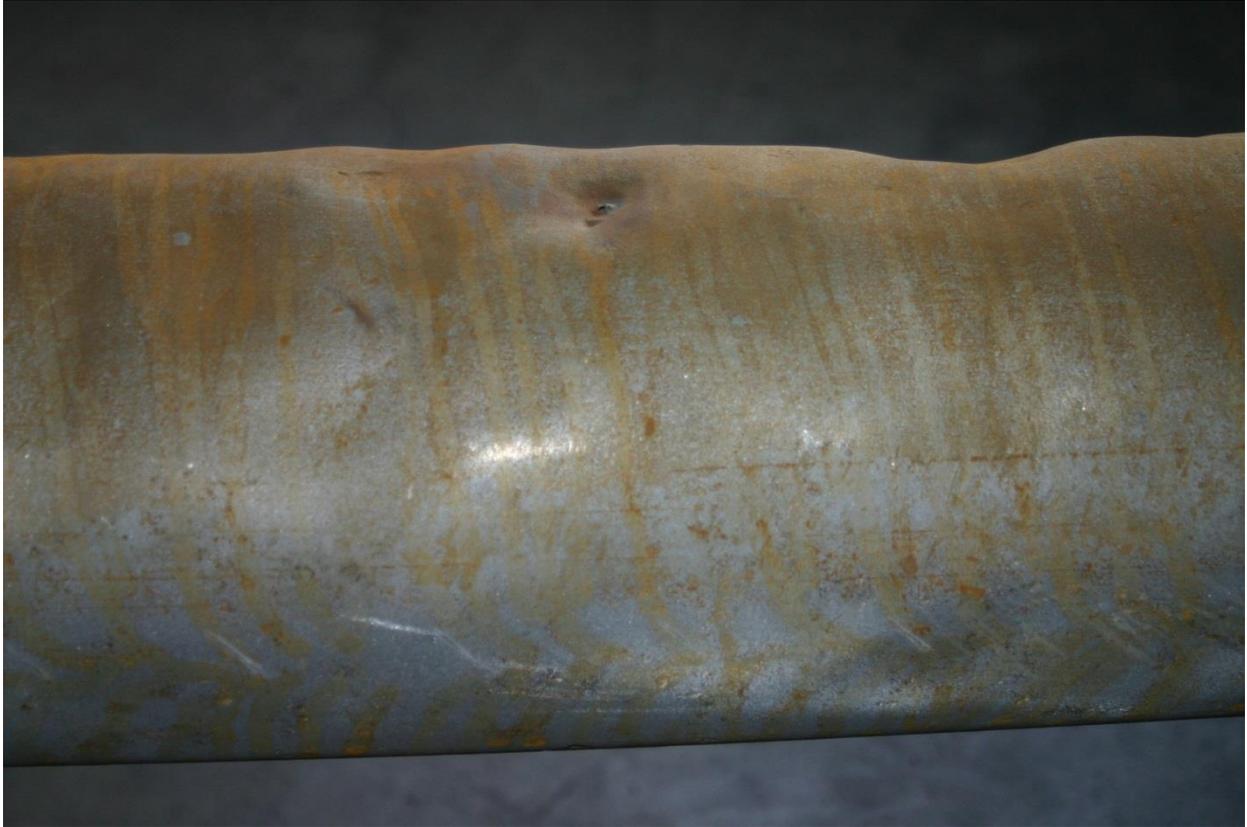
Photo #4 of 6

Williams' 8-inch Wenatchee Lateral. The leak was at about the nine o'clock position and 3/16 inch diameter hole. About 31 dents were discovered on the exposed pipe section.

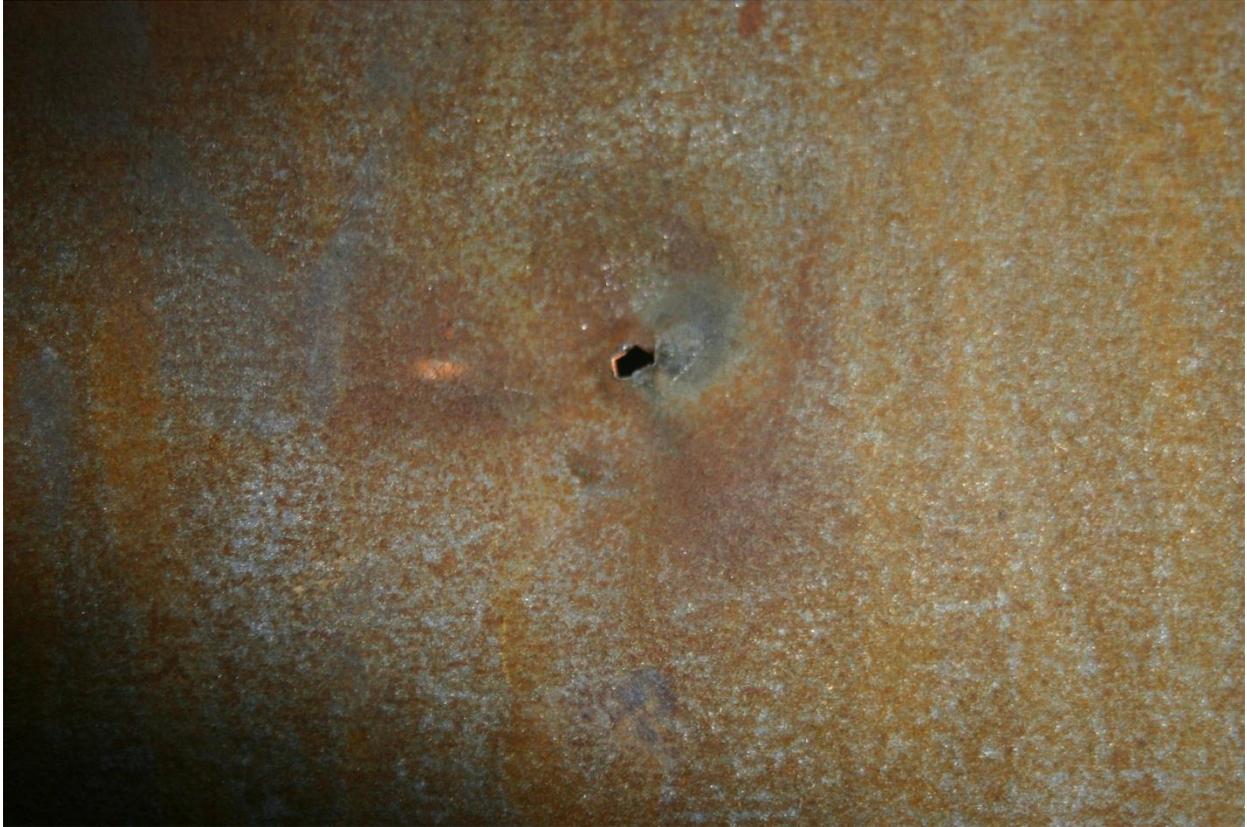
Photo #5 of 6

Williams' 8-inch Wenatchee Lateral. The leak was at about the nine o'clock position and about 3/16 inch diameter hole.

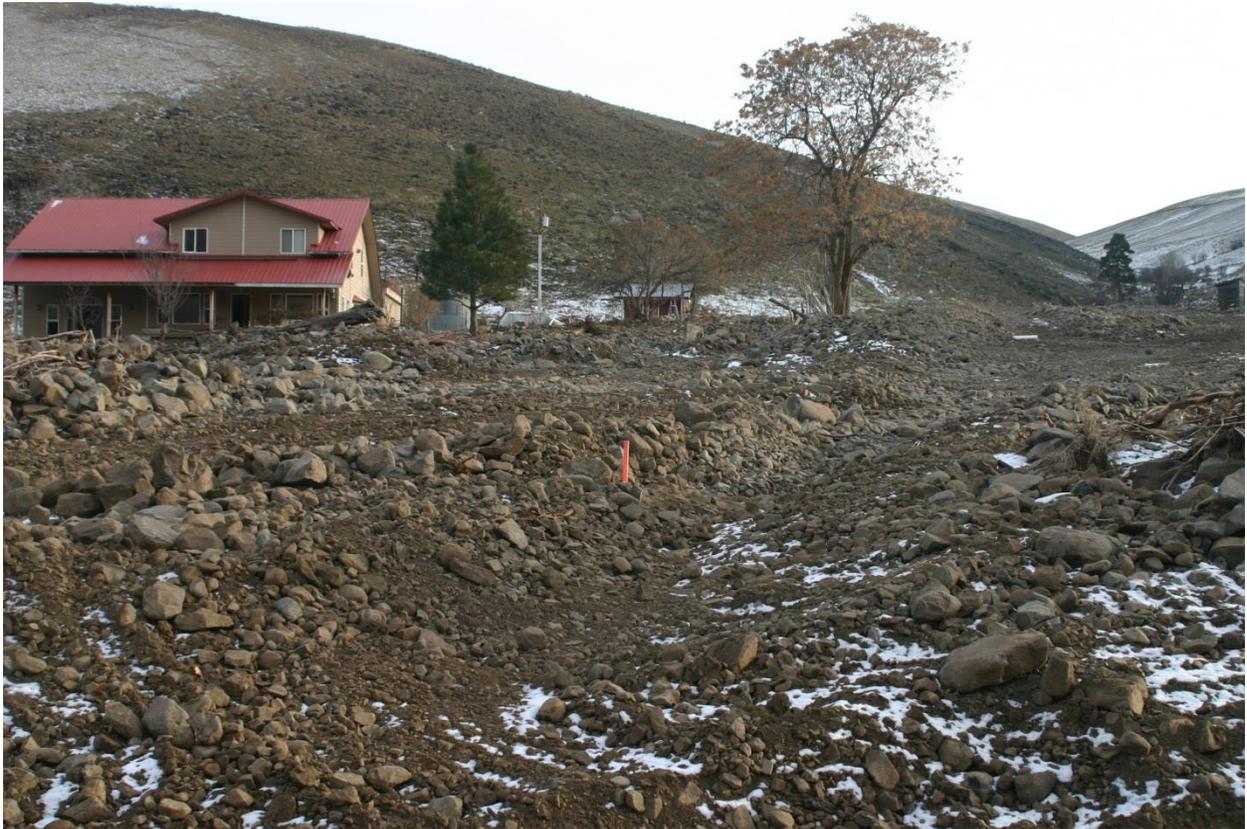
Photo #6 of 6

View of flood damage and debris flow from the August through October, 2013 storm near the Quincy lateral. The flood water washed out the Chelan County road at several locations.
