Bremerton District Field

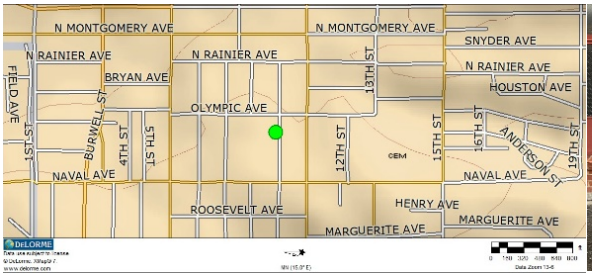
1. **Bremerton,** Meter #273854. 900 Olympic Ave, Naval Avenue School

Cathodic protection reading was -1.711v.

CNG provided the leak surveys of the right of way surrounding the school and grounds as a HOS or area.

CNG provided 2 AC surveys of the MSA.

No issues.

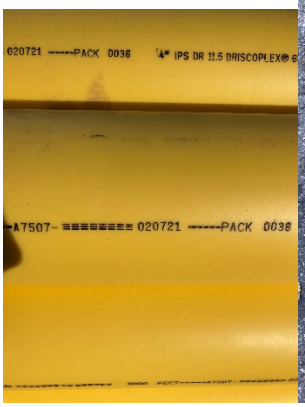
5. **Bremerton**

CNG's pipe storage yard. All pipe and materials were properly stored and exposed to UV under 2 years. Two pallets of polyethylene pipe were exposed to UV over the time allowed and were marked for non use.
