# PLYMOUTH PLANT INCIDENT INVESTIGATION

# Overview

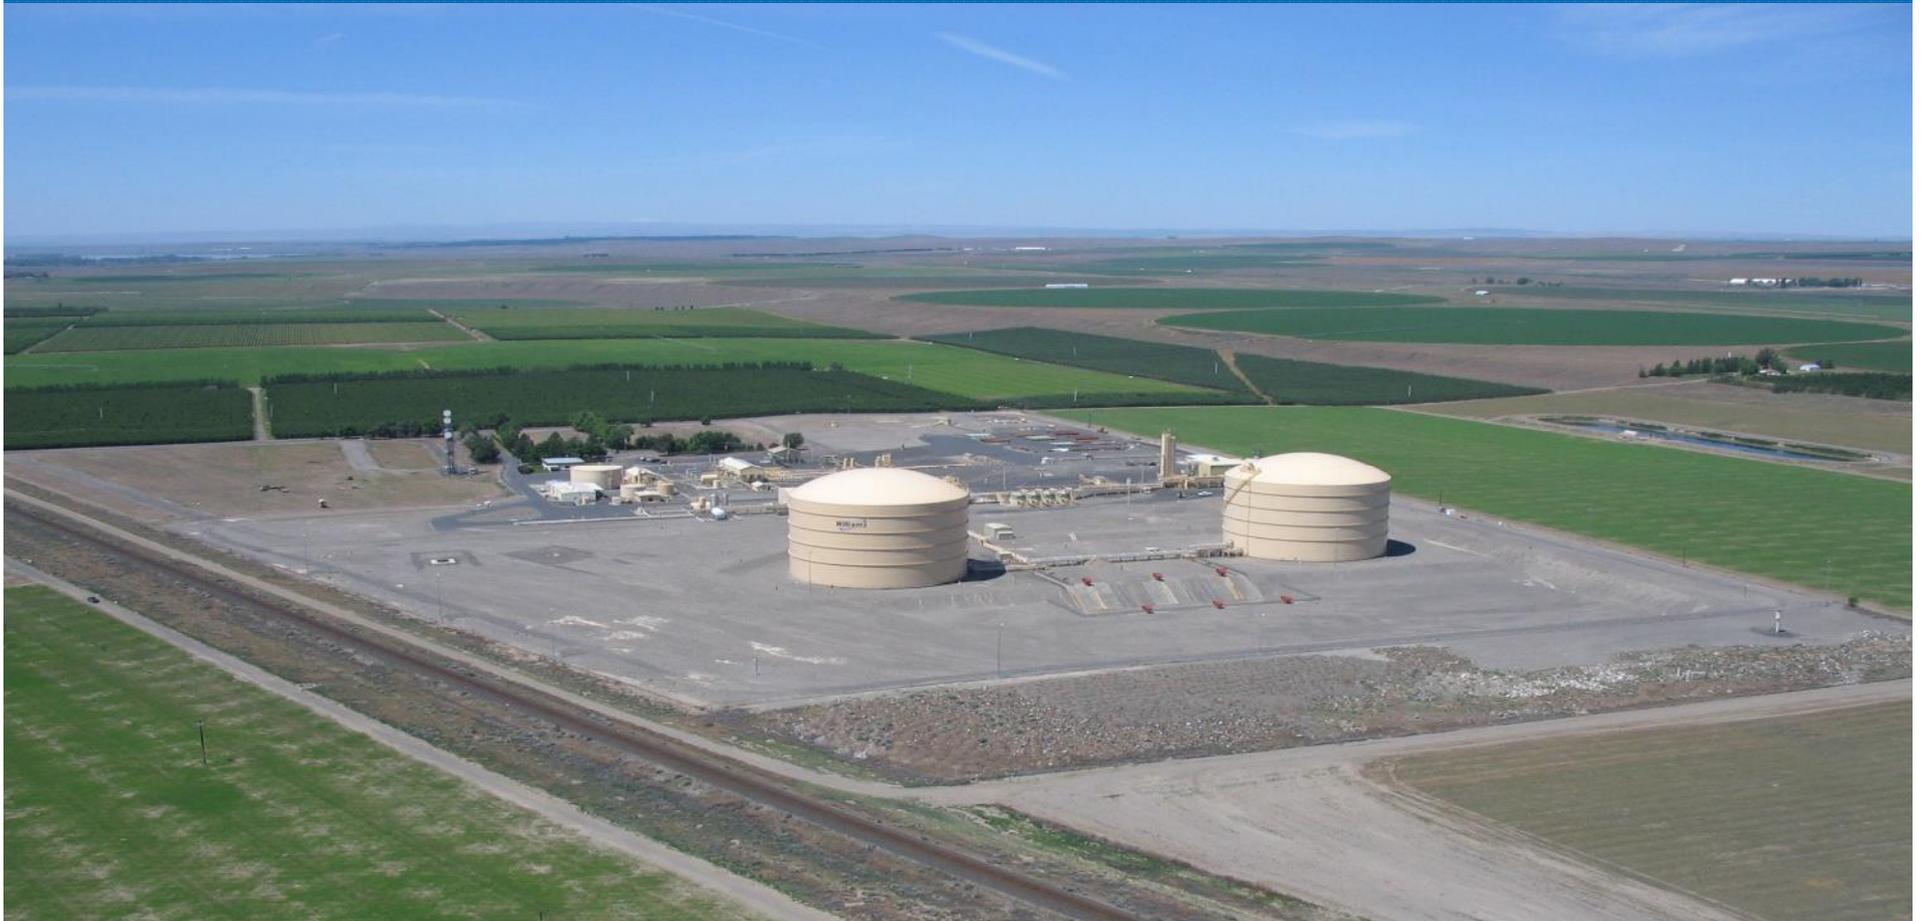
Outer Tank Wall Penetration  
Gas Vapor Leak

Damaged Boil Off Piping  
Small Fire

Damaged 1/2" Fitting  
LNG Leak

Damaged 1" Pipe  
Gas Leak

Damaged 10" Pipe  
Gas Leak

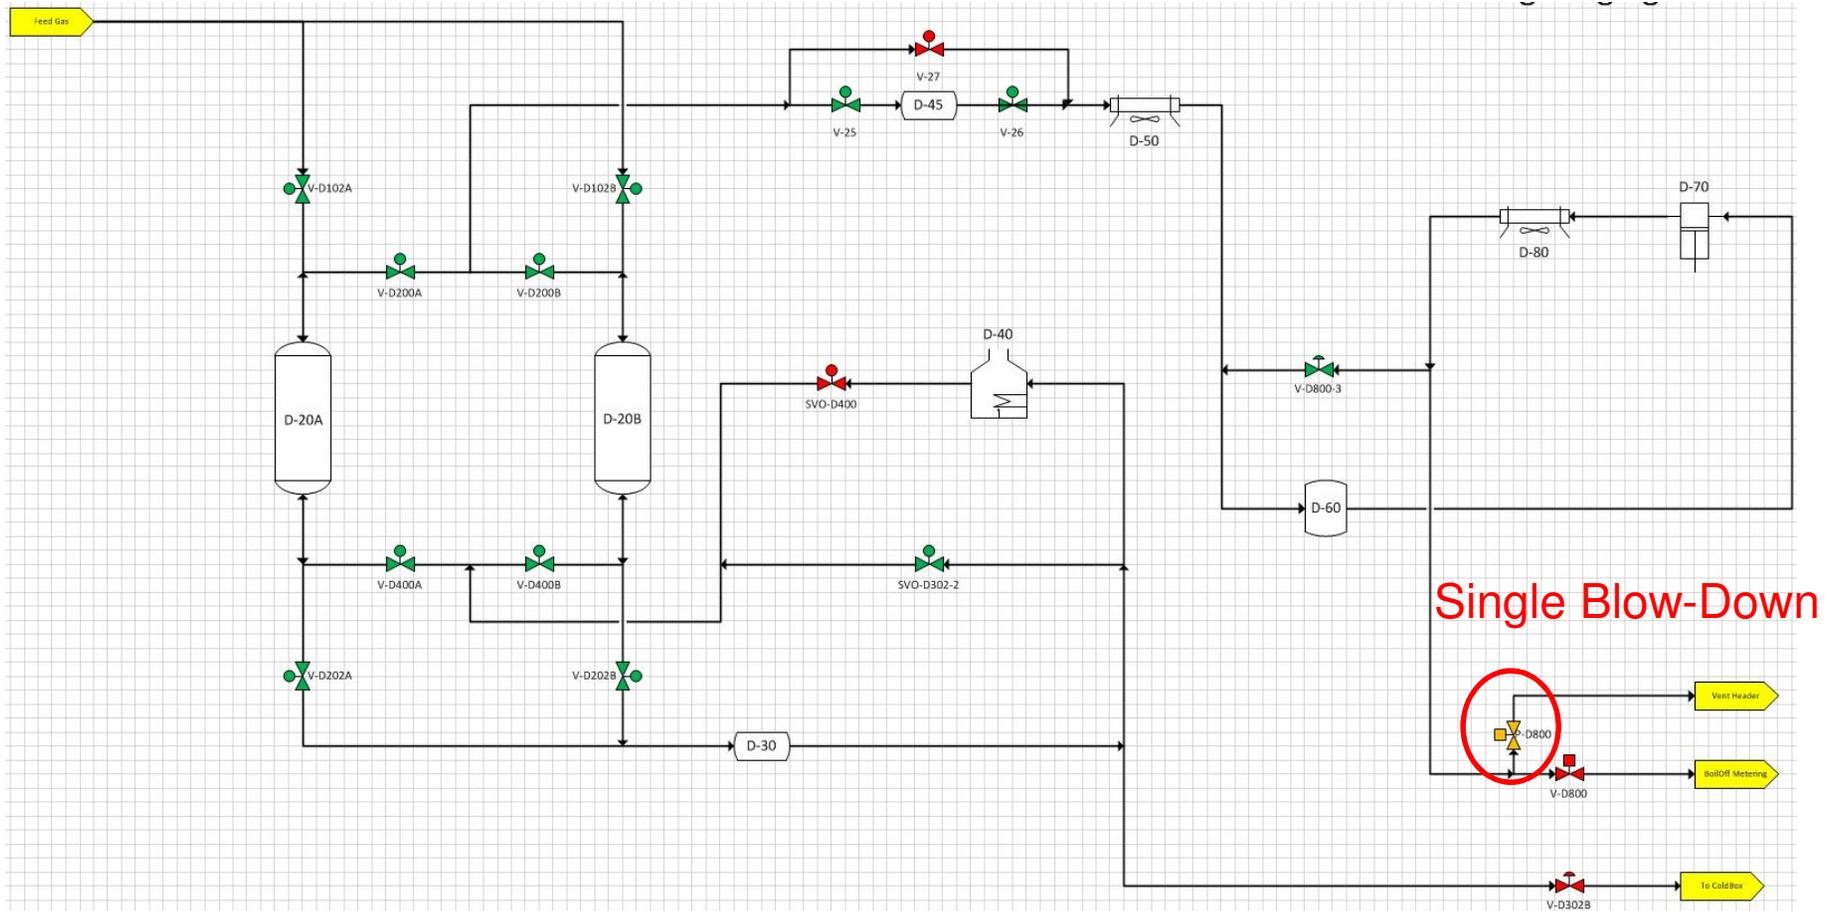
- In the start-up section of the Purification System Procedure it calls for a specific valve alignment and a **“Pack and Purge to 100 PSIG 3 times”**
- Before purification system is started each season purging was performed to remove oxygen that could have been introduced to the system during maintenance activities
- Equipment maintenance files demonstrated that (3) manual valves had been removed from the system for several months and were re-installed just prior to the March 31<sup>st</sup> start-up

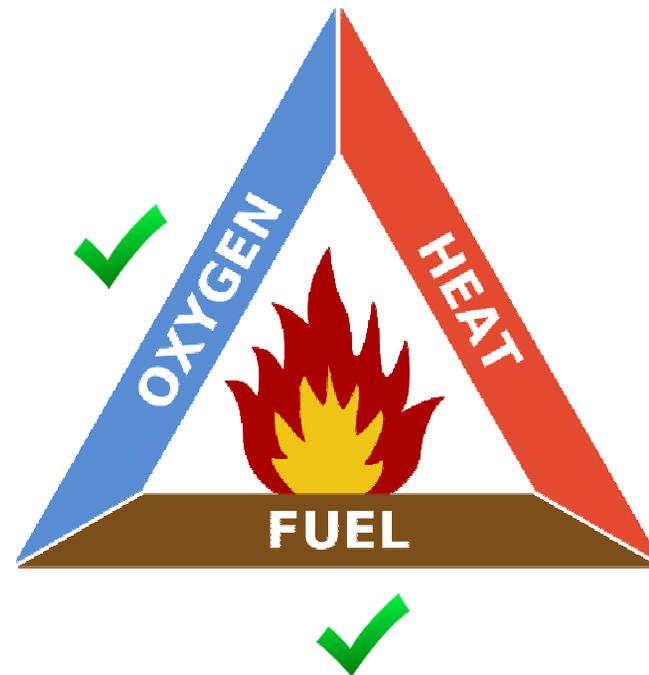
- “Pack and Purge to 100 PSIG 3 times”
  - Valve Alignment allowed for “spring effect” if not blown down to 0 psig
  - AGA: Purging Principles and Practice provides purging guidelines, however it doesn’t prescribe methodology for purging molecular sieve adsorbers.

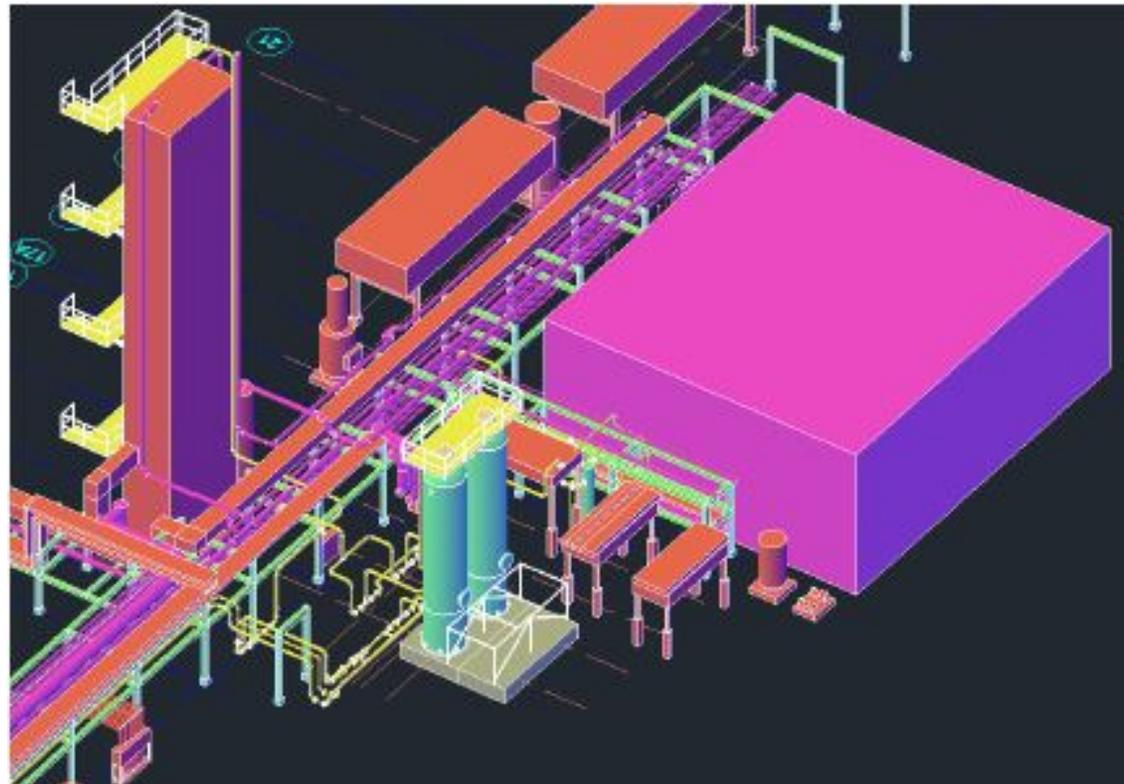
- With evidence that combustion was not internal to Adsorber D-20A the investigation team hired ABS to perform blast modeling in order to determine potential ignition locations

- Results identified the Salt Bath Heater inlet nozzle as the initial ignition location (identified as ignition location 5)

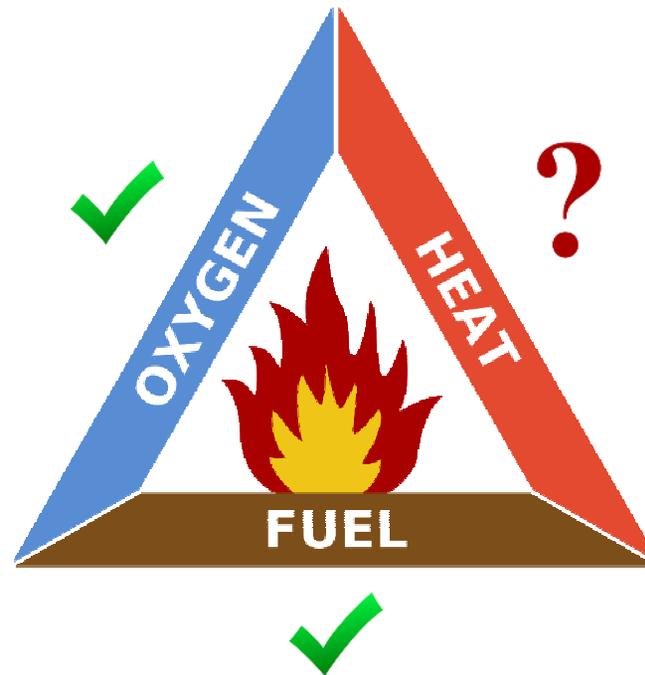
- Published values of the auto-ignition temperature of Methane is currently documented as ~1000-1100 deg F
- Salt Bath Heater set-point = 550 deg F

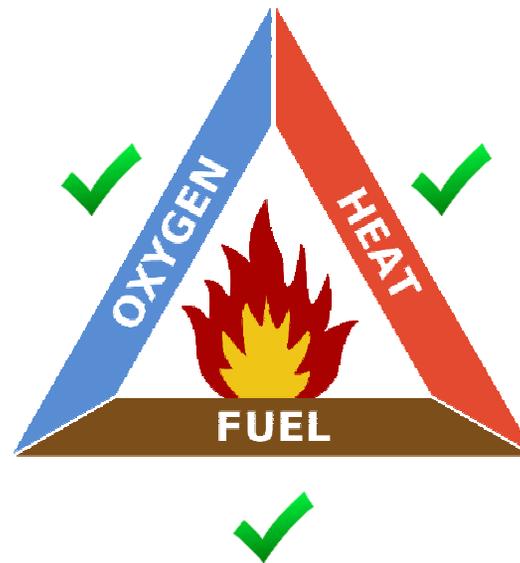
- The lack of a complete purge left an air and natural gas mixture in plant piping downstream of the adsorber towers. During startup the flammable mixture was pulled into the salt bath purification heater where it then ignited, creating a rolling detonation back through the purification piping until it reached adsorber D-20A which then failed, dissipating the energy of the rolling detonation.

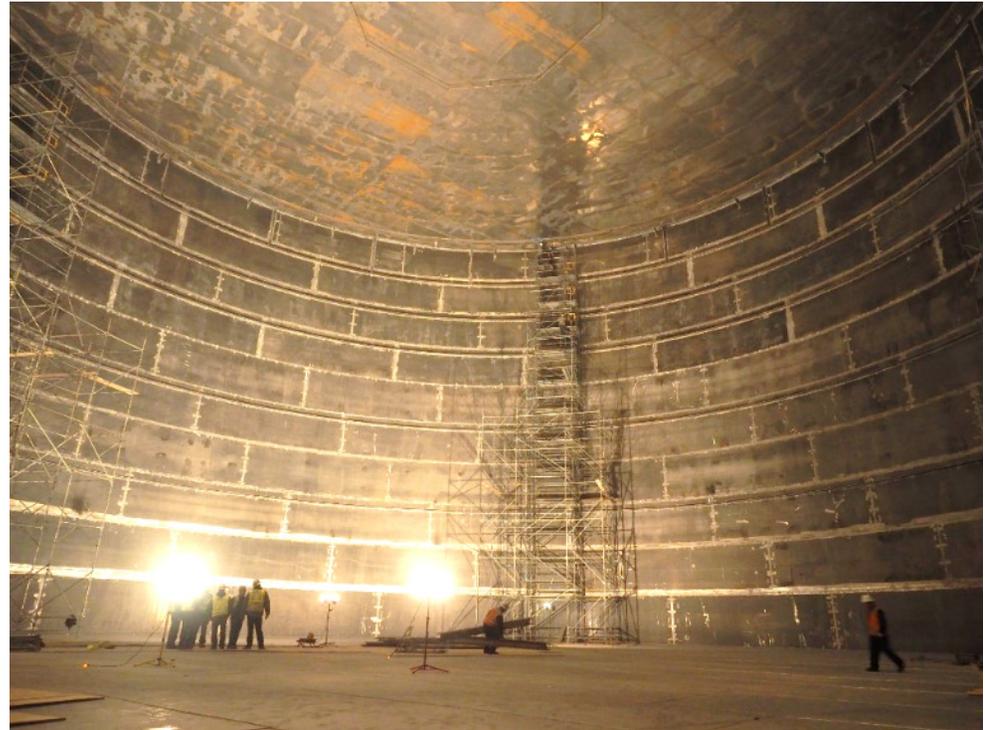
- API 653 inspections of the inner and outer tanks
- 4 full height quadrant inspections using penetrant (PT) and visual methods
- 100% shell to floor weld vacuum box inspection and sample penetrant and vacuum box inspections on the floor plates

- Dent indication on east quadrant was characterized using electromagnetic residual stress sensors and laser scanning. Fitness for service was performed by Stress Engineering. The dent was repaired by blend grinding and was made safe for continued operation
- External foundation inspection
- Roof support bolts inspected by Chicago Bridge and Iron
