UTC Incident Investigation Form

Notification ID:	3199	Investigation ID:	7508
NRC#	1186063

Operator:	McChord Pipeline Company, OPID 31049
District/Unit:	McChord Pipeline Company 3001 Marshall Ave, Tacoma, WA 98421
Locations:	100 th St at A St Tacoma, WA
Incident Dates:	August 2, 2017

Summary:

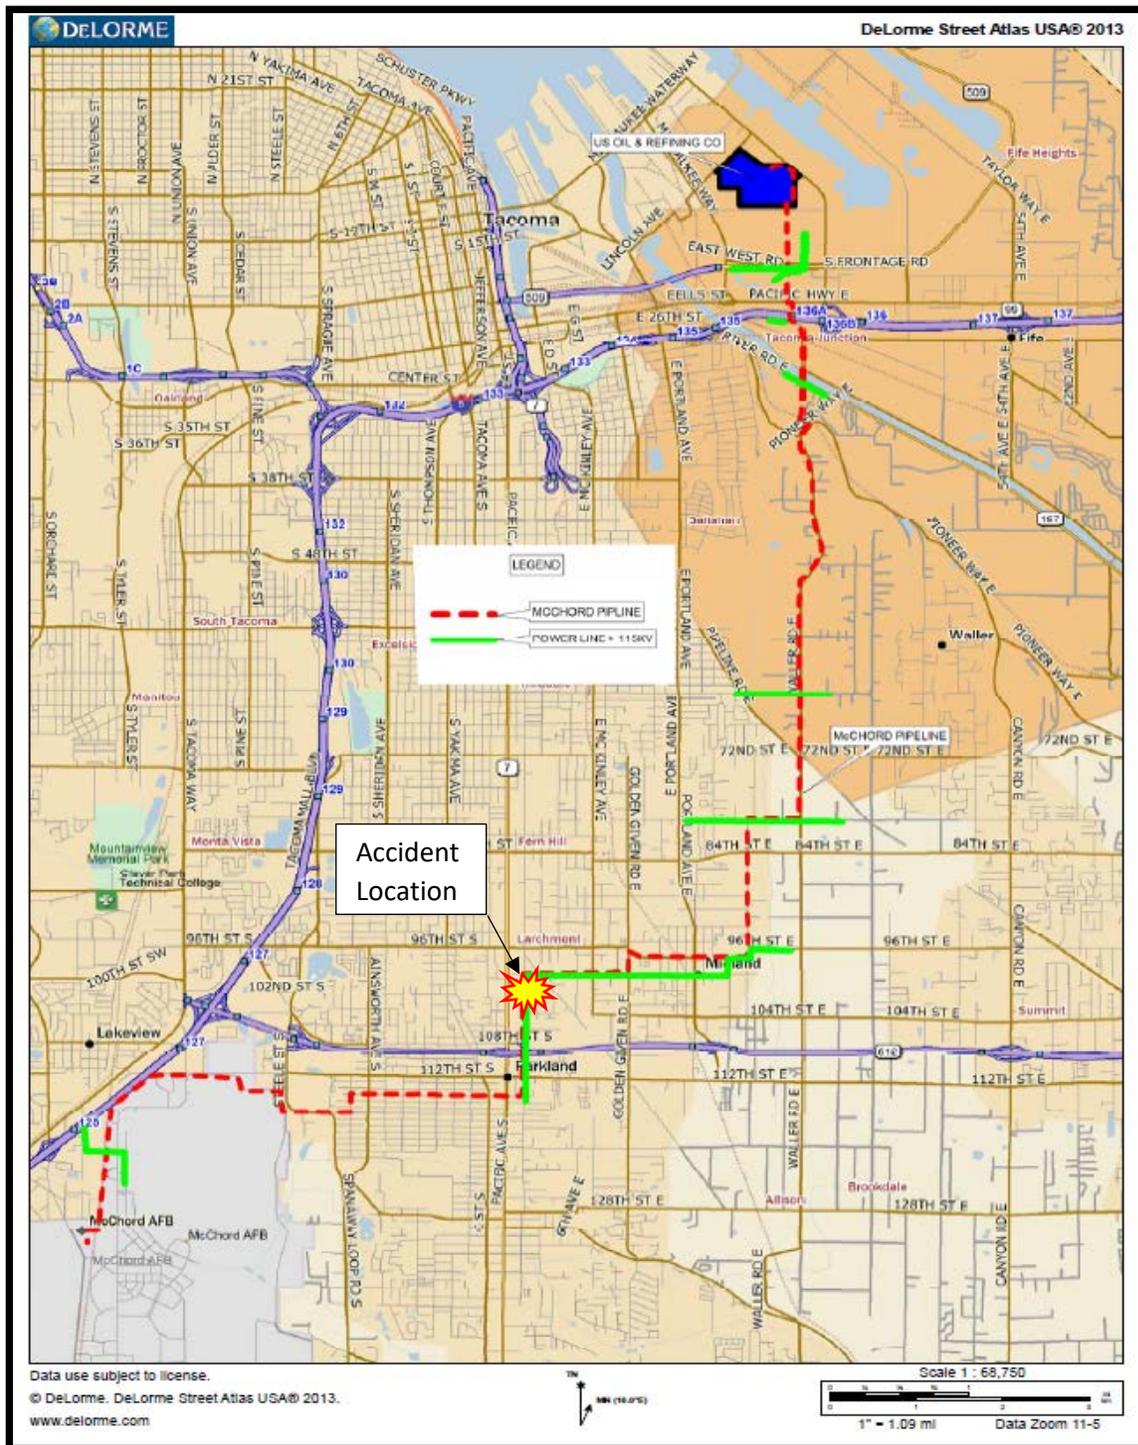
Figure 1—McChord Pipeline (red dashed line)

The McChord Pipeline is an intrastate, hazardous liquid pipeline 14.25 miles in length. The pipeline transports jet fuel (JP-8) from US Oil Refinery (USOR) located in Tacoma's industrial area in the tide flats to the McChord AFB (now Joint Base Lewis McChord or JBLM) (**Figure 1**). It was constructed in 1966 of 6-inch nominal diameter, grade B steel pipeline with wall thickness ranging from 0.188 inch to 0.432 inch. The pipeline has a 720 psig MOP (36% SMYS) with a normal operating pressure at 450 psig (21% SMYS). The pipeline is divided into four sections with isolation valves between each section (**Figure 2**). The entire pipeline is within a HCA. There is approximately 400 feet of elevation gain from USOR to McChord AFB (JBLM). Jurisdiction begins at the pump suction valves (P-1401) and ends at the custody transfer manifold valves downstream of the meters at McChord (JBLM). The pipeline was hydrostatically tested in 1996 and inline inspected by GE in 2004

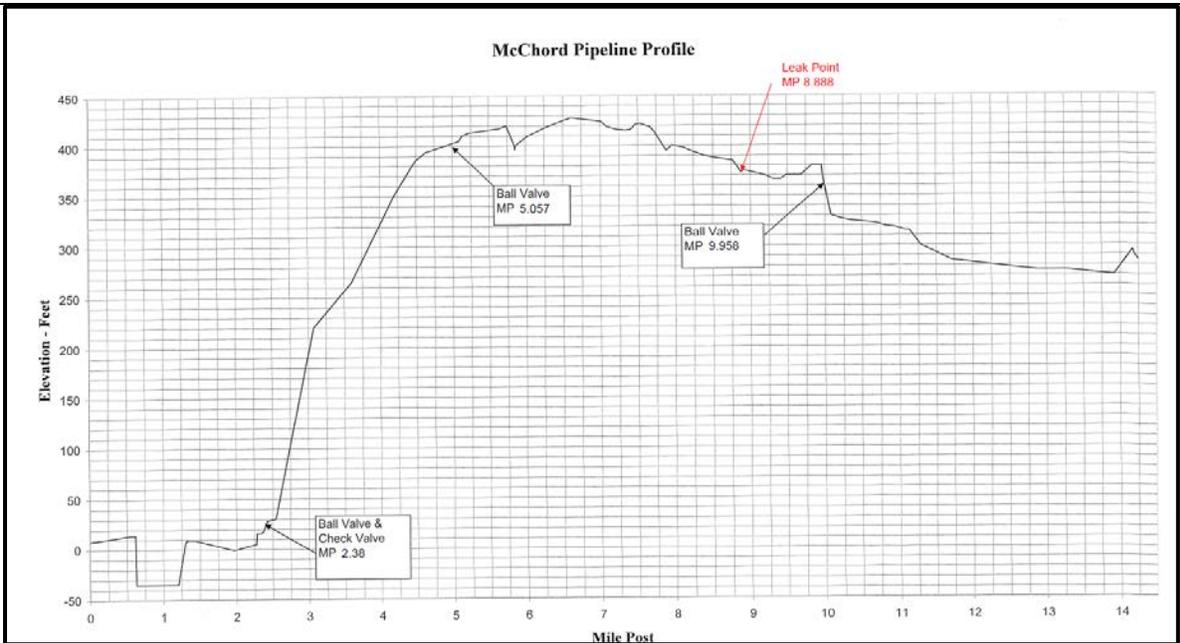
Figure 2 McChord Pipeline Elevation Profile

At 12:45 USOR closes the downstream valve (MP 9.958) from the leak location, followed by the upstream valve (MP 5.057) at 12:54 (**Figure 2**). USOR activated their emergency response plan getting personnel and oil spill removal organizations (OSROs) organized and in route. USOR stages their clean-up crews on site and begins product recovery and assessing steps to access the line for repair (**Photo 1-6**).
