**McCHORD PIPELINE CO.**

September 21<sup>st</sup>, 2017

**Damage to McChord Pipeline  
at 100<sup>th</sup> and A Street  
Tacoma, WA**

Nicholas D. Peelo  
Chief Engineer  
McChord Pipeline Co.

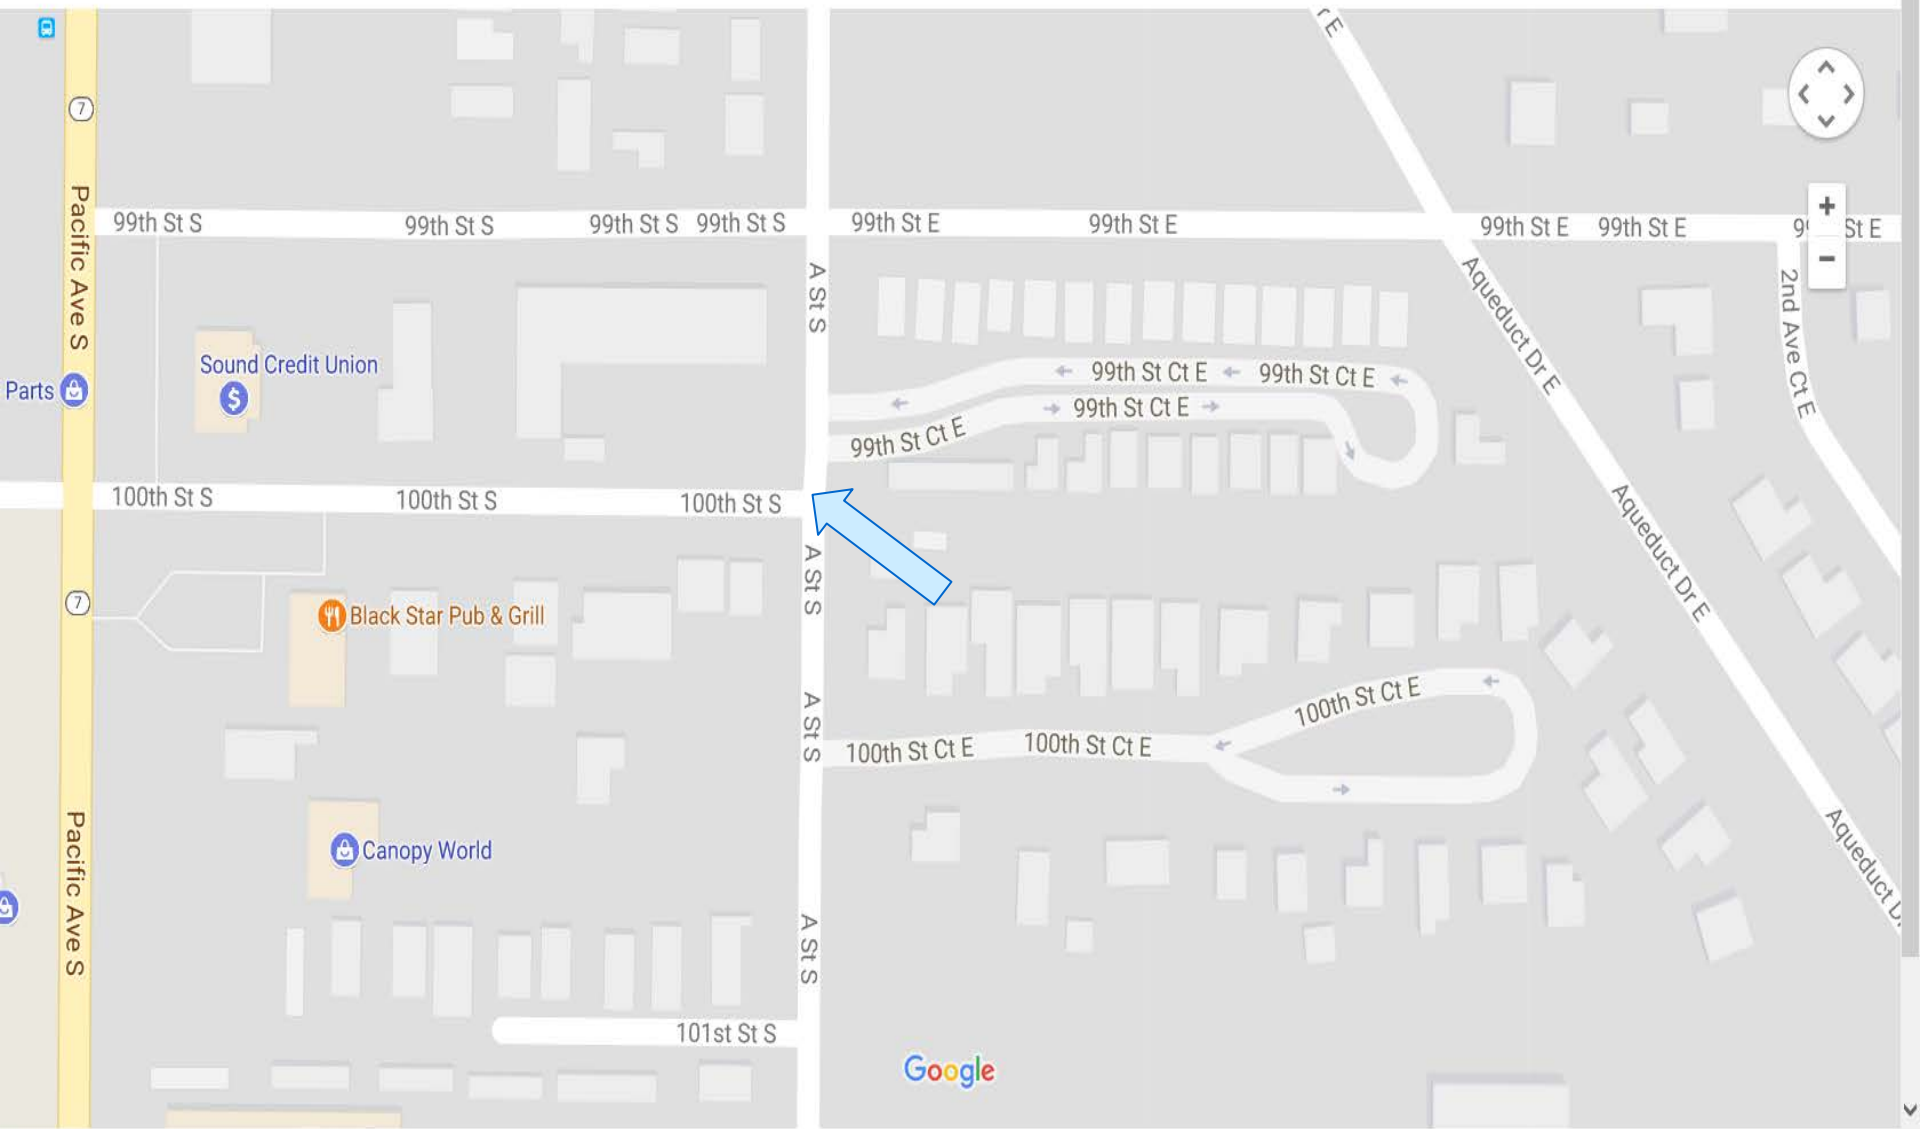
# Damage Location

- ❖ On 8/2/17, USOR was in the process of transferring 10,000 bbl of jet to JBLM (about 34% complete)
- ❖ At approx. 1212, MPL was damaged by a directional drill operated by SEFNCO, a 3<sup>rd</sup> party contractor installing cable TV for Comcast
- ❖ Pipeline was punctured causing a spill of jet fuel west along 100<sup>th</sup> St and north / northwest into parking lot and landscaping for adjacent apartment complex

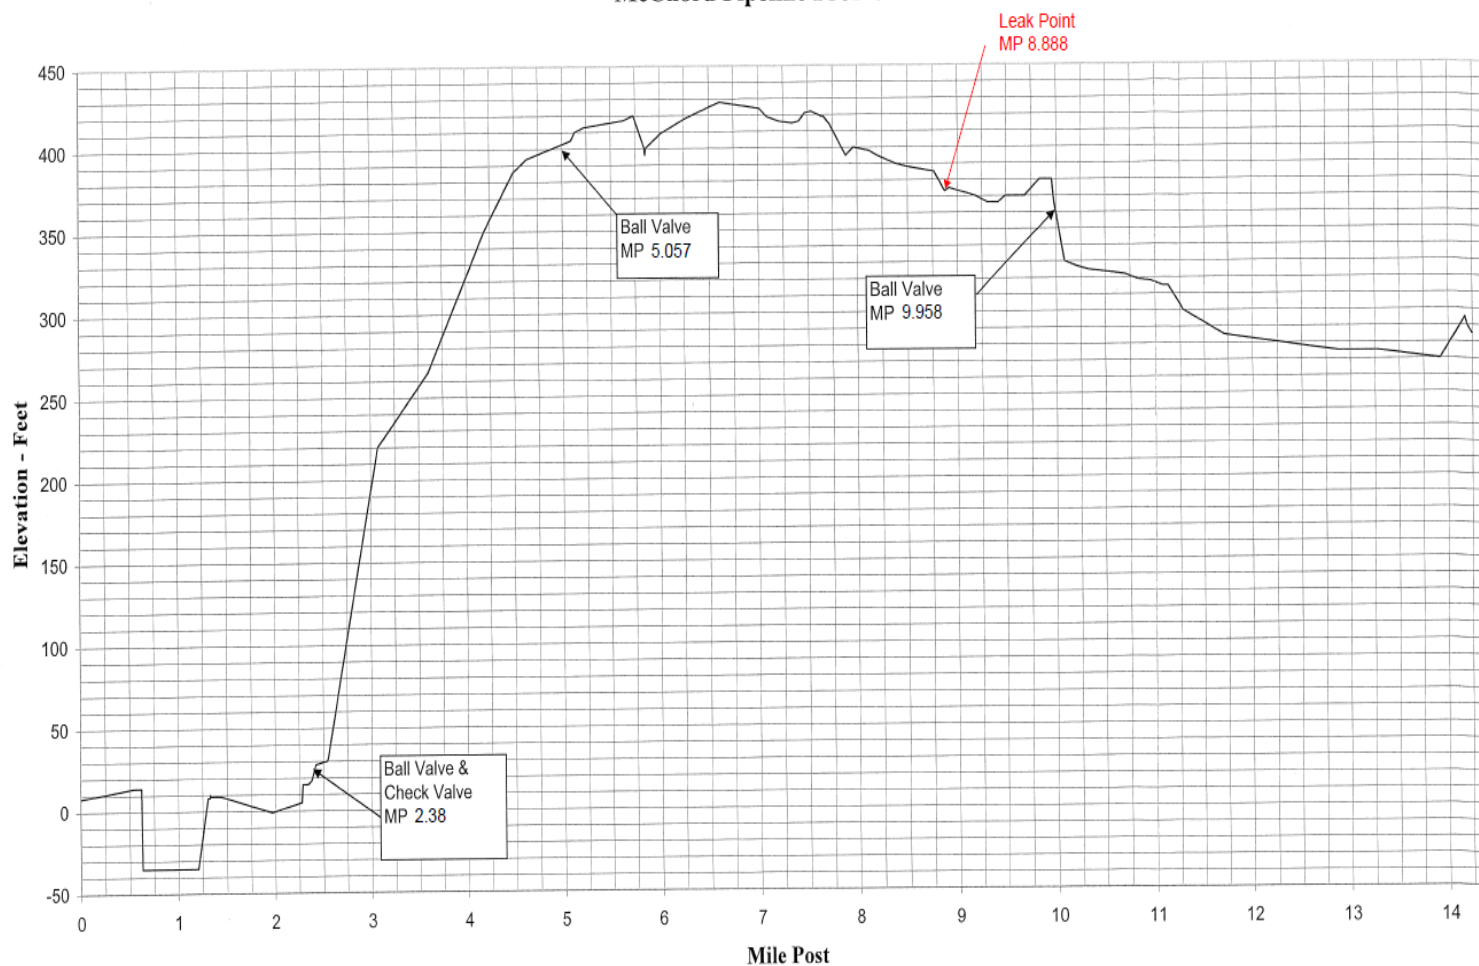
# Elevation Profile

- ❖ Valves were opened on either side of the leak point to drain jet towards the AFB, and USOR

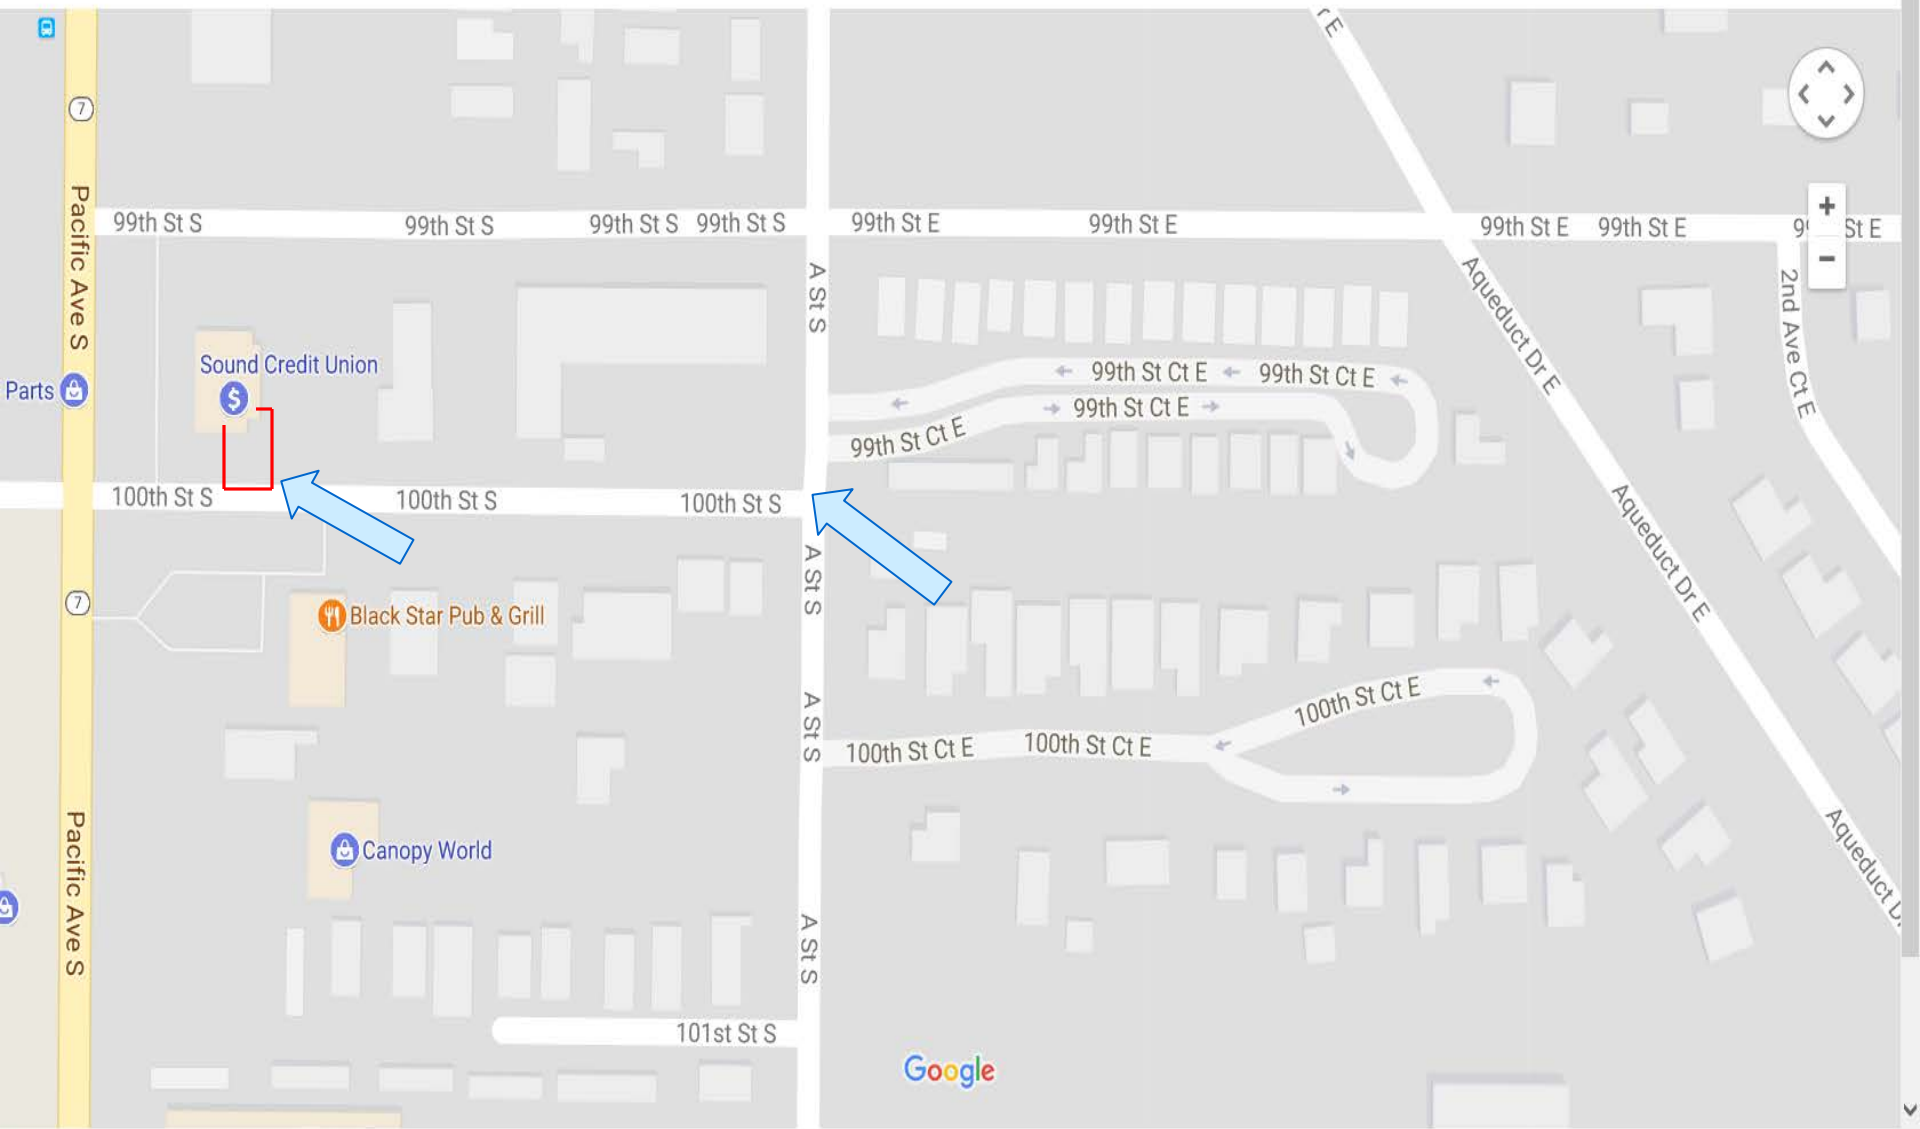
# Damage Location and Marks

- The root cause of the damage to MPL and subsequent jet fuel leak is inadequate location marking by a third party contractor, SEFNCO
- SEFNCO did not follow the marking requirements spelled out in RCW 19.122.030, and did not contact MPL when they marked the intersection of 100<sup>th</sup> and A Street less than one day before the incident. A damage report has been filed with the WUTC to this effect
