PHMSA/Inspector Training & Qualification

Inspection Findings!!

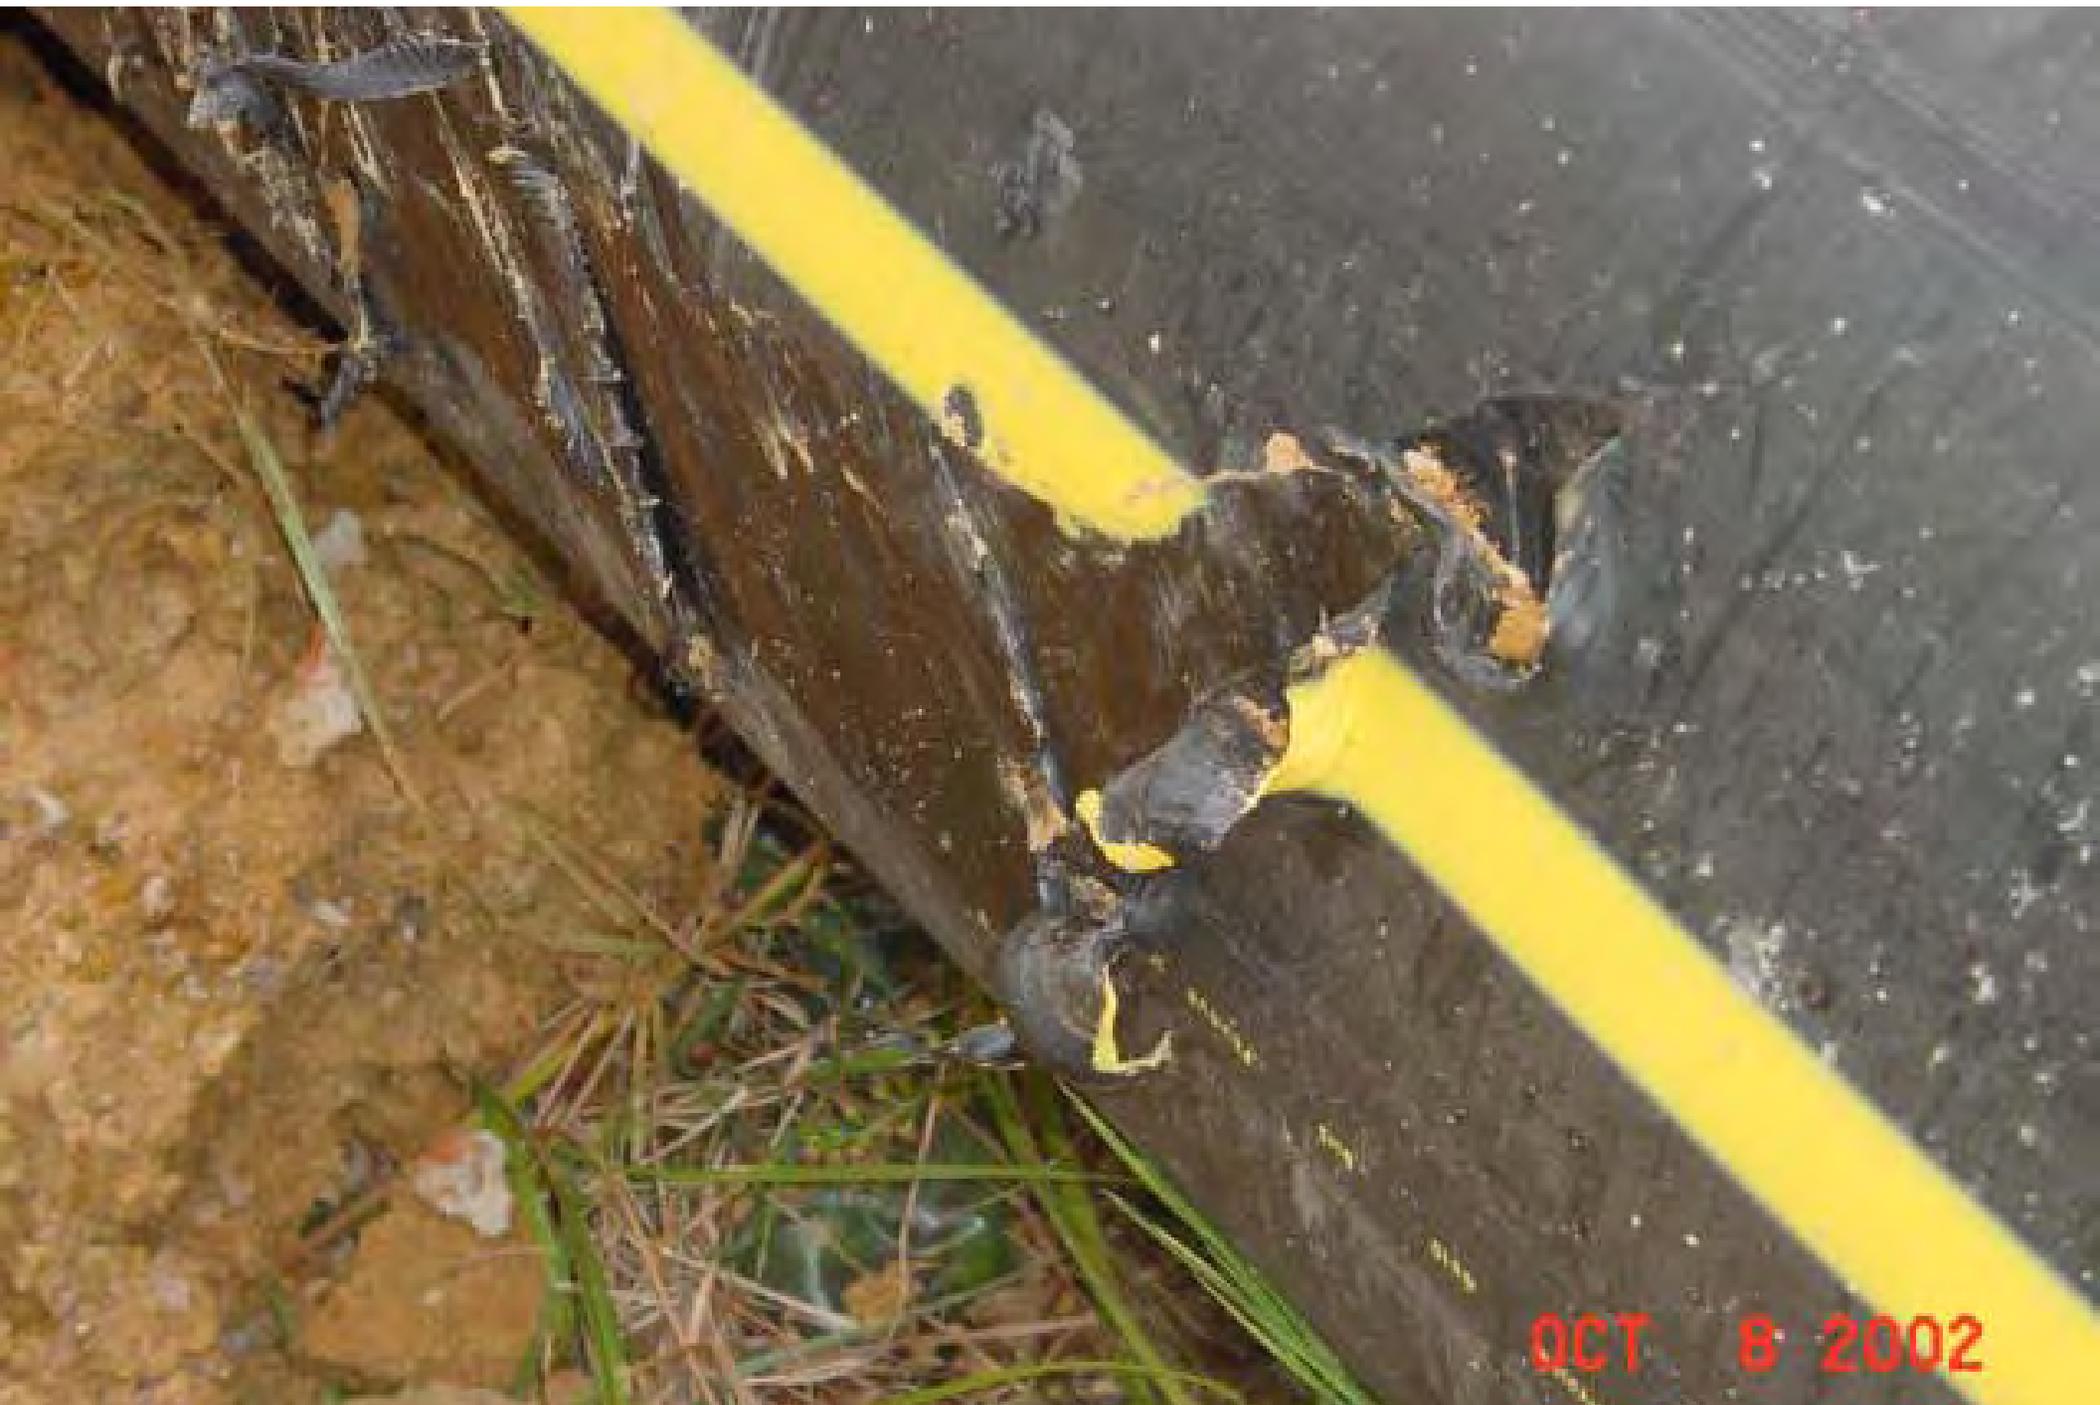
Bad Hair Day

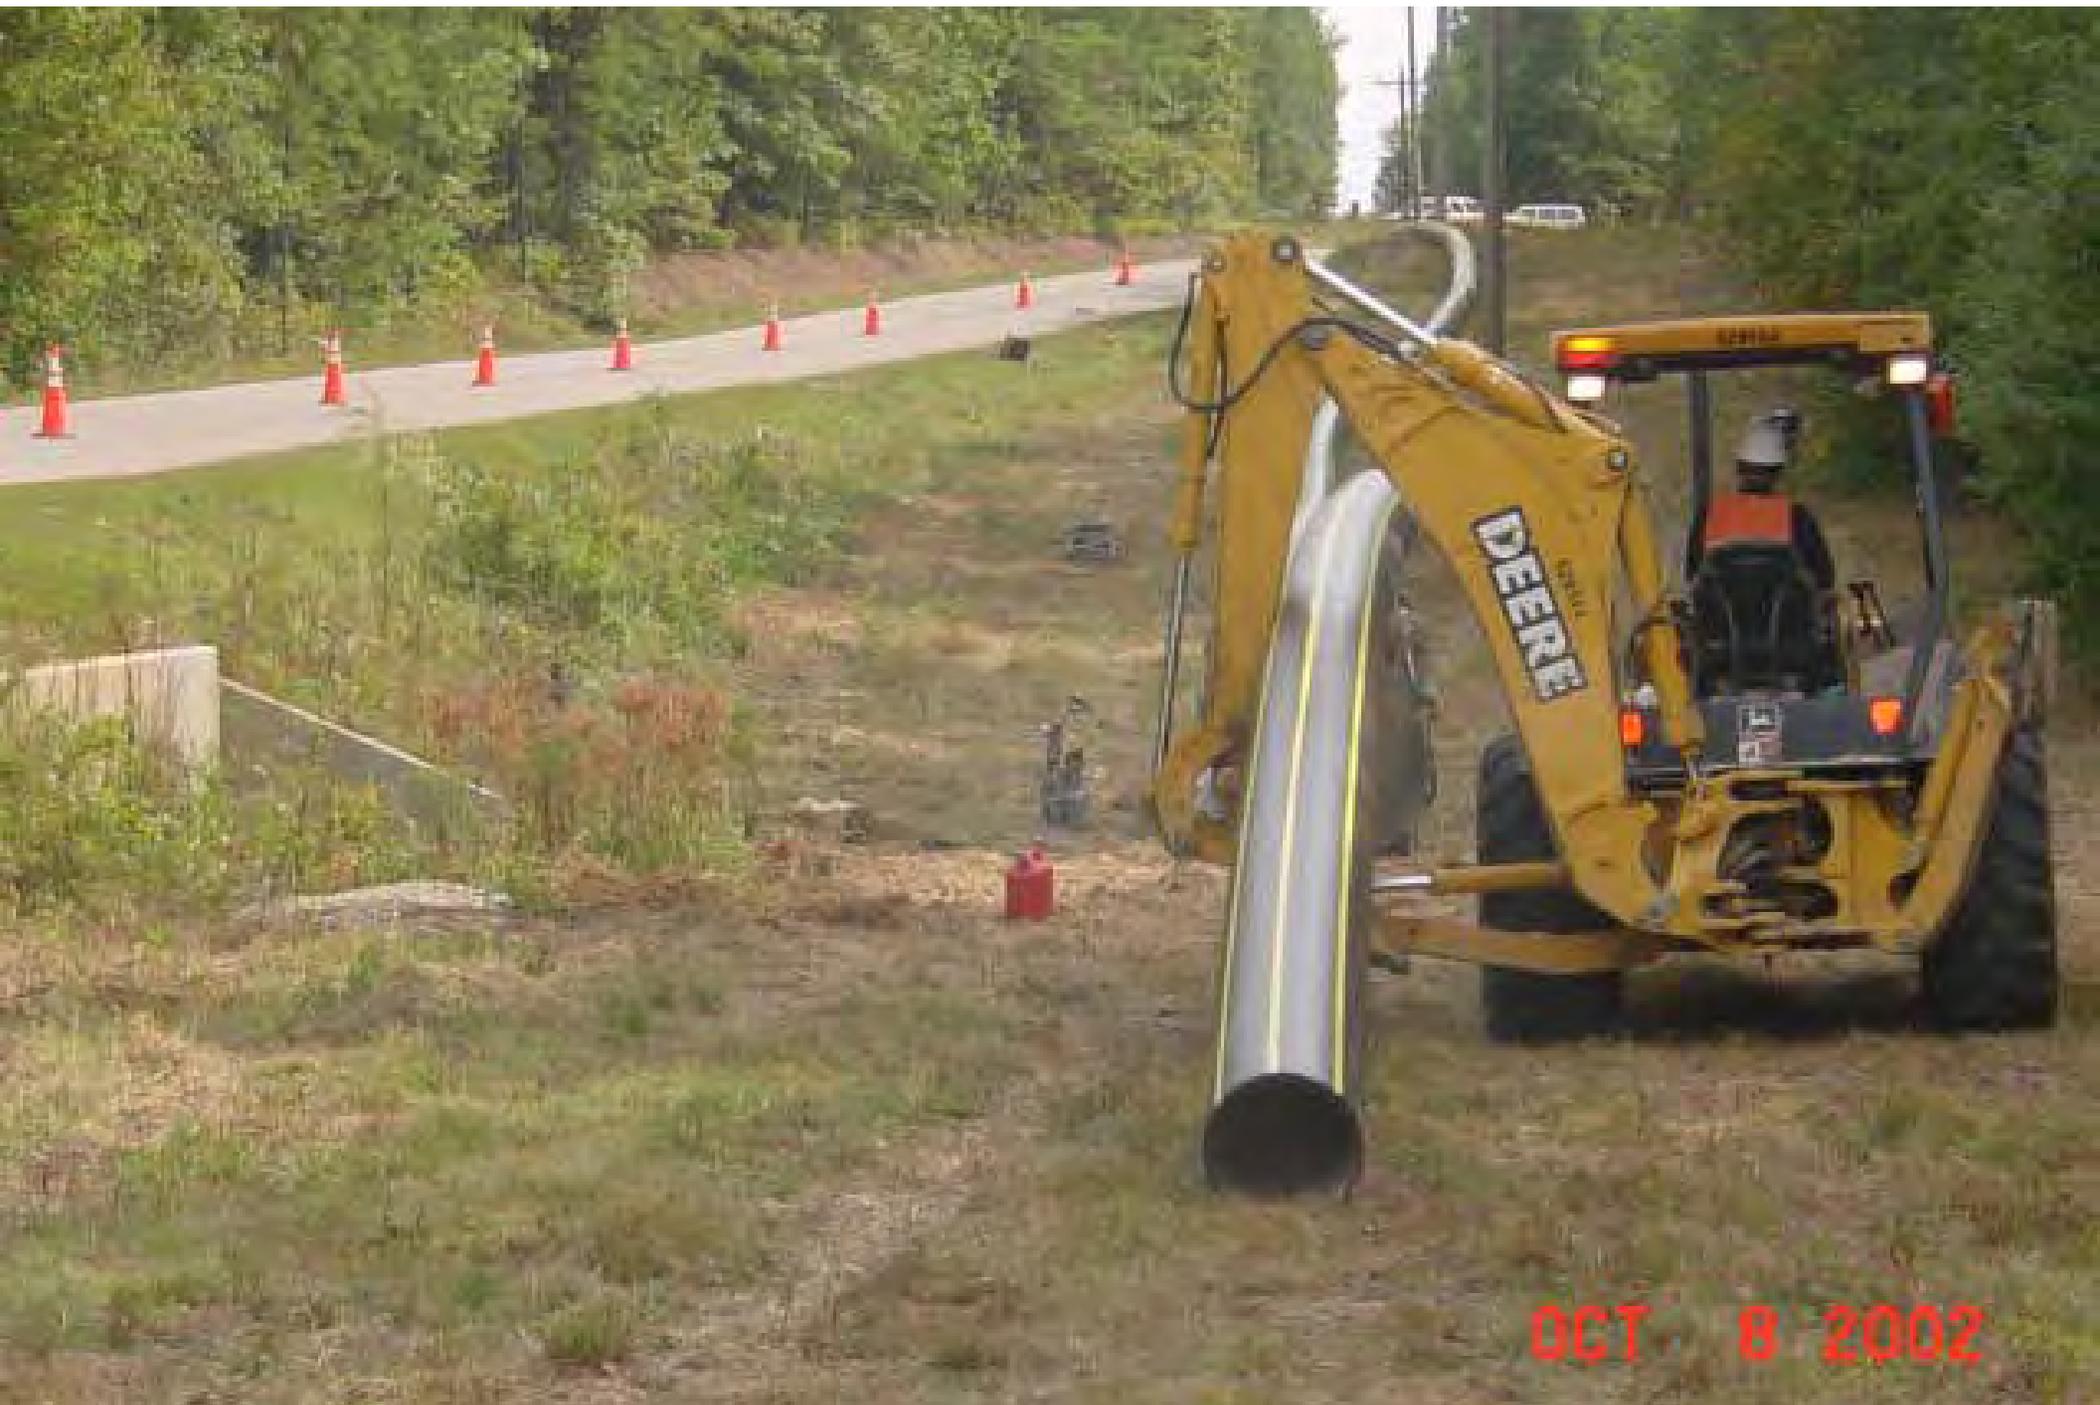
Subpart G – Construction

- Requirements for Mains - §192.311 - Repair of Plastic Pipe

Each imperfection or damage that would impair the serviceability of plastic pipe must be repaired or removed.

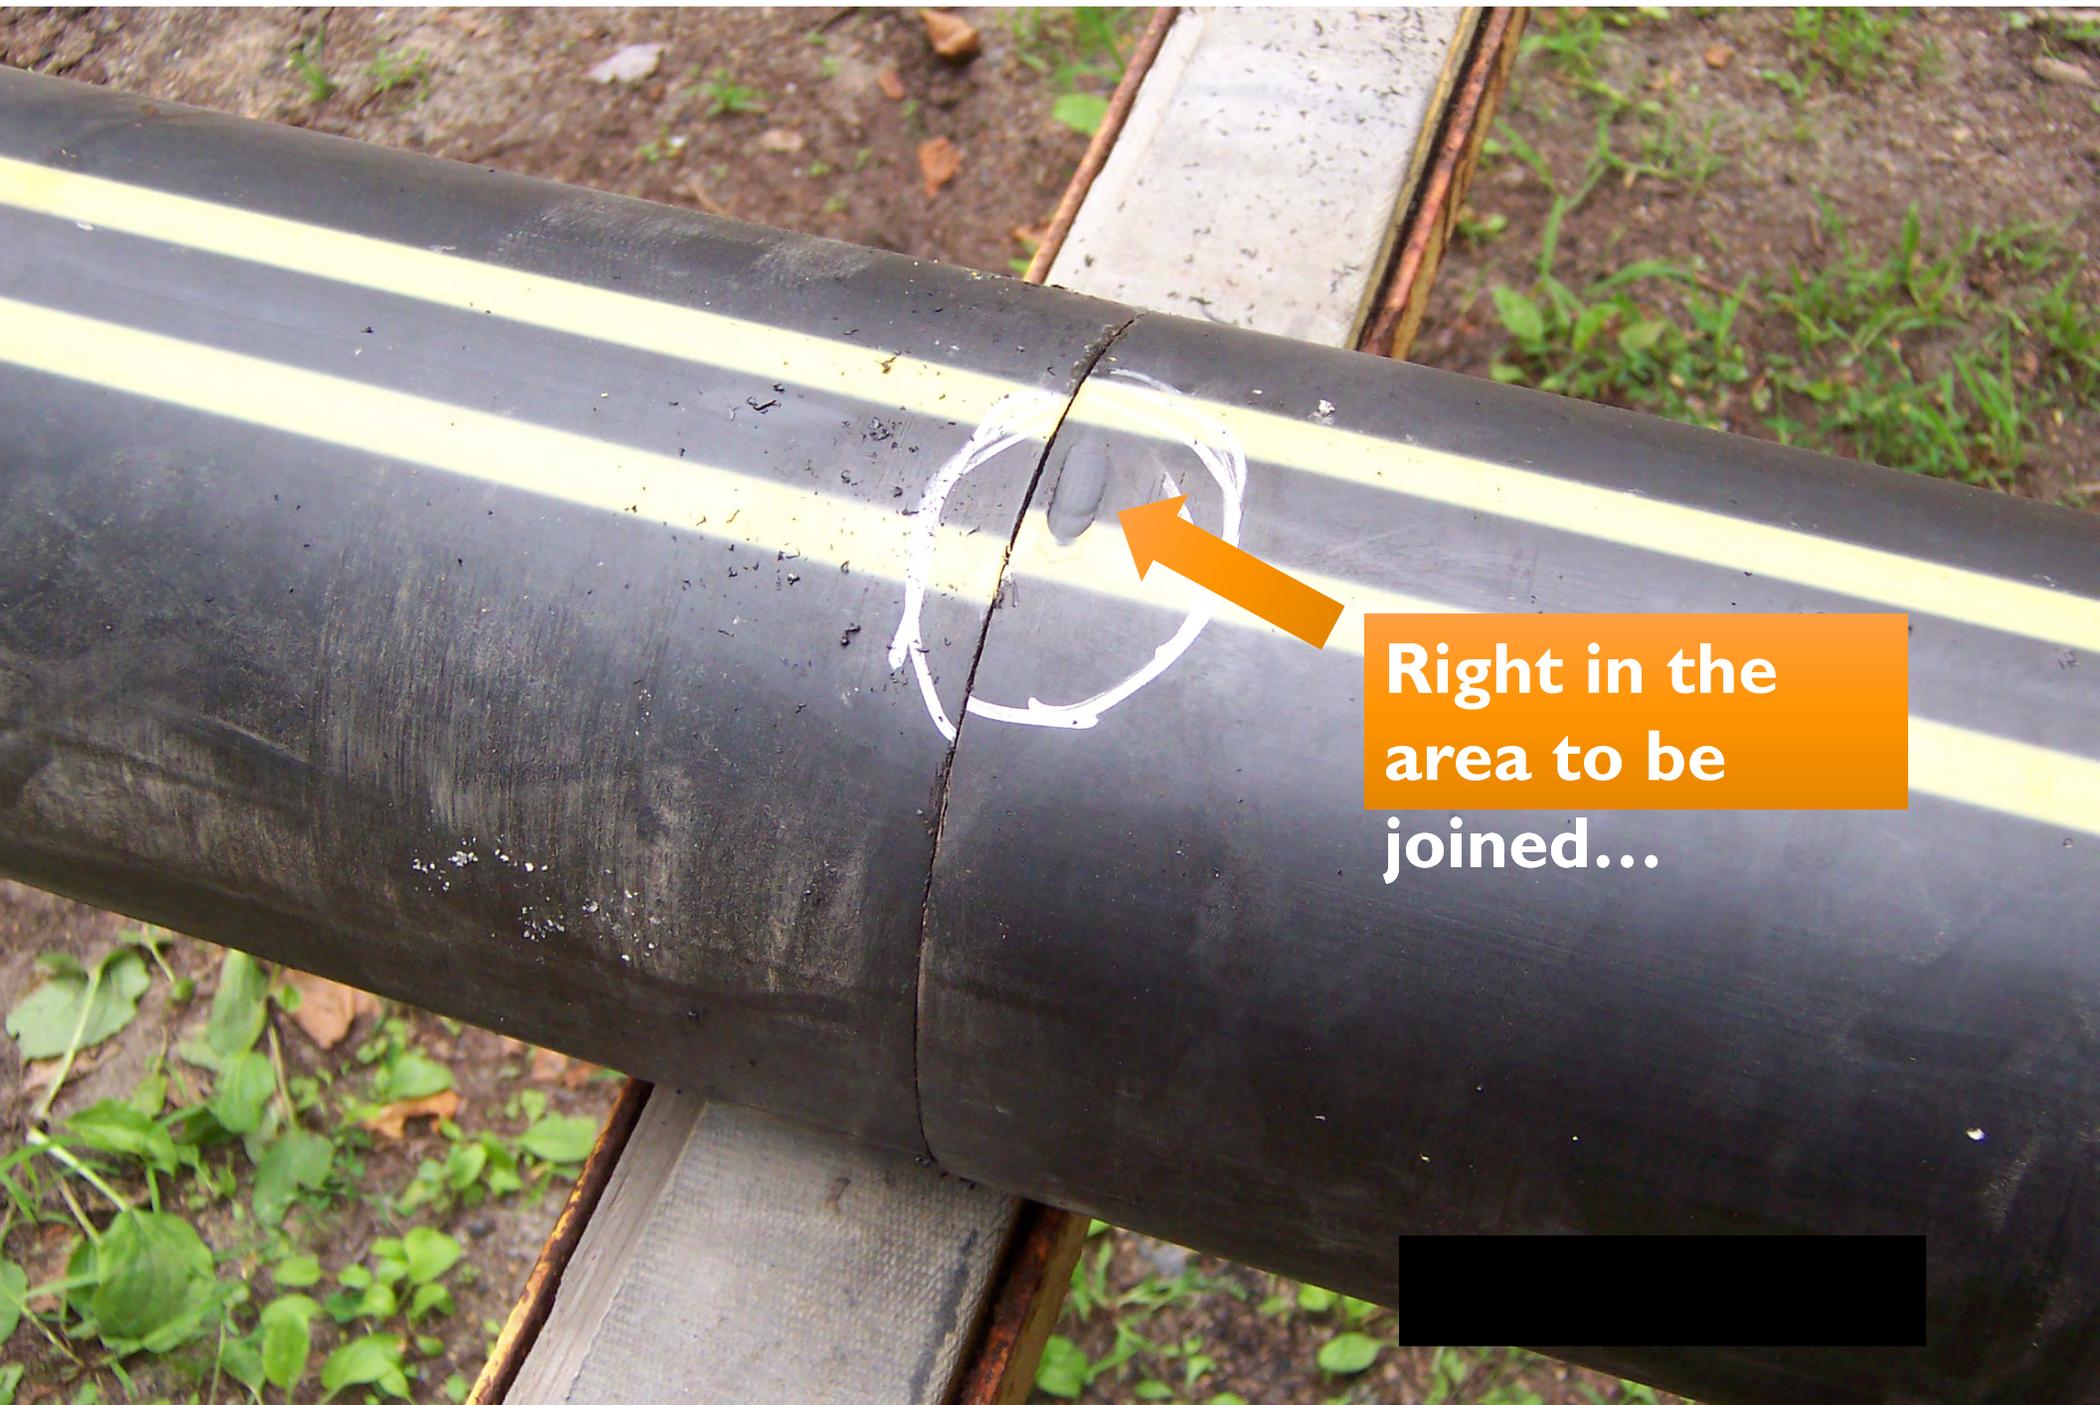
**Right in the
area to be
joined...**

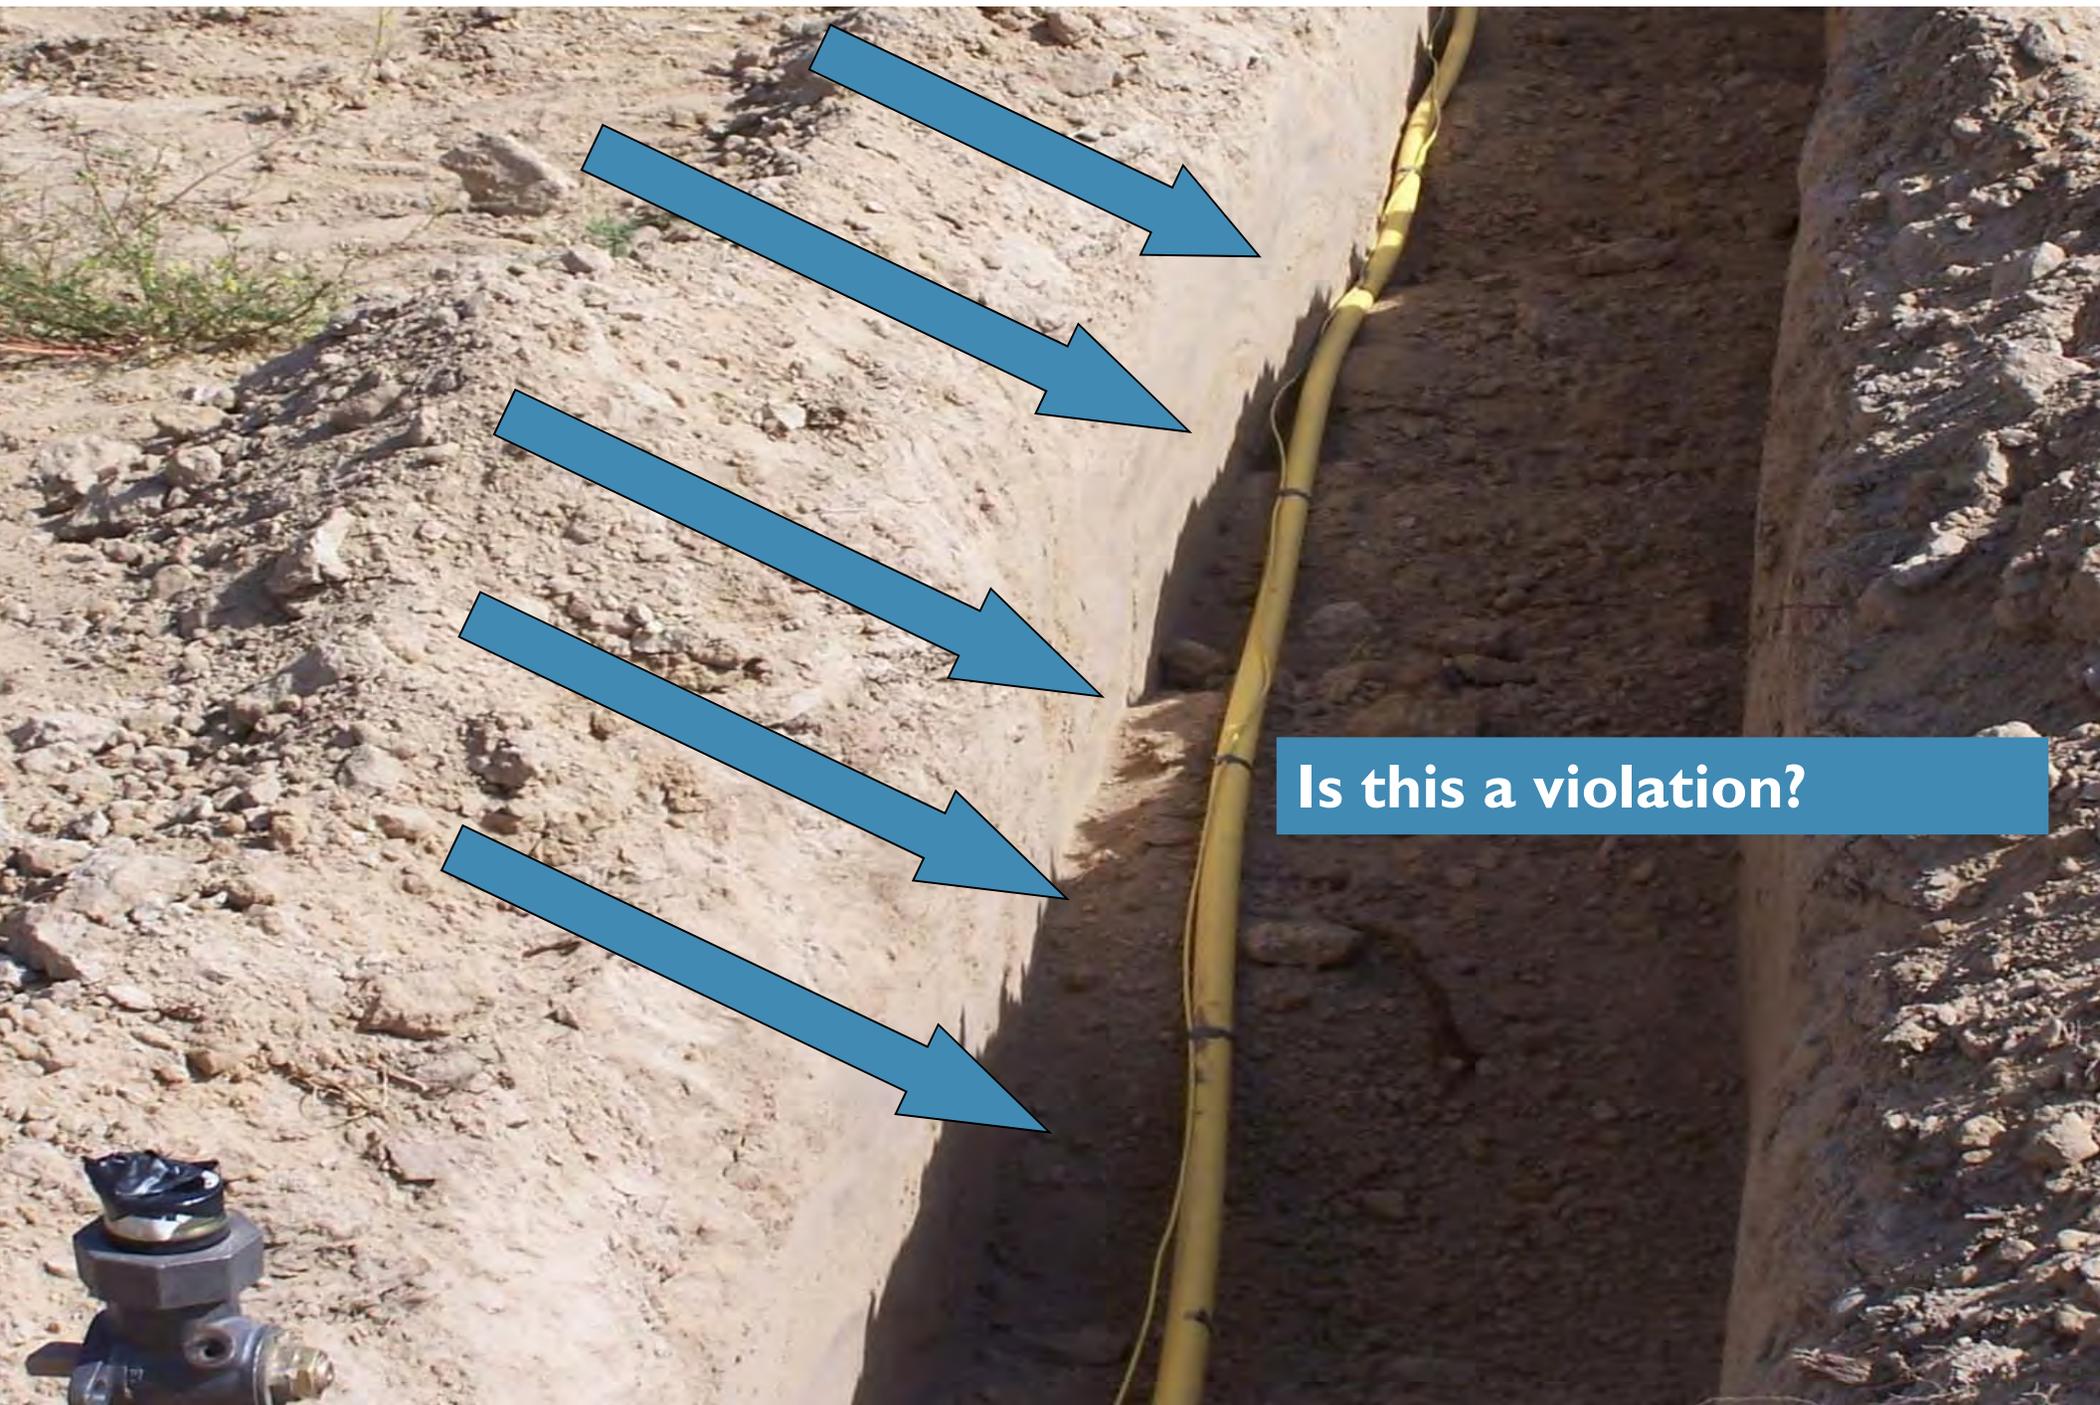
Is this a violation?

§192.321(e) Installation of Plastic Pipe

- ...tracer wire may not be wrapped around the pipe and contact must be minimized, but is not prohibited

How is this line going to be marked?

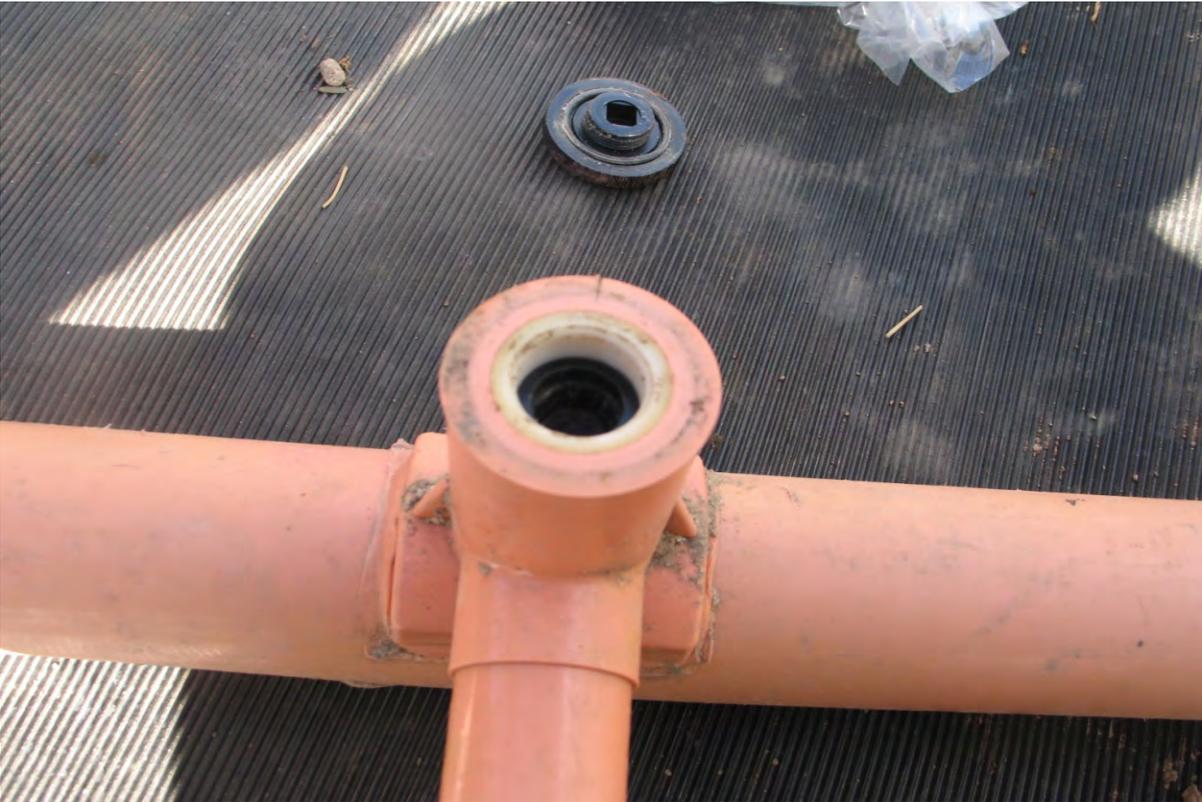
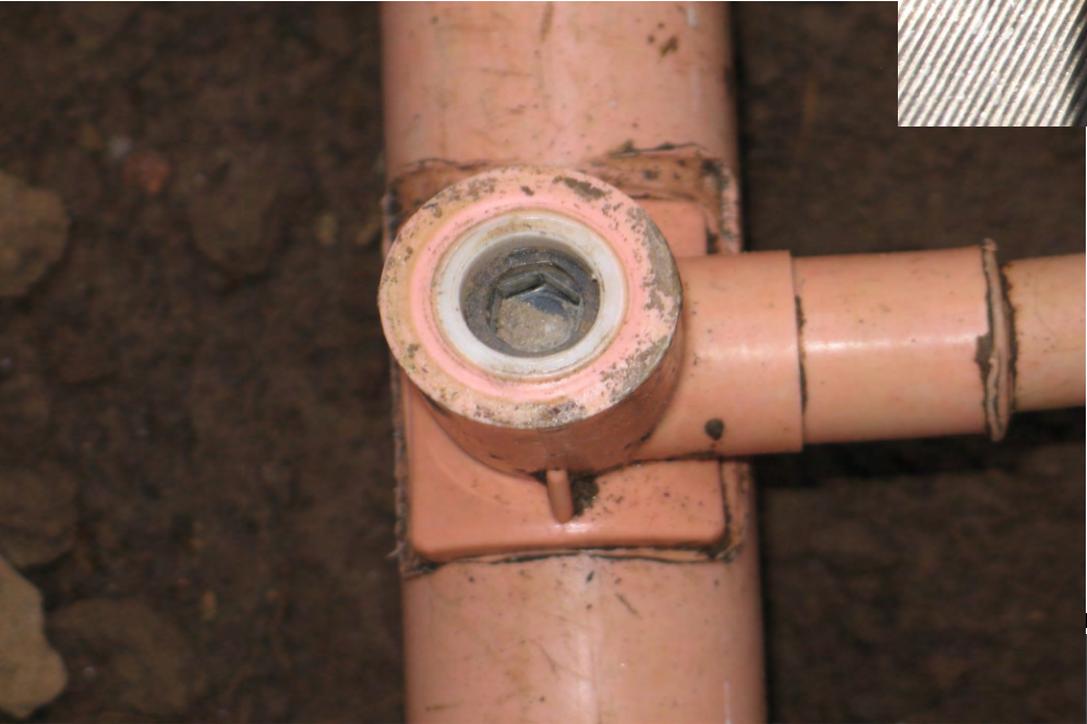
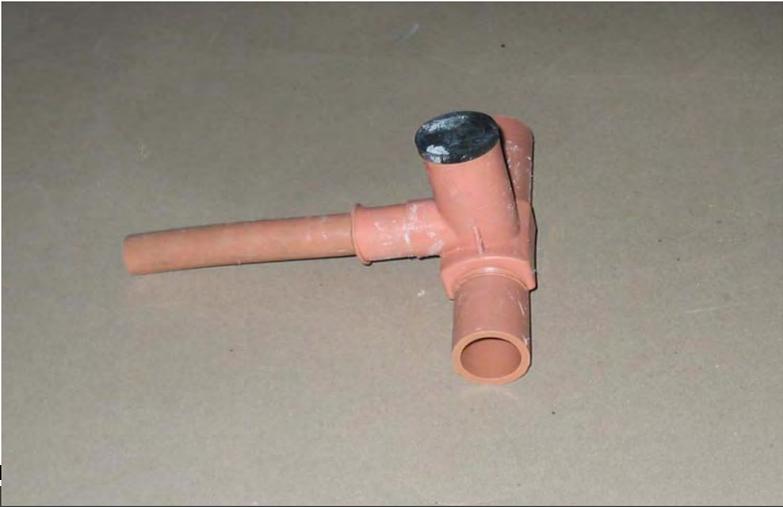
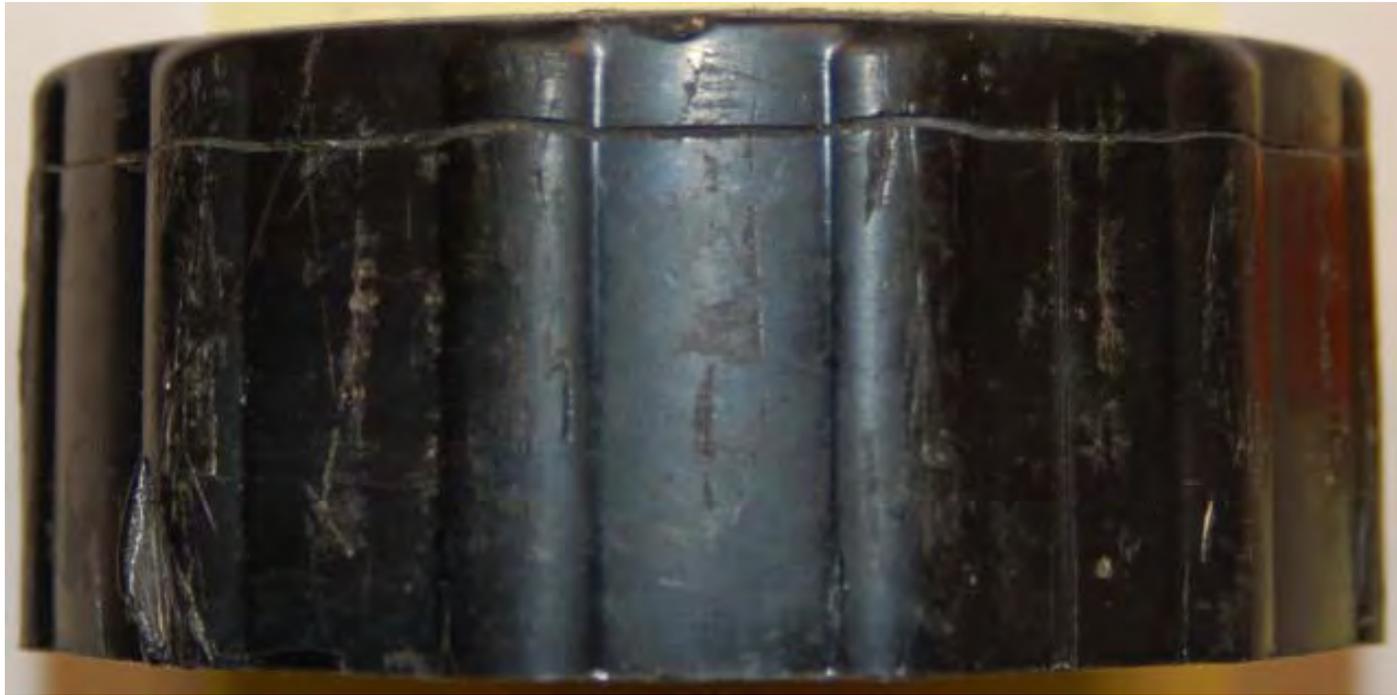
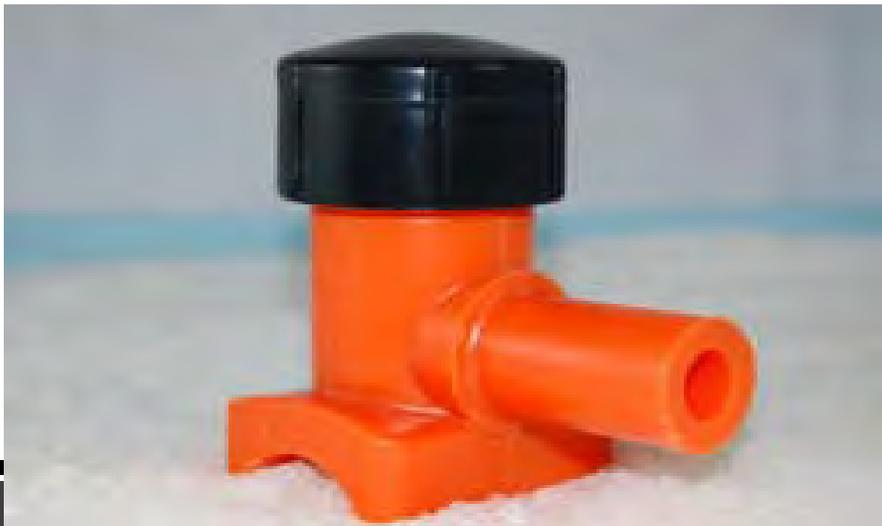
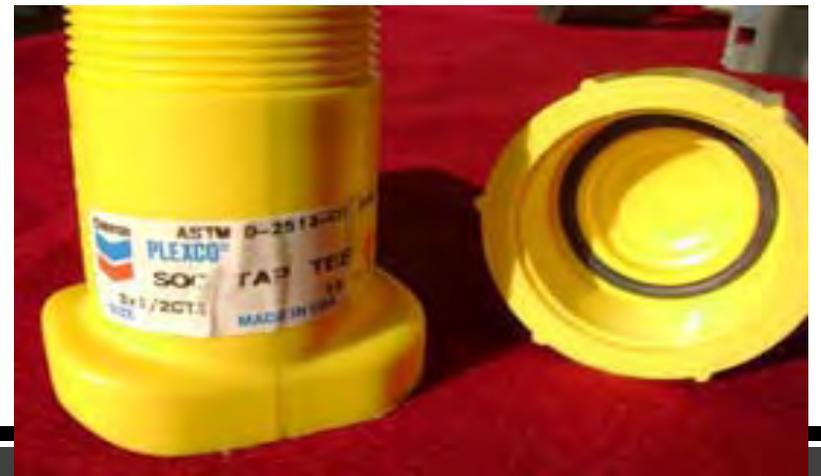
ADB-07-01 (02)

- Delrin insert tap tees
- Plexco service tee Celcon (polyacetal) caps.

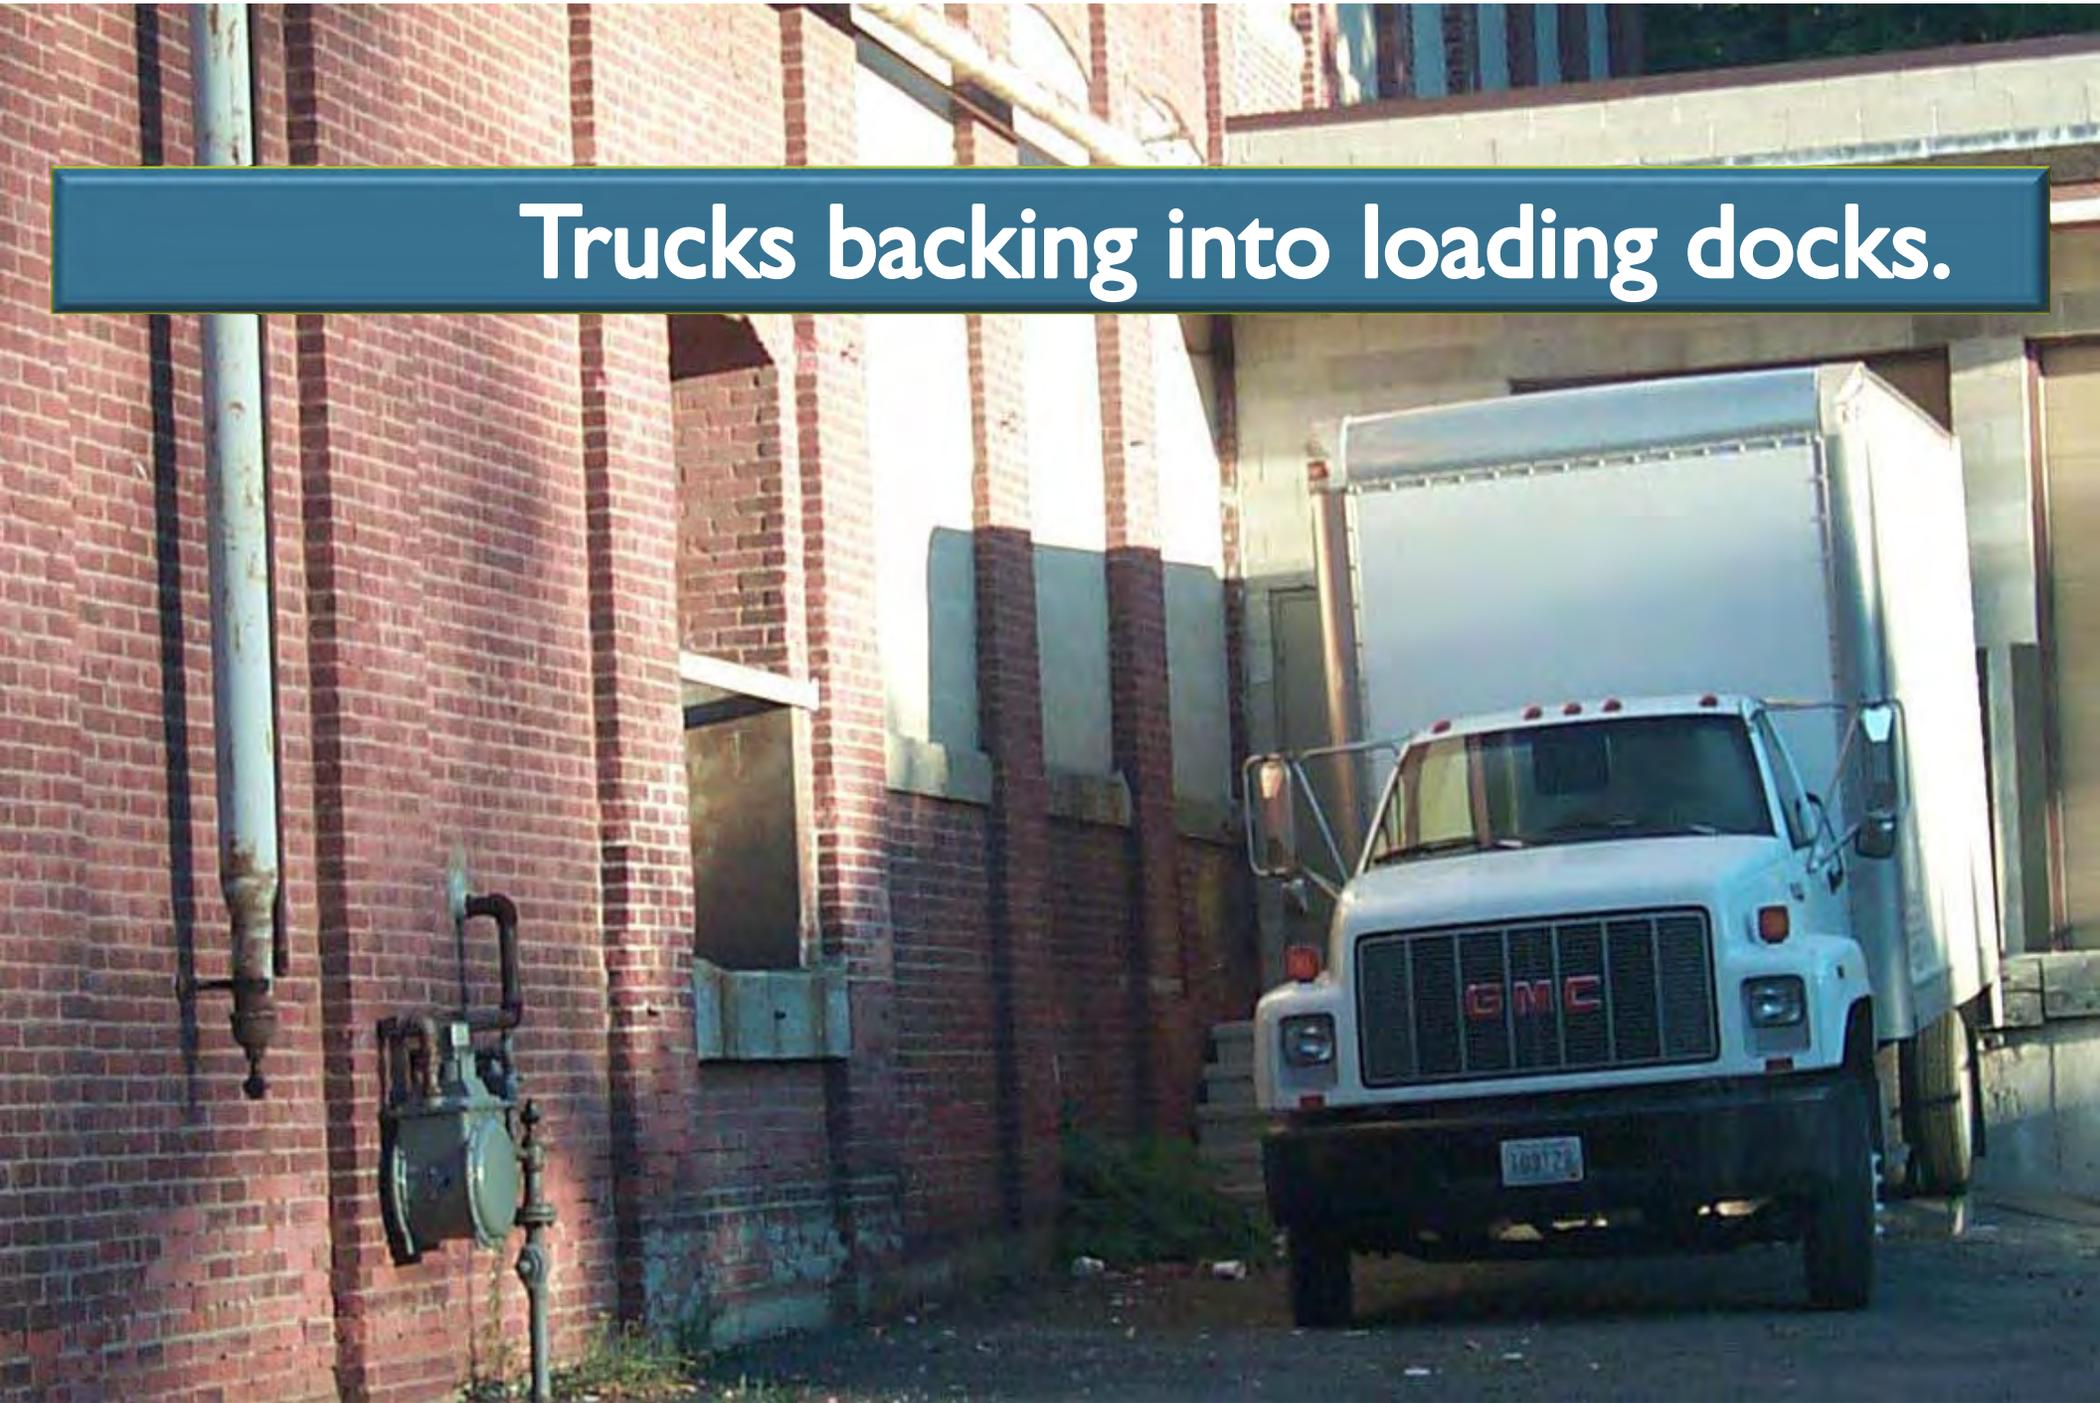
Trucks backing into loading docks.

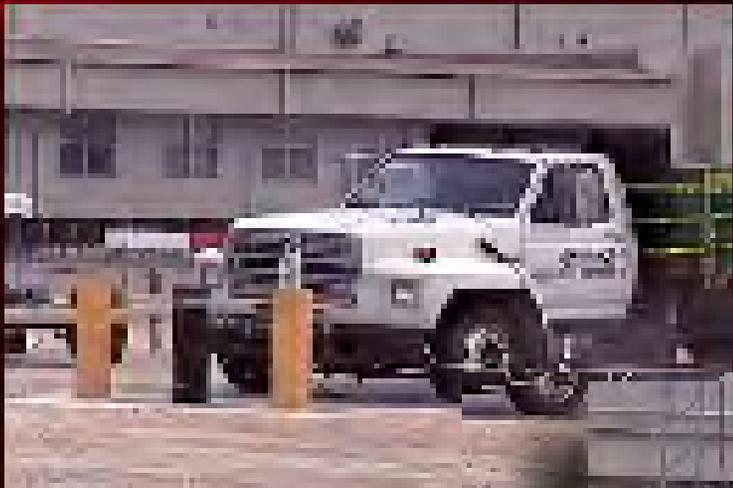
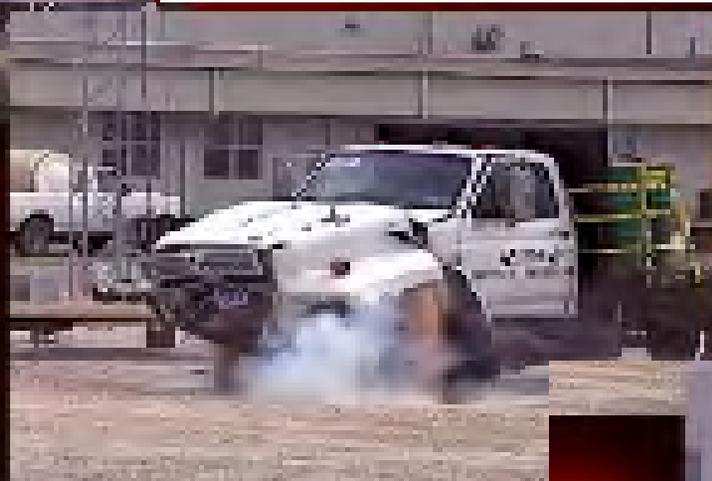
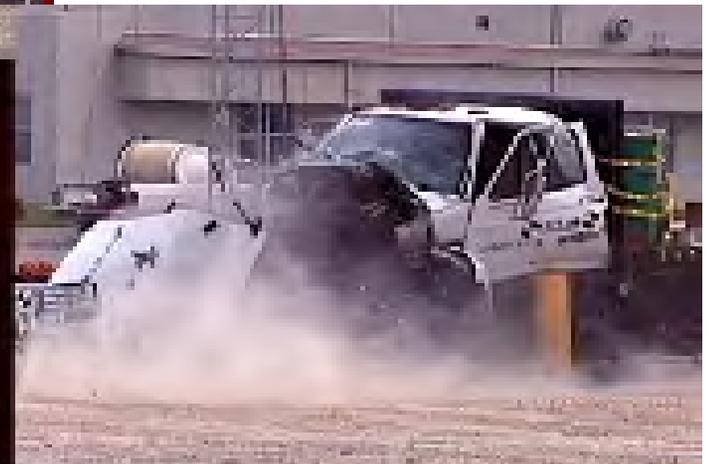
Waste Haulers.

What is Adequate
Protection?
