PHMSA/Inspector Training & Qualification

Inspection Findings!!

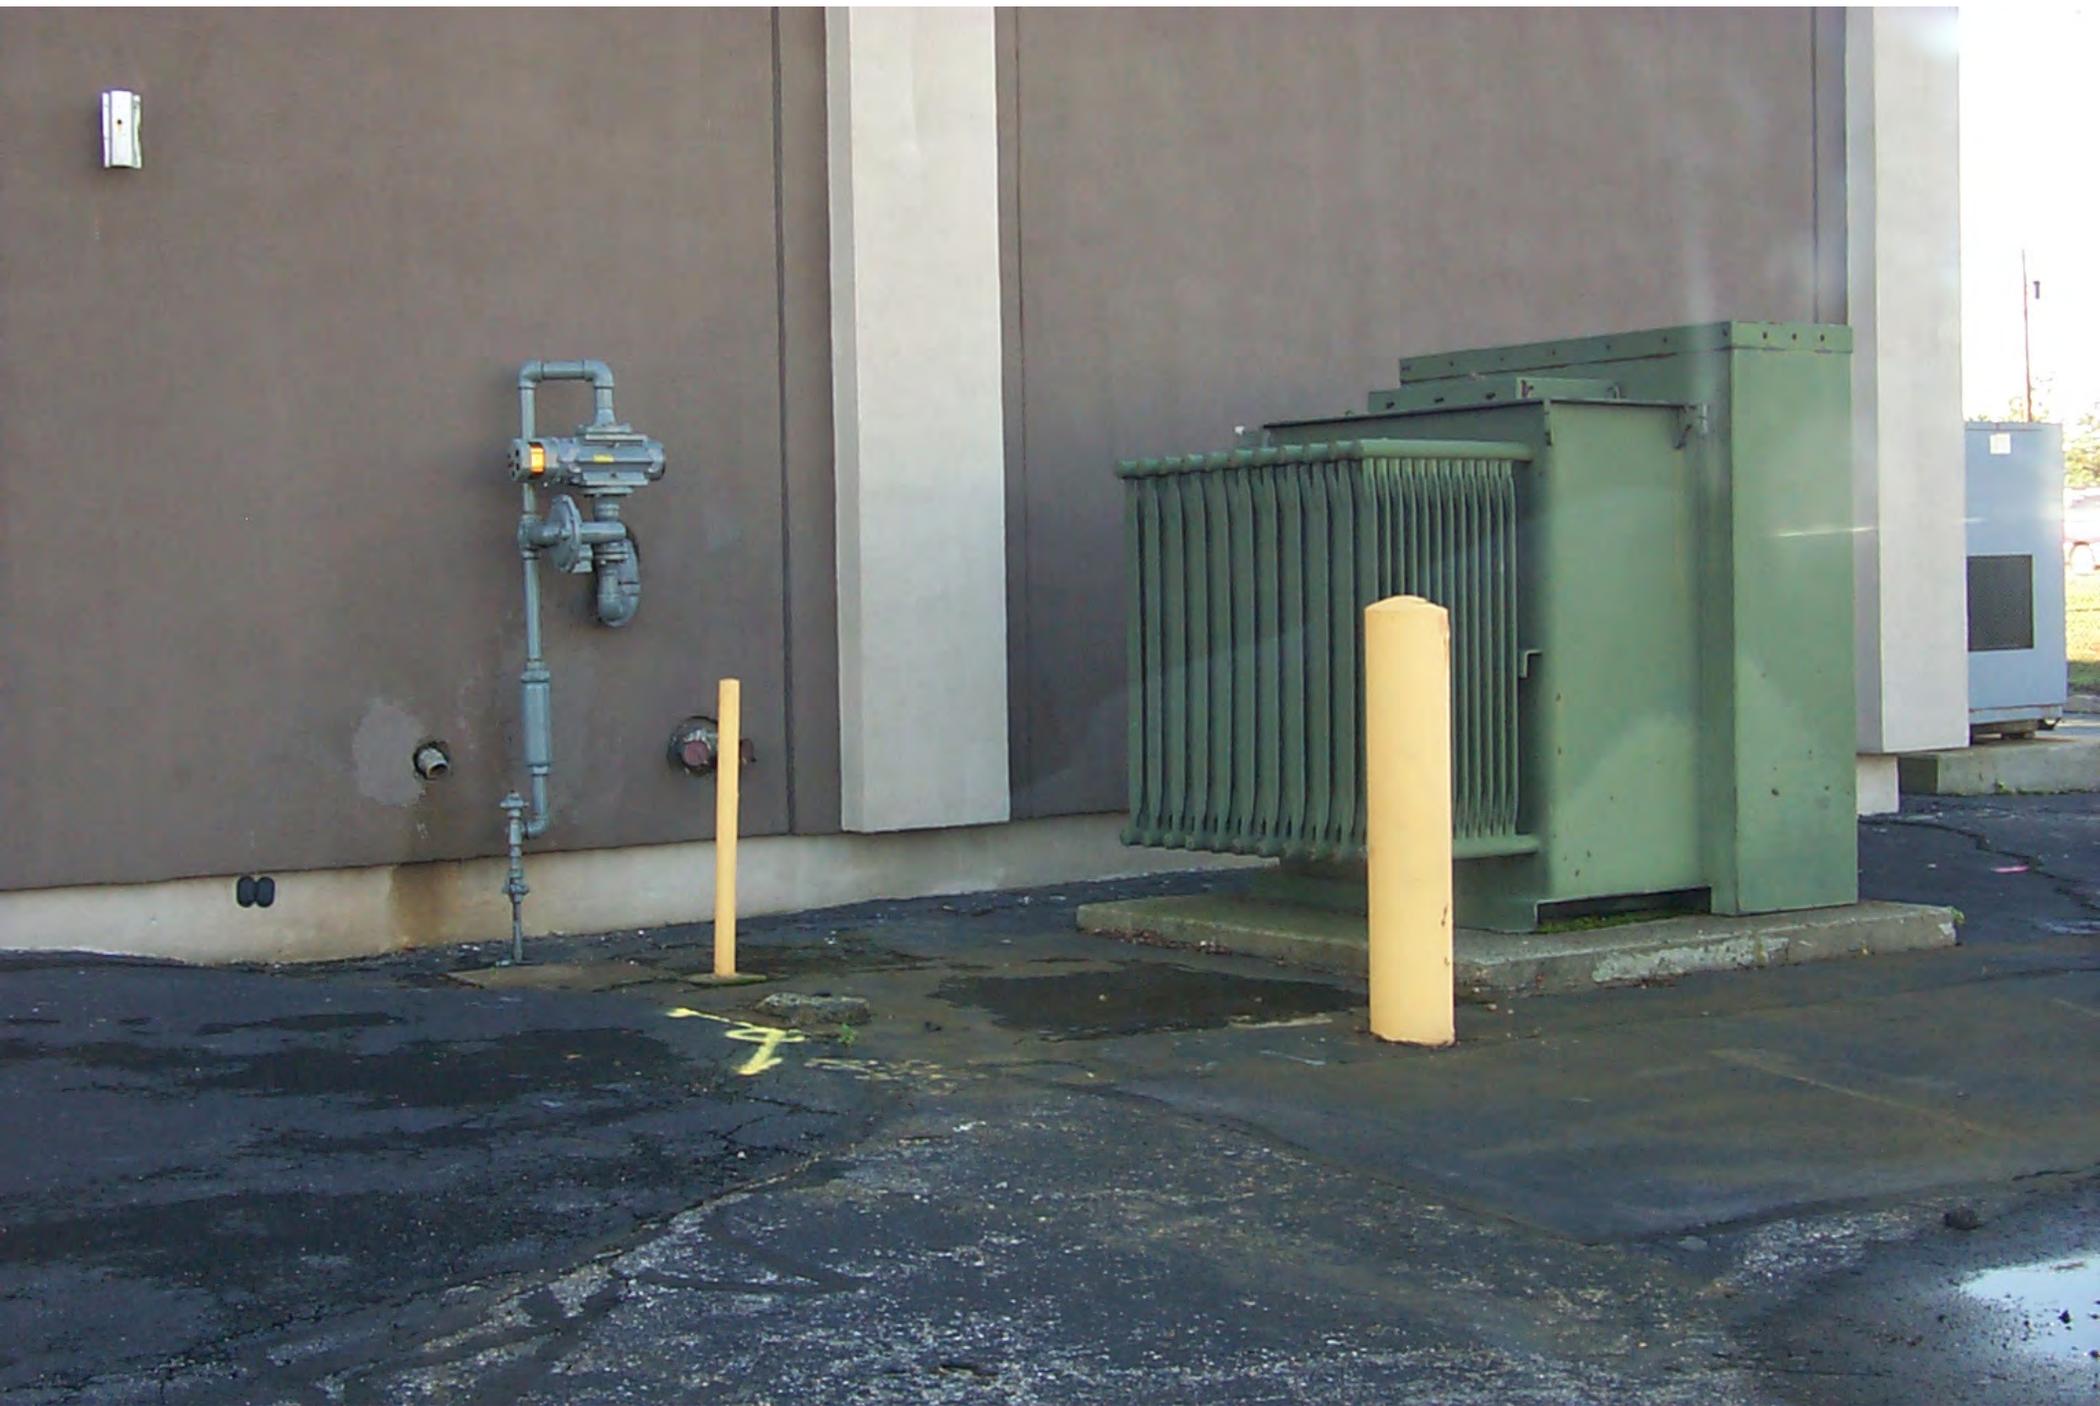
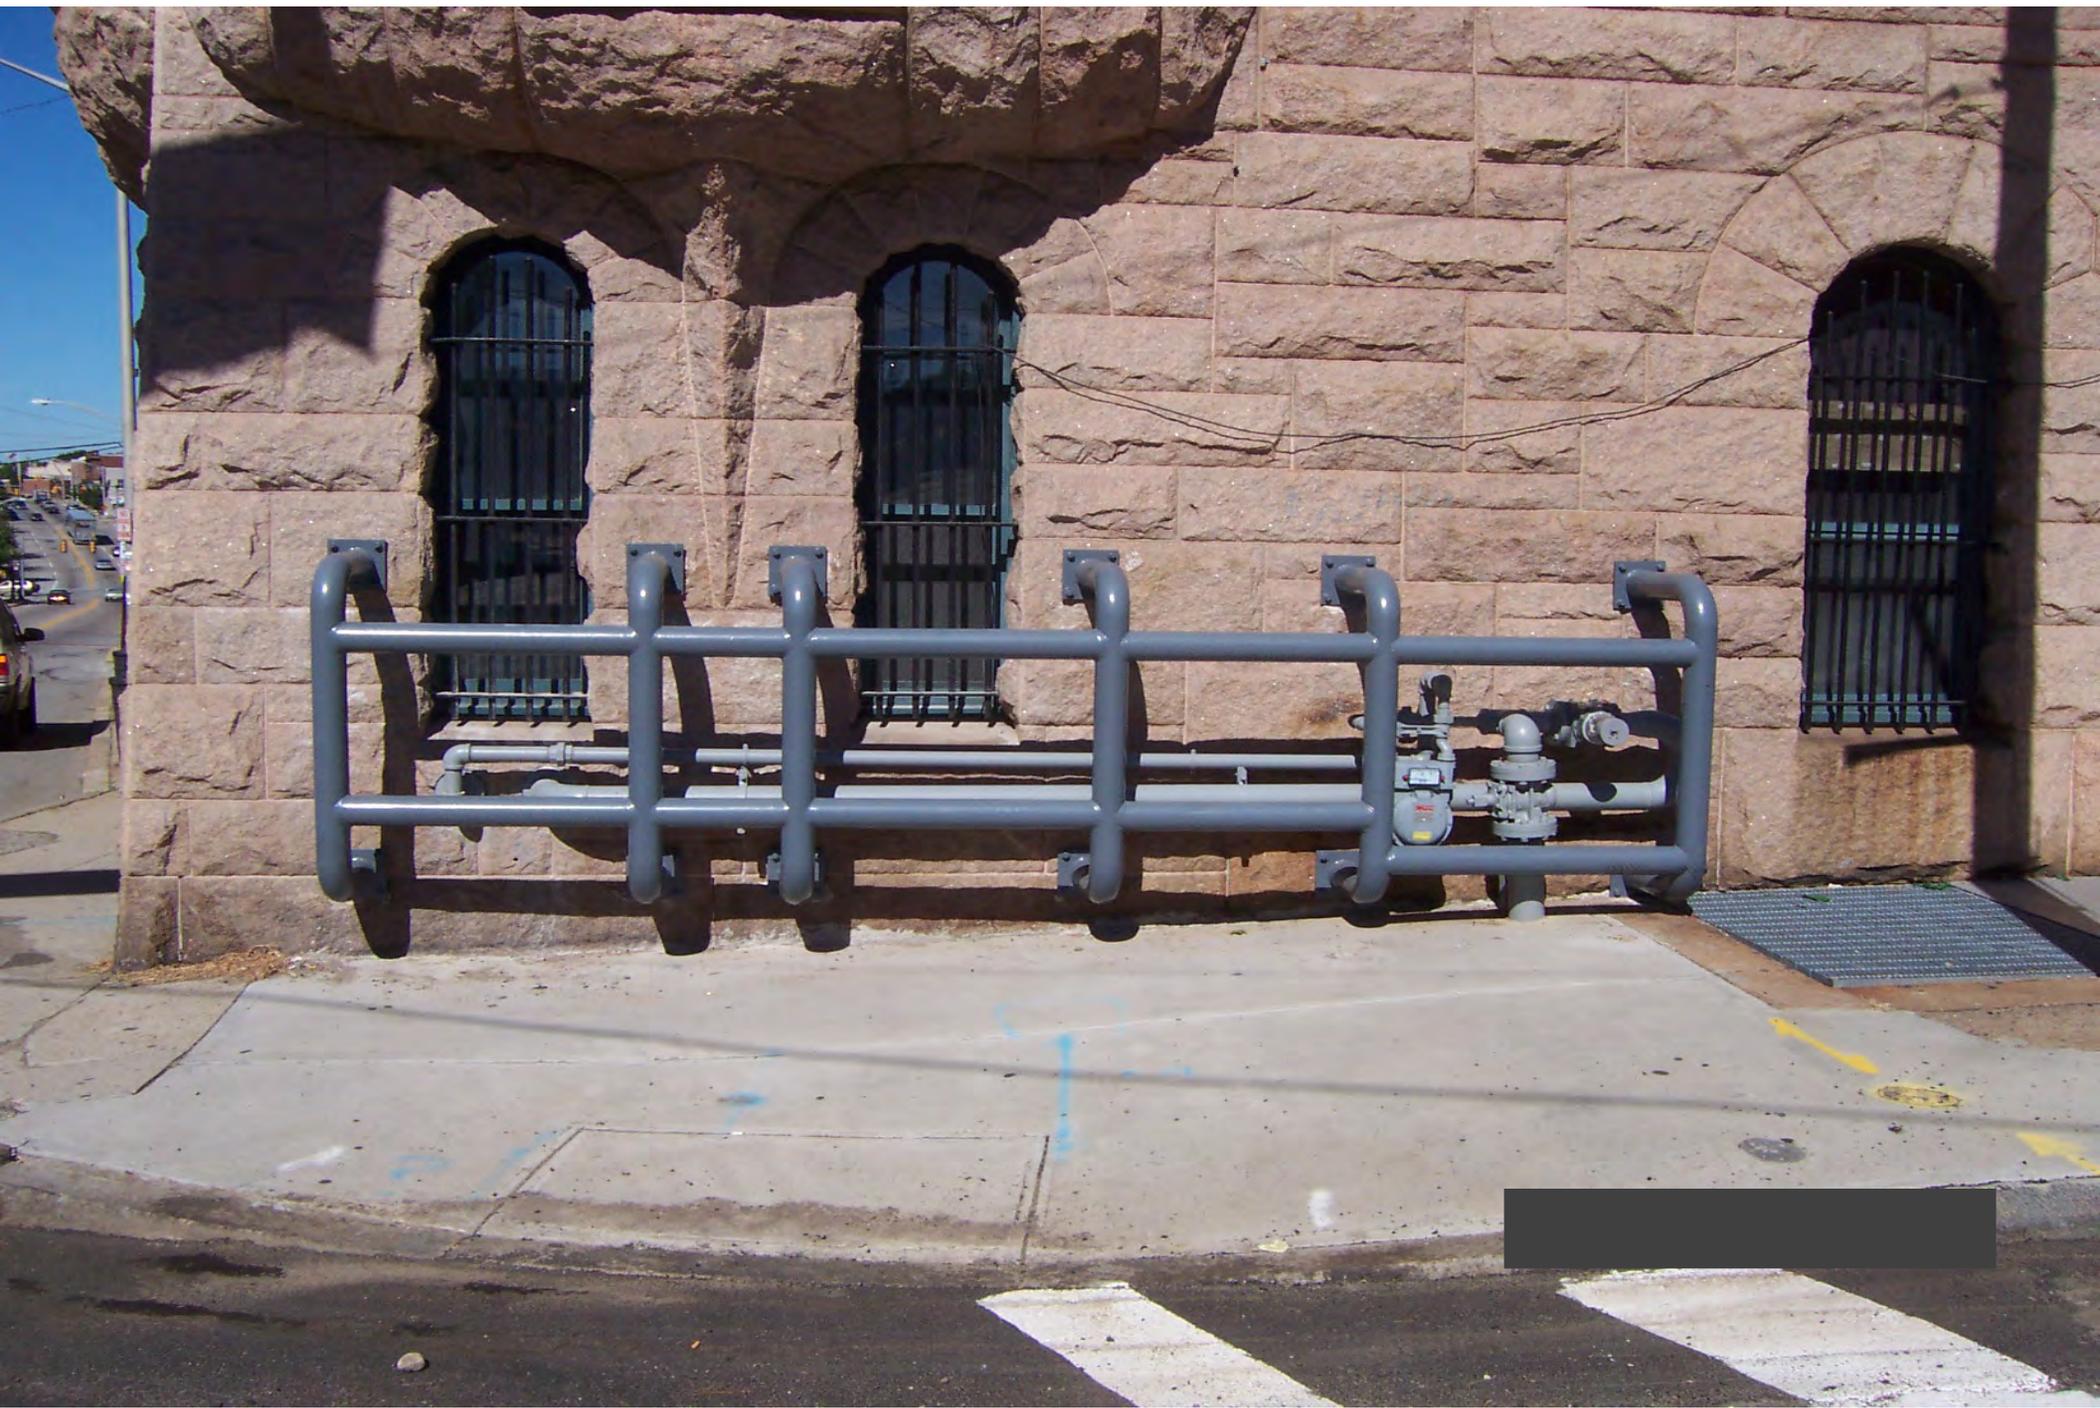
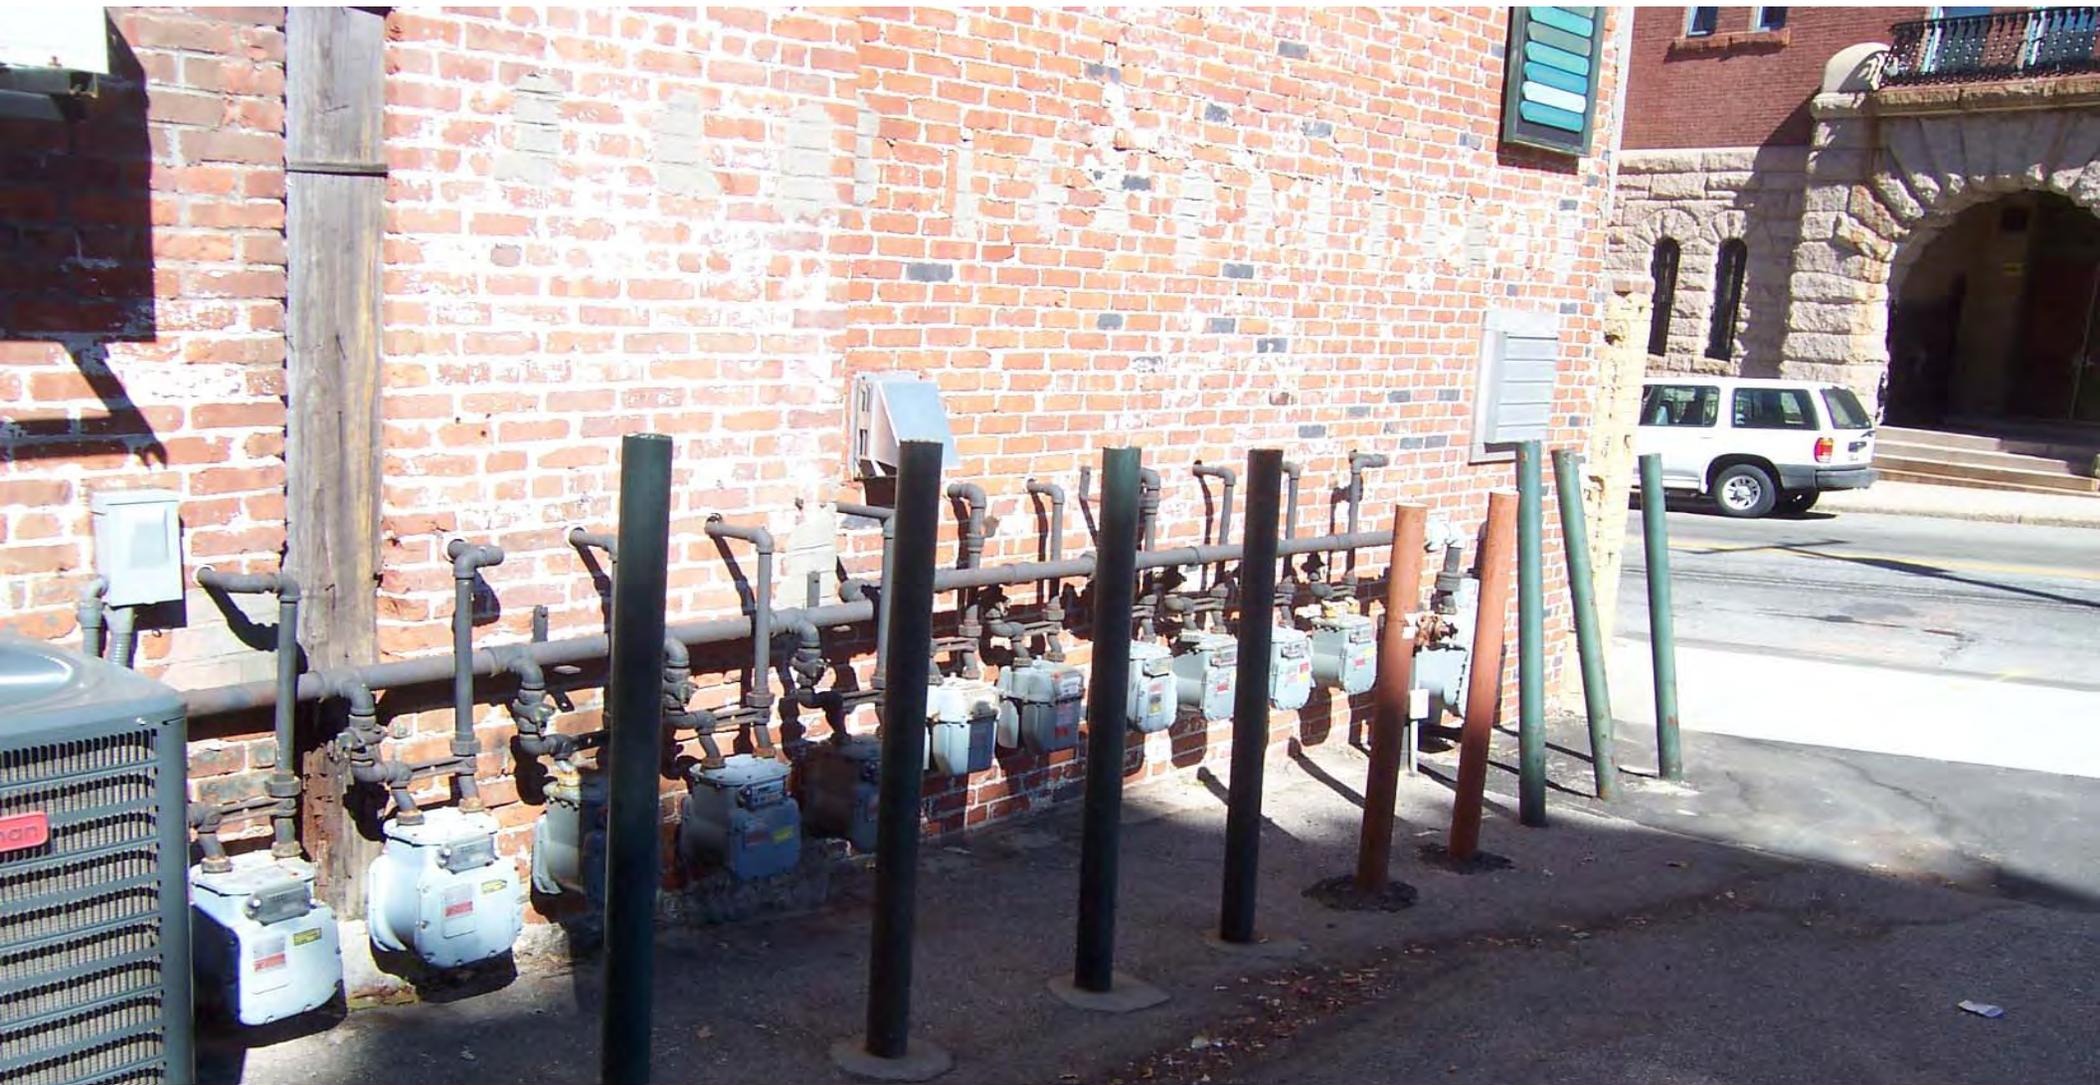
Can you drive a car through the opening?

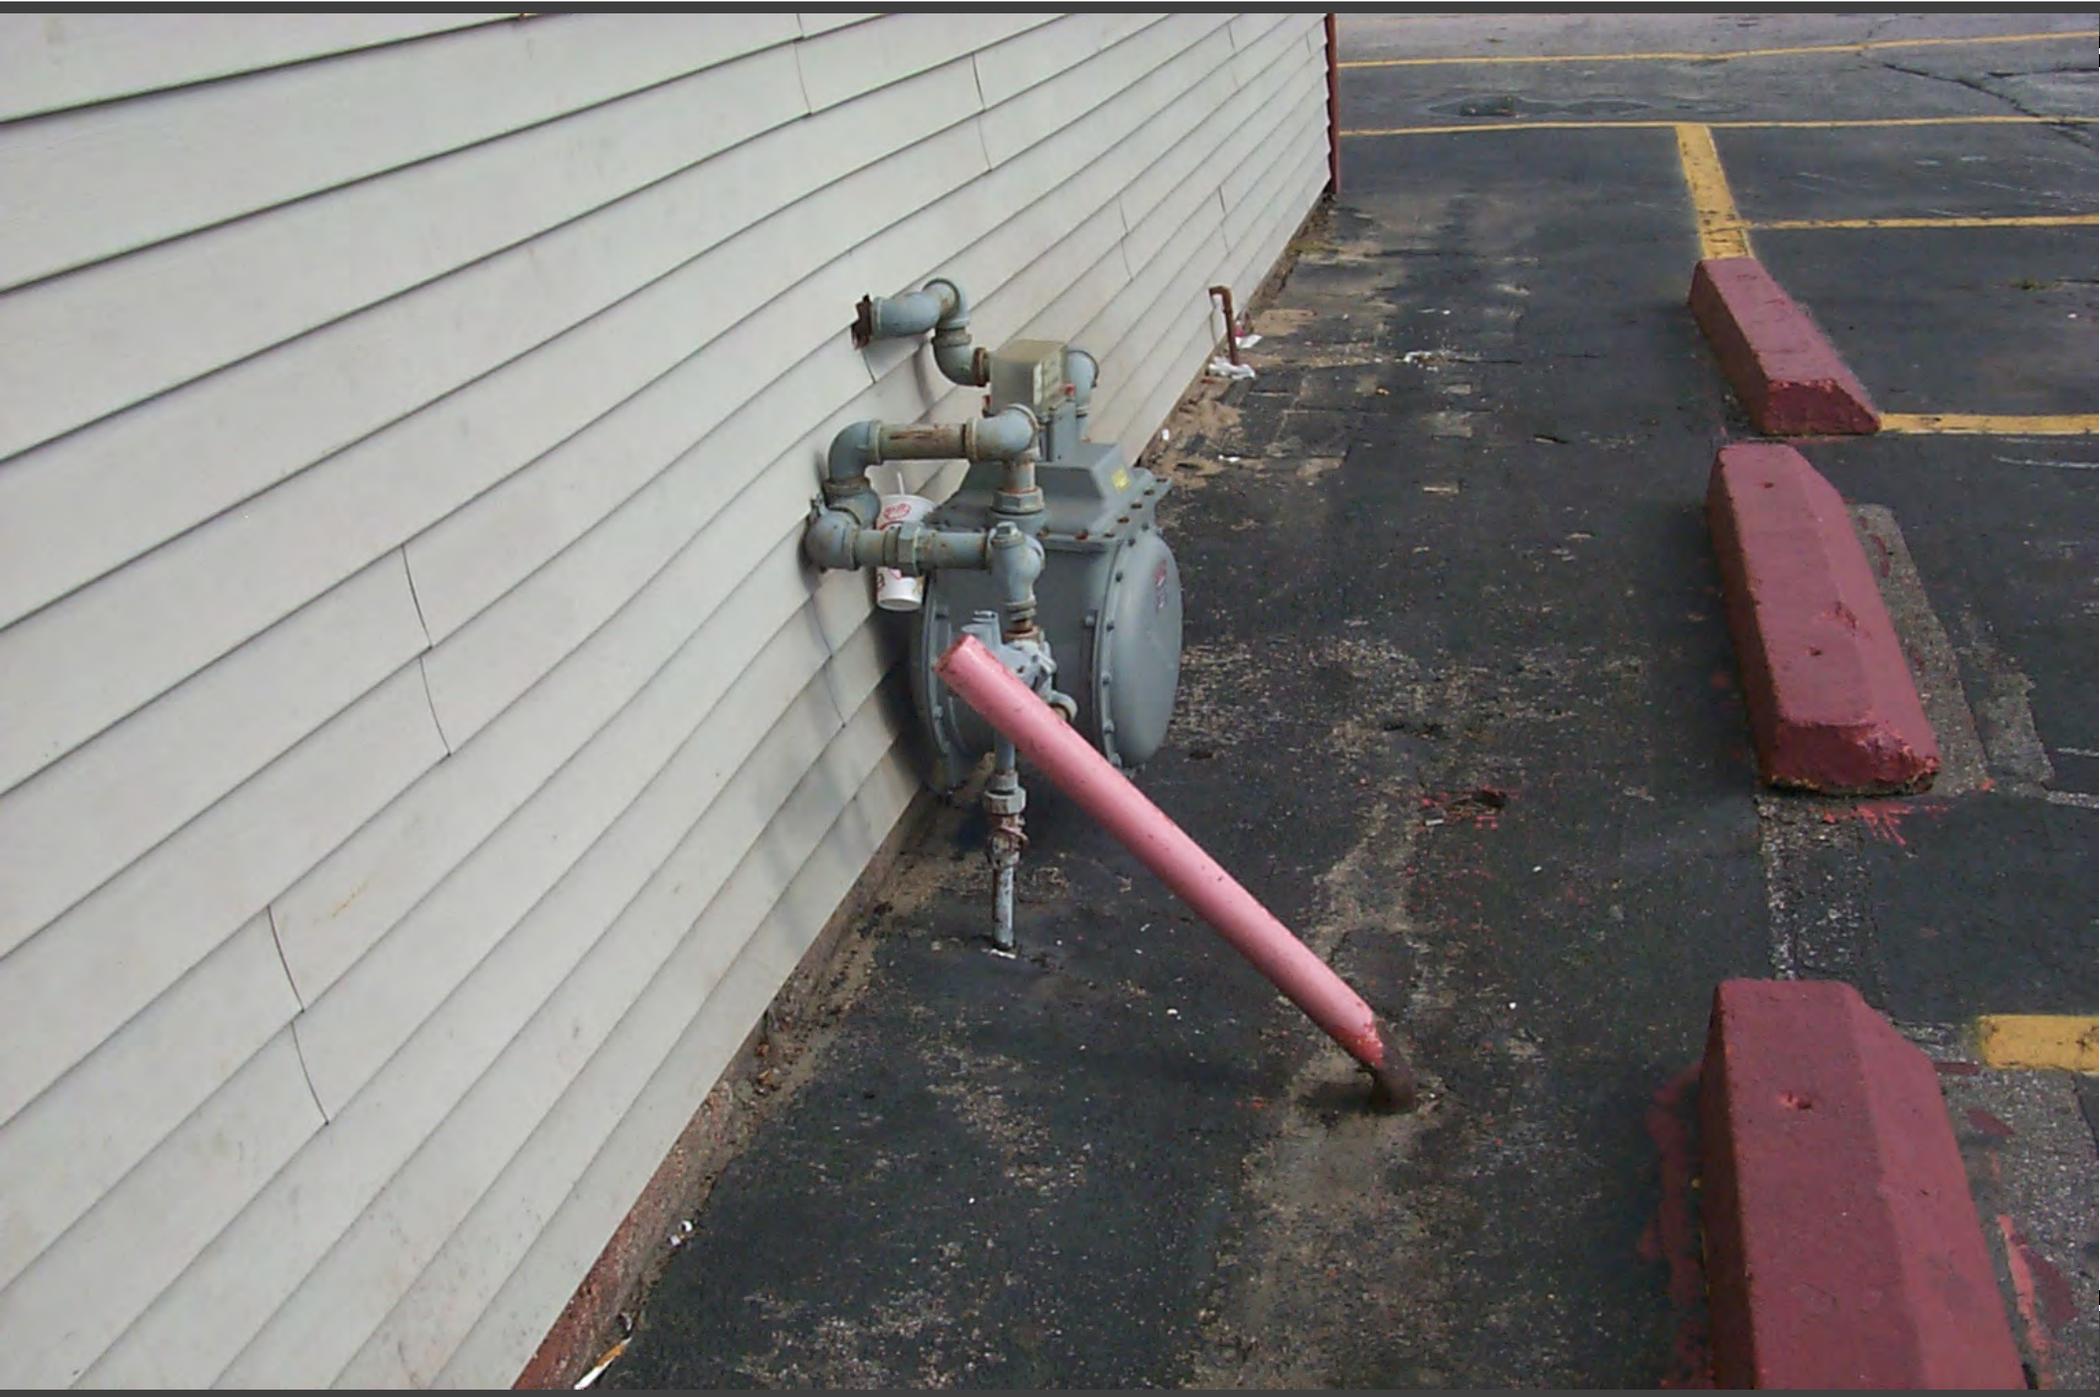
**But you
don't have
to go
overboard
by adding
too many
posts.**

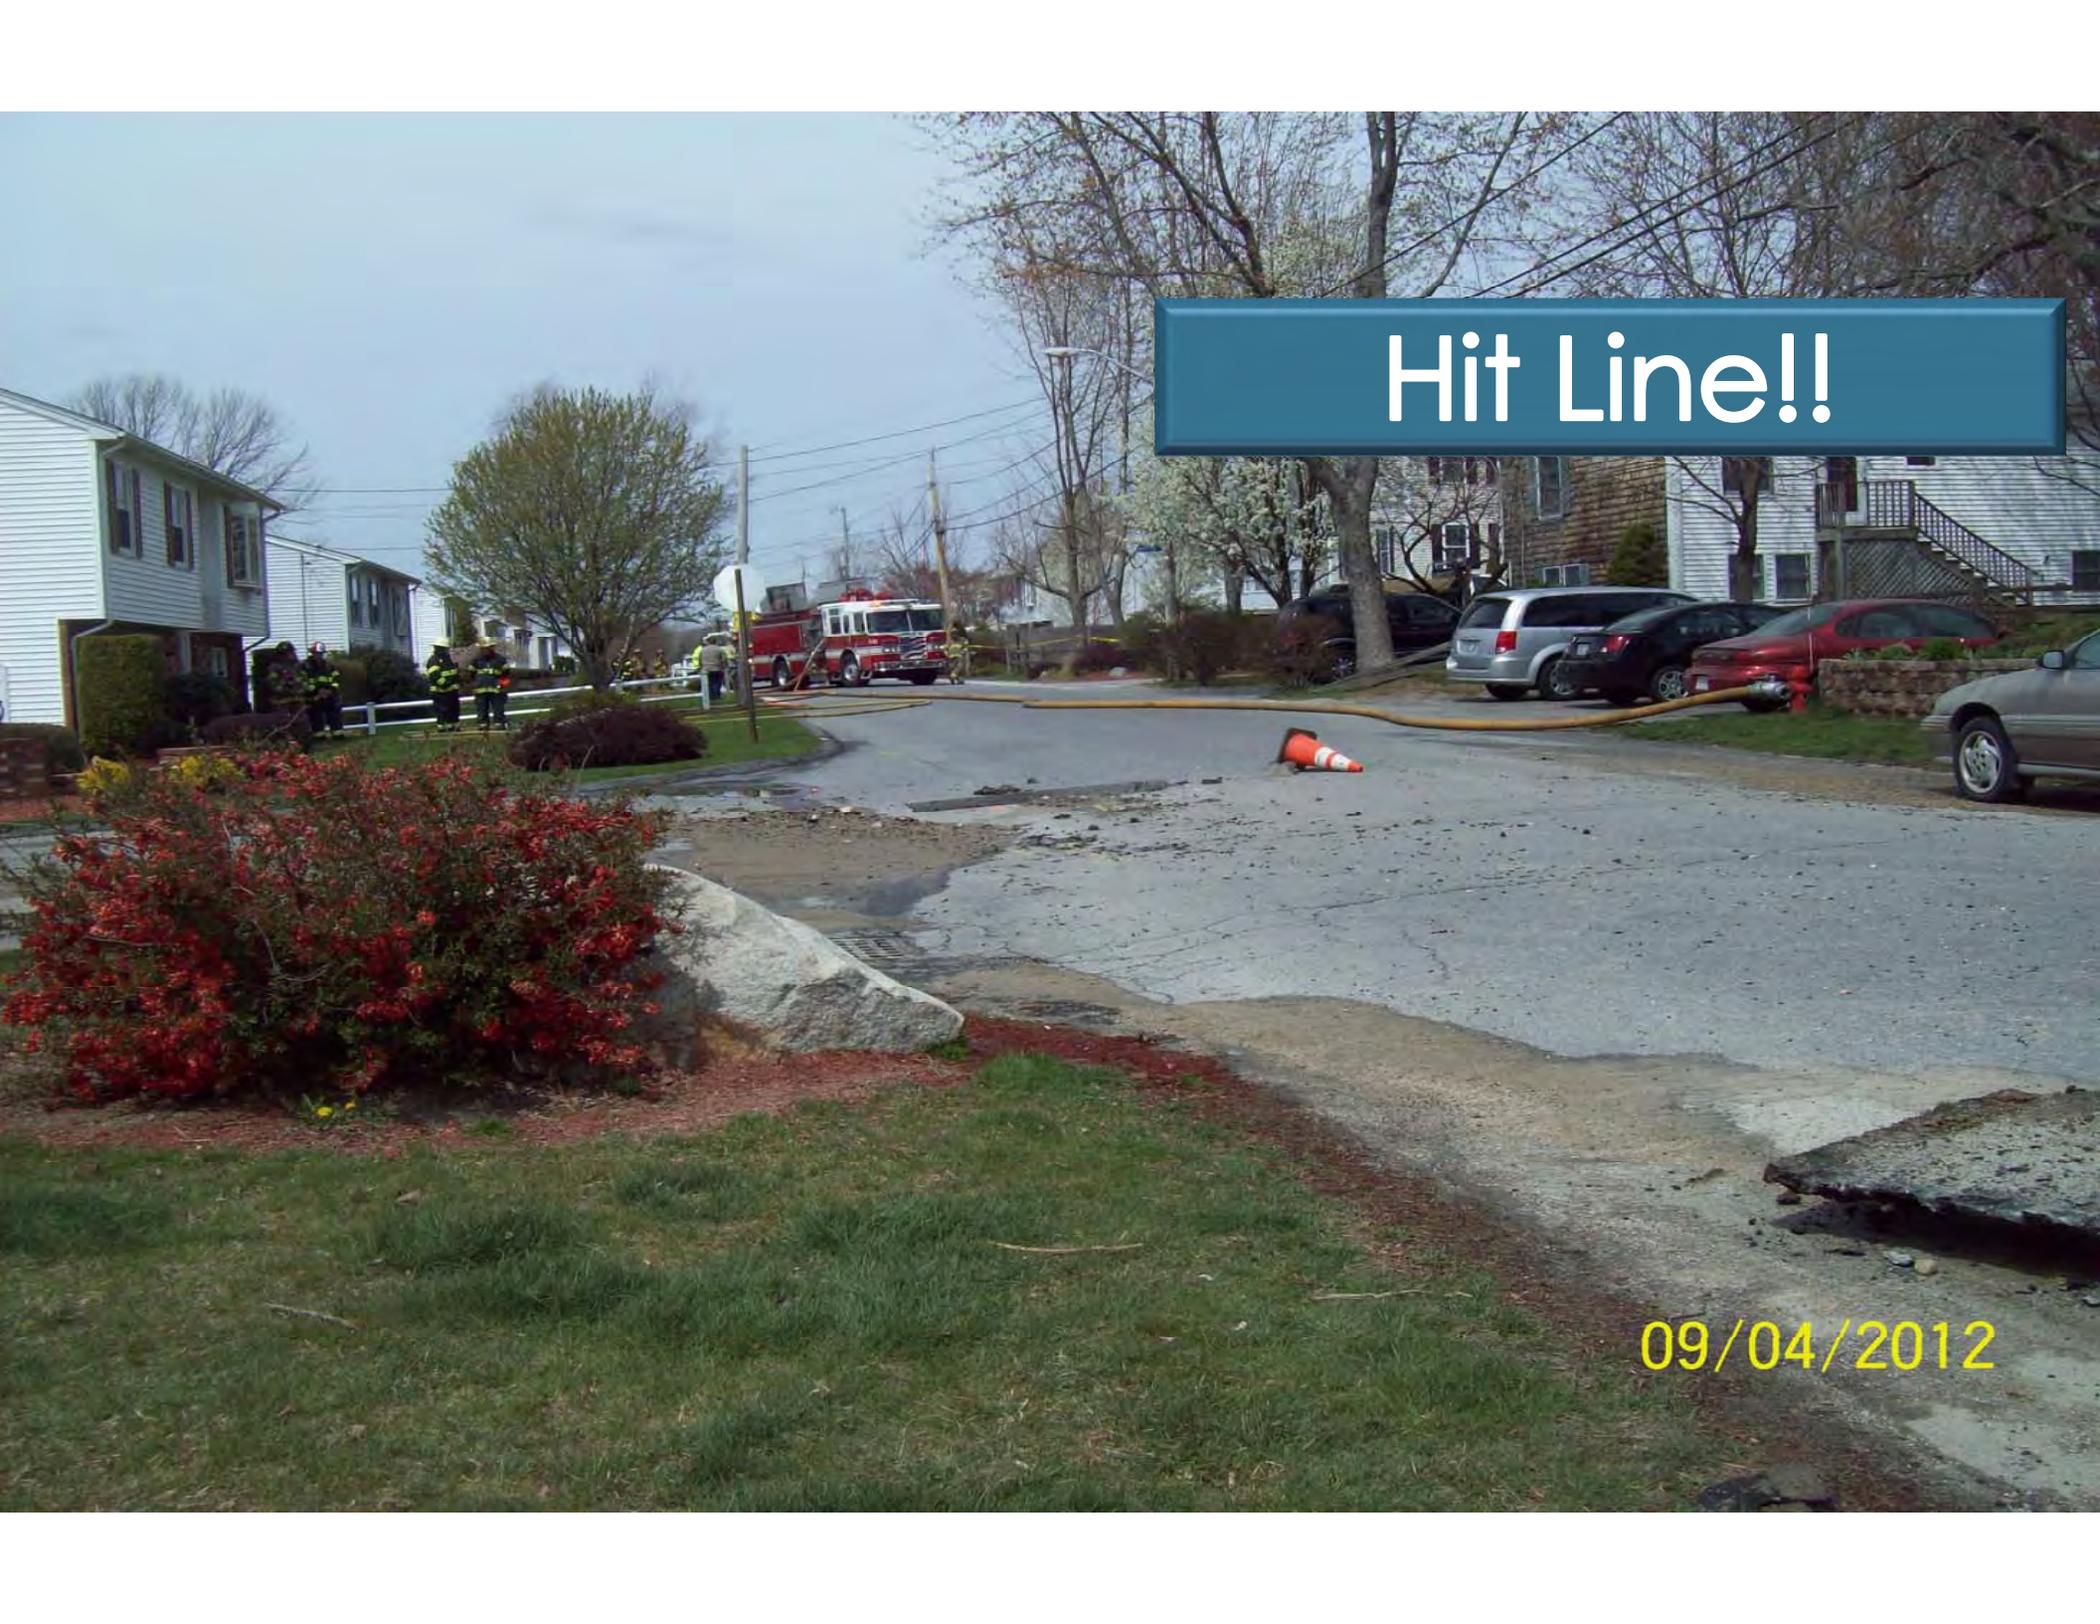
Hit Line!!

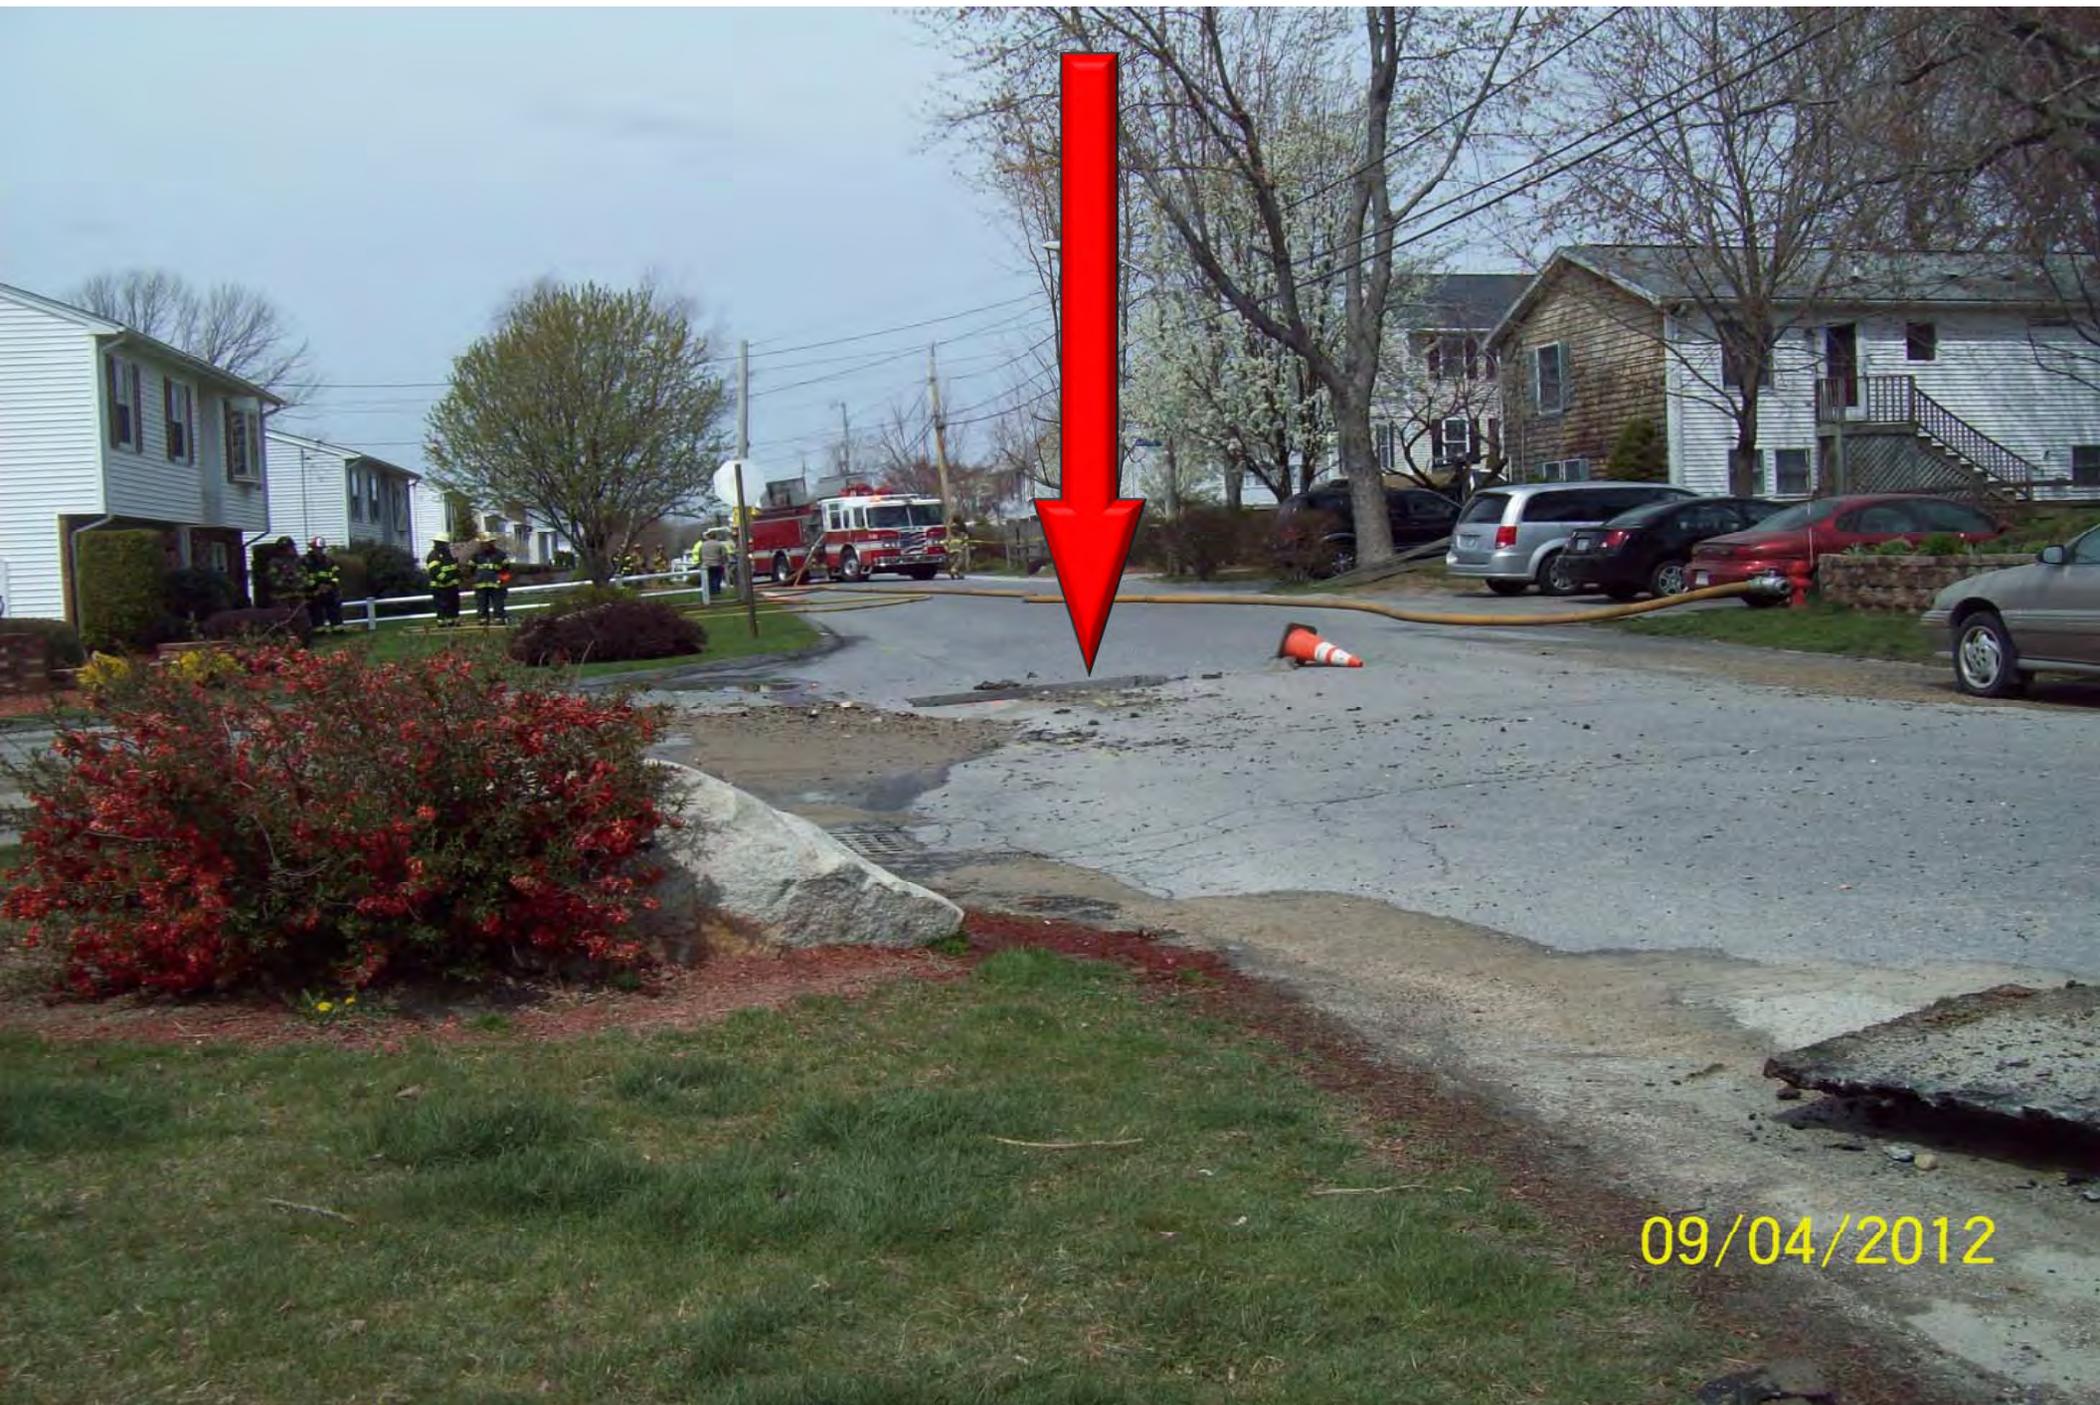
60 psi gas
blowing for 7
hrs

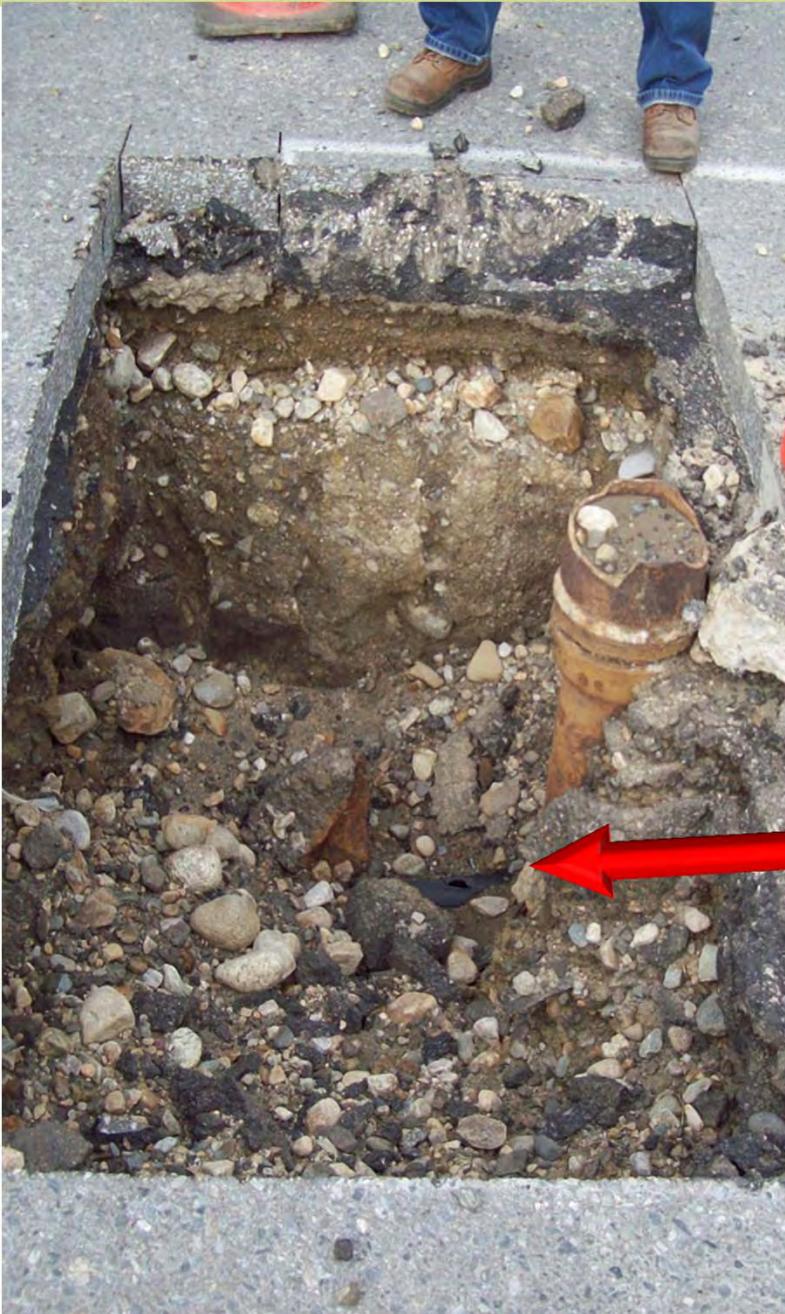
60 psi gas
blowing here

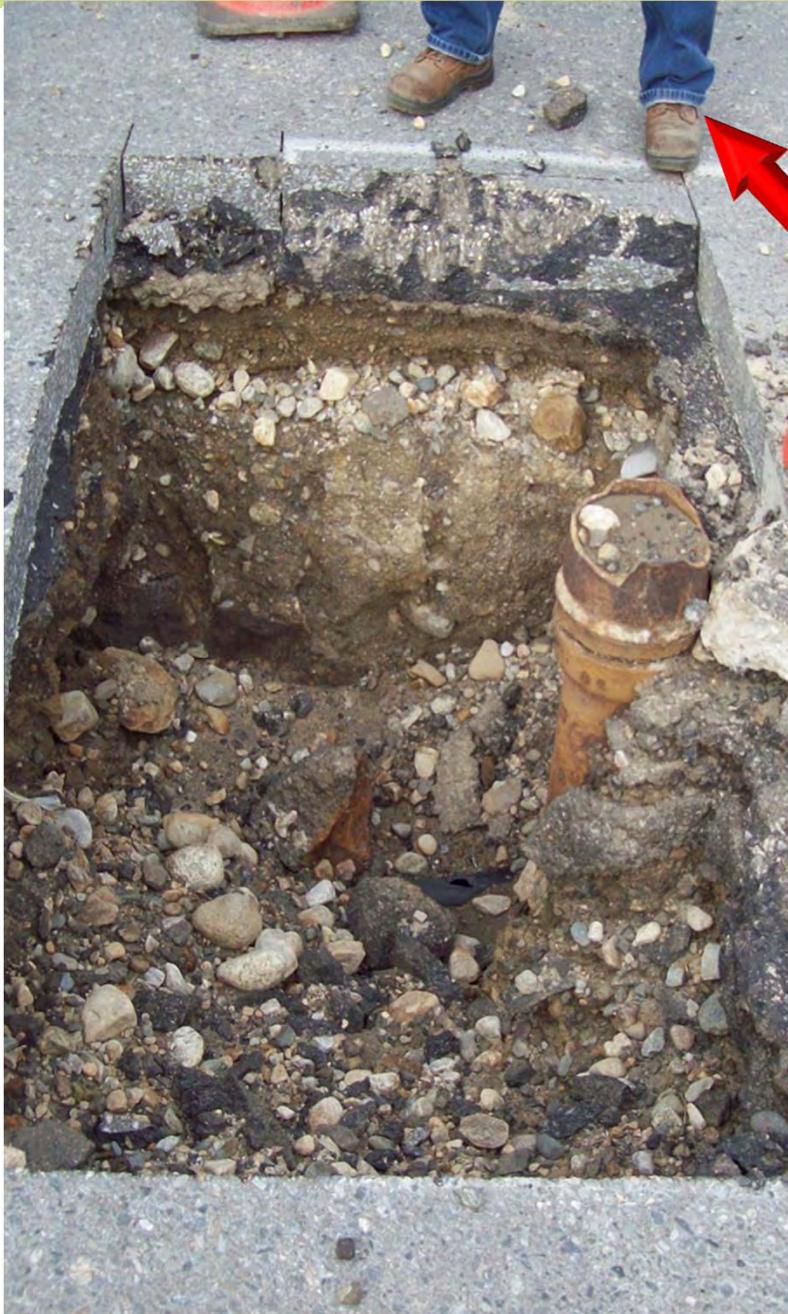
Backhoe
operator who hit
the gas line is
taking pictures
with his cell
phone.

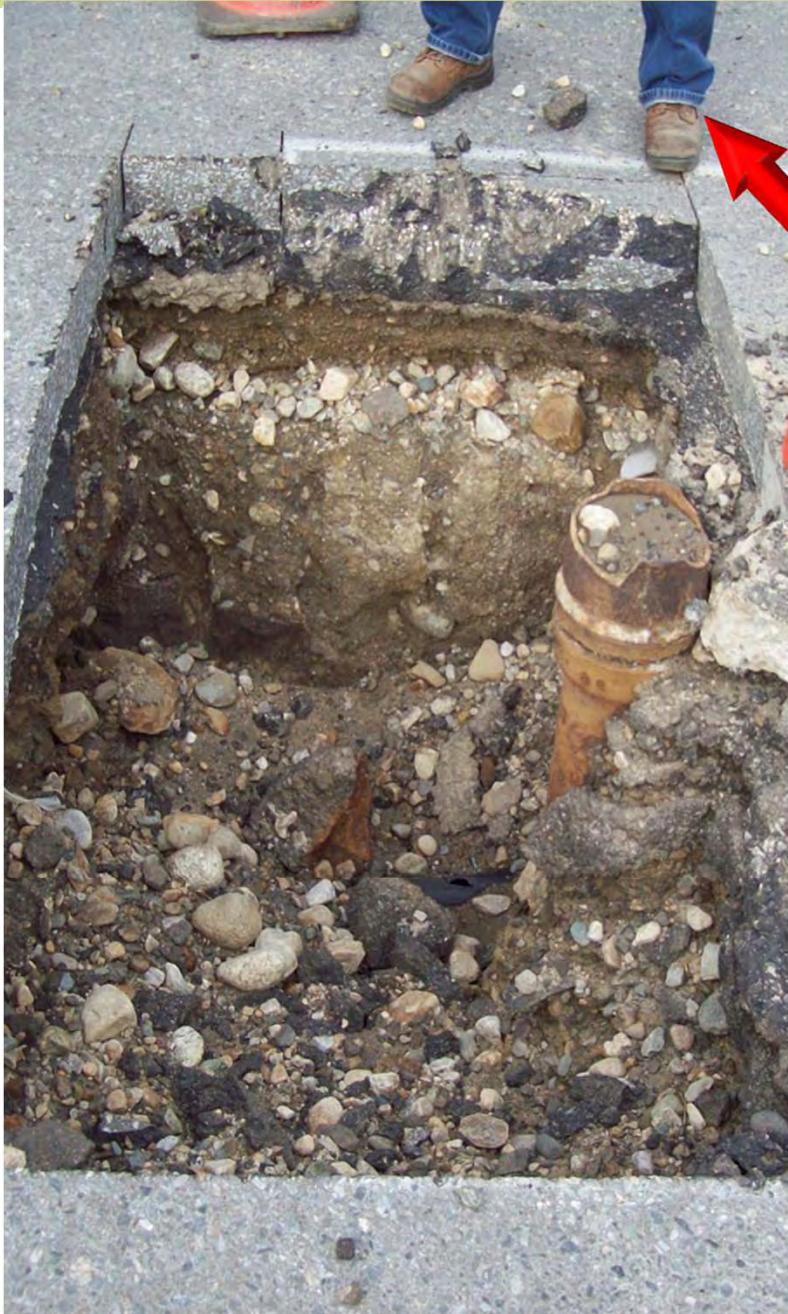
Gas line is
Mismarked
by 26
inches

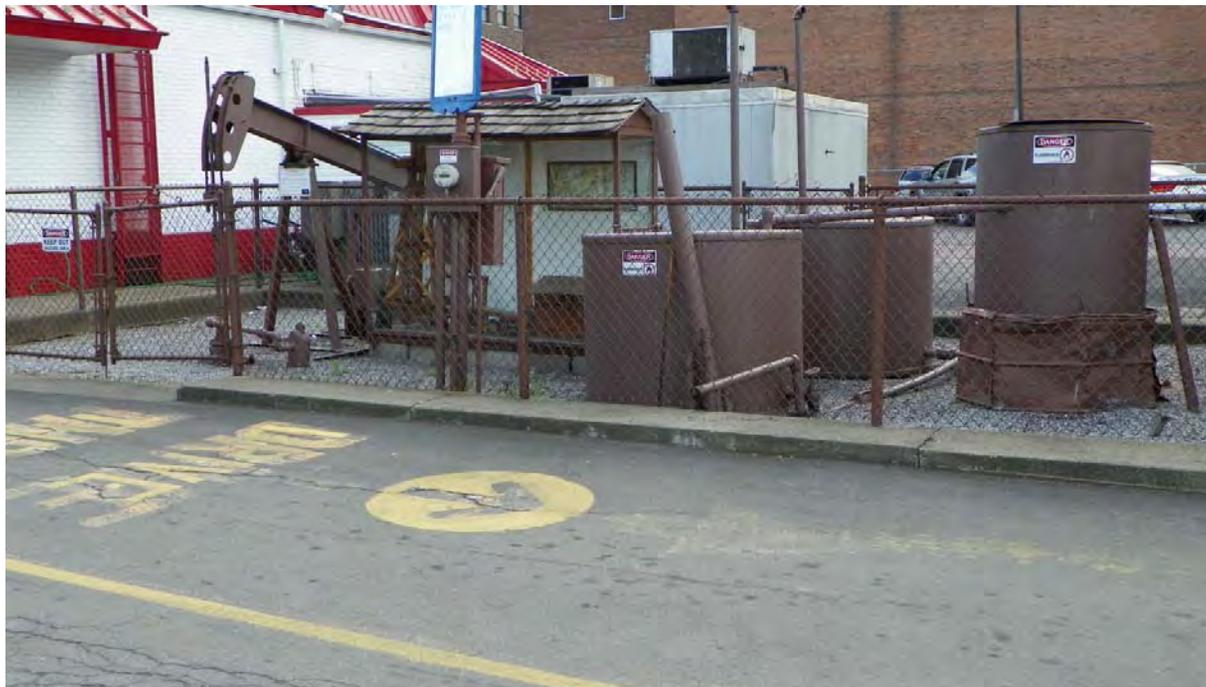
Active Oil Well at McDonald's Drive Thru – Bradford, PA
